**Re: Liner Inspection and Closure Request
ConocoPhillips (Heritage COG Operating, LLC)
Pygmy 27 State #001H Tank Battery Release
Lea County, New Mexico
DOR: 7/30/2018
Incident ID nOY1821448734
Approximate Release Point: 32.45616°, -103.56834°**

Liner Inspection and Closure Request
September 1, 2023

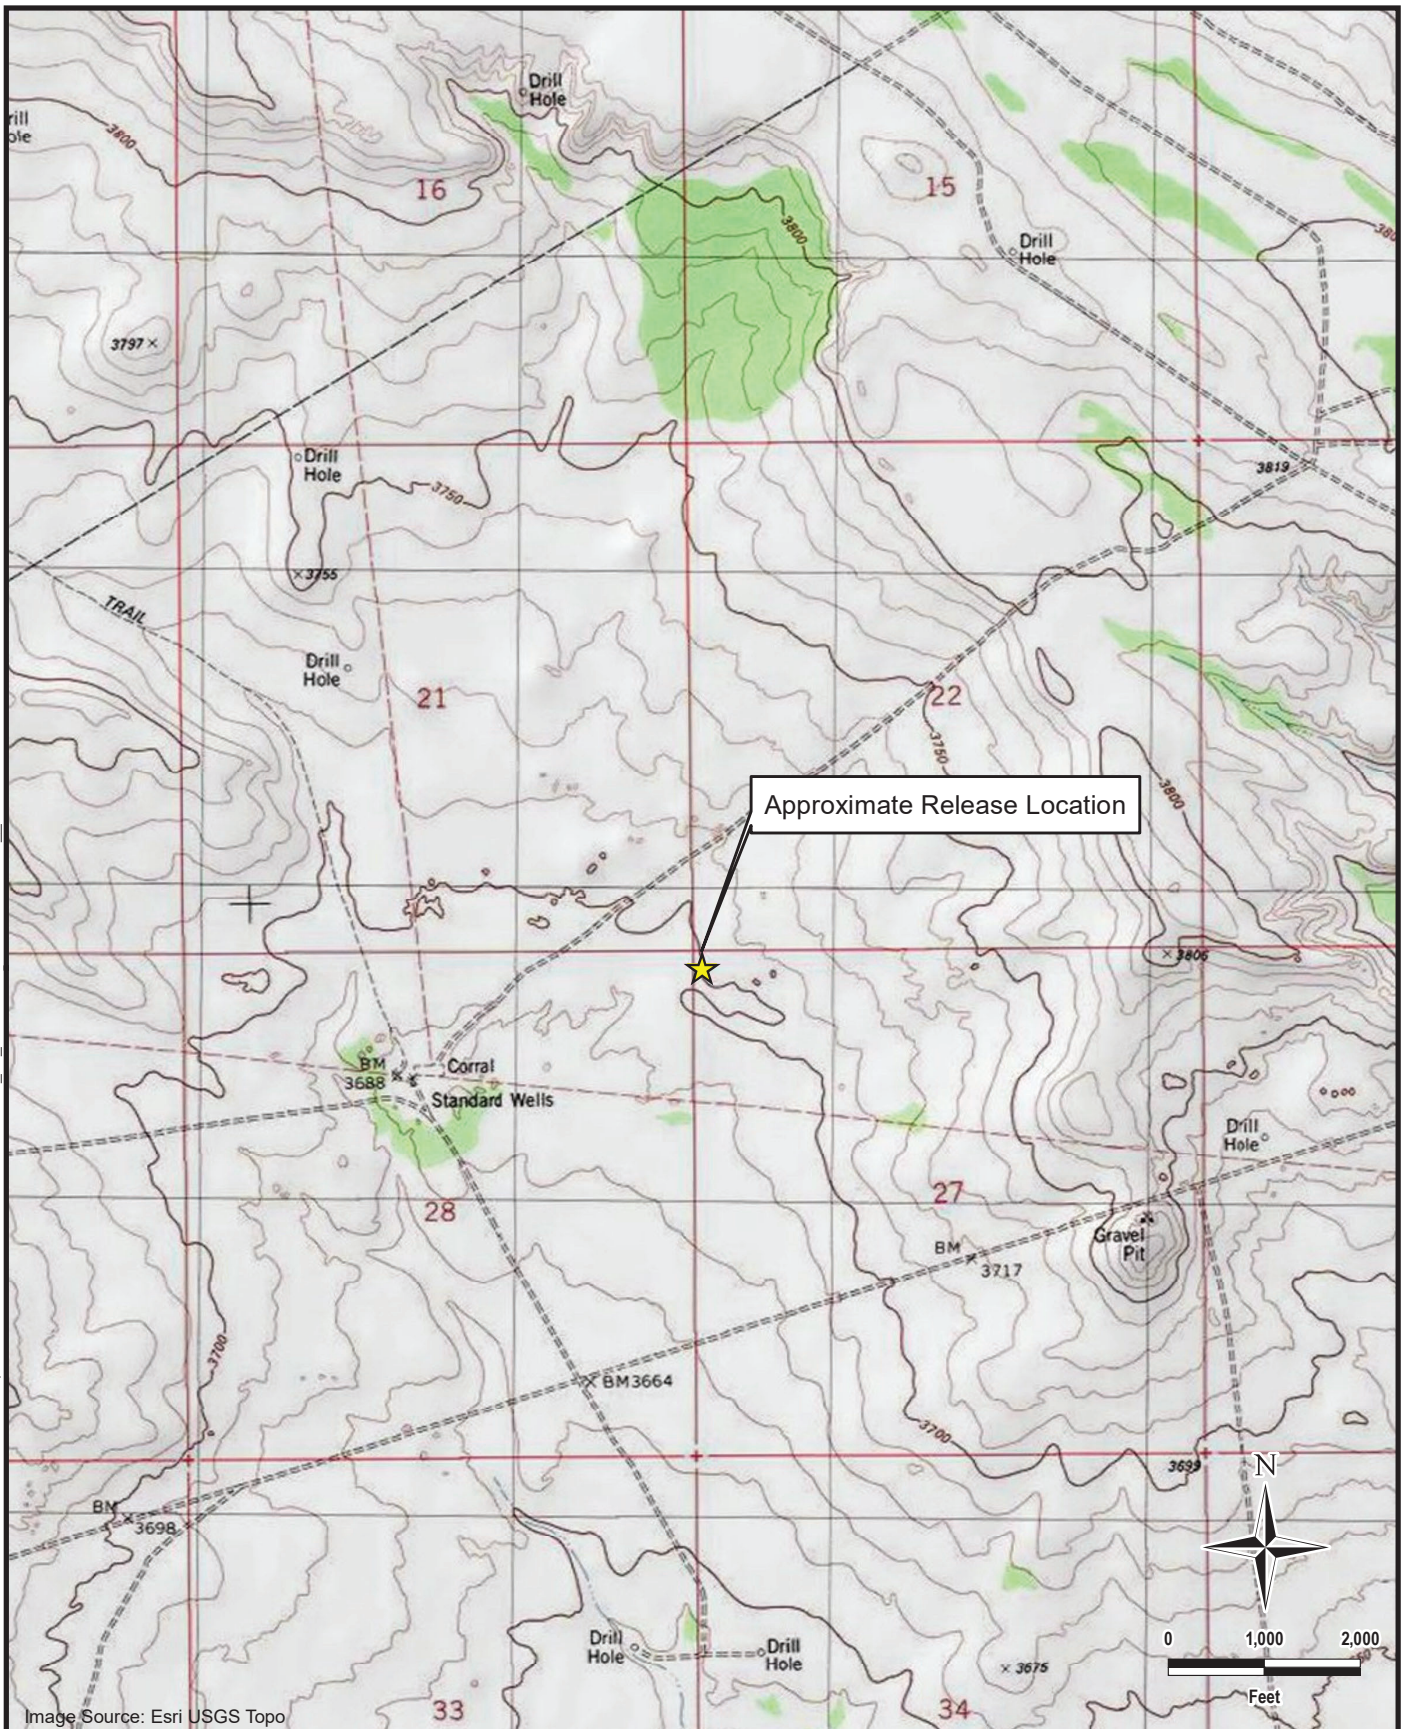
Figure No.

**PYGMY 27 STATE #001H RELEASE
TOPOGRAPHIC MAP**

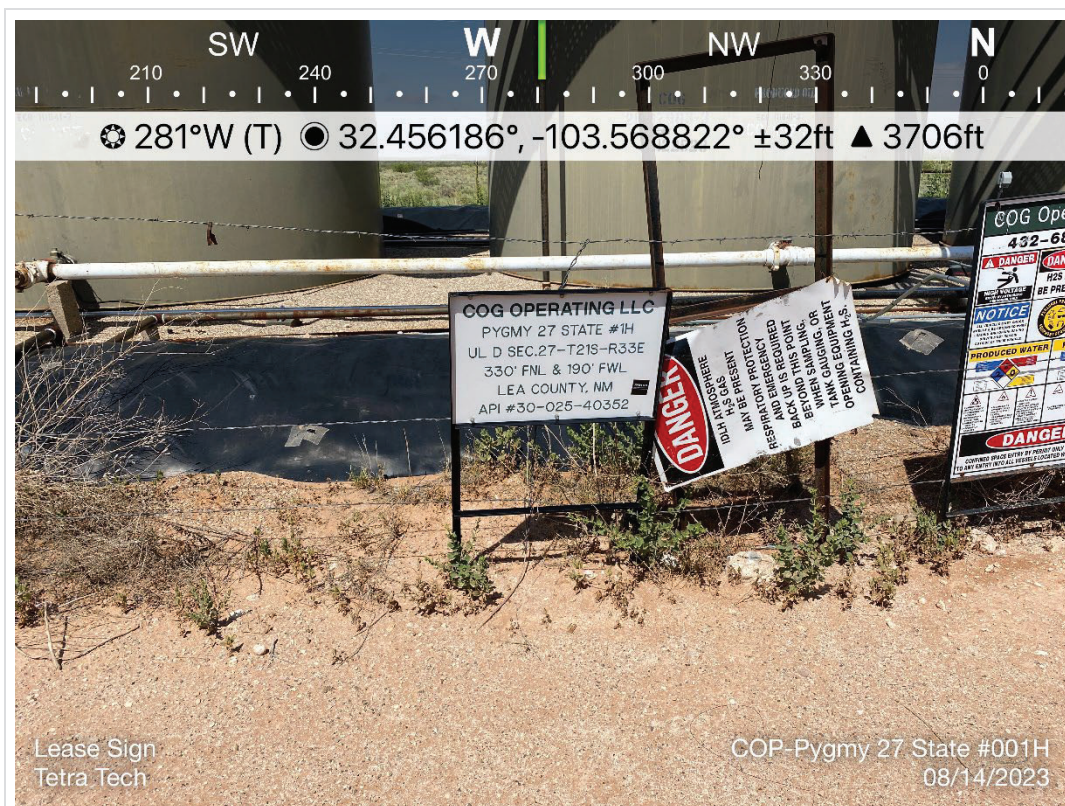
TETRA TECH, INC. PROJECT NO. 212C-MD-03182	DESCRIPTION	Site Signage and location information; PYGMY 27 State #1H	1
	SITE NAME	Pygmy 27 State #001H Release	8/14/2023

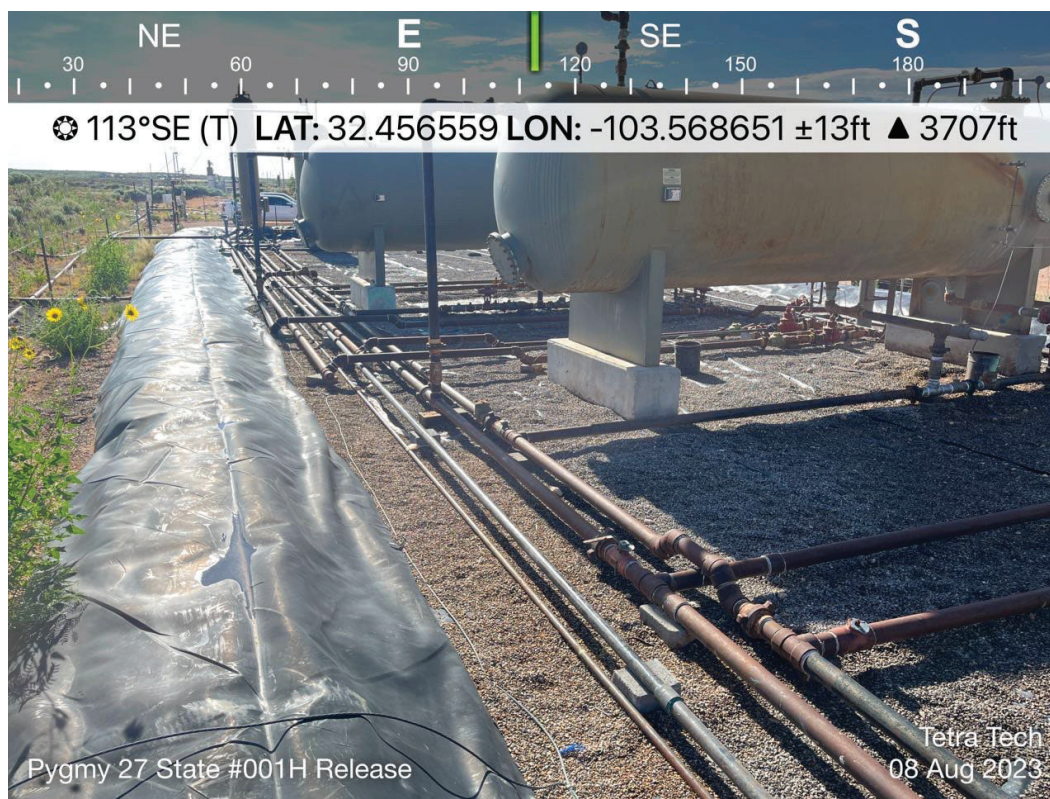
TETRA TECH, INC. PROJECT NO. 212C-MD-03182	DESCRIPTION	View east-southeast. Lined containment area with caliche.	2
	SITE NAME	Pygmy 27 State #001H Release	8/08/2023

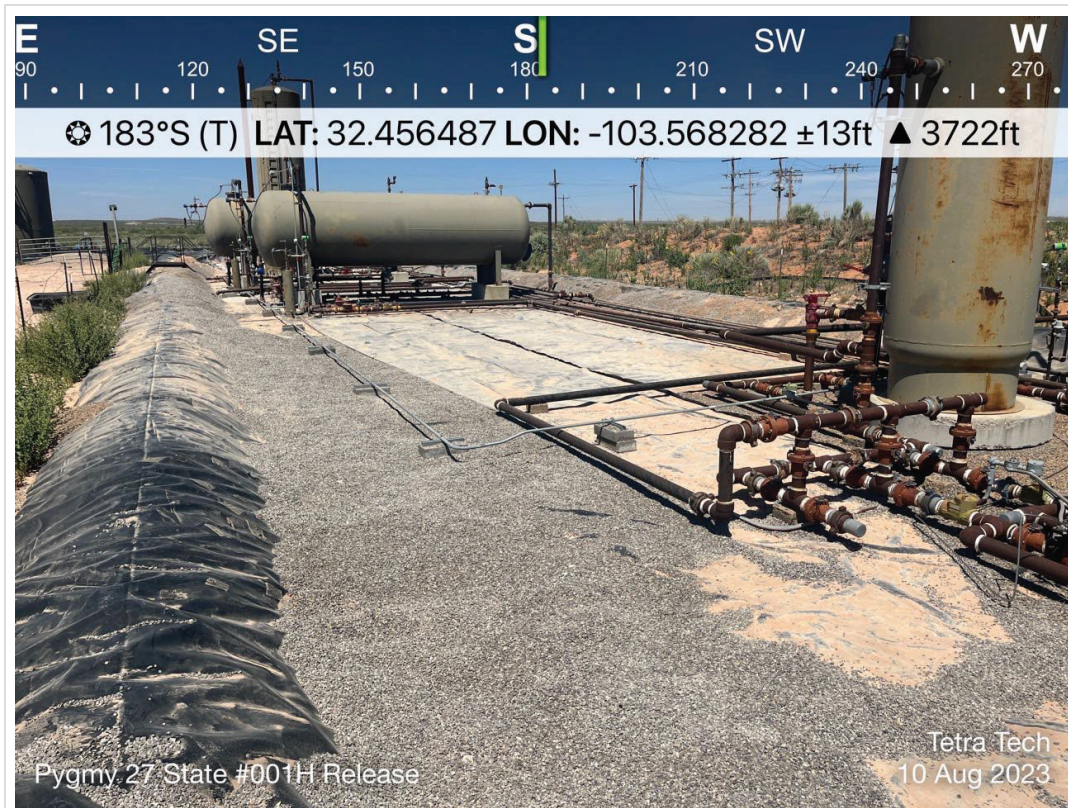
TETRA TECH, INC. PROJECT NO. 212C-MD-03182	DESCRIPTION	View south. Liner integrity intact.	3
	SITE NAME	Pygmy 27 State #001H Release	8/10/2023

On August 8, 2023, Tetra Tech personnel performed an inspection of the liner within the secondary containment of the Pygmy 27 State #001H Tank Battery. This work was completed to verify the previous documentation of liner integrity provided by TRC and Heritage Concho. The clean base course/gravel material was carefully extracted from the area surrounding the tanks and the surrounding vicinity. The liner was observed to underlie the entirety of the tank battery secondary containment area. The liner was intact with no visible rips or tears and encompassed by a 2-foot-tall earthen berm. The liner extended up and over the berm and was anchored on the exterior. At the time of the inspection, the liner was intact and had the ability to contain the leak in question. Photographic documentation of the liner inspection is included in Appendix E.

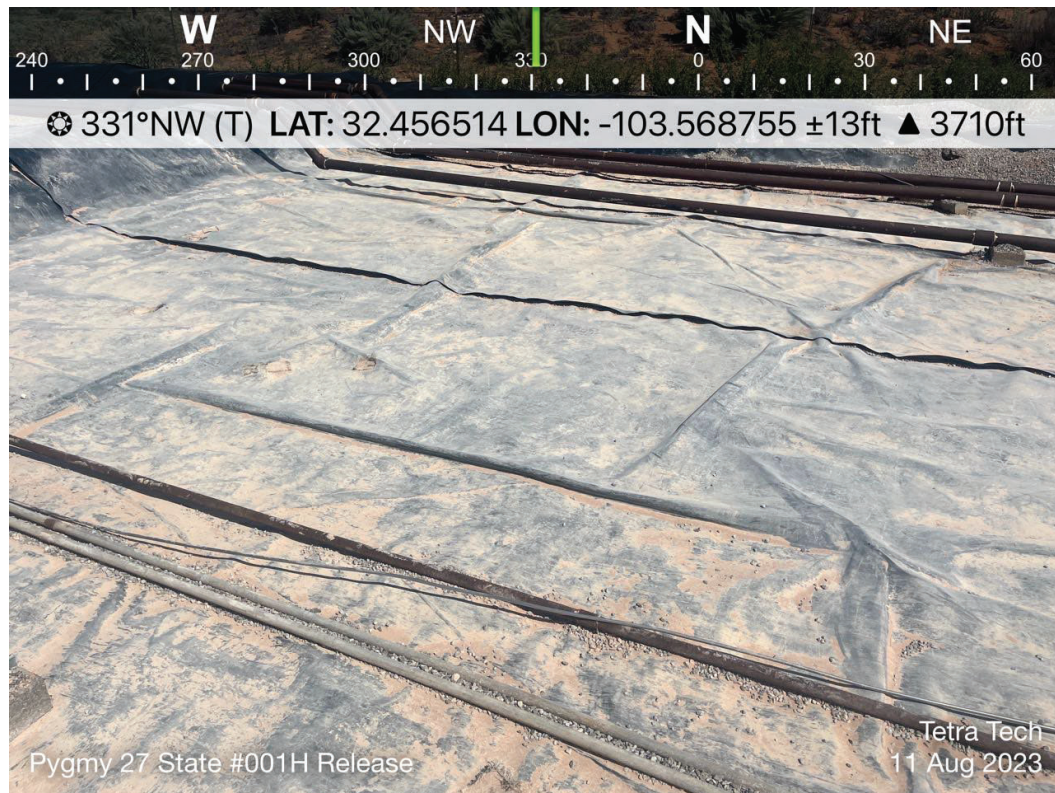
TETRA TECH, INC. PROJECT NO. 212C-MD-03182	DESCRIPTION	View north-northwest. Liner integrity intact.	4
	SITE NAME	Pygmy 27 State #001H Release	8/11/2023

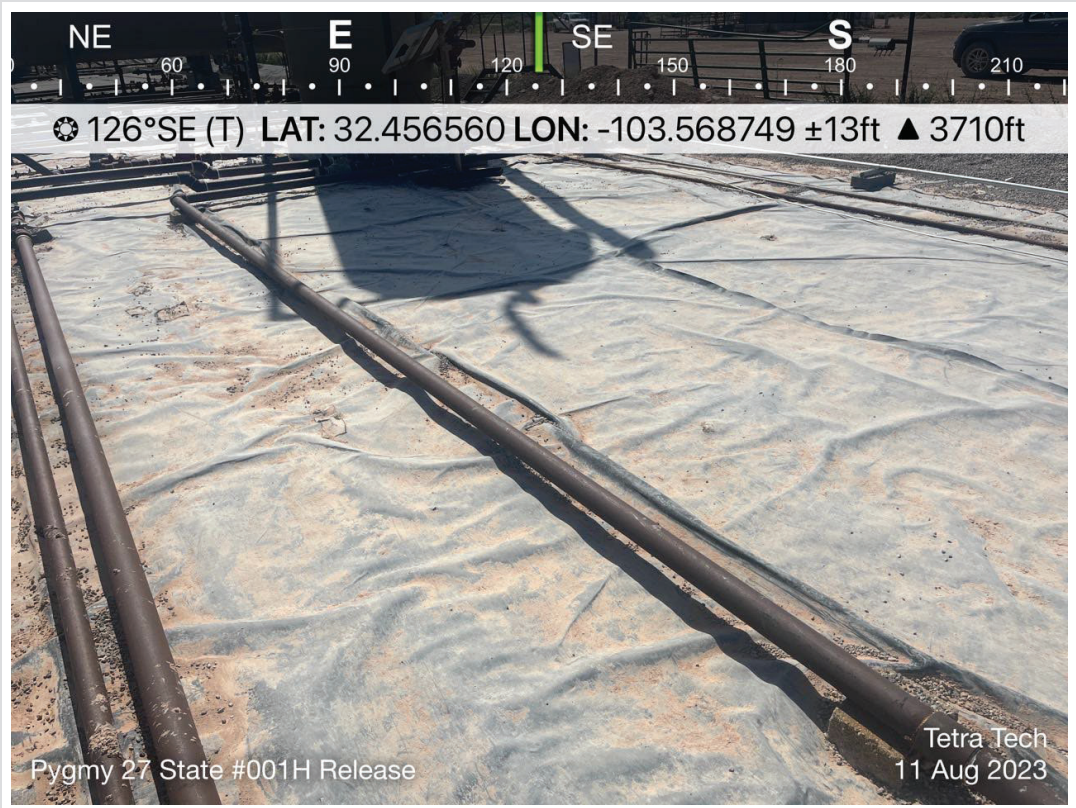
TETRA TECH, INC. PROJECT NO. 212C-MD-03182	DESCRIPTION	View south-southwest. Liner integrity intact.	5
	SITE NAME	Pygmy 27 State #001H Release	8/11/2023

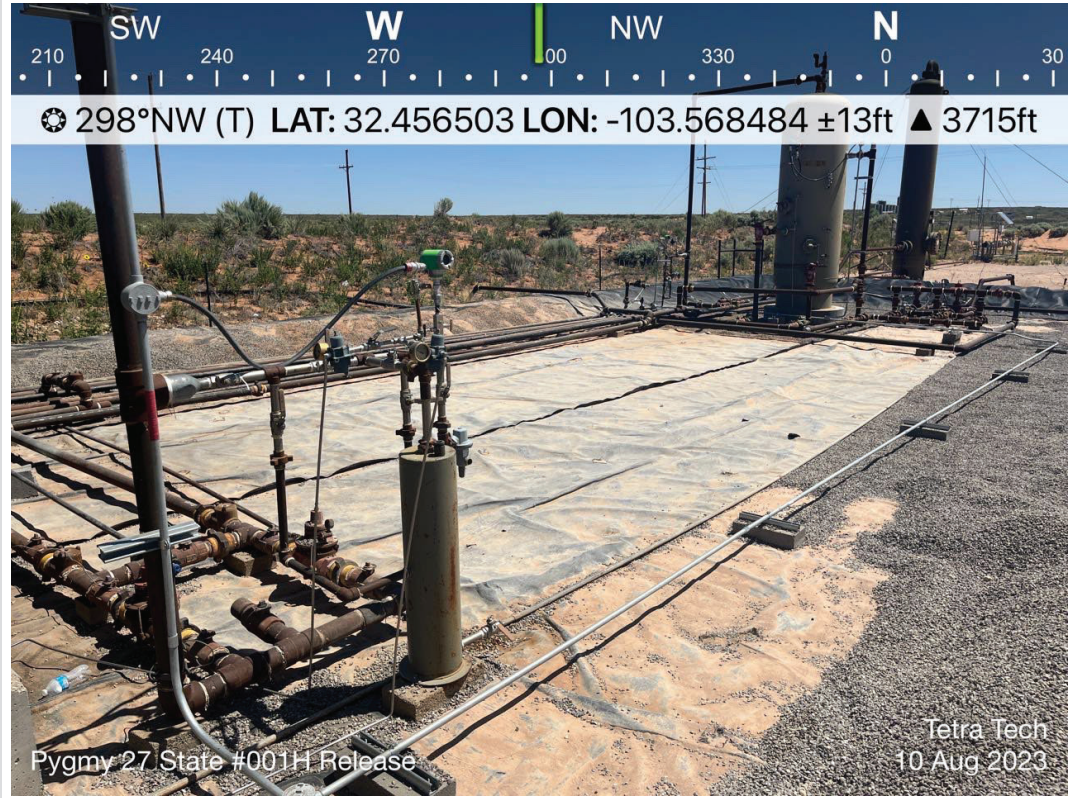
TETRA TECH, INC. PROJECT NO. 212C-MD-03182	DESCRIPTION	View east-southeast. Lined containment area.	6
	SITE NAME	Pygmy 27 State #001H Release	8/10/2023

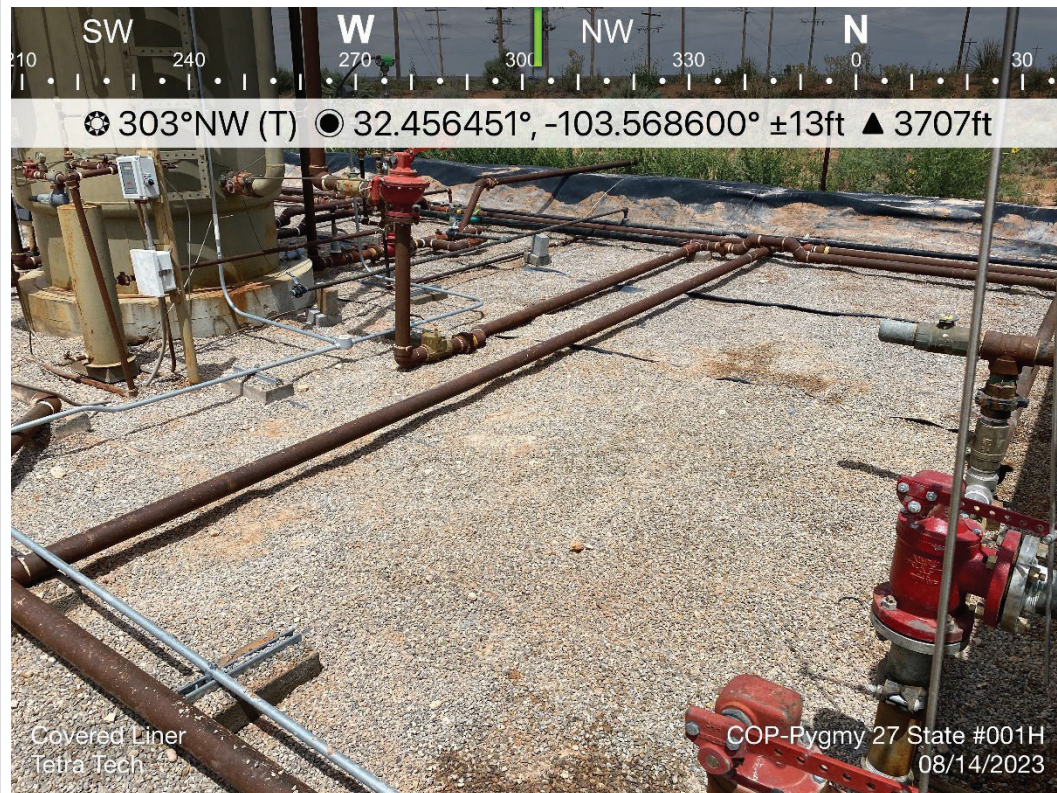
TETRA TECH, INC. PROJECT NO. 212C-MD-03182	DESCRIPTION	View west-northwest. Lined containment area with caliche prior to removal.	8
	SITE NAME	Pygmy 27 State #001H Release	8/14/2023

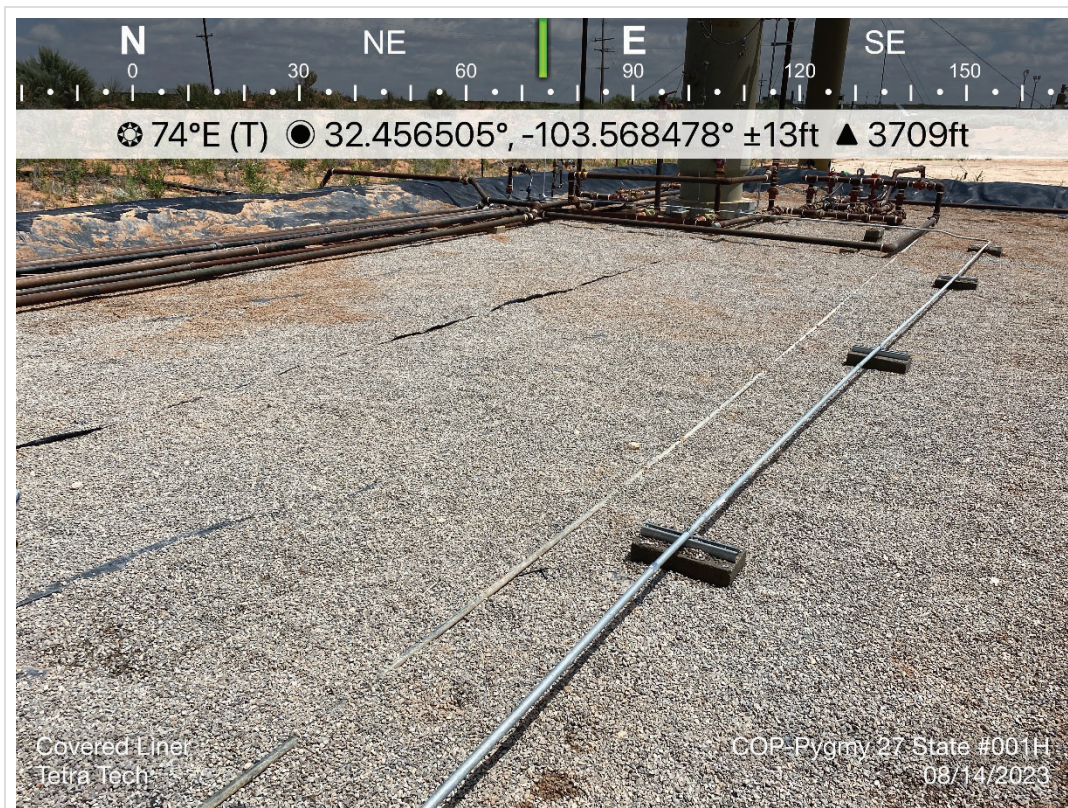
TETRA TECH, INC. PROJECT NO. 212C-MD-03182	DESCRIPTION	View east-northeast. Lined containment area with caliche prior to removal.	9
	SITE NAME	Pygmy 27 State #001H Release	8/14/2023

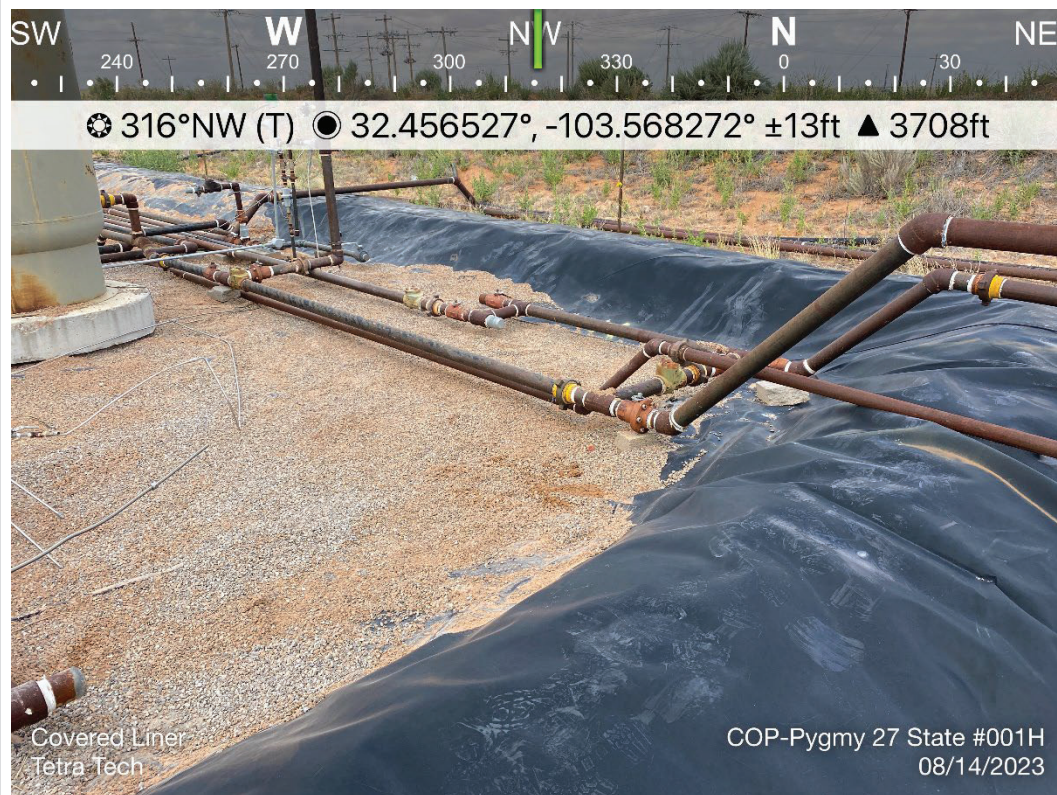
TETRA TECH, INC. PROJECT NO. 212C-MD-03182	DESCRIPTION	View northwest. Lined containment area with caliche prior to removal.	10
	SITE NAME	Pygmy 27 State #001H Release	8/14/2023

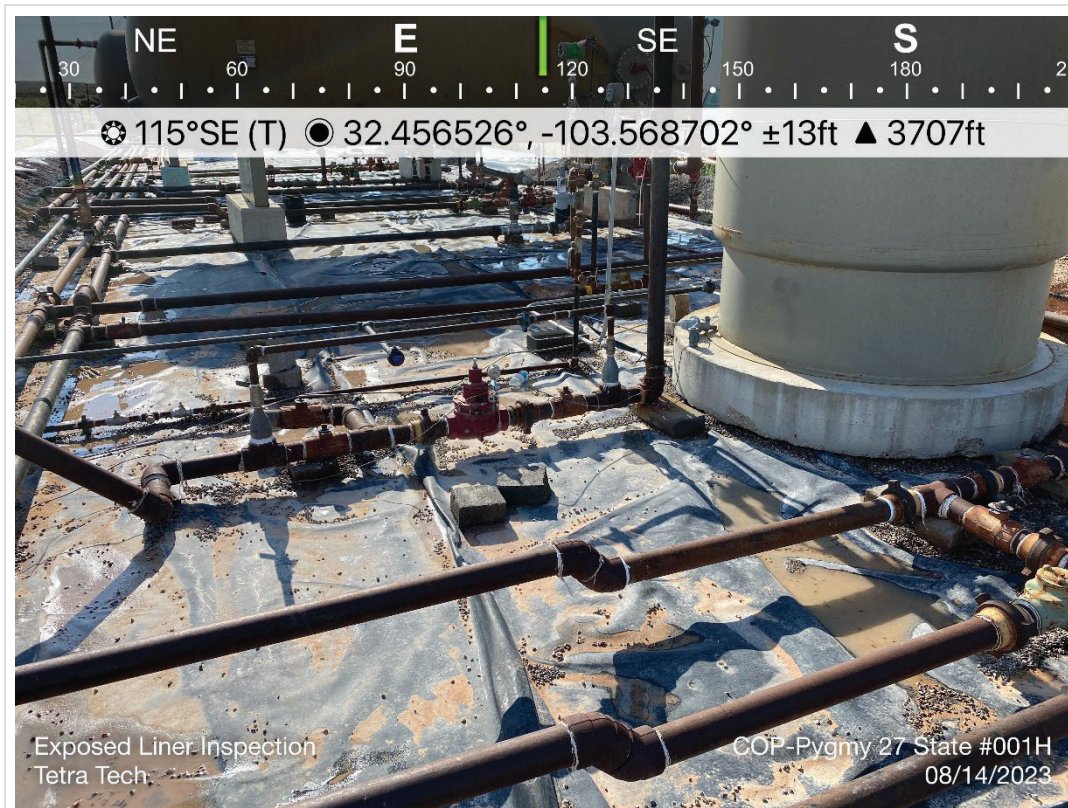
According to the State of New Mexico Form C-141 Initial Report (Appendix A), the release was caused by a failed gasket. The release occurred within the lined facility, with the exception of a 100 square foot area of overspray in the pasture north of the secondary containment. The approximate release extent is presented in Figure 3.

TETRA TECH, INC. PROJECT NO. 212C-MD-03182	DESCRIPTION	Liner integrity intact at release point. Standing water from recent rainfall in area.	11
	SITE NAME	Pygmny 27 State #001H Release	8/11/2023

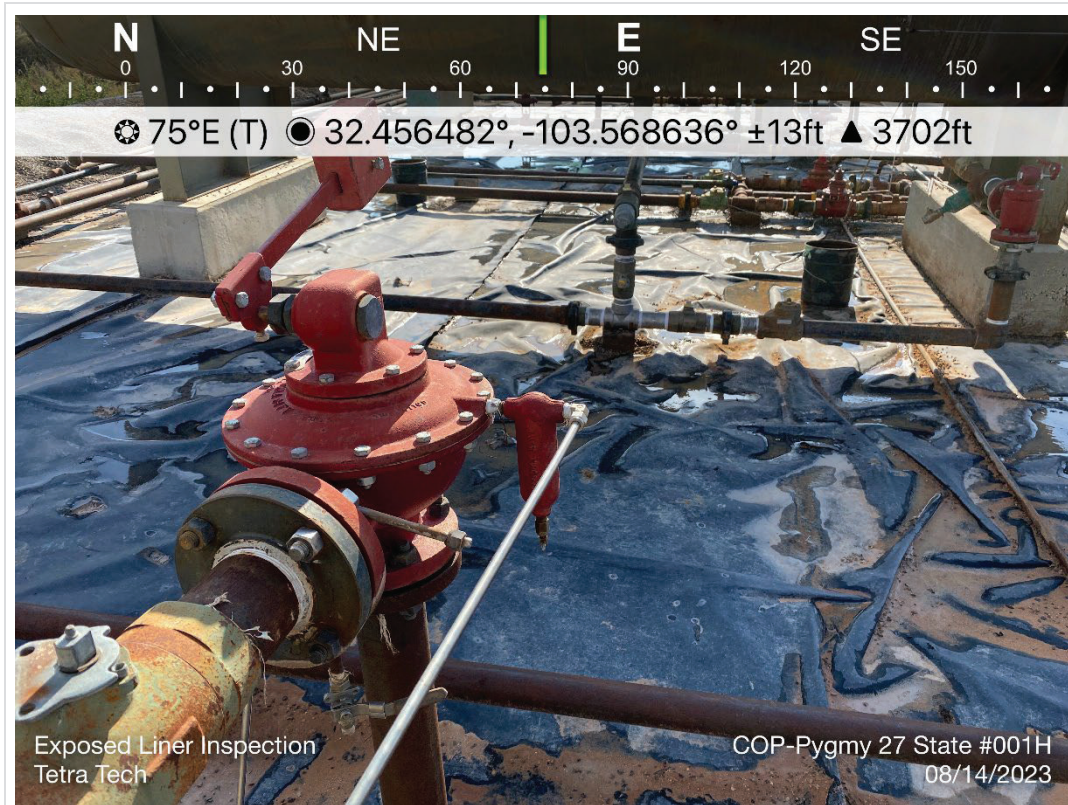
TETRA TECH, INC. PROJECT NO. 212C-MD-03182	DESCRIPTION	Liner integrity intact at release point. Standing water from recent rainfall in area.	12
	SITE NAME	Pygmny 27 State #001H Release	8/14/2023

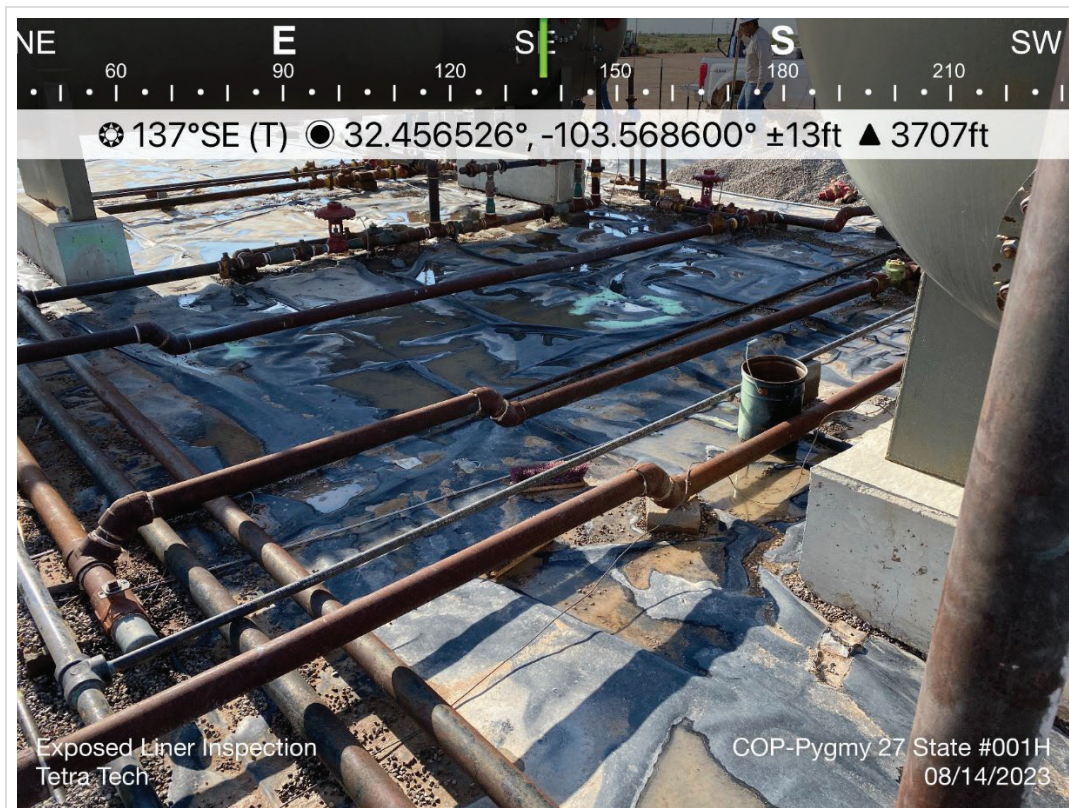
TETRA TECH, INC. PROJECT NO. 212C-MD-03182	DESCRIPTION	Liner integrity intact at release point. Standing water from recent rainfall in area.	13
	SITE NAME	Pygmy 27 State #001H Release	8/14/2023

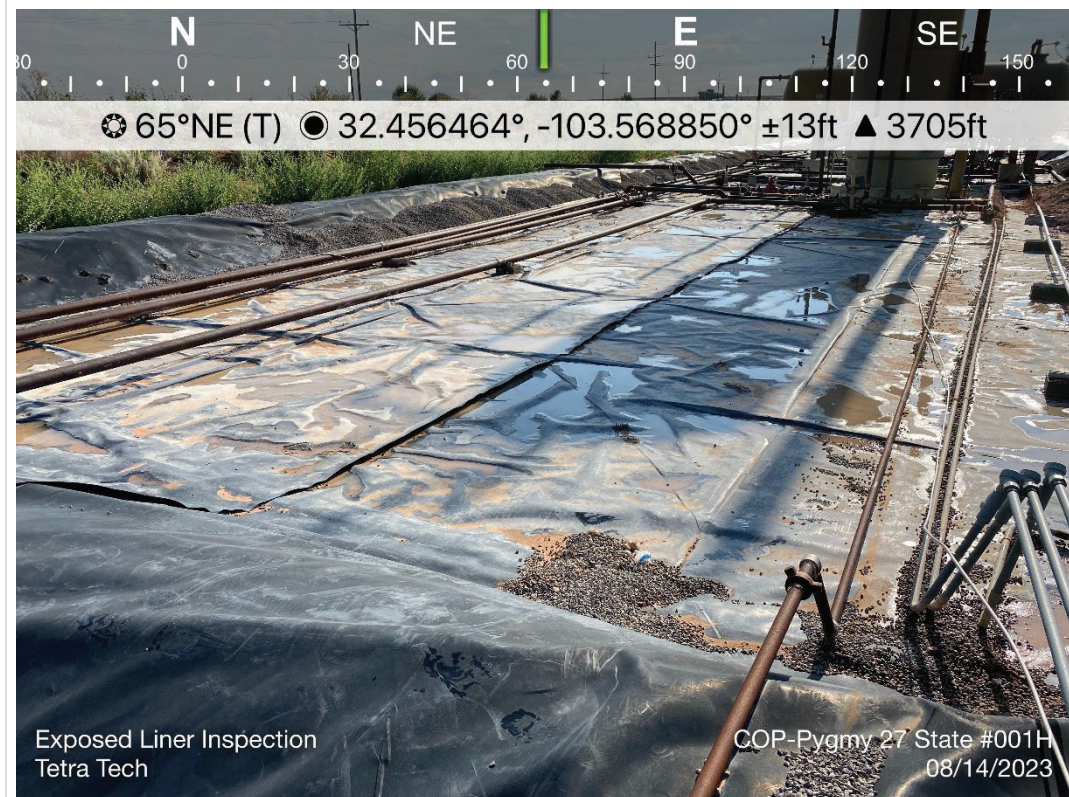
TETRA TECH, INC. PROJECT NO. 212C-MD-03182	DESCRIPTION	Liner integrity intact. Standing water from recent rainfall in area.	14
	SITE NAME	Pygmy 27 State #001H Release	8/14/2023
