Site Assessment/Characterization

Closure

Re: Site Assessment and Closure Report
Trionyx 6 CTB 3
API No. N/A
GPS: Latitude 32.163631 Longitude -103.712420
UL -- B, Section 6, T25S, R32E
Lea County, NM
NMOCD Ref. No. NAPP2217930382

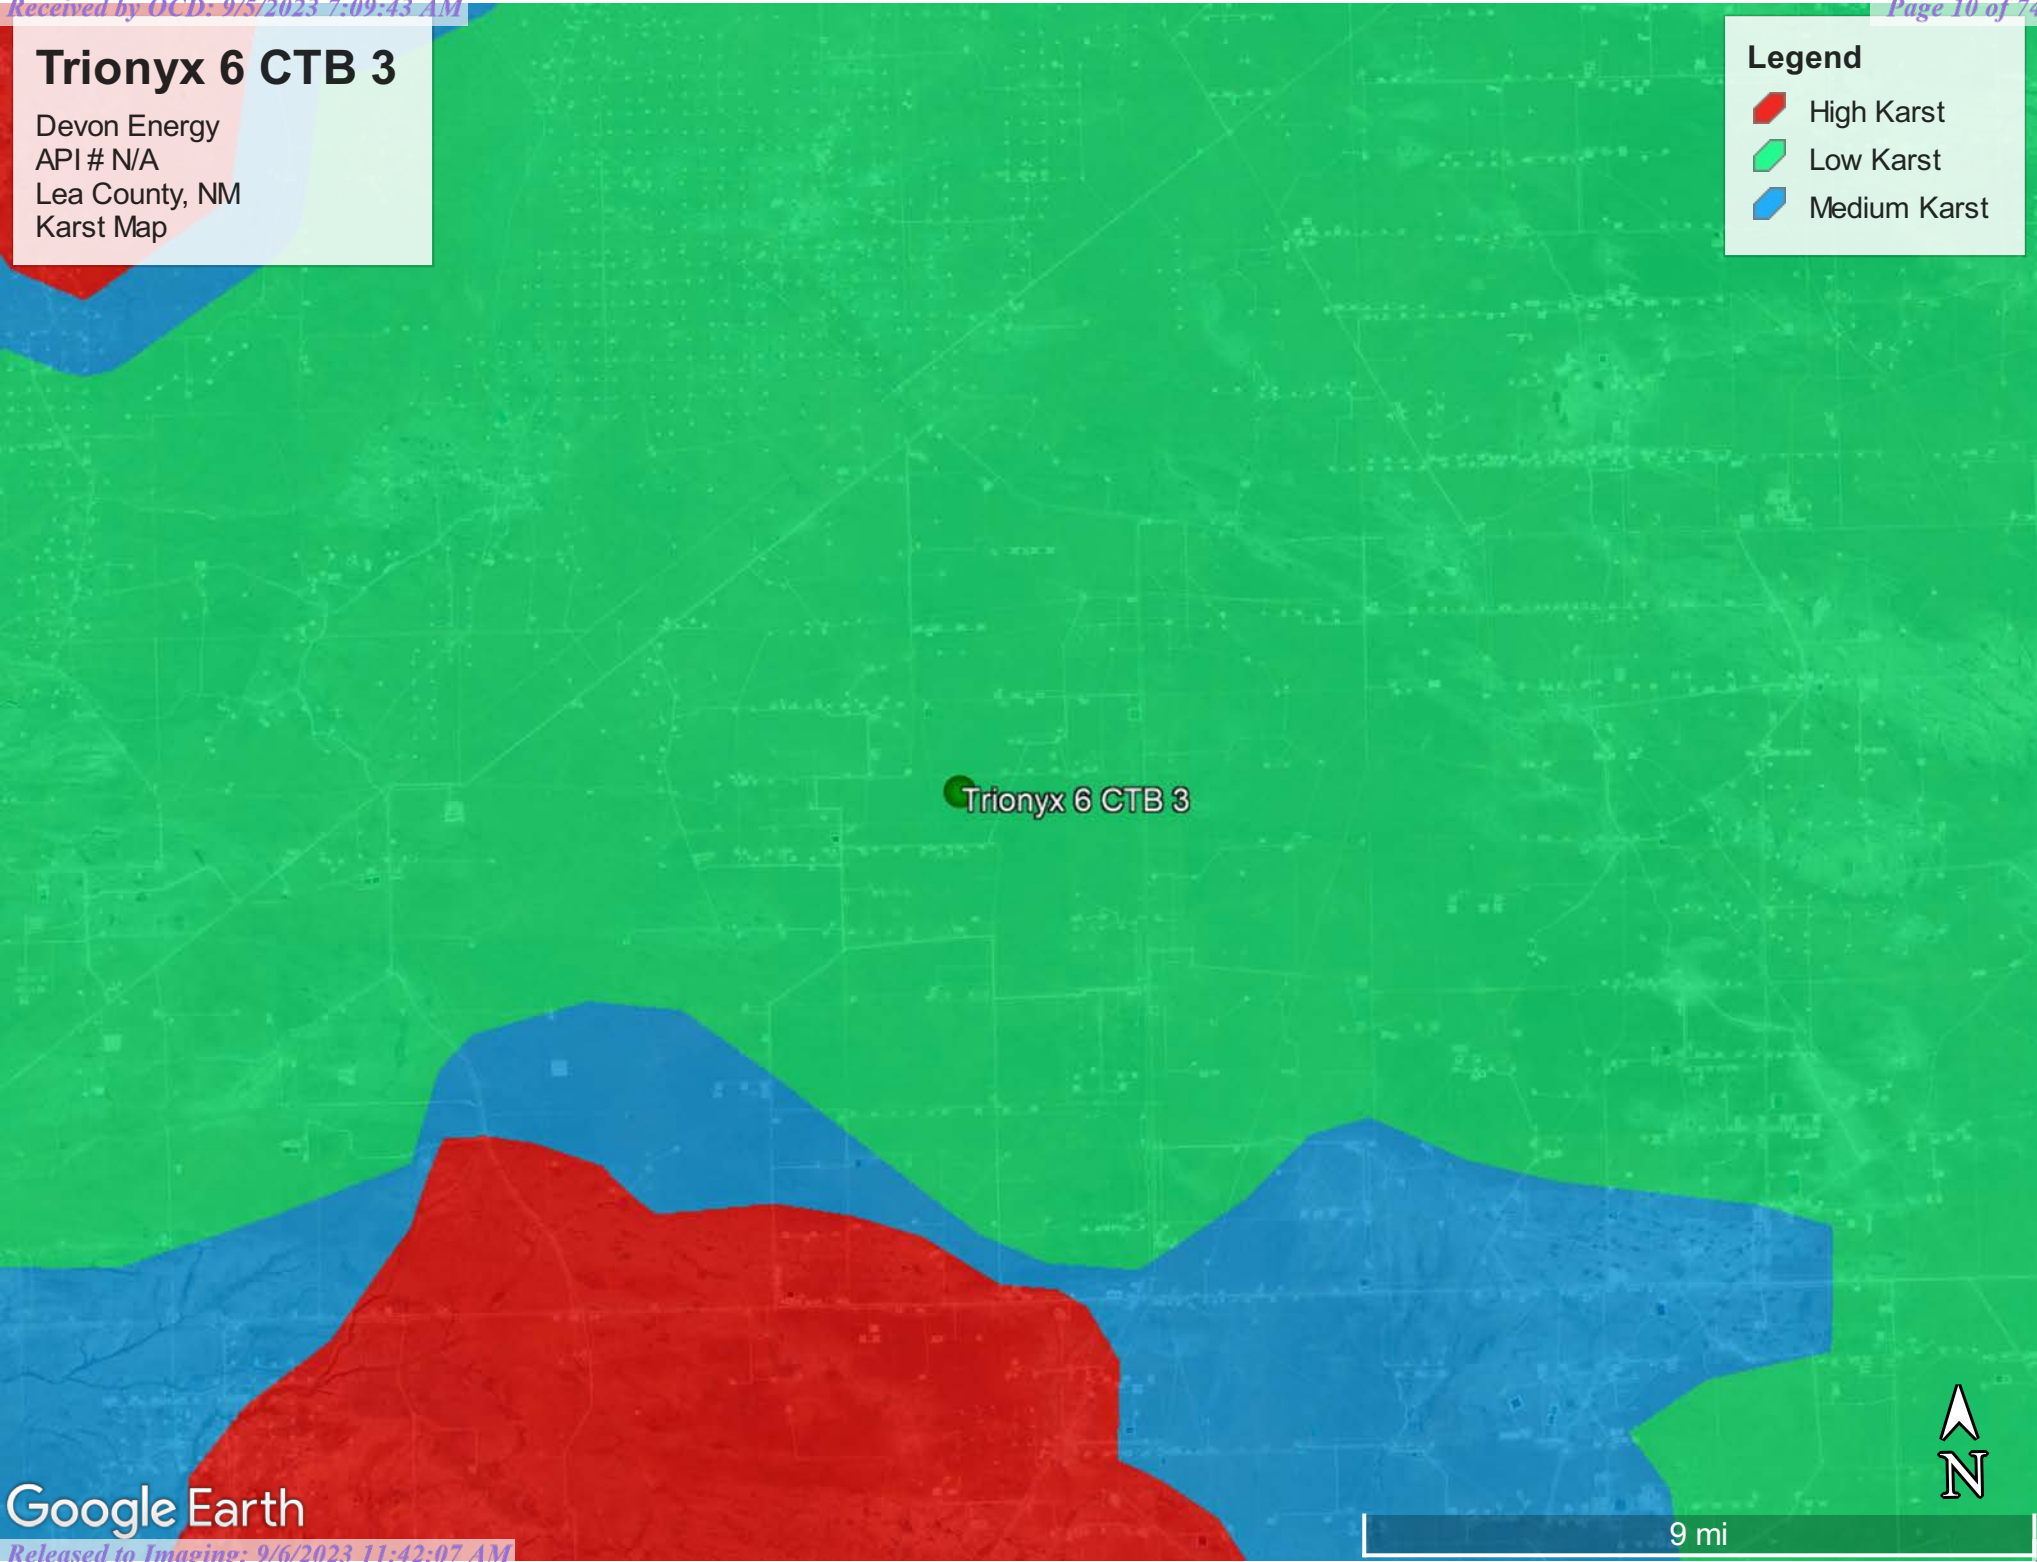
Devon Energy
API # N/A
Lea County, NM
Karst Map

Per the New Mexico Bureau of Geology and Mineral Resources, the geology is made up of Interlayered eolian sands and piedmont-slope deposits along the eastern flank of the Pecos River valley, primarily between Roswell and Carlsbad. Typically capped by thin eolian deposits. The soil in this area is made up of Maljamar and Palomas fine sands, 0 to 3 percent slopes according to the United States Department of Agriculture Natural Resources Conservation Service soil survey (Appendix B). The drainage class in this area is well drained. There is a low potential for karst geology to be present around the Trionyx (Figure 3).

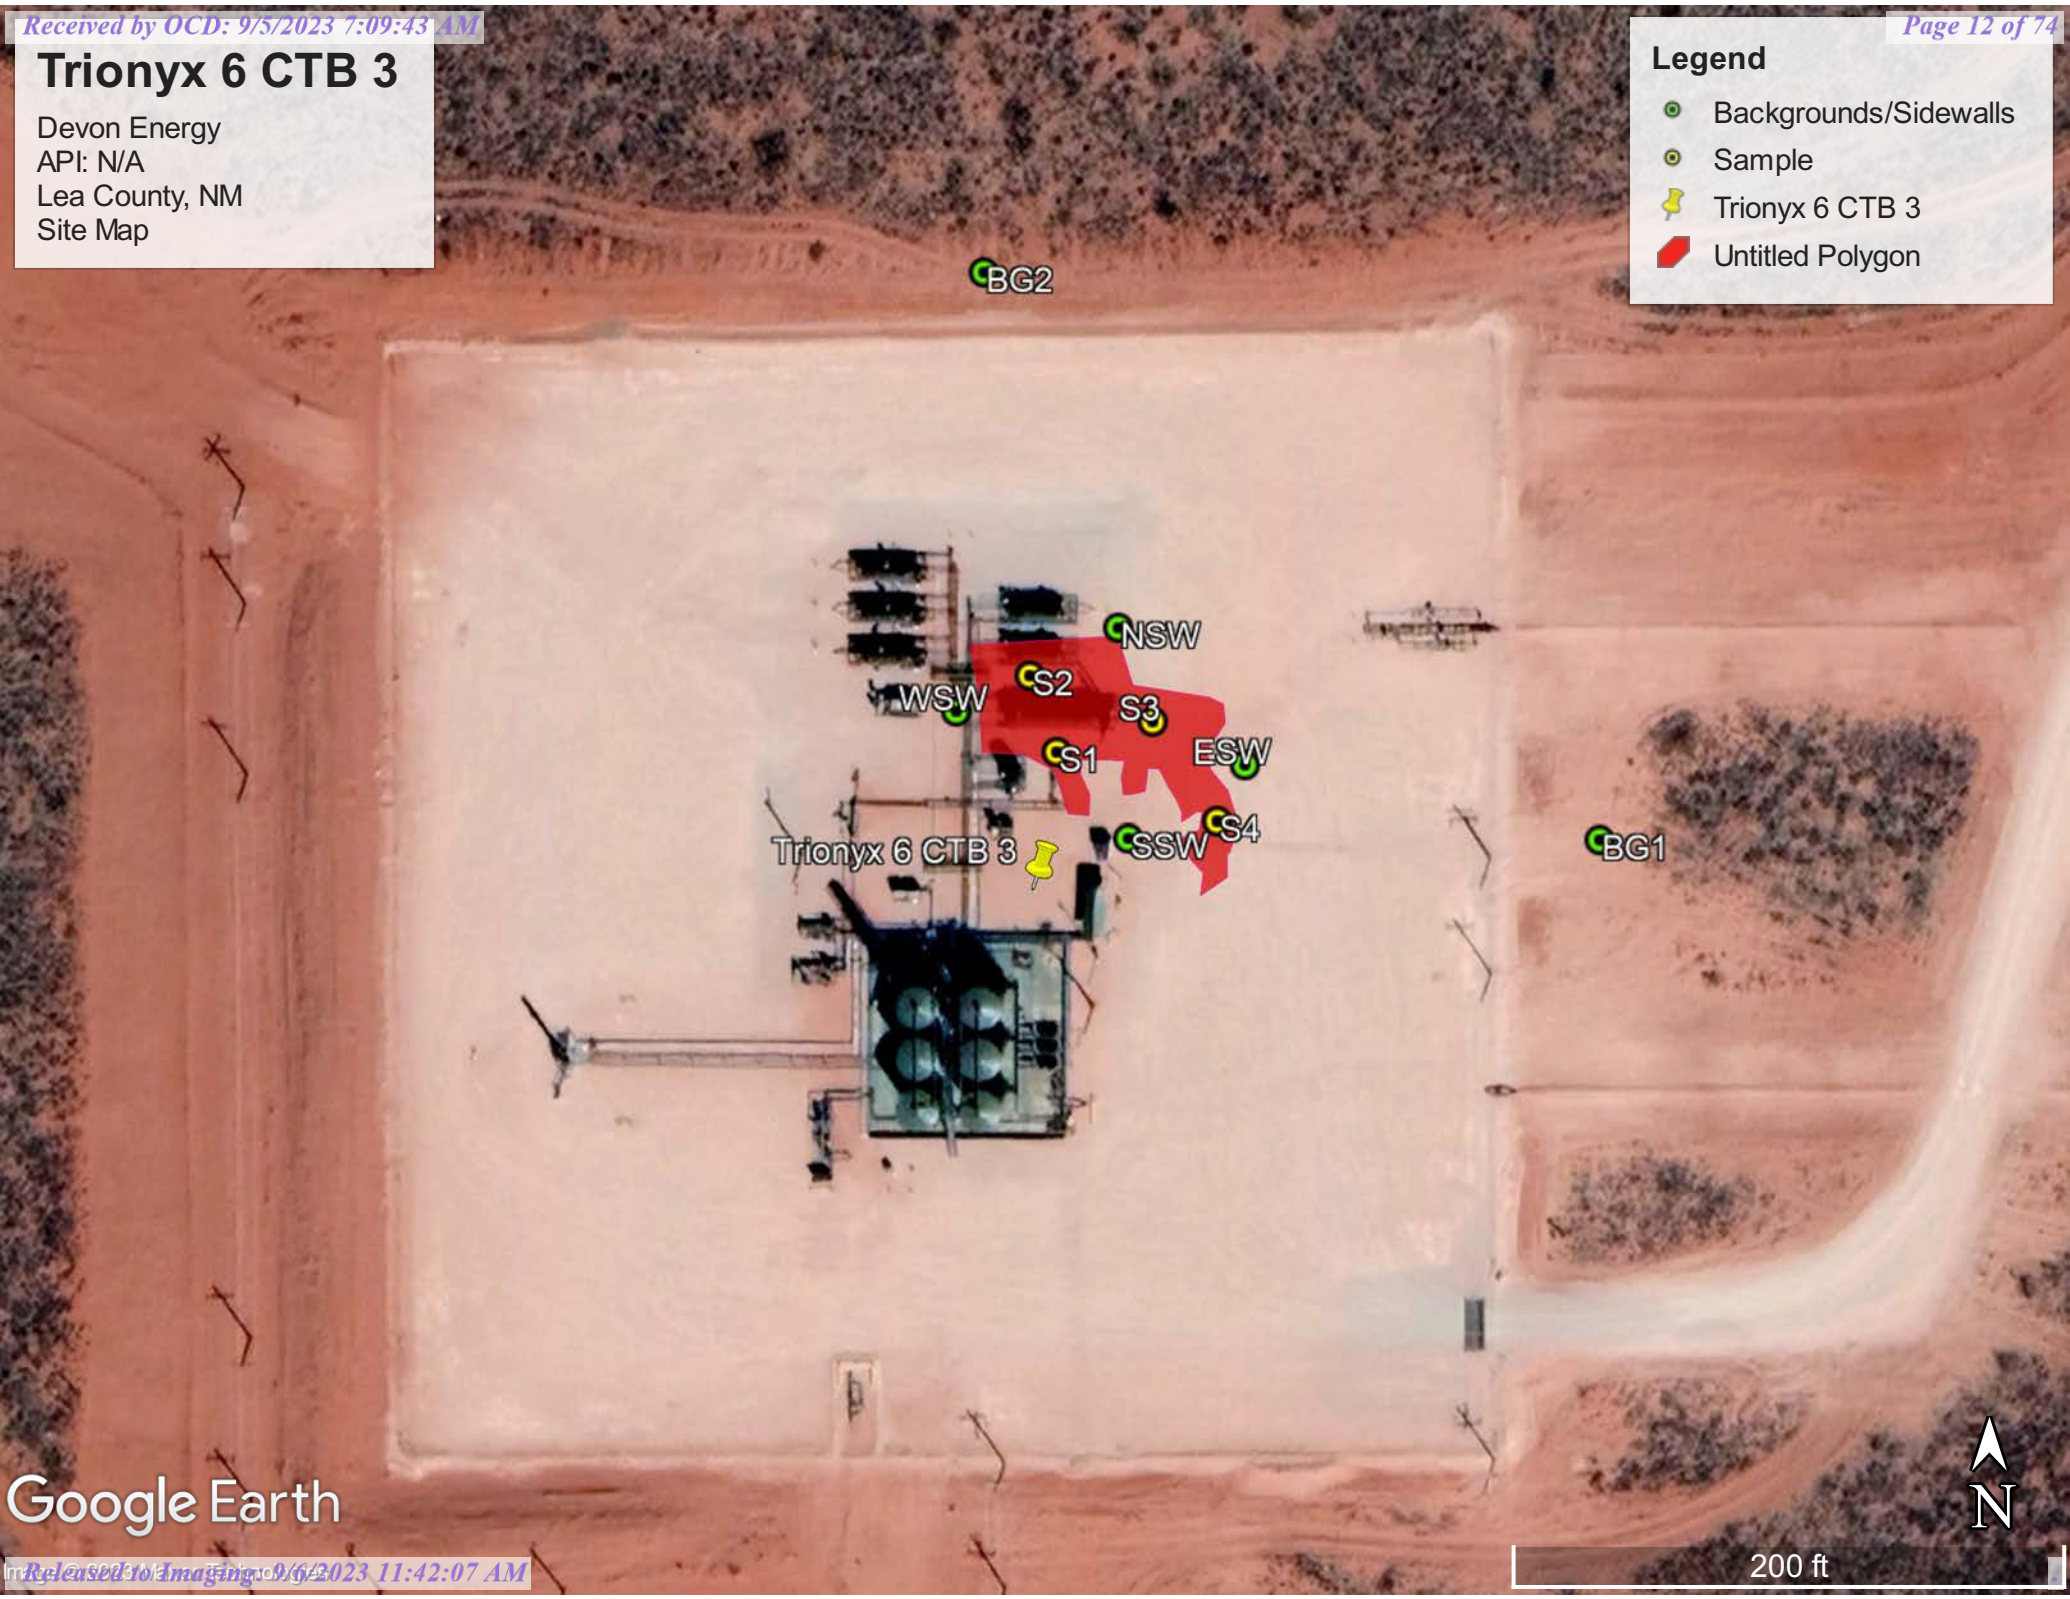
Devon Energy
API: N/A
Lea County, NM
Site Map

July 24, 2022, Pima mobilized personnel to the site to begin collecting soil samples from spill area. The laboratory results of this sampling event can be found in the following data table. A Site Map can be found in Figure 4.

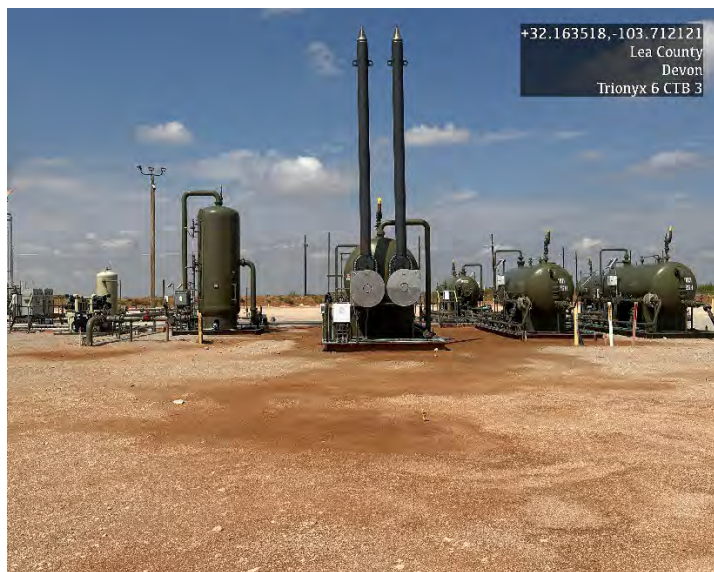
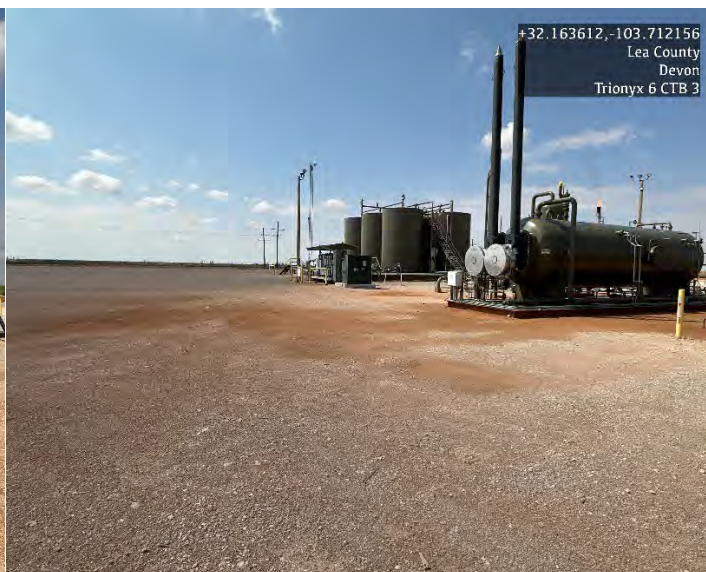
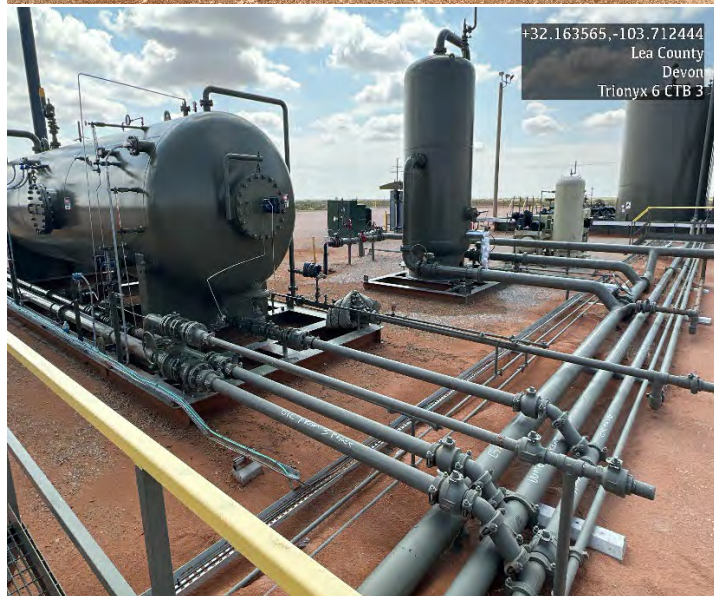
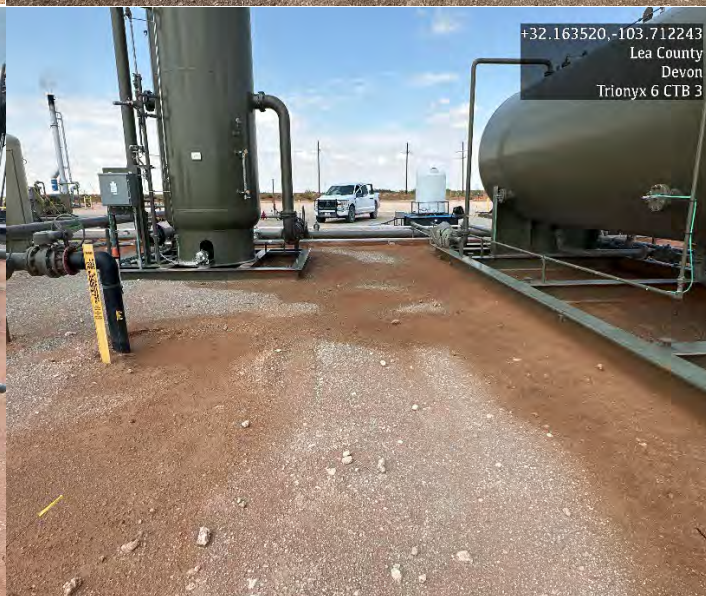
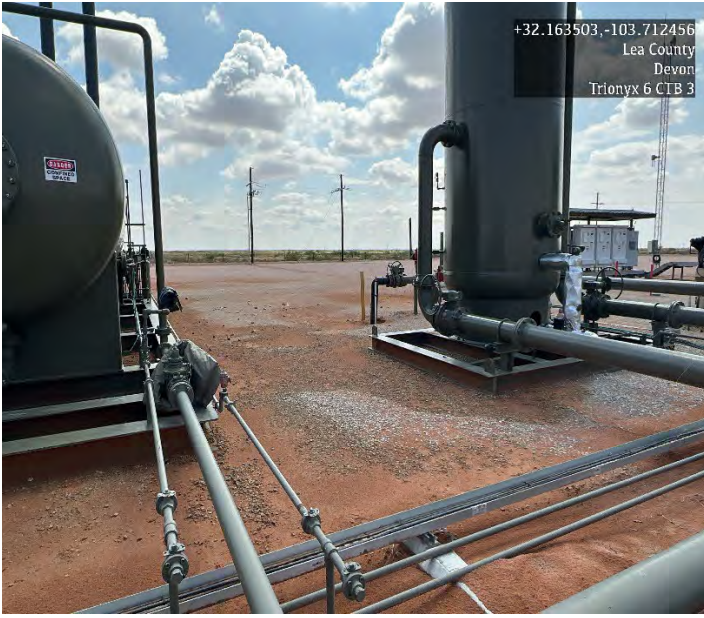
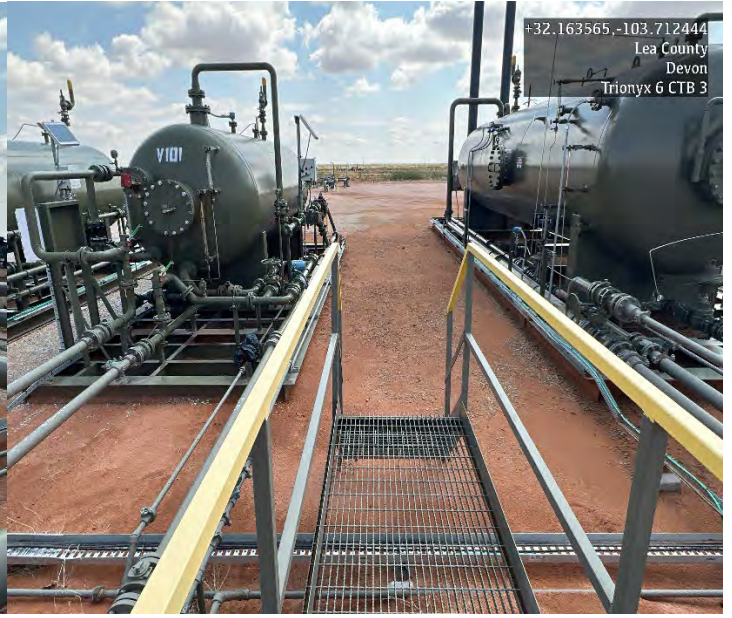
**SITE PHOTOGRAPHS
DEVON ENERGY
TRIONYX 6 CTB 3**

See Appendix D for Photographic Documentation.
