Closure Report

Tank 1 Federal #002
Lea County, New Mexico
API ID # 30-025-30112
Incident # NGRL0919443035

Subject: **Closure Report**
Tank 1 Federal #002
Lea County, New Mexico
API ID # 30-025-30112
Incident # NGRL0919443035

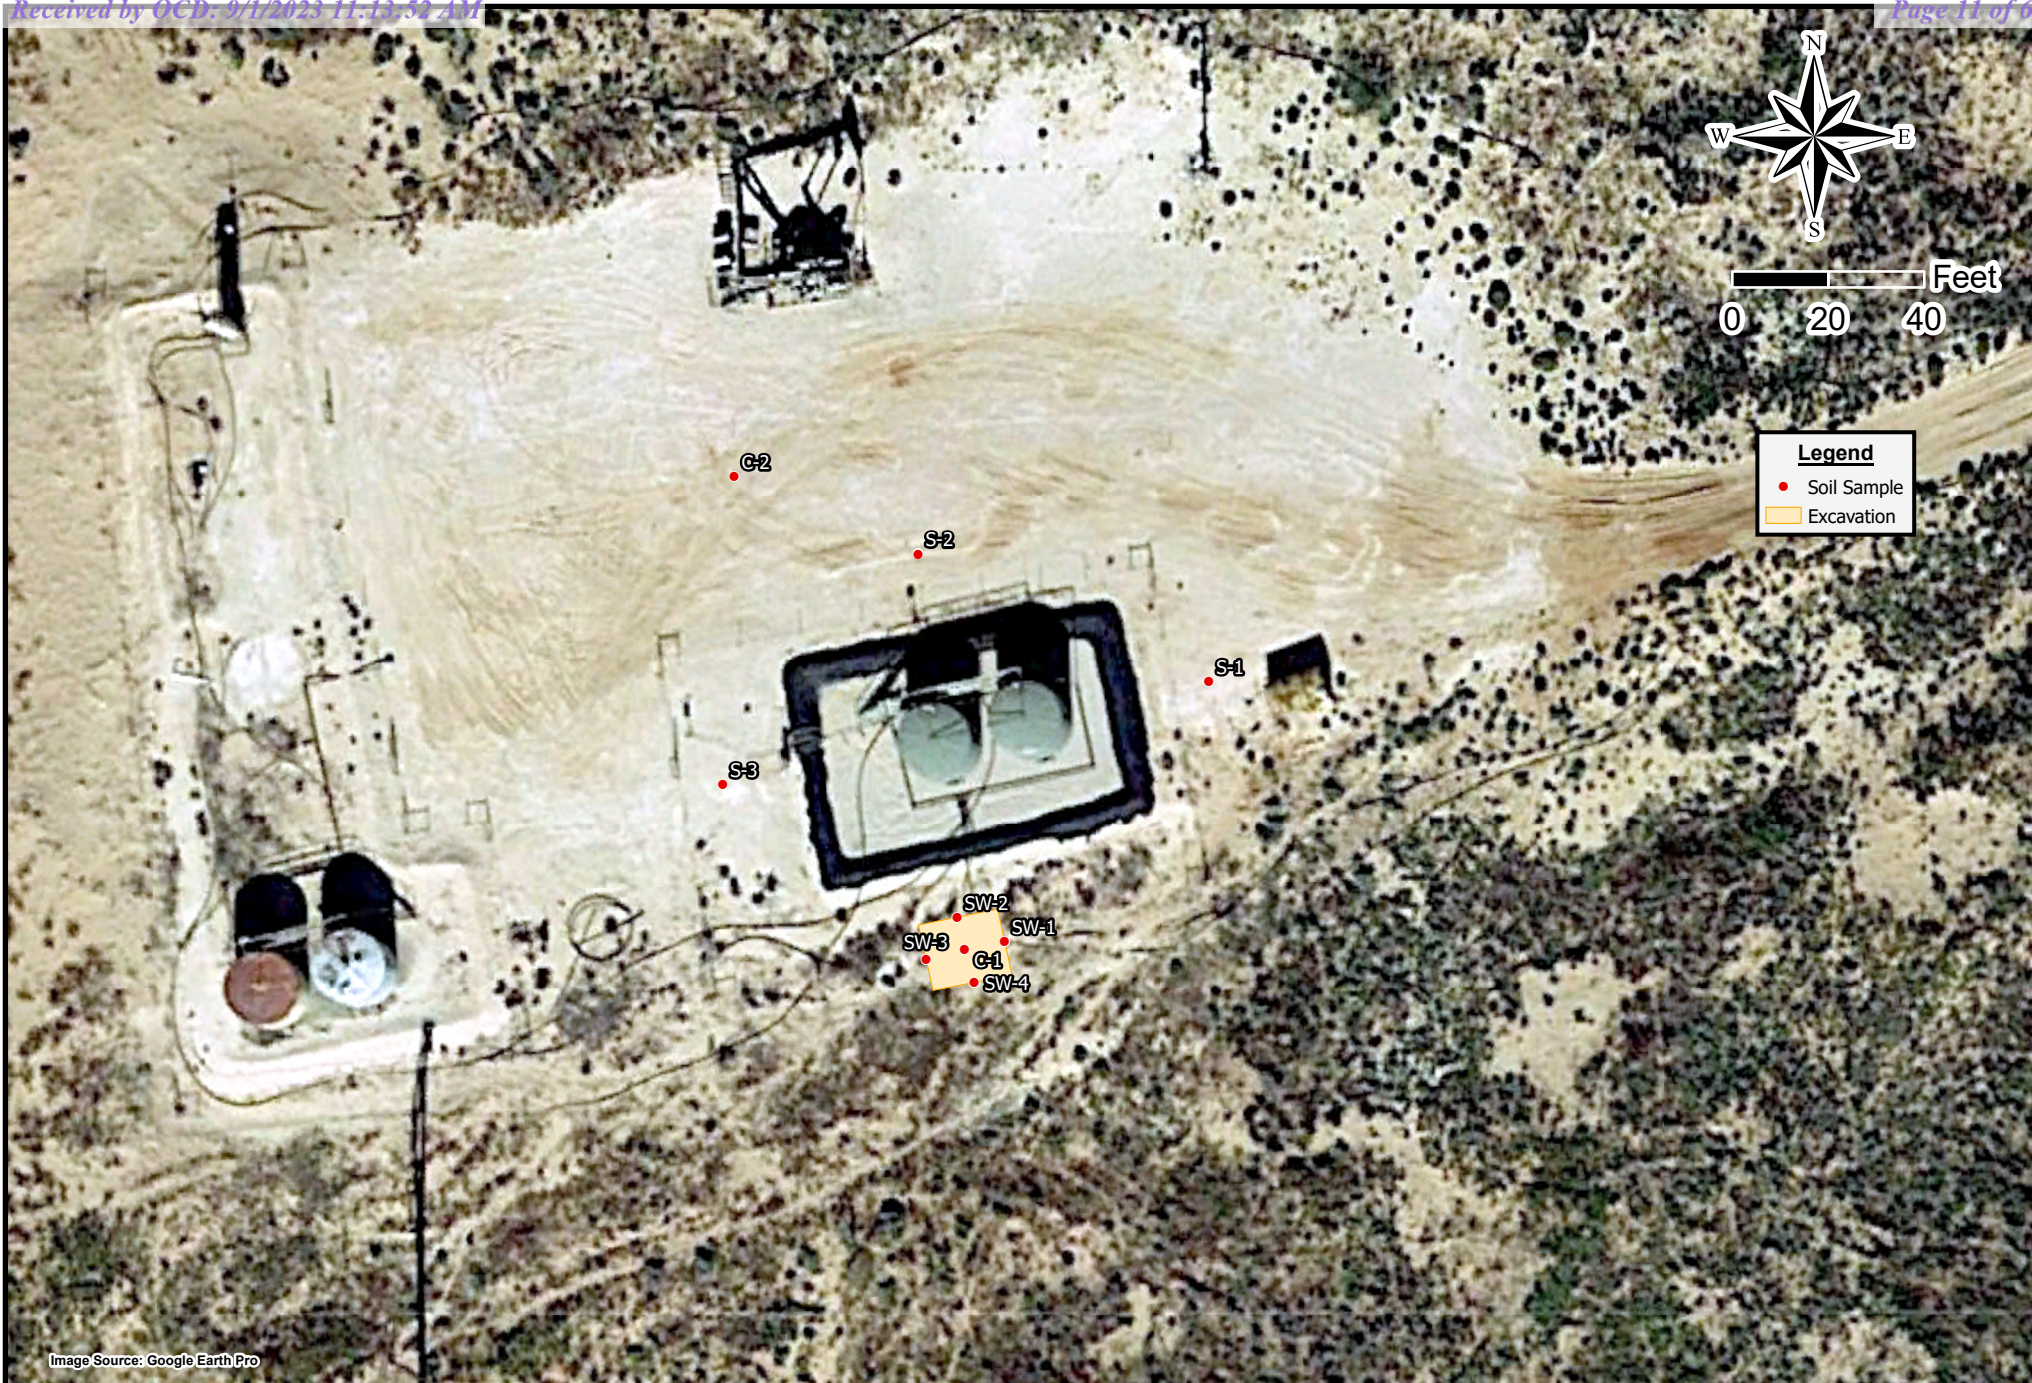
Figure 1

Matador Production Co.
Tank 1 Federal 2H
API: 30-025-30112
Lea County NM
Assessment Map

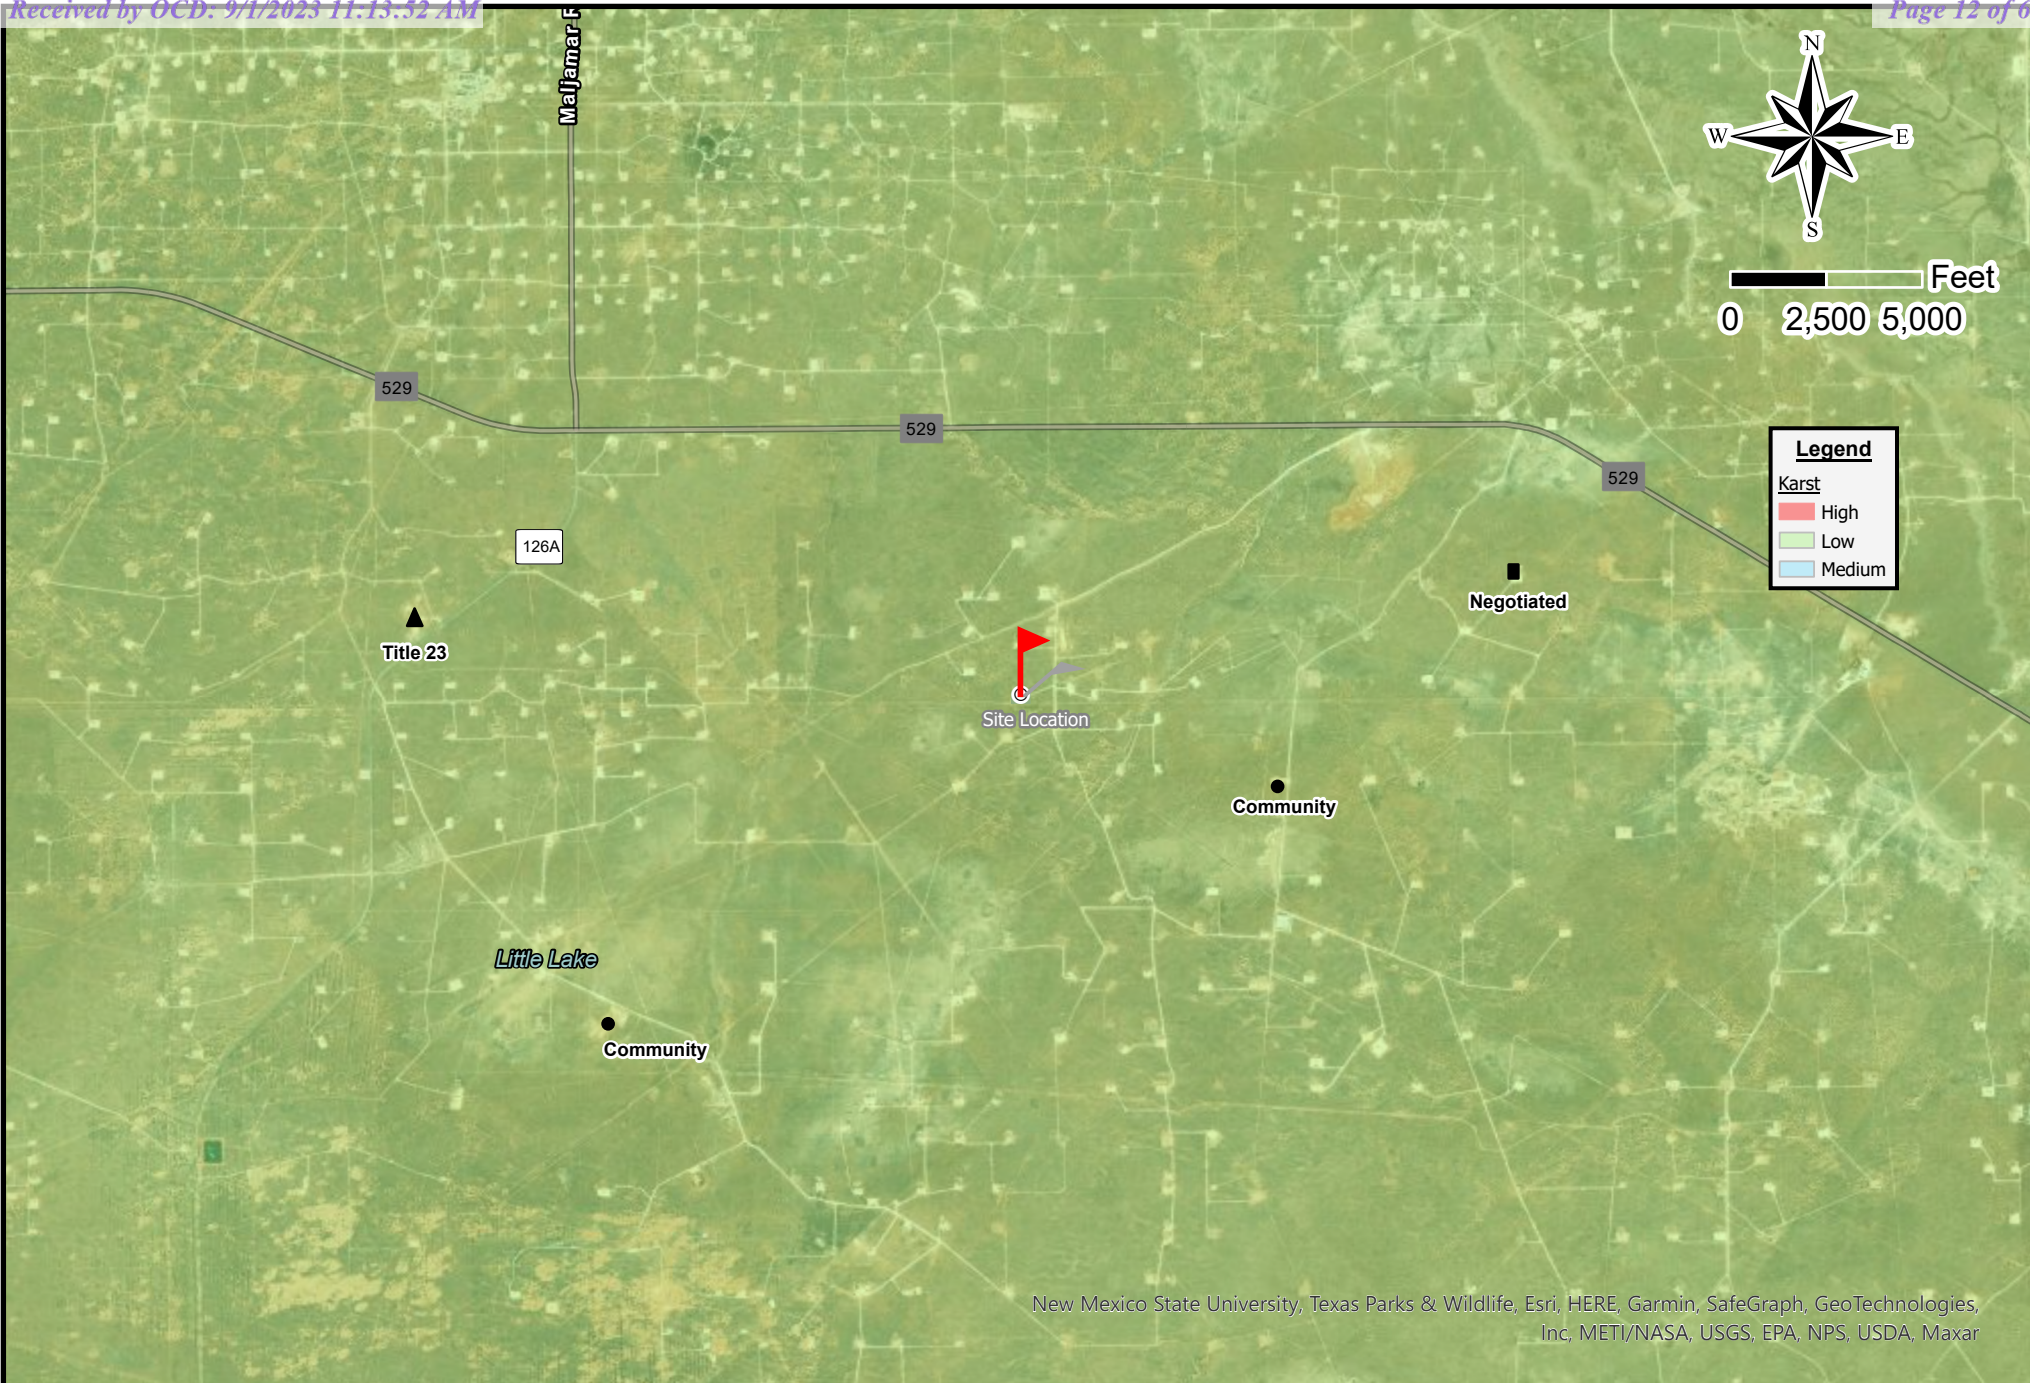
The soil sample results from the laboratory analytical are summarized below. Sample locations are illustrated on Figure 2 in [Appendix I](#) and complete laboratory analytical reports are presented in [Appendix V](#).

Matador Production Co.
Tank 1 Federal 2H
API: 30-025-30112
Lea County NM
Assessment Map C-1
