**Re: Closure Request  
Chiso 14 #3 & 4 / Chiso 14 State 8711 #3H Flare Stack  
Incident Numbers nOY1829542961 and nCH1903548008  
Lea County, New Mexico**

Ensolum, LLC (Ensolum), on behalf of BTA Oil Producers, LLC (BTA), has prepared this *Closure Request* to document assessment, excavation, and soil sampling activities performed at the Chiso 14 #3 & 4 and Chiso 14 State 8711 #3H Flare Stack (collectively referred to as the Site). The purpose of the excavation and soil sampling activities was to address impacts to soil resulting from two release events at the Site. Based on the excavation activities and laboratory analytical results from soil sampling events, BTA is submitting this *Closure Request*, describing remediation that has occurred and requesting closure for Incident Numbers nOY1829542961 and nCH1903548008.

BTA Oil Producers, LLC  
Closure Request  
Chiso 14 #3 / 4 and Chiso 14 State 711 #3H Flare Stack

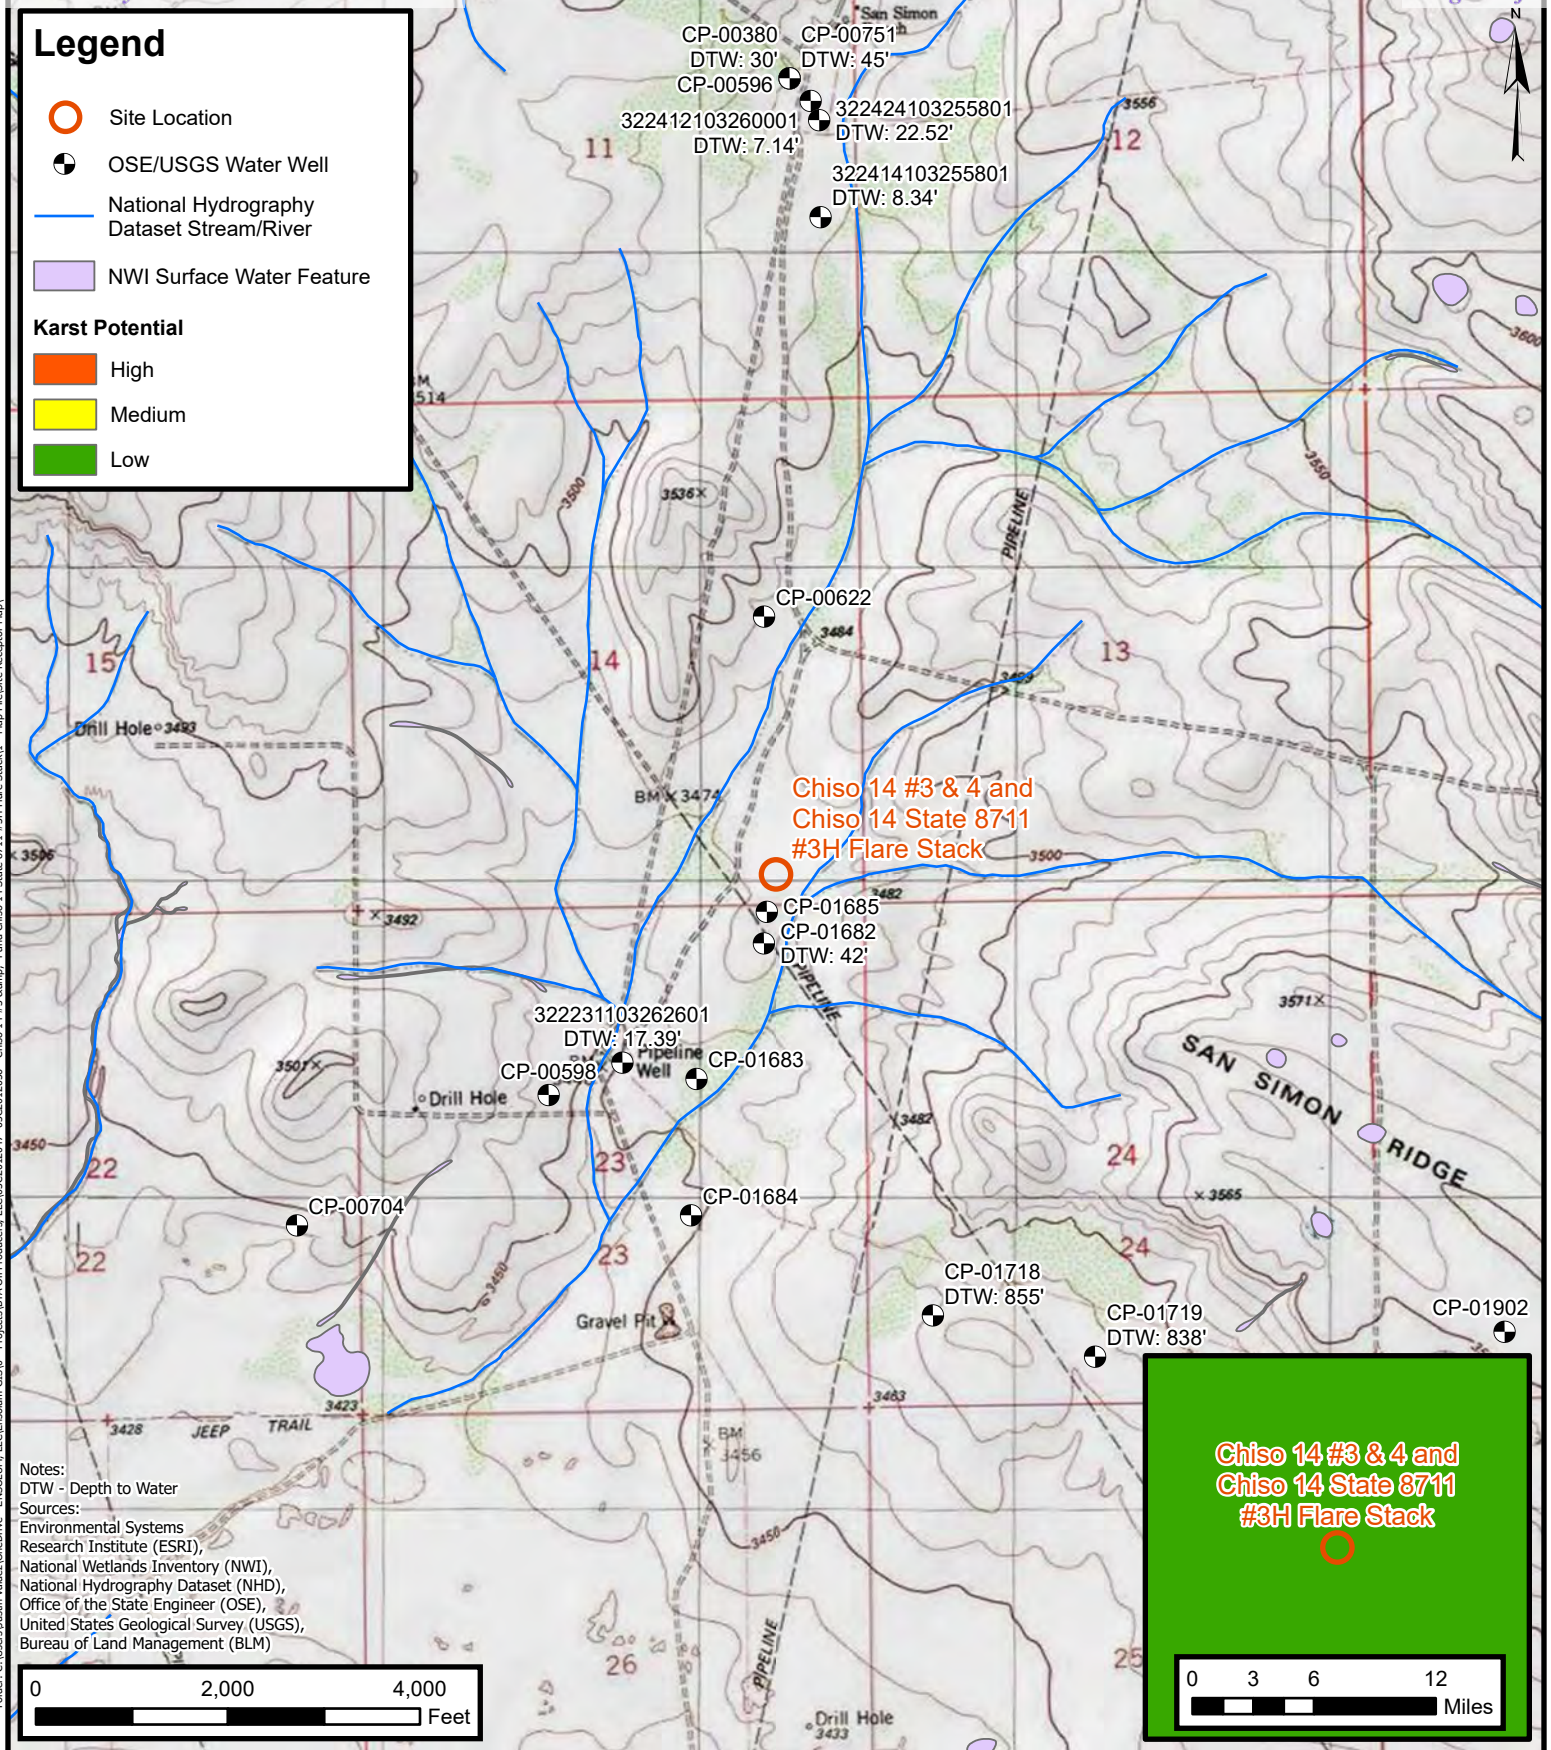
**FIGURE**  
**1**

**Site Receptor Map**  
 BTA Oil Producers, LLC  
 Chiso 14 #3 & 4 and Chiso 14 State 8711 #3H Flare Stack  
 Incident Number: nOY1829542961 and nCH1903548008  
 Unit P, Sec 14, 22S, R34E  
 Lea County, New Mexico

The Site was characterized to assess the applicability of Table I, Closure Criteria for Soils Impacted by a Release, of Title 19, Chapter 15, Part 29 (19.15.29) of the New Mexico Administrative Code (NMAC). Results from the characterization desktop review are presented on page 3 of the Form C-141s, Site Assessment/Characterization. Potential Site receptors are identified on Figure 1.

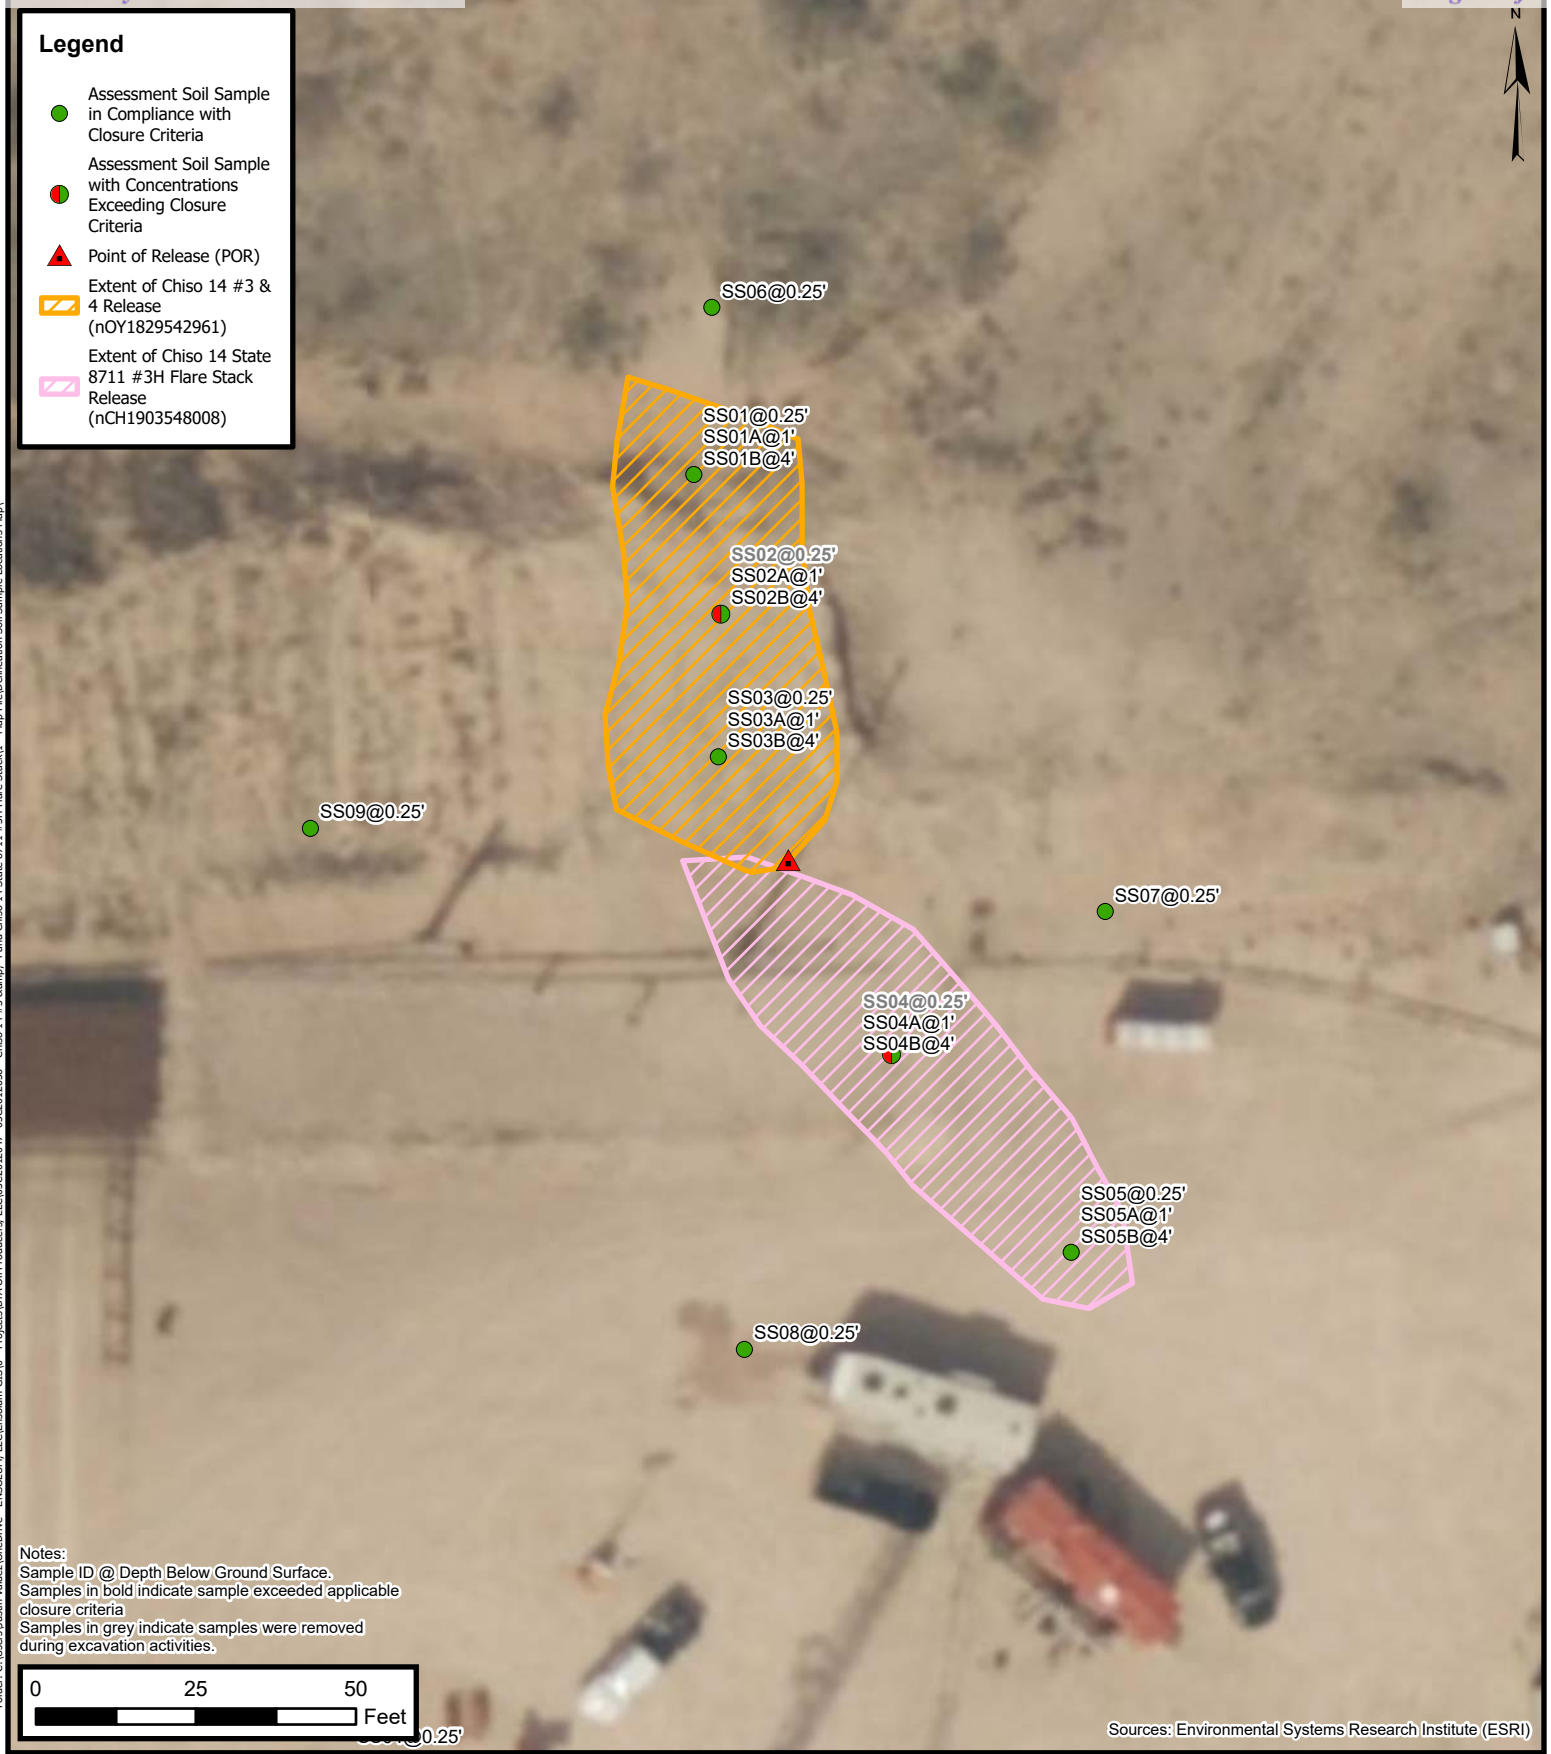
# Delineation Soil Sample Locations

**Notes:**  
 Sample ID @ Depth Below Ground Surface.  
 Samples in bold indicate sample exceeded applicable closure criteria  
 Samples in grey indicate samples were removed during excavation activities.

BTA Oil Producers, LLC  
 Chiso 14 #3 & 4 and Chiso 14 State 8711 #3H Flare Stack  
 Incident Number: nOY1829542961 and nCH1903548008  
 Unit P, Sec 14, 22S, R34E  
 Lea County, New Mexico

Between May 24, 2023, and June 1, 2023, Ensolum personnel were at the Site to evaluate the release extents based on the Form C141s and visual observations. No visible indications of the historical releases were observed during the Site visit. Five delineation boreholes (SS01 through SS05) were advanced via hand-auger within the inferred release areas, to assess for the presence or absence of impacted soil. Delineation soil samples were collected from each borehole at depths ranging from 0.25 feet to 4 feet bgs. In addition, four soil samples (SS06 through SS09) were collected around the release extent from a depth of 0.25 feet bgs to assess the lateral extent of the impacted soil. The soil samples were field screened for volatile organic compounds (VOCs) utilizing a calibrated photoionization detector (PID) and chloride using Hach® chloride QuanTab® test strips. Visual observations and field screening results were logged on lithologic soil sampling logs which are included in Appendix B. The inferred release areas and soil sample locations were mapped utilizing a handheld Global Positioning System (GPS) unit and are depicted on Figure 2. Photographic documentation was completed during site assessment and a photographic log is included in Appendix C.

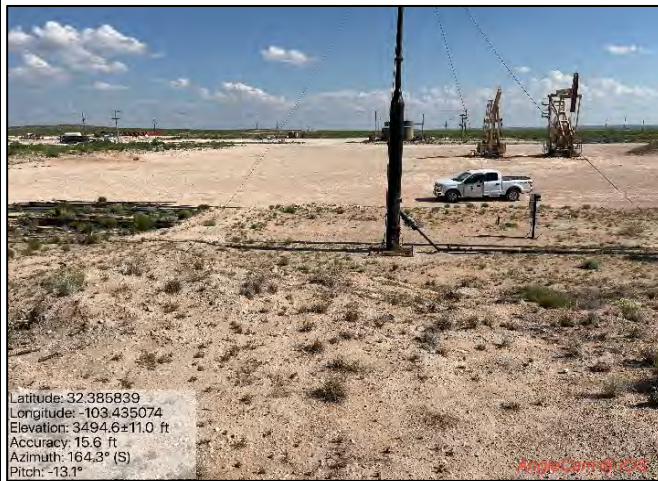
Photograph: 3 Date: 5/25/2023  
Description: Assessment activities  
View: southeast

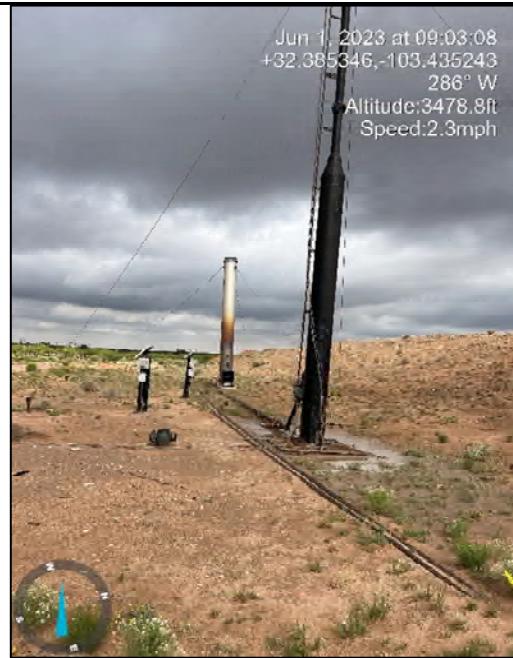
Photograph: 4 Date: 6/1/2023  
Description: Assessment activities  
View: West

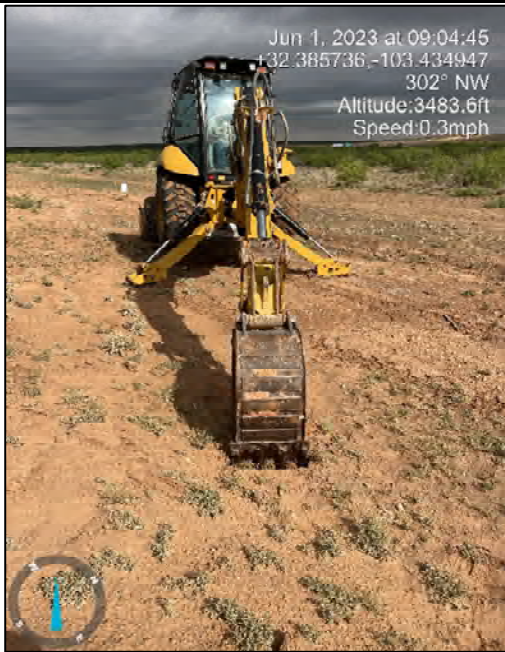
Photograph: 1 Date: 6/1/2023  
Description: Assessment activities  
View: Northwest

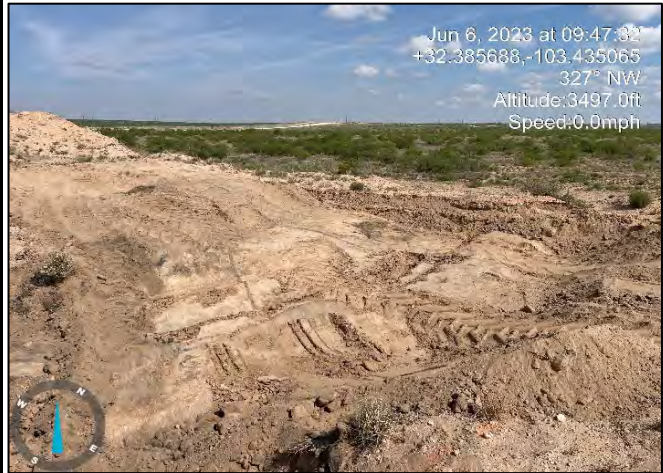
Photograph: 2 Date: 6/6/2023  
Description: Excavation activities  
View: Northwest

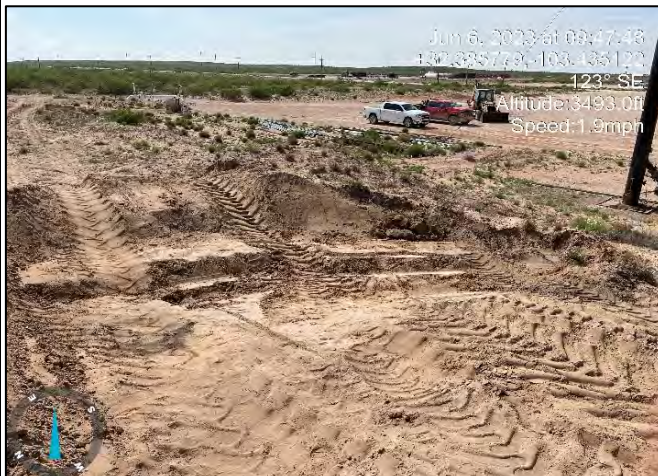
Photograph: 3 Date: 6/6/2023  
Description: Excavation activities  
View: Southeast

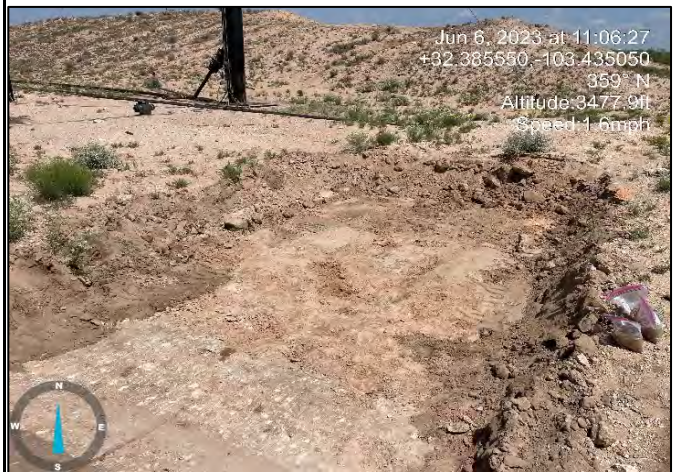
Photograph: 4 Date: 6/6/2023  
Description: Excavation activities  
View: North
