Incident ID	nAB1819053650
District RP	
Facility ID	
Application ID

Release Notification

# CLOSURE REQUEST REPORT

**Heritage Central Tank Battery  
Eddy County, New Mexico  
Incident Number nAB1819053650**

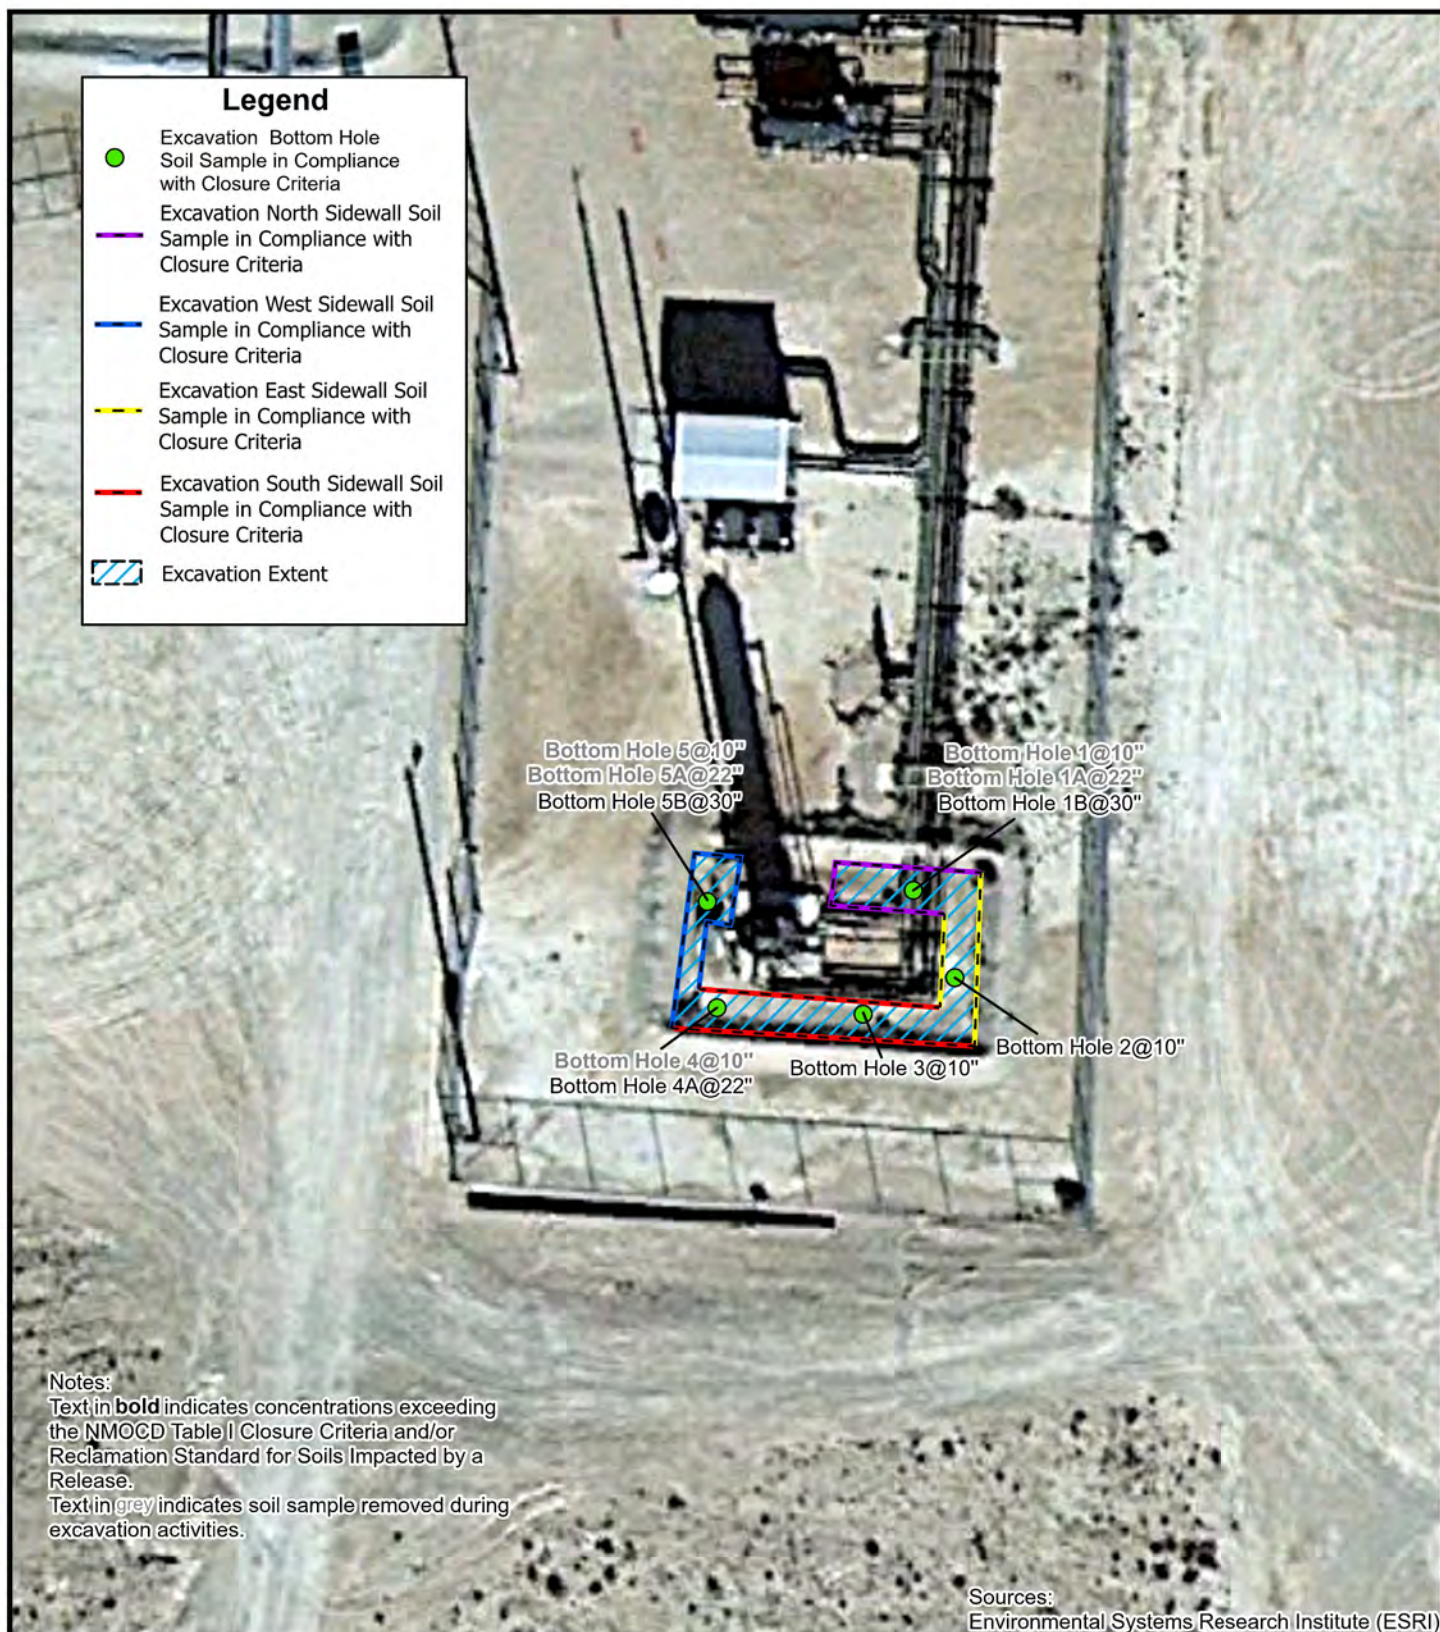
FIGURE 2

Following the removal of soil, Etech collected 5-point composite confirmation excavation soil samples at a sampling frequency of 200 square feet from the excavation floor and sidewalls. The 5-point composite samples were comprised of five equivalent aliquots homogenized in a 1-gallon, resealable plastic bag. Each sidewall sample depth represents the approximate average depth from which the five aliquots were collected. Floor samples were collected from approximately 10 inches below ground surface (bgs). The samples were then placed into lab provided pre-cleaned glass jars, packaged with minimal void space, labeled, and immediately placed on ice. The soil samples were transported under strict chain-of-custody procedures to Permian Basin Environmental Laboratory (PBELAB) in Midland, Texas, for analysis of COCs. The location of confirmation excavation soil samples is shown in **Figure 2** in **Appendix A**.

## Excavation Soil Sample Locations

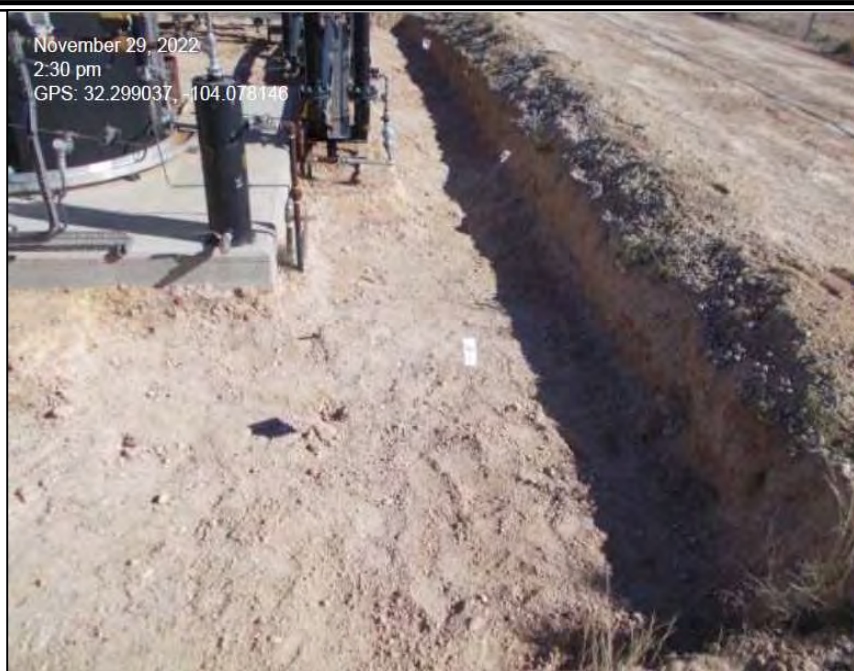
**Photograph 1****Date: 11/29/2022**

Description: Western view during excavation activities.

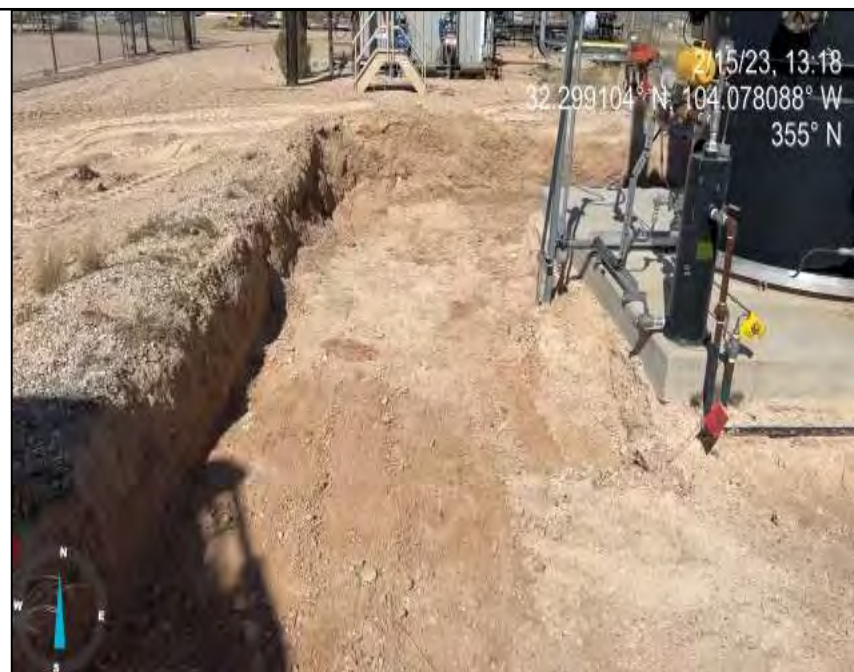
**Photograph 2****Date: 02/15/2023**

Description: Northern view during excavation activities.

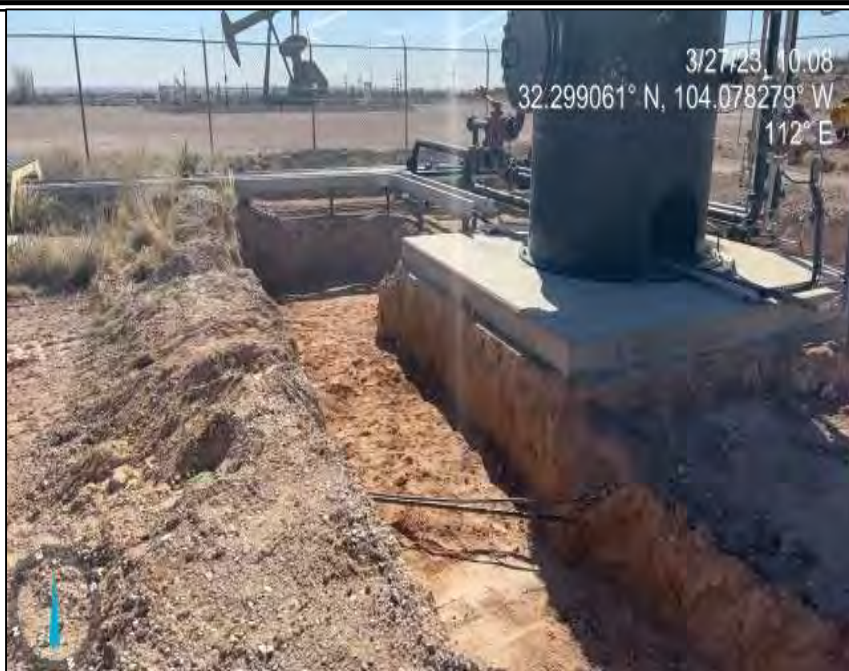
**Photograph 3****Date: 03/27/2023**

Description: Eastern view during excavation activities.

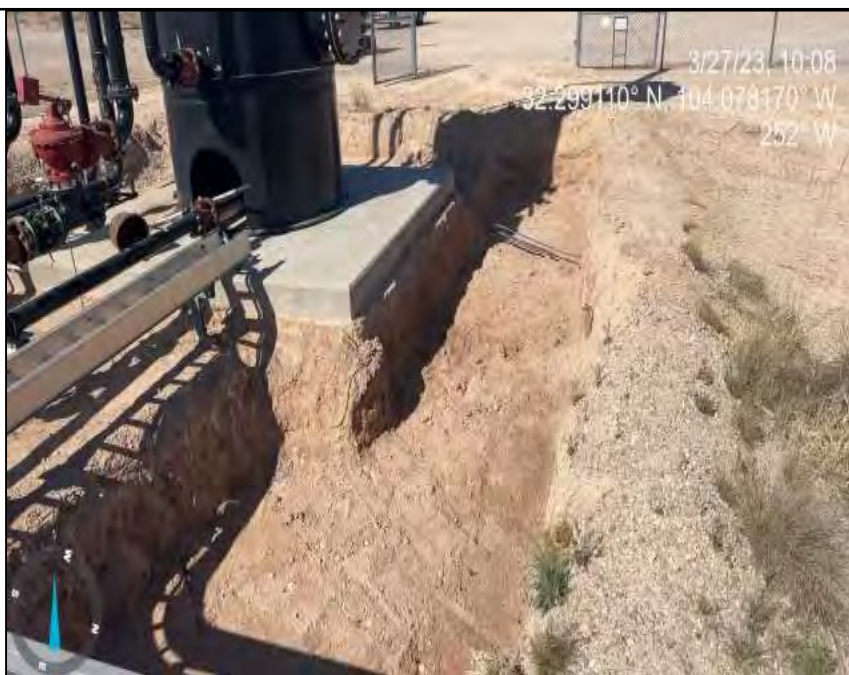
**Photograph 4****Date: 03/27/2023**

Description: Southwestern view during excavation activities.

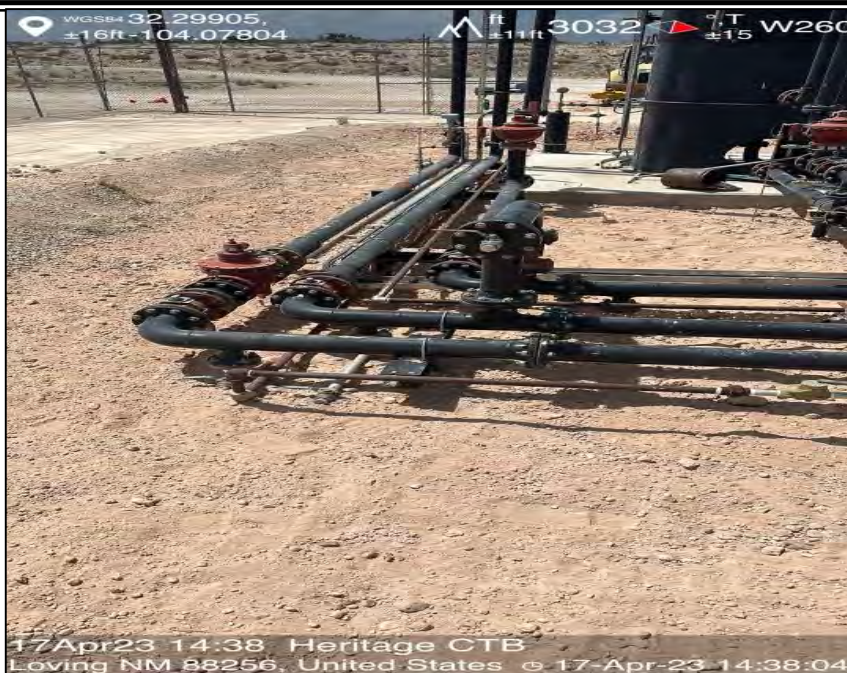
**Photograph 5****Date: 04/17/2023**

Description: Western view following remediation activities.

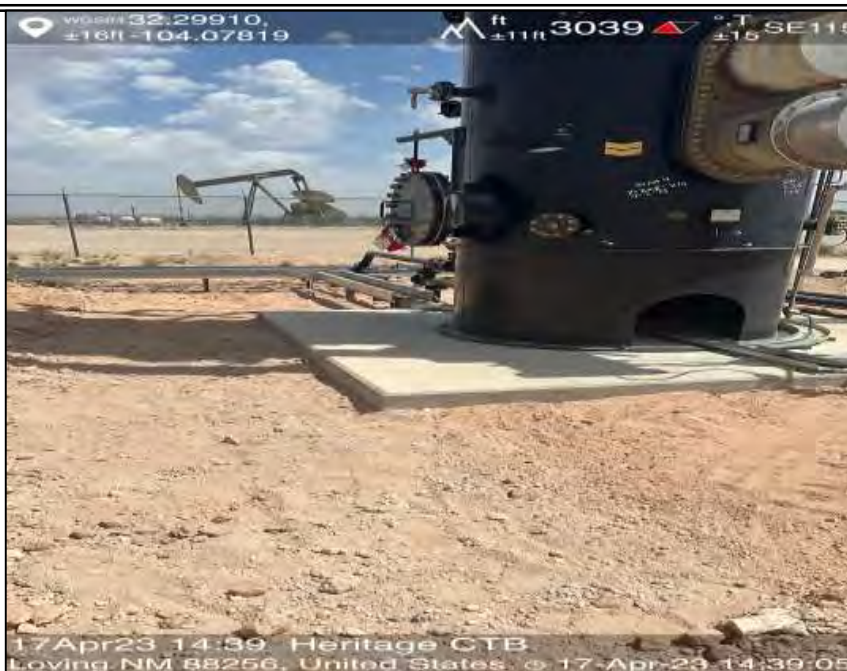
**Photograph 6****Date: 04/17/2023**

Description: Eastern view following remediation activities.
