**Closure Report**  
**Crow Flats 16 State Com #002**  
**Incident ID: NAB1617627149**  
**Eddy County, New Mexico**  
**Unit M Sec 16 T16S R28E**  
**32.9171333°, -104.1882935°**

**Point of Release:**  
**Crude oil stock tank developed a hole in the bottom of it.**  
**Release Date: 06/20/2016**  
**Volume Released: 165 Barrels of Crude Oil**  
**Volume Recovered: 85 Barrels of Crude Oil**

**Prepared for:**  
**Cimarex Energy Co. of Colorado**  
**600 N. Marienfeld Street**  
**Suite 600**  
**Midland, Texas 79701**

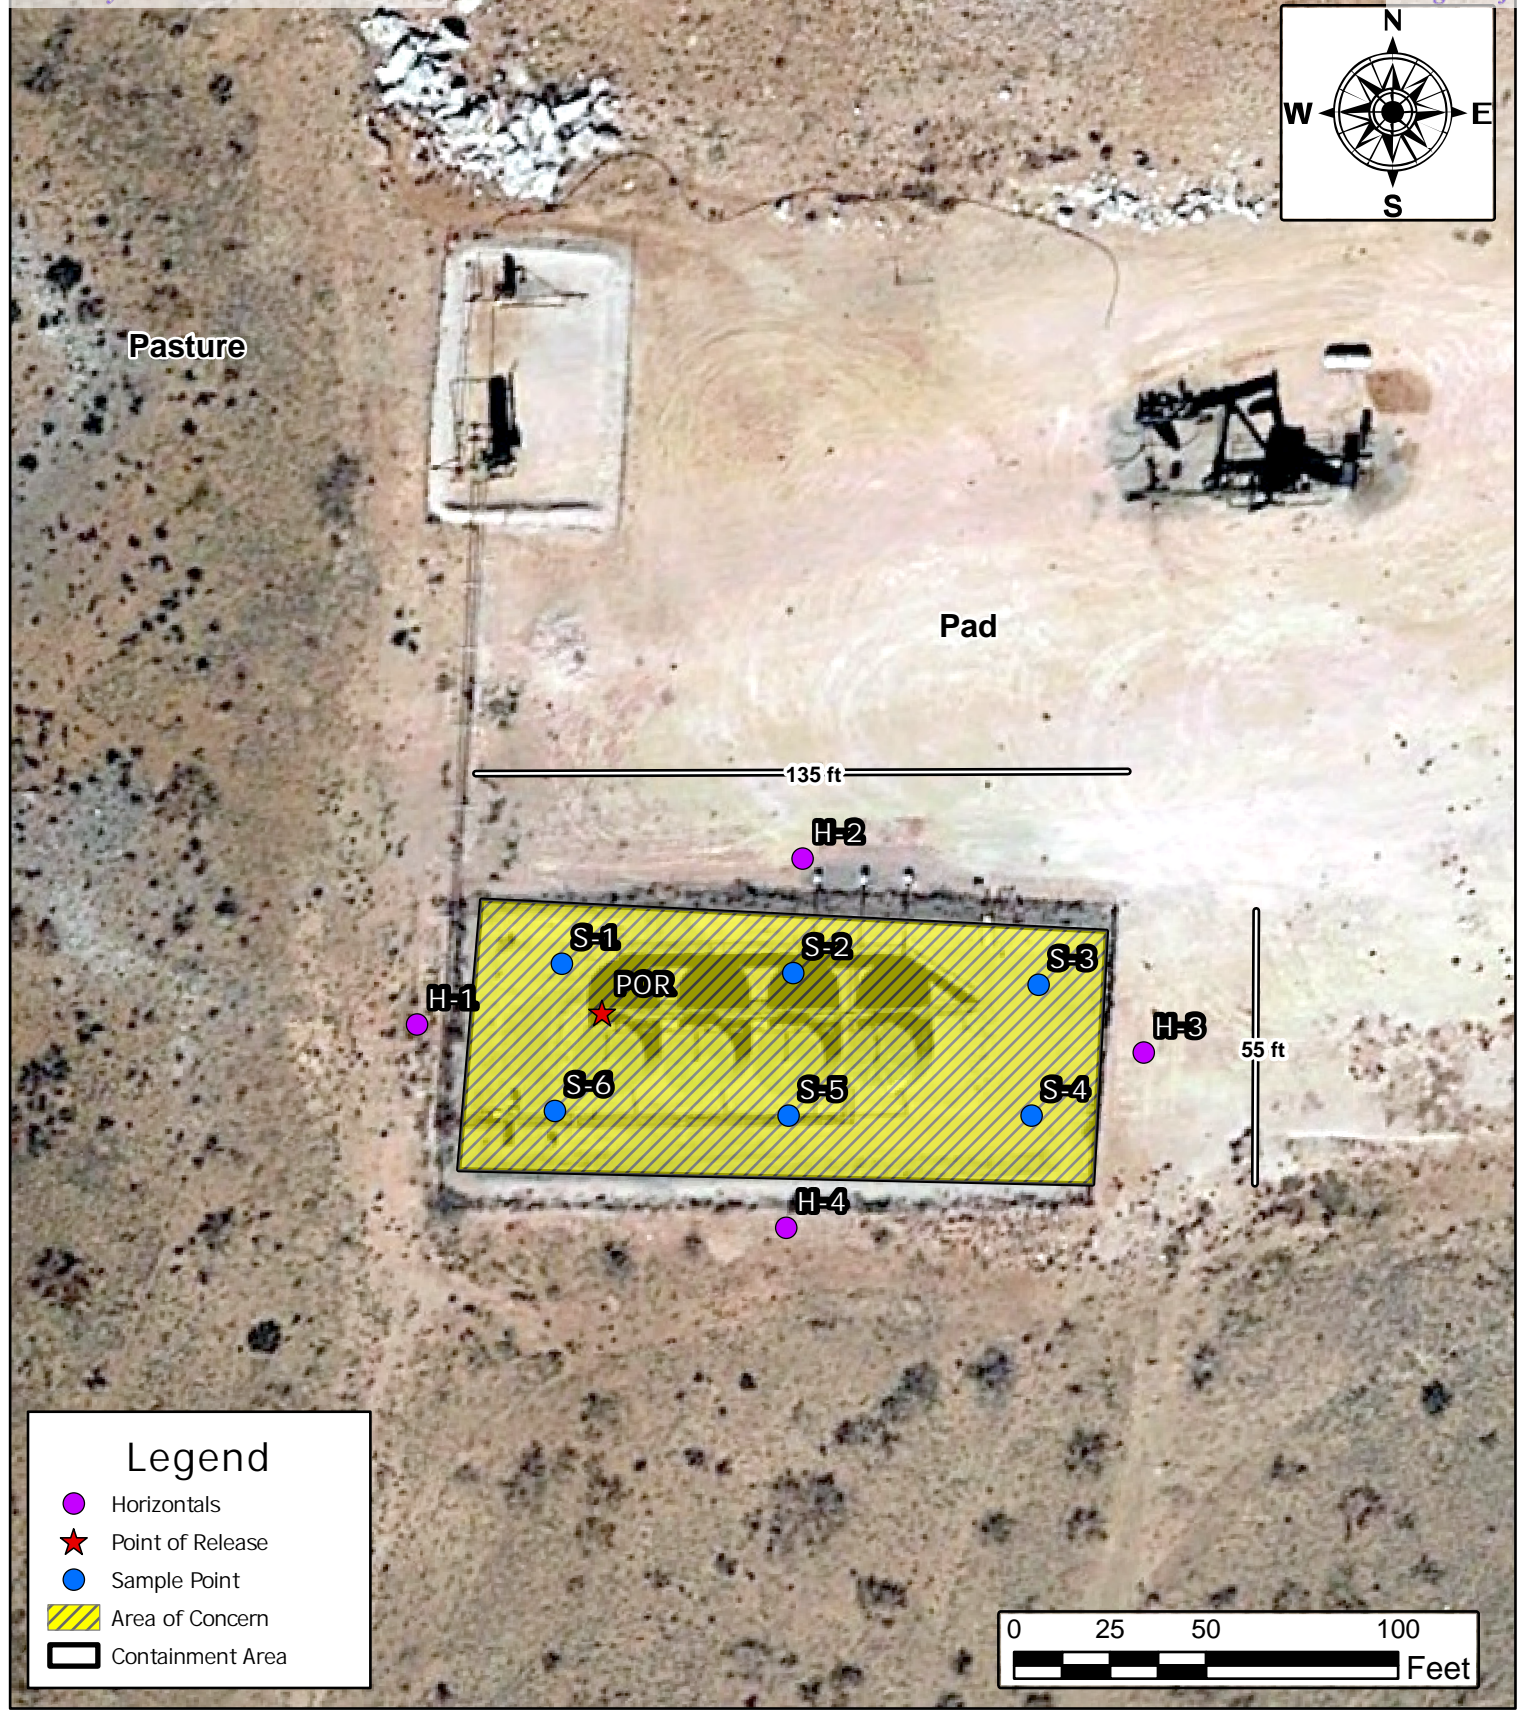
**SAMPLE LOCATION MAP**  
**CIMAREX ENERGY CO. OF COLORADO**  
CROW FLATS 16 STATE COM #002  
EDDY COUNTY, NEW MEXICO  
32.9171333, -104.1882935

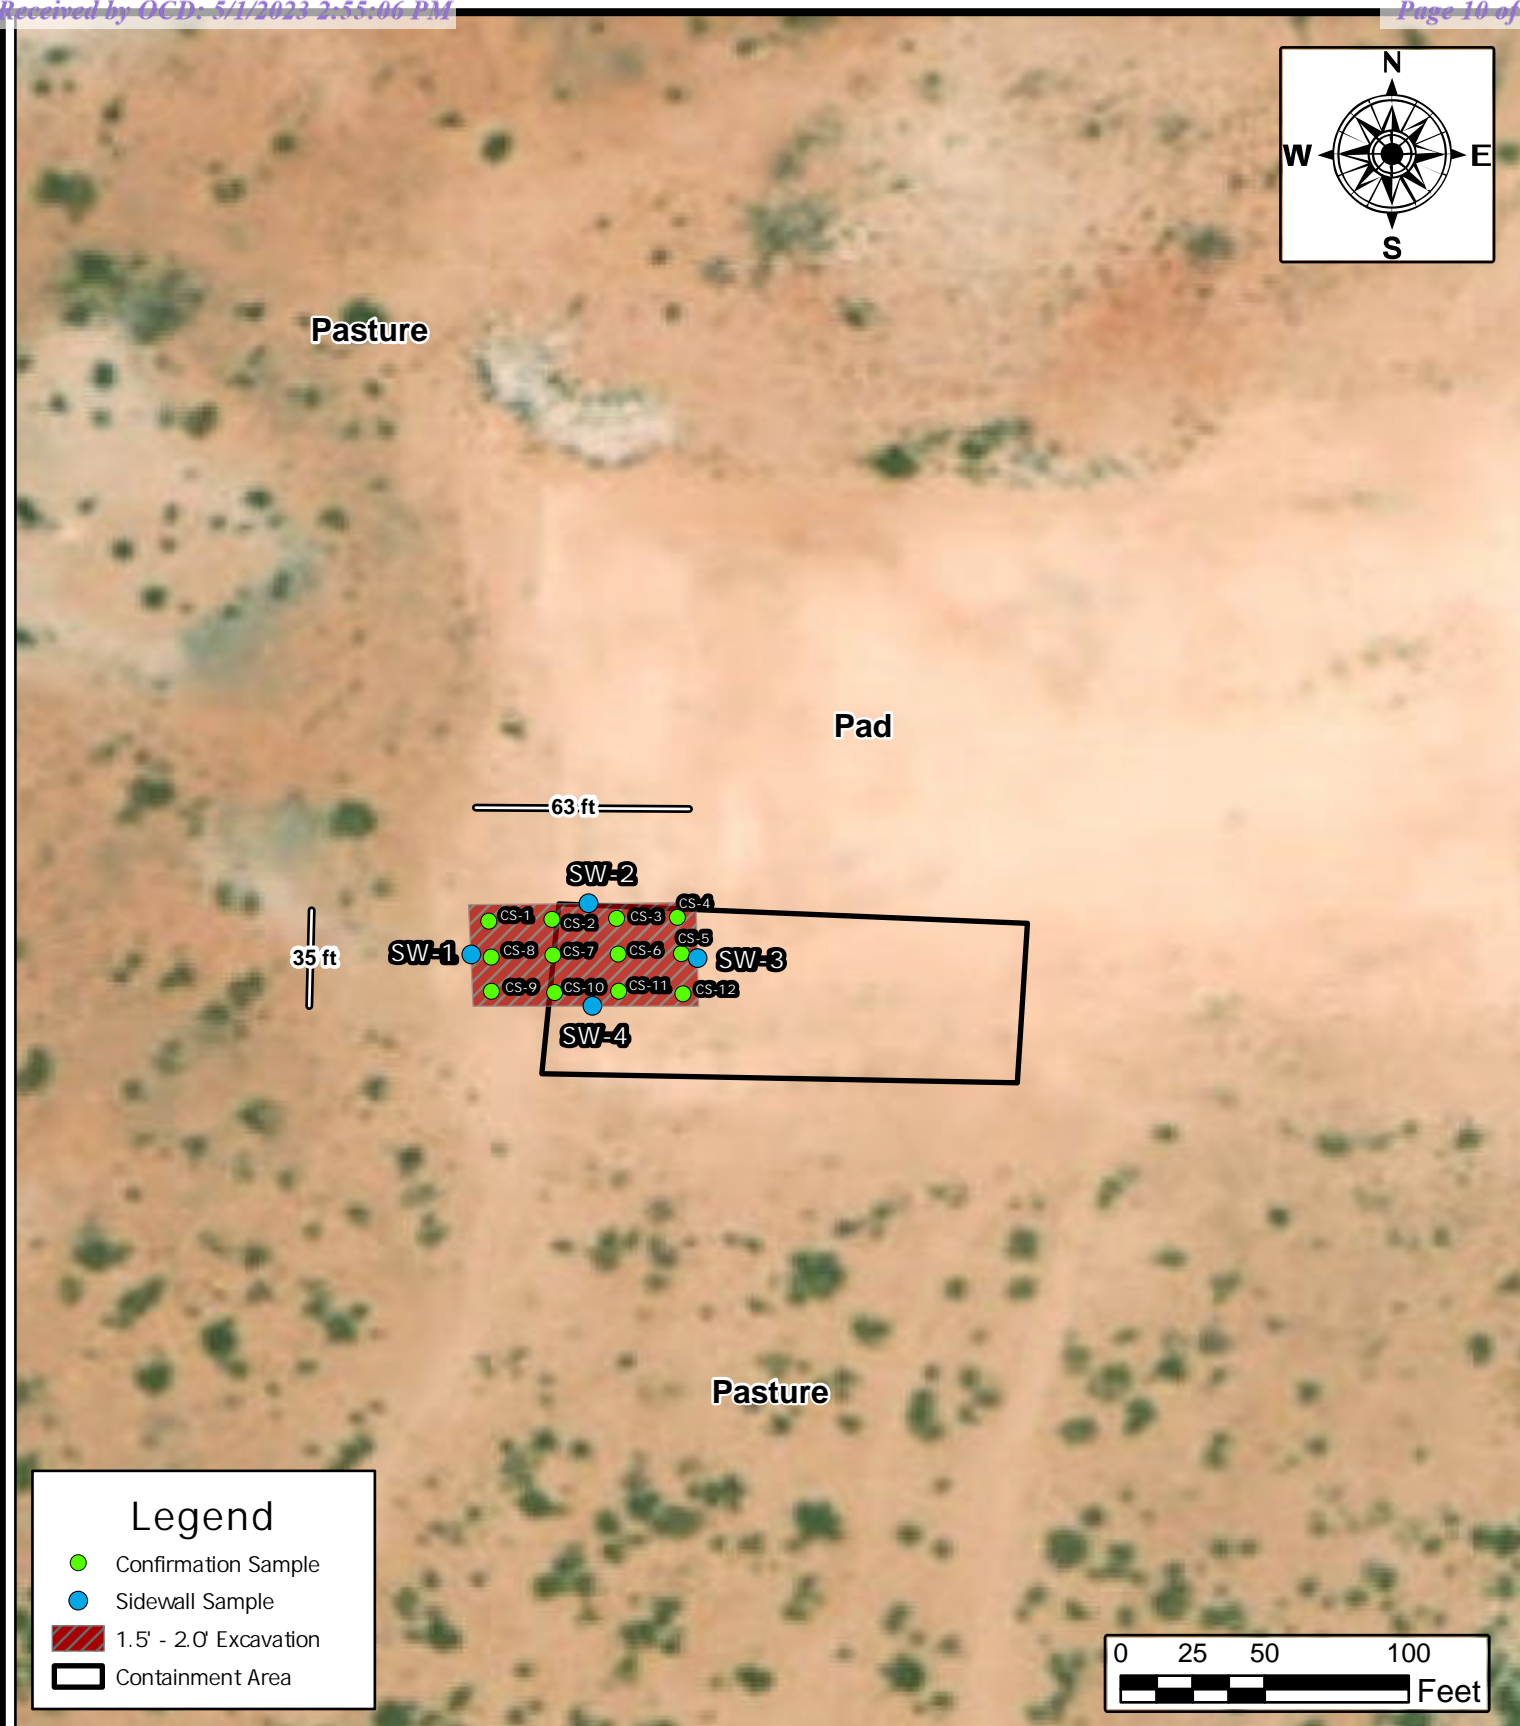
**EXCAVATION DEPTH MAP**  
**CIMAREX ENERGY CO. OF COLORADO**  
 CROW FLATS 16 STATE COM #002  
 EDDY COUNTY, NEW MEXICO  
 32.9171333, -104.1882935

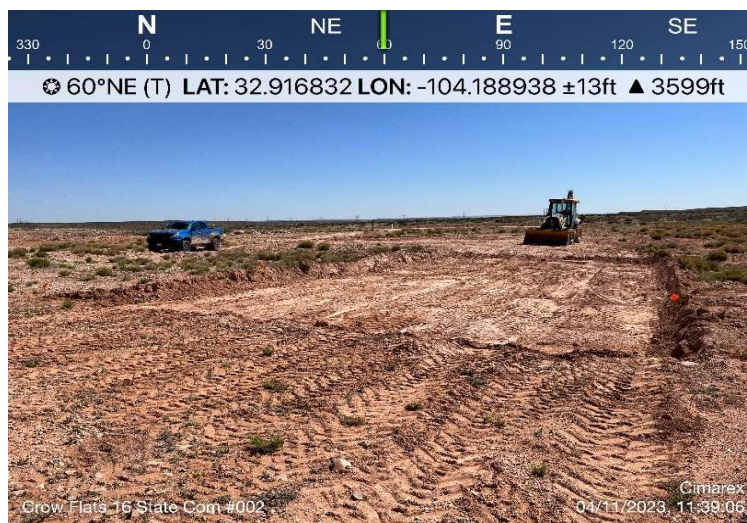
View Northeast, area of CS-1 through CS-12.

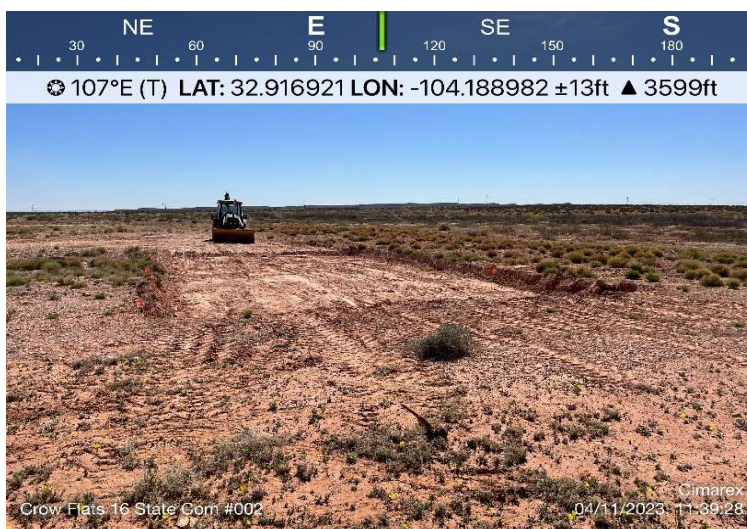
## Photograph No. 2

View East, area of CS-1 through CS-12.

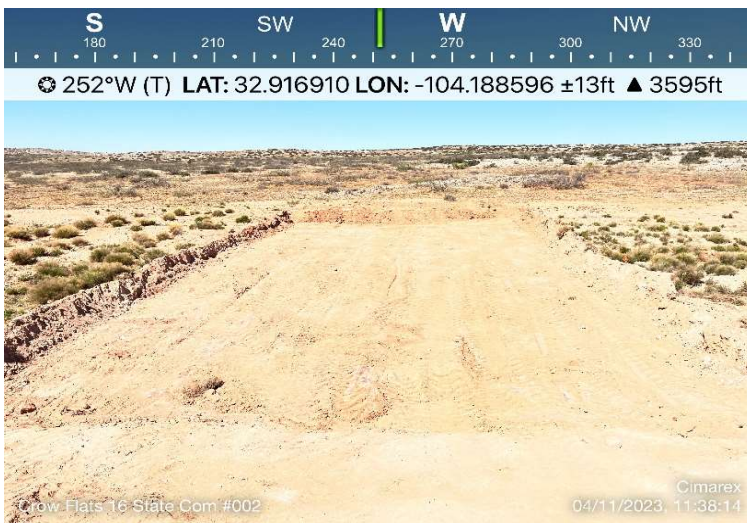
## Photograph No. 3

View West, area of CS-1 through CS-12.
