Vertex Project #: 22E-00197

Spill Closure Report: Gem North Tank Battery
Unit L2, Section 2, Township 20 South, Range 33 East
API: 30-025-29916
County: Lea
Incident ID: nAPP2201956795

2022 Spill Assessment and Closure
June 2023

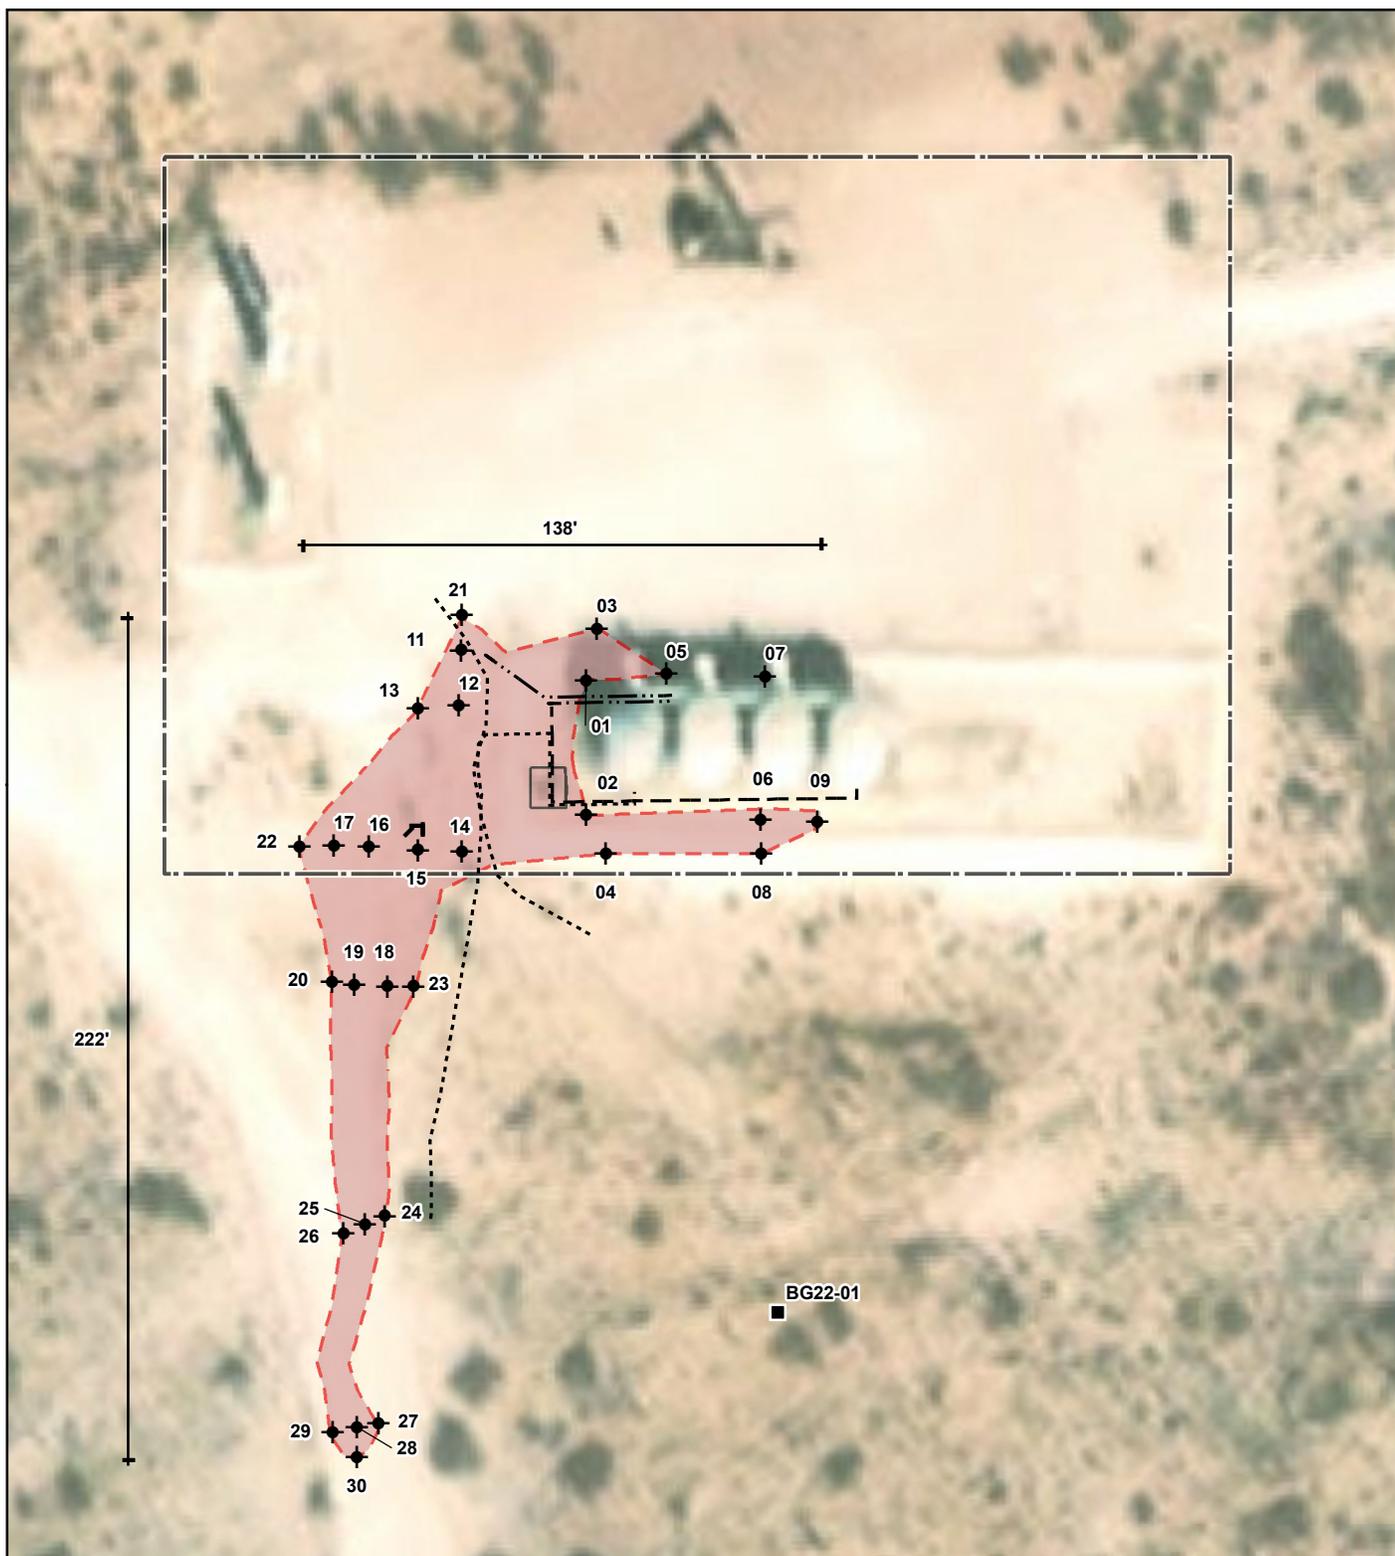
- Background Sample
- ◆ Borehole (Prefixed by "BH22-")
- ↗ Riser
- Flowline
- Pipeline
- - - Pipeline Inside Containment
- Approximate Lease Boundary
- Total Spill Extent (6,449 sq. ft.)
- Water Transfer Pump

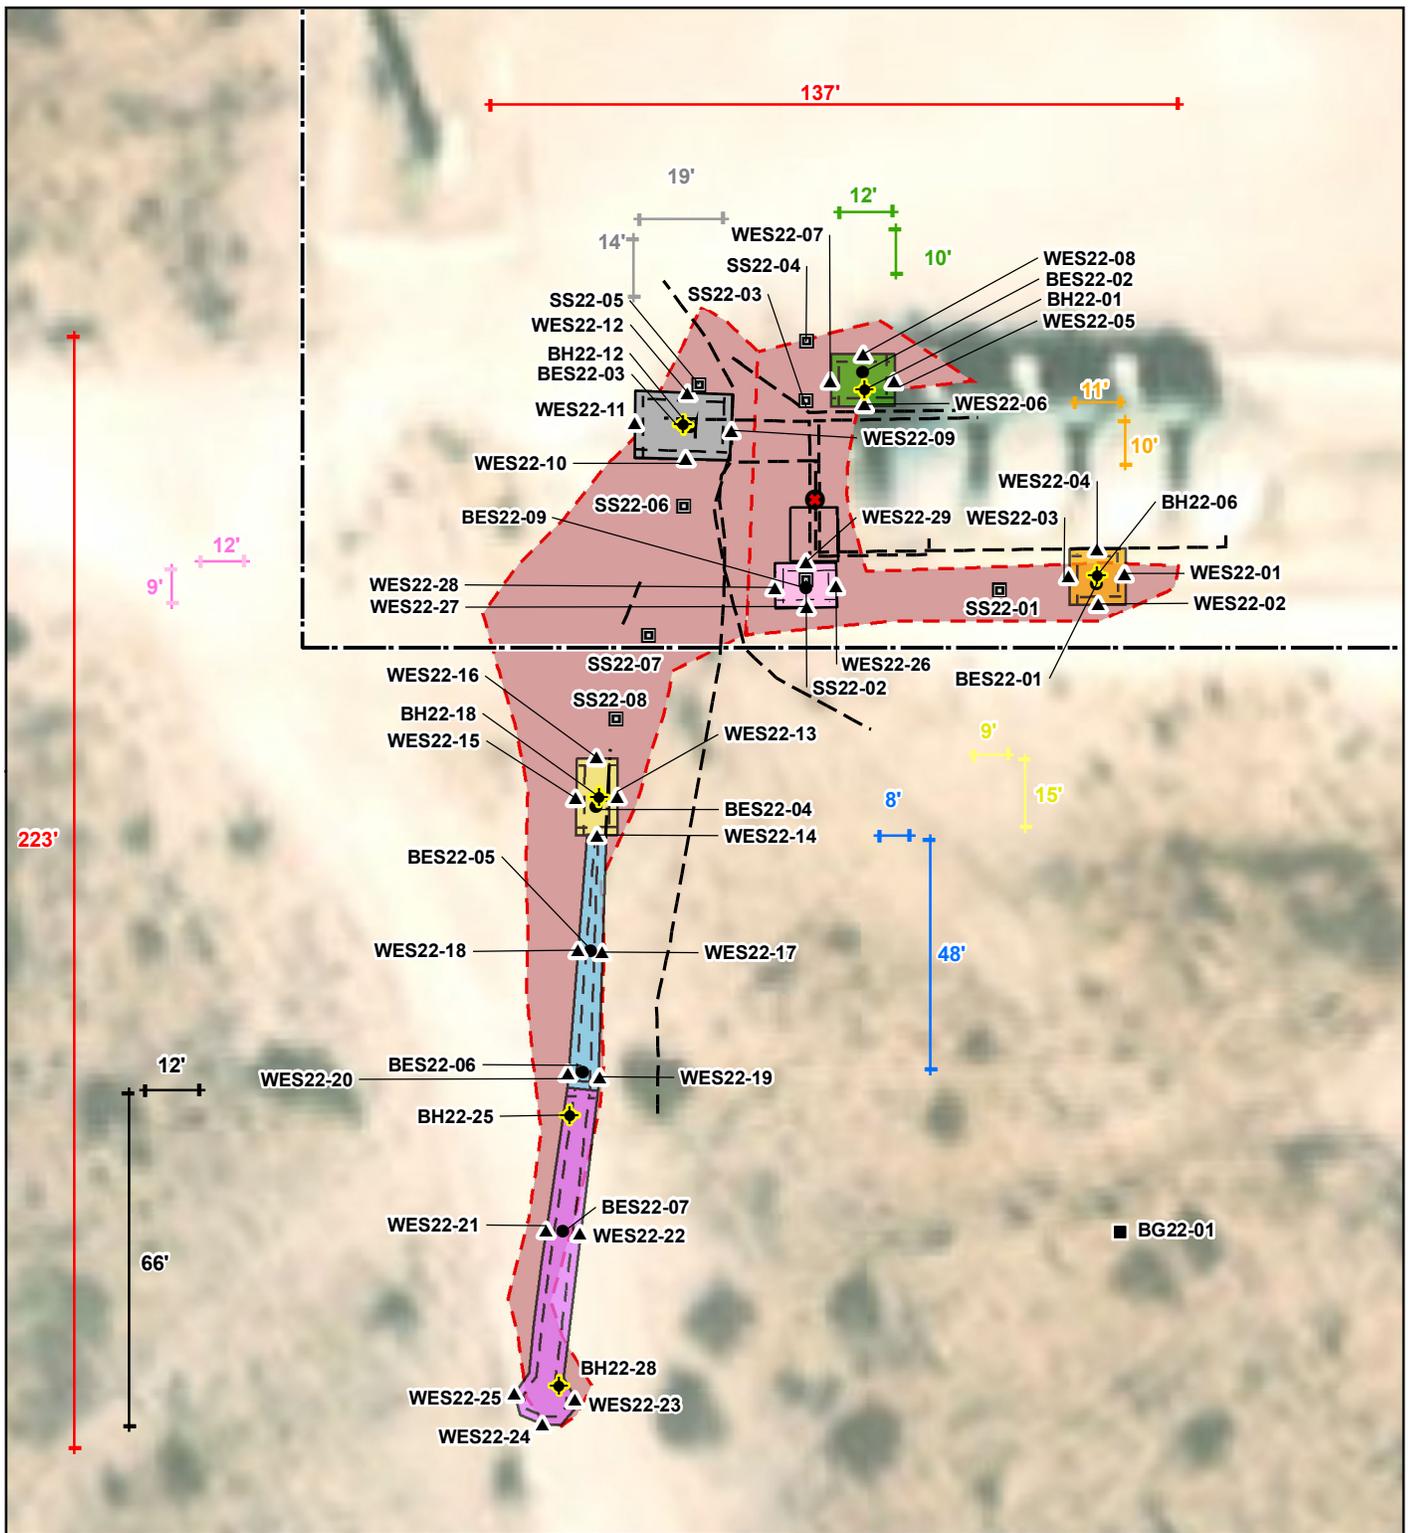
- Background Sample (US)
- Base Sample (Excavated)
- Point of Release (US)
- Surface Sample (US)
- ▲ Wall Sample (Excavated)
- - Pipeline (Aboveground)
- ··· Pipeline (Underground)
- ▭ 2 ft. Excavation (246 sq. ft.)
- ▭ 2 ft. Excavation (127 sq. ft.)
- ▭ 2 ft. Excavation (107 sq. ft.)
- ▭ 0.5 ft. Excavation (472 sq. ft.)
- ▭ 1 ft. Excavation (244 sq. ft.)
- ▭ 2 ft. Excavation (122 sq. ft.)
- ▭ 5 ft. Excavation (123 sq. ft.)
- ▭ Infrastructure (Existing)
- ▭ Lease Boundary
- ▭ Spill Area (6,444 sq. ft.)

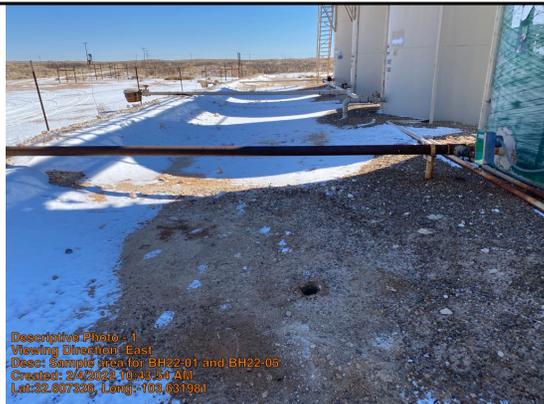
Descriptive Photo - 1
Viewing Direction: East
Desc: Sample area for BH22-01 and BH22-05
Created: 2/4/2022 10:49:54 AM
Lat:32.607335, Long:-103.631981

Sample area for BH22-01 and BH22-05

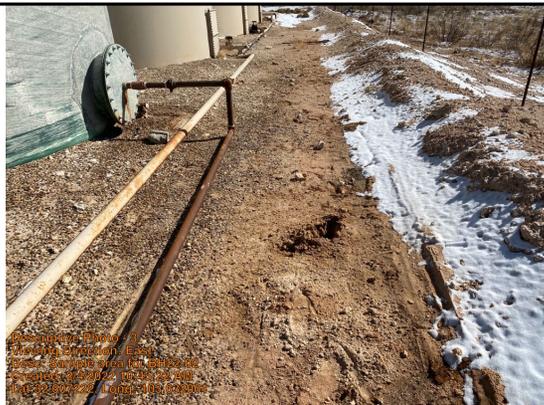
Descriptive Photo - 3
Viewing Direction: East
Desc: Sample area for BH22-02
Created: 2/4/2022 10:46:24 AM
Lat:32.607322, Long:-103.631981

Sample area for BH22-02

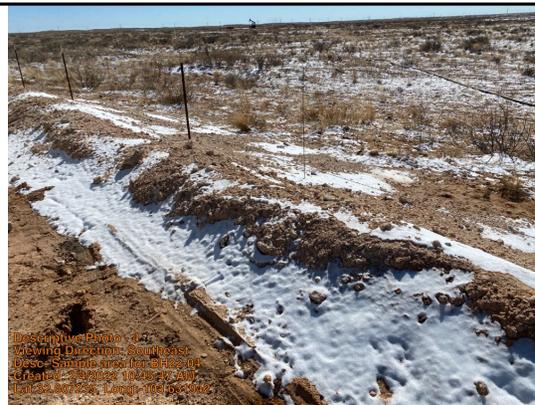
Descriptive Photo - 4
Viewing Direction: Southeast
Desc: Sample area for BH22-04
Created: 2/4/2022 10:46:24 AM
Lat:32.60665, Long:-103.631979

Sample area for BH22-04 on south side of the berm.

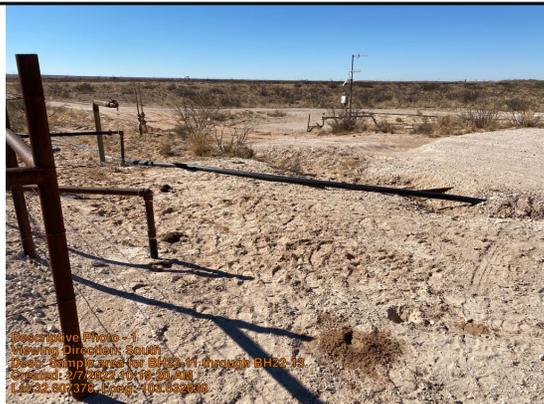
Describe Photo - 1
Viewing Direction: South
Desc: Sample area for BH22-11 through BH22-13
Created: 2/7/2022 10:18:20 AM
Lat:32.802378, Long: -103.832898

Sample area for BH22-11 through BH22-13

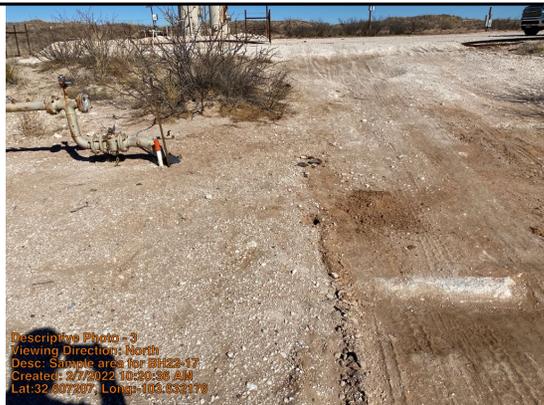
Describe Photo - 3
Viewing Direction: North
Desc: Sample area for BH22-17
Created: 2/7/2022 10:30:38 AM
Lat:32.807207, Long: -103.833178

Sample area for BH22-17

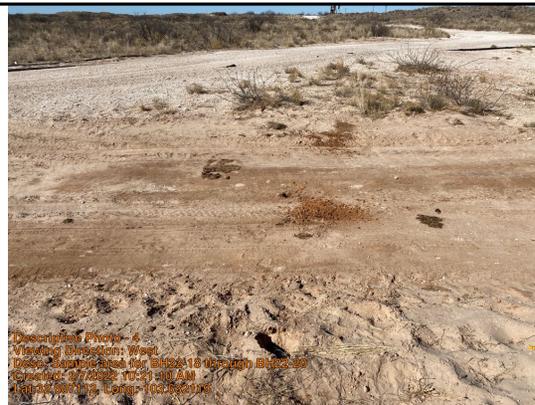
Describe Photo - 4
Viewing Direction: West
Desc: Sample area for BH22-18 through BH22-20
Created: 2/7/2022 10:31:10 AM
Lat:32.807118, Long: -103.832118

Sample area for BH22-18 through BH22-20

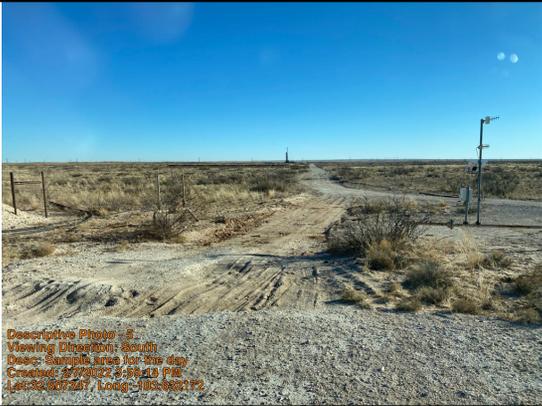
Describe Photo:
Viewing Direction: South
Desc: Sample area for the day
Created: 2/7/2022 4:58:13 PM
Lat:32.807267, Long:-103.882192

Sample area for the day

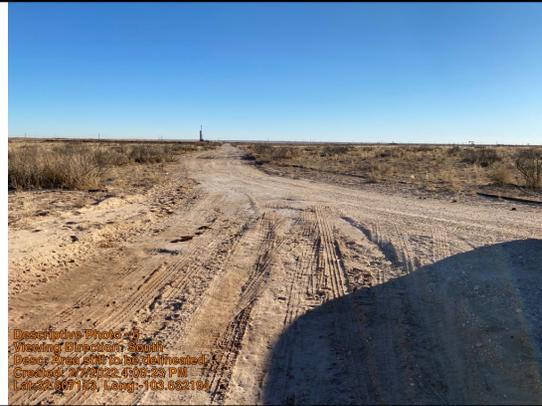
Describe Photo:
Viewing Direction: South
Desc: Area still to be delineated
Created: 2/7/2022 4:56:23 PM
Lat:32.807182, Long:-103.882192

Area still to be delineated.

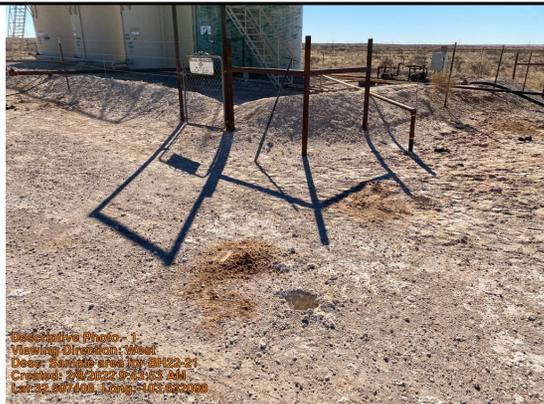
Descriptive Photo - 1
Viewing Direction: Southeast
Desc: Sample area for BH22-21
Created: 2/8/2022 9:43:03 AM
Lat:32.807408, Long:-103.632208

Sample area for BH22-21

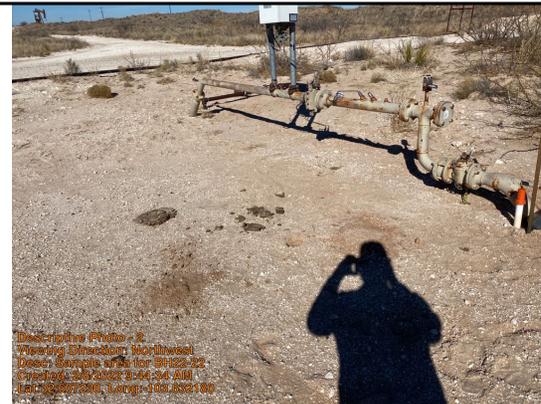
Descriptive Photo - 2
Viewing Direction: Northwest
Desc: Sample area for BH22-22
Created: 2/8/2022 9:44:24 AM
Lat:32.807226, Long:-103.632189

Sample area for BH22-22

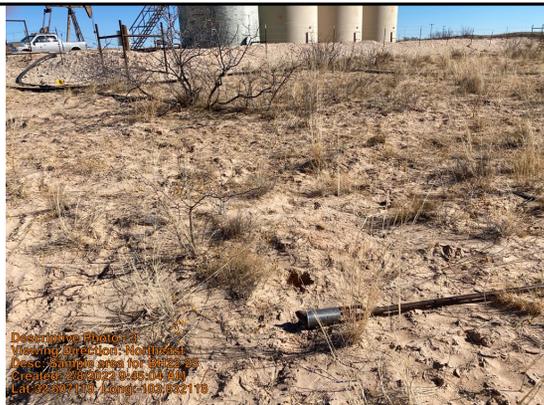
Descriptive Photo - 3
Viewing Direction: Northeast
Desc: Sample area for BH22-23
Created: 2/8/2022 9:45:04 AM
Lat:32.807178, Long:-103.632178

Sample area for BH22-23

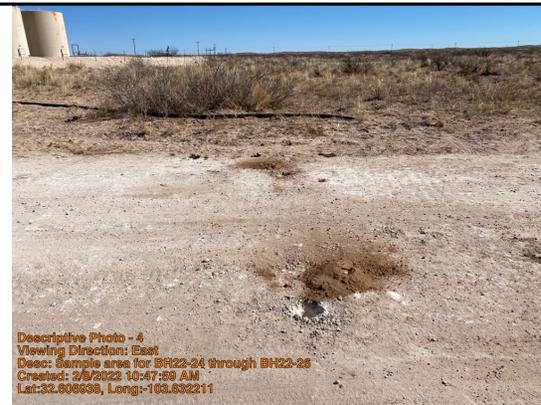
Descriptive Photo - 4
Viewing Direction: East
Desc: Sample area for BH22-24 through BH22-26
Created: 2/8/2022 10:47:59 AM
Lat:32.806938, Long:-103.632211

Sample area for BH22-24 through BH22-26

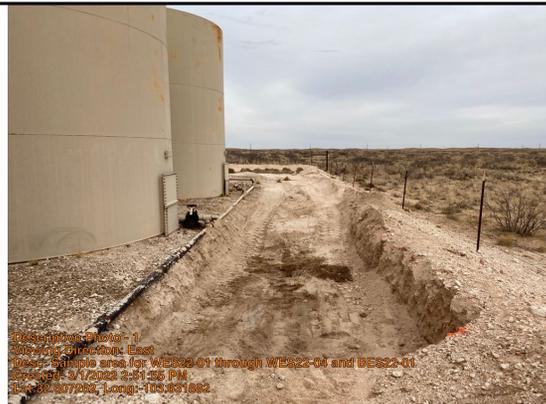
Descriptive Photo - 1
Viewing Direction: East
Area: Sample area for WES22-01 through WES22-04 and BES22-01
Created: 3/1/2022 2:51:25 PM
Lat: 33.207248, Long: -105.431848

Sample area for WES22-01 through WES22-04 and BES22-01 south side of tanks inside containment.

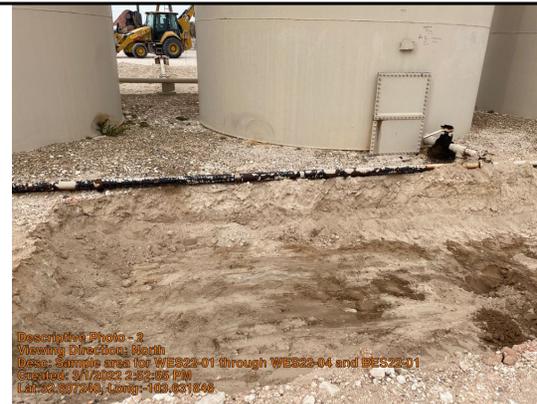
Descriptive Photo - 2
Viewing Direction: North
Area: Sample area for WES22-01 through WES22-04 and BES22-01
Created: 3/1/2022 2:52:55 PM
Lat: 33.207248, Long: -105.431848

Sample area for WES22-01 through WES22-04 and BES22-01

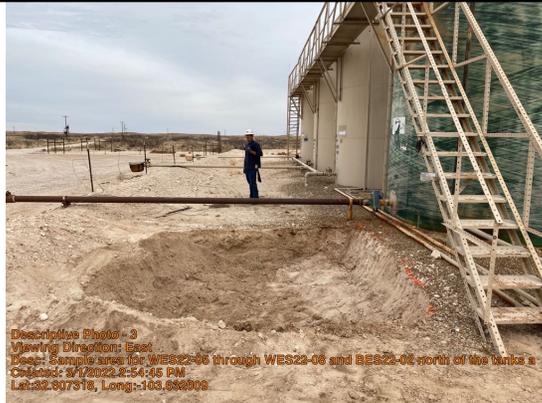
Descriptive Photo - 3
Viewing Direction: East
Desc: Sample area for WES22-05 through WES22-08 and BES22-02 north of the tanks and inside the containment.
Created: 3/1/2022 2:54:45 PM
Lat:32.607318, Long:-103.632003

Sample area for WES22-05 through WES22-08 and BES22-02 north of the tanks and inside the containment.

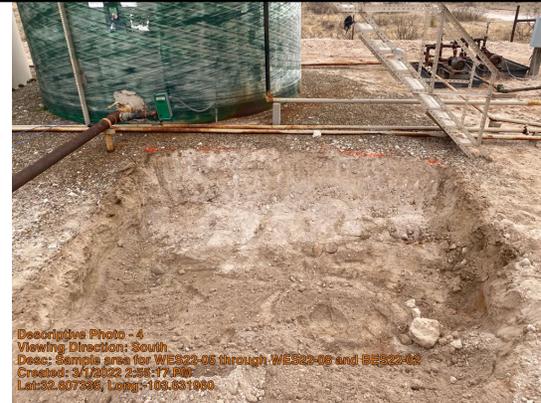
Descriptive Photo - 4
Viewing Direction: South
Desc: Sample area for WES22-05 through WES22-08 and BES22-02
Created: 3/1/2022 2:58:17 PM
Lat:32.607336, Long:-103.631960

Sample area for WES22-05 through WES22-08 and BES22-02

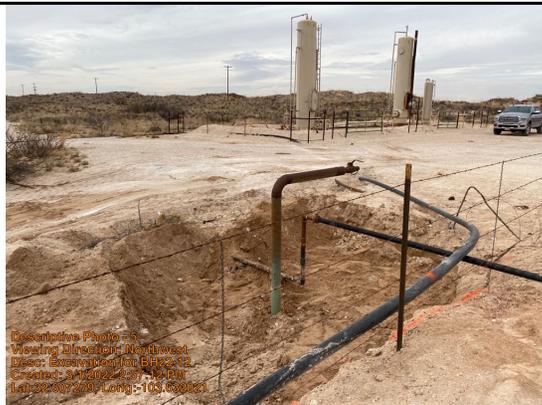
Descriptive Photo - 5
Viewing Direction: Northwest
Desc: Excavation for BH22-12
Created: 3/1/2022 2:57:13 PM
Lat:32.607200, Long:-103.632021

Excavation for BH22-12

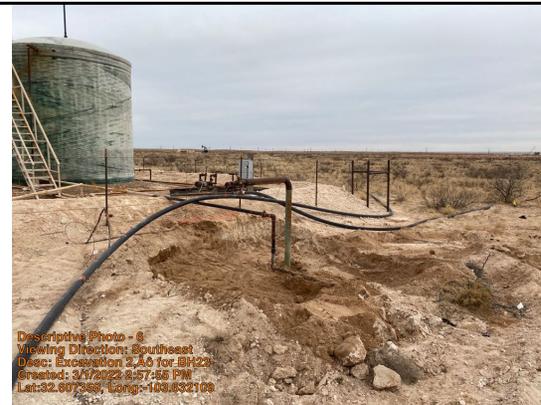
Descriptive Photo - 6
Viewing Direction: Southeast
Desc: Excavation 2' for BH22-12
Created: 3/1/2022 2:57:56 PM
Lat:32.607359, Long:-103.632109

Excavation 2' for BH22-12

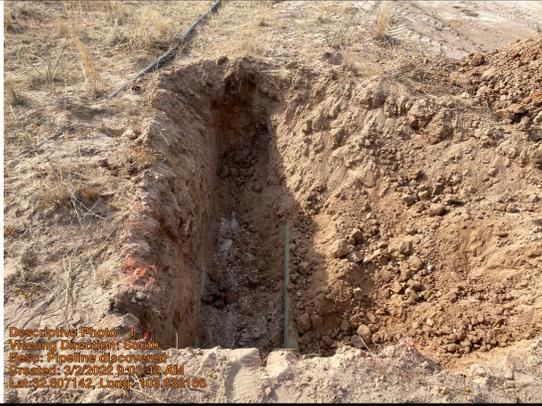
Descriptive Photo - 1
Viewing Direction: South
Event: Pipeline discovered
Created: 3/2/2022 8:03:46 AM
Lat: 32.807142, Long: 103.832199

Pipeline discovered

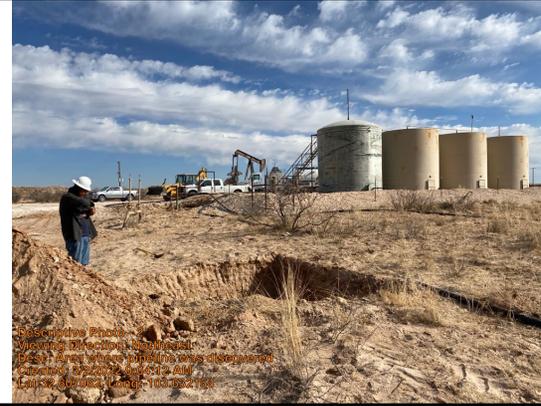
Descriptive Photo - 2
Viewing Direction: Northeast
Event: Area where pipeline was discovered
Created: 3/2/2022 8:04:15 AM
Lat: 32.807142, Long: 103.832199

Area where pipeline was discovered

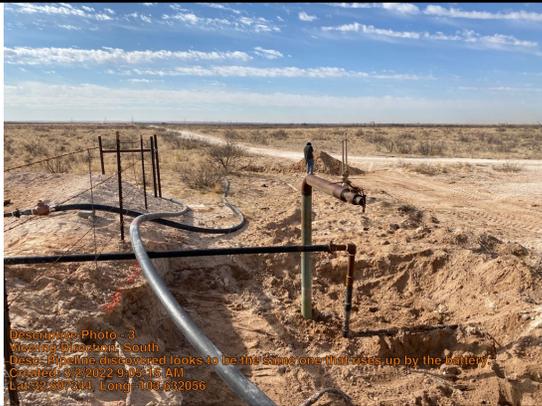
Descriptive Photo - 3
Viewing Direction: South
Event: Pipeline discovered looks to be the same one that rises up by the battery
Created: 3/2/2022 9:03:15 AM
Lat: 32.807144, Long: 103.832056

Pipeline discovered looks to be the same one that rises up by the battery.

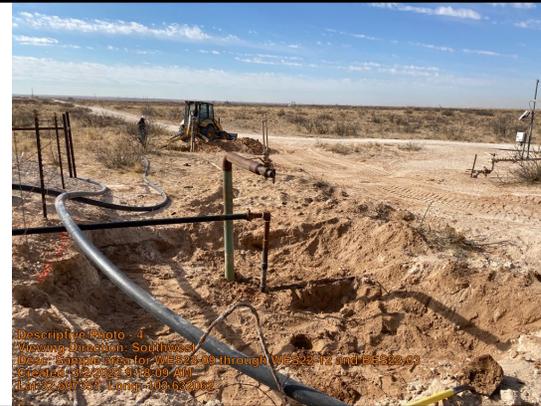
Descriptive Photo - 4
Viewing Direction: Southwest
Event: Sample area for WES22-09 through WES22-12 and BES22-03
Created: 3/2/2022 9:19:09 AM
Lat: 32.807142, Long: 103.832199

Sample area for WES22-09 through WES22-12 and BES22-03

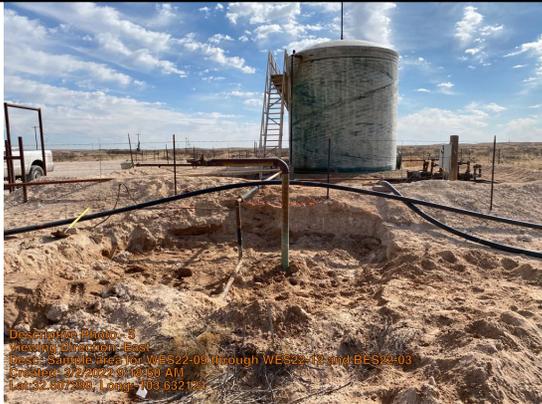
Descriptive Photo - 6
Viewing Direction: East
Date: Sample area for WES22-09 through WES22-12 and BES22-03
Created: 3/2/2022 9:19:50 AM
Lat: 32.807286, Long: 103.832137

Sample area for WES22-09 through WES22-12 and BES22-03

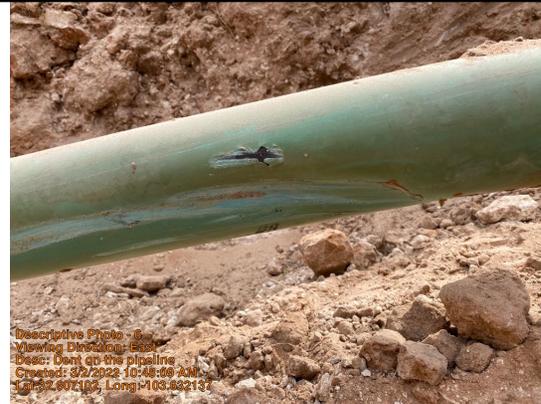
Descriptive Photo - 6
Viewing Direction: East
Date: Dent on the pipeline
Created: 3/2/2022 10:48:00 AM
Lat: 32.807185, Long: 103.832137

Dent on the pipeline

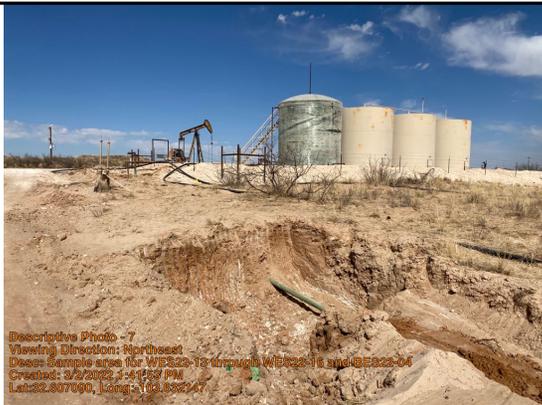
Descriptive Photo - 7
Viewing Direction: Northeast
Date: Sample area for WES22-13 through WES22-16 and BES22-04
Created: 3/2/2022 4:51:37 PM
Lat: 32.807090, Long: 103.832147

Sample area for WES22-13 through WES22-16 and BES22-04

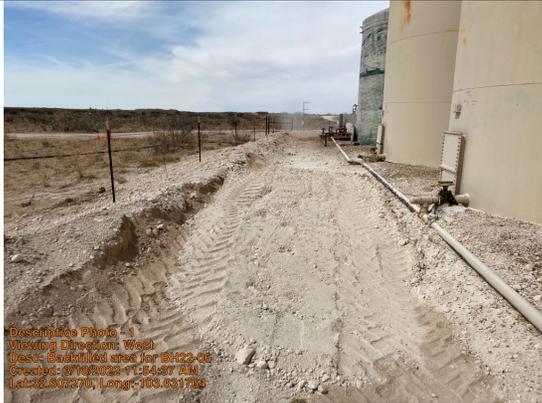
Descriptive Photo - 1
Viewing Direction: West
Desc: Backfilled area for BH22-06
Created: 3/18/2022 11:54:57 AM
Lat:32.807270, Long:-103.831733

Backfilled area for BH22-06

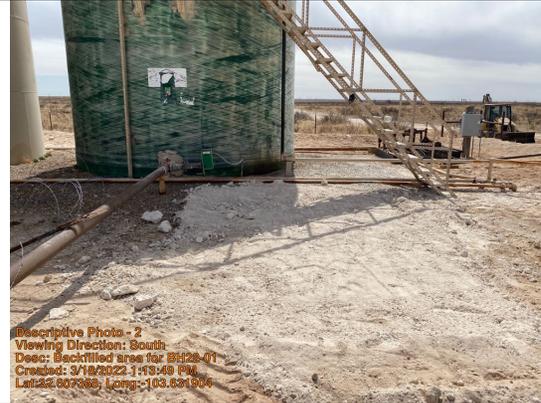
Descriptive Photo - 2
Viewing Direction: South
Desc: Backfilled area for BH22-01
Created: 3/18/2022 1:13:48 PM
Lat:32.807385, Long:-103.831905

Backfilled area for BH22-01

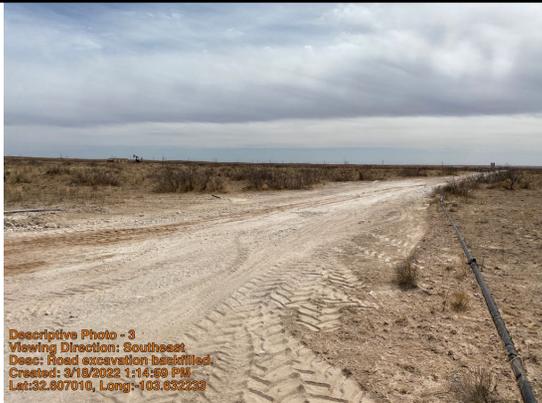
Descriptive Photo - 3
Viewing Direction: Southeast
Desc: Road excavation backfilled
Created: 3/18/2022 1:14:59 PM
Lat:32.807010, Long:-103.832233

Road excavation backfilled.

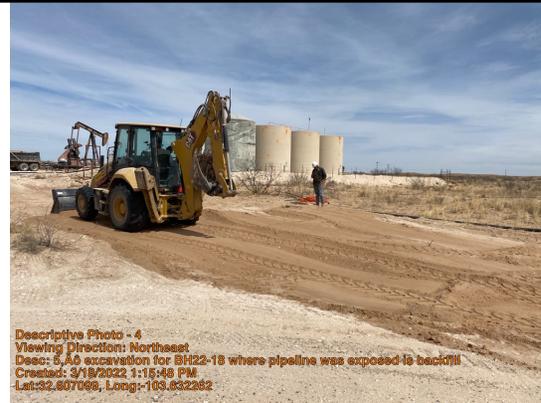
Descriptive Photo - 4
Viewing Direction: Northeast
Desc: 5' AO excavation for BH22-18 where pipeline was exposed is backfill
Created: 3/18/2022 1:15:48 PM
Lat:32.807069, Long:-103.832252

5' excavation for BH22-18 where pipeline was exposed is backfilled

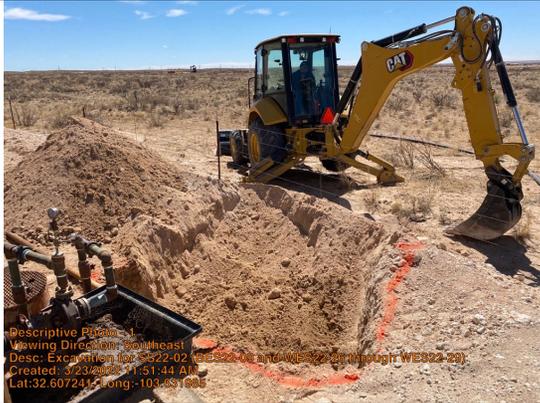
Descriptive Photo - 1
Viewing Direction: Southeast
Desc: Excavation for SS22-02 (BES22-09 and WES22-26 through WES22-29)
Created: 3/23/2022 11:51:44 AM
Lat:32.6072417, Long:-103.631985

Excavation for SS22-02 (BES22-09 and WES22-26 through WES22-29)

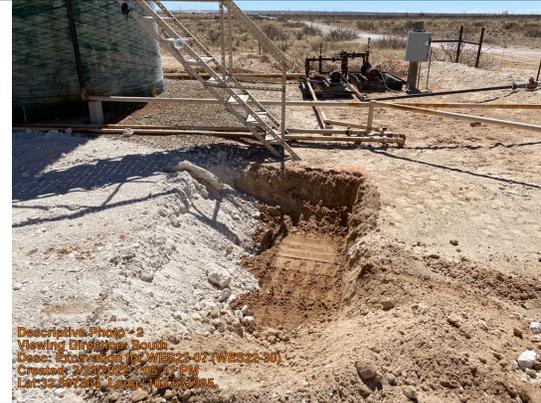
Descriptive Photo - 2
Viewing Direction: South
Desc: Excavation for WES22-07 (WES22-30)
Created: 3/23/2022 1:09:11 PM
Lat:32.6072417, Long:-103.631985

Excavation for WES22-07 (WES22-30)

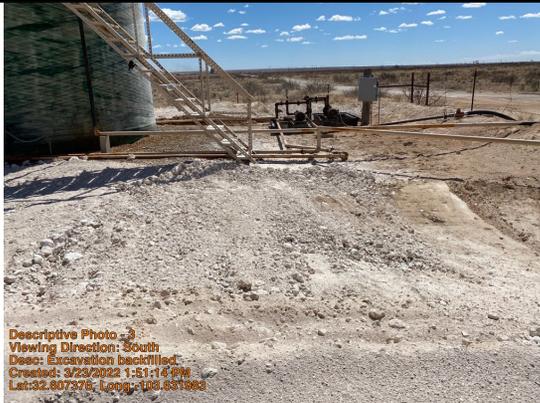
Descriptive Photo - 3
Viewing Direction: South
Desc: Excavation backfilled
Created: 3/23/2022 1:51:14 PM
Lat:32.6072417, Long:-103.631985

Excavation backfilled

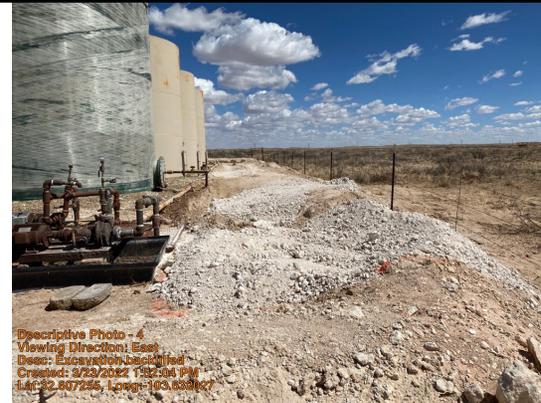
Descriptive Photo - 4
Viewing Direction: East
Desc: Excavation backfilled
Created: 3/23/2022 1:52:58 PM
Lat:32.6072417, Long:-103.631985

Excavation backfilled

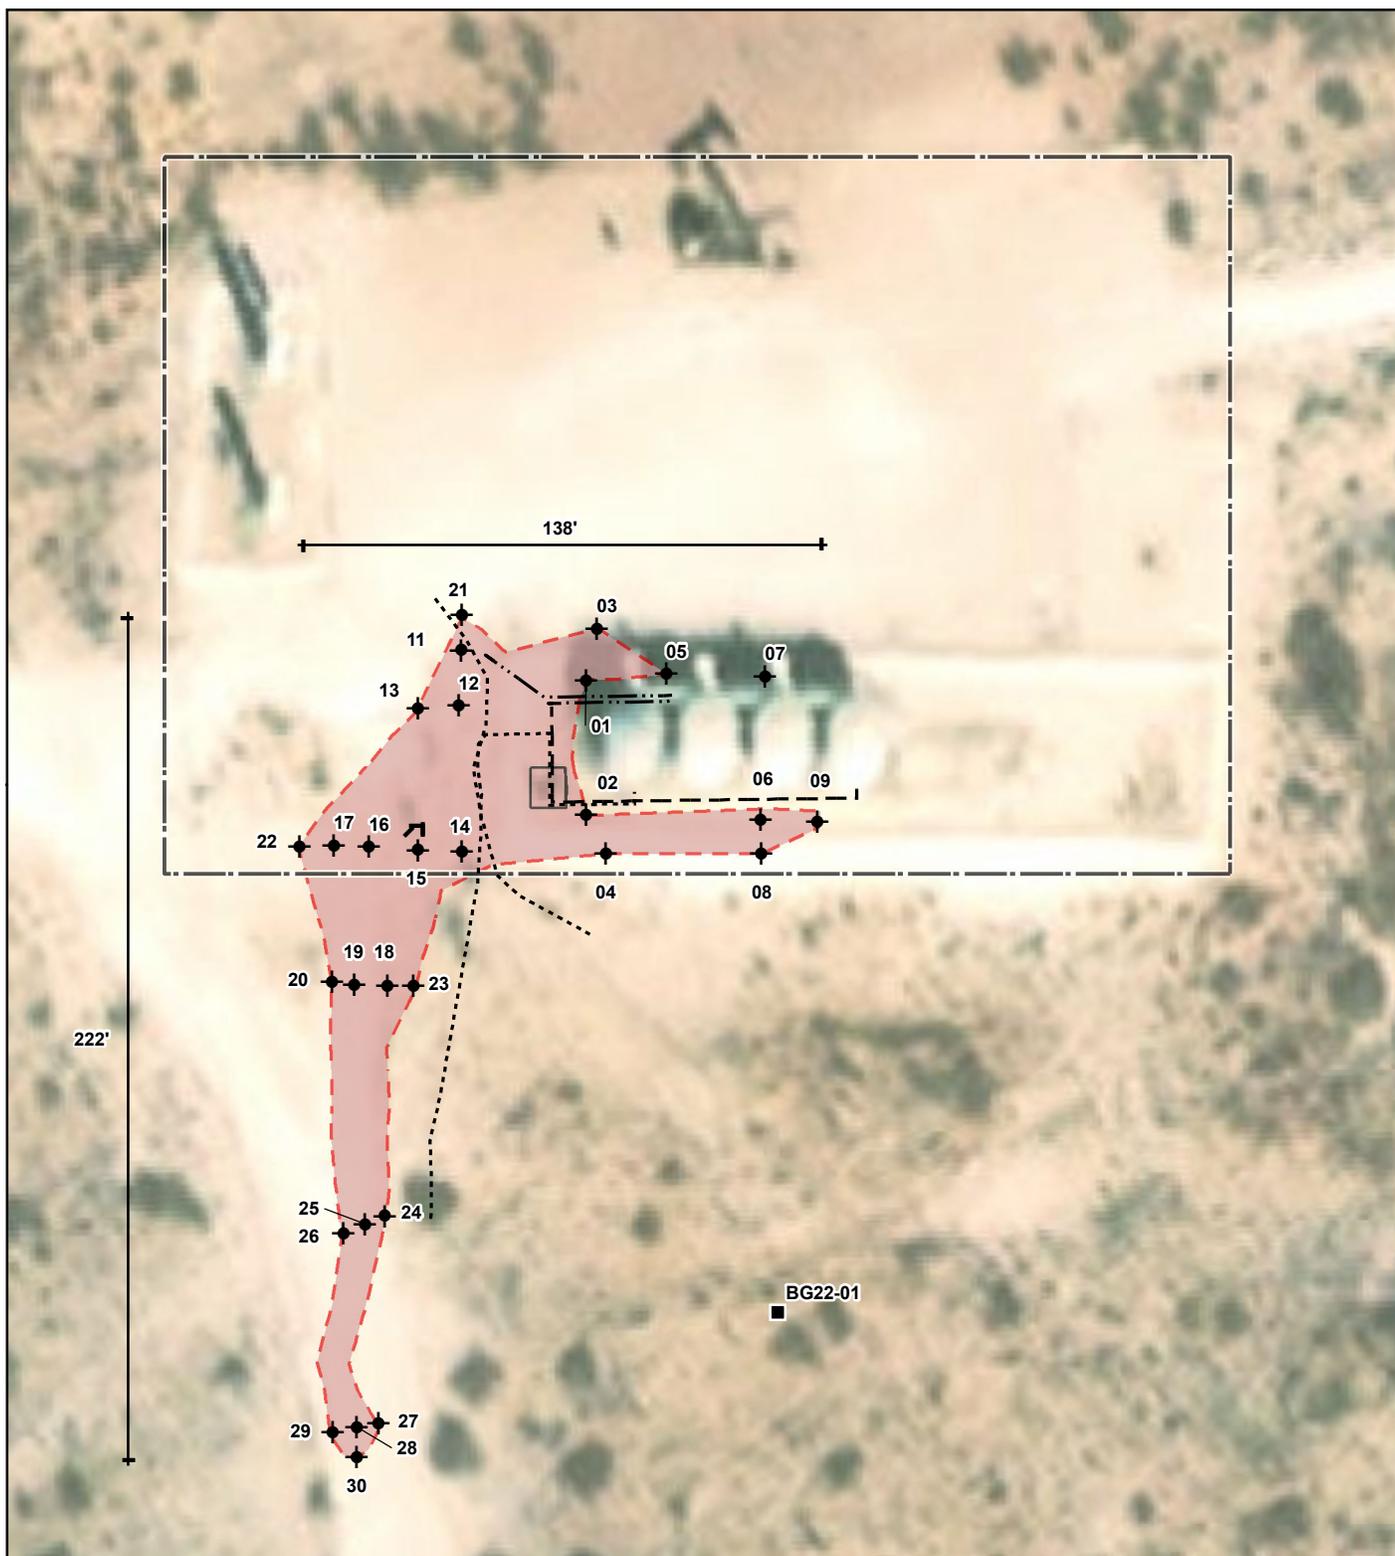
- Background Sample
- ◆ Borehole (Prefixed by "BH22-")
- ↗ Riser
- Flowline
- Pipeline
- - - Pipeline Inside Containment
- Approximate Lease Boundary
- Total Spill Extent (6,449 sq. ft.)
- Water Transfer Pump
