Incident ID	nAPP2236031213
District RP	
Facility ID	
Application ID

Closure

Based on laboratory analytical results and field activities conducted to date, Etech recommends Mewbourne Oil Company provide copies of this *Remediation Summary & Soil Closure Request* to the appropriate agencies and request closure be granted to the Yardbirds release site.

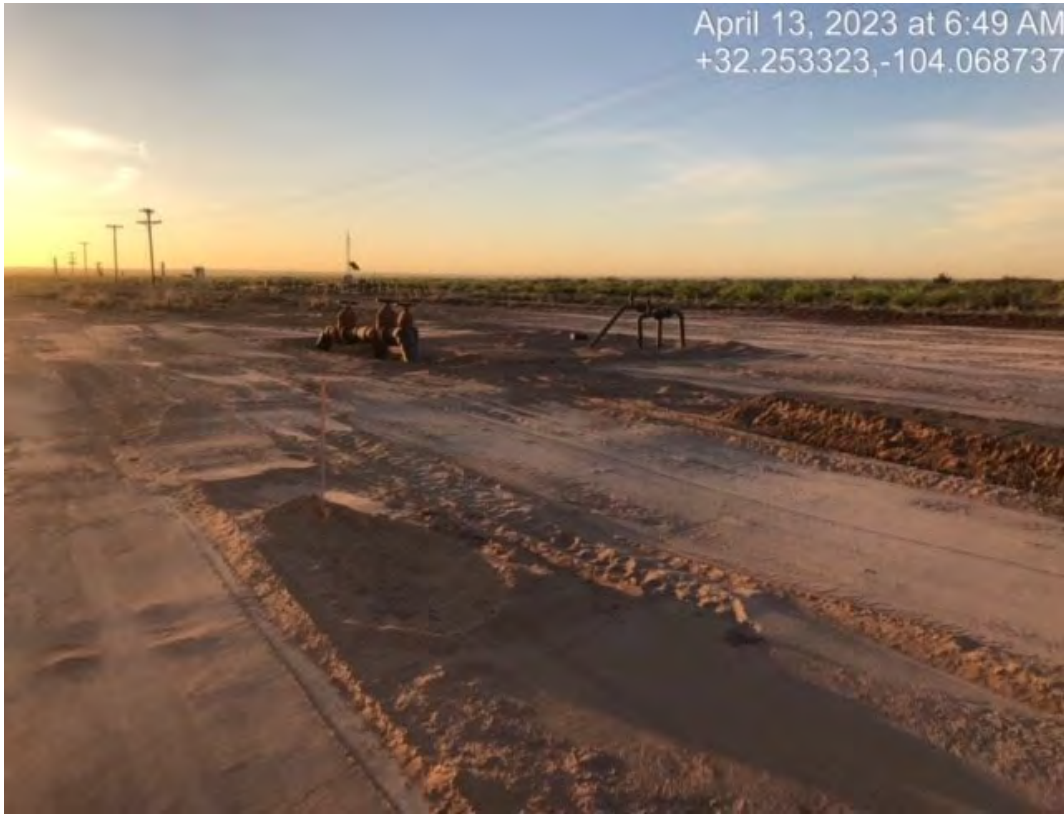
Photo Number: 11

<p>April 13, 2023 at 6:49 AM +32.253323,-104.068737</p>
Photo Direction: Southeast	
Photo Description: View of the remediated area after backfill and regrading.
