Mal-11-5 Fed AF 6" Poly Line LP  
32.7723056°, -103.8054167°  
NMOCD Reference # nAPP2233262667  
Terracon Project # KH237020

**RE: Release Investigation, and Closure Report**

Mal-11-5 Fed AF 6" Poly Line LP  
Unit O, Section 6, Township 18 South, Range 32 East  
32.77221°, -103.80566°  
Lea County, New Mexico  
Terracon Project No. KH237020

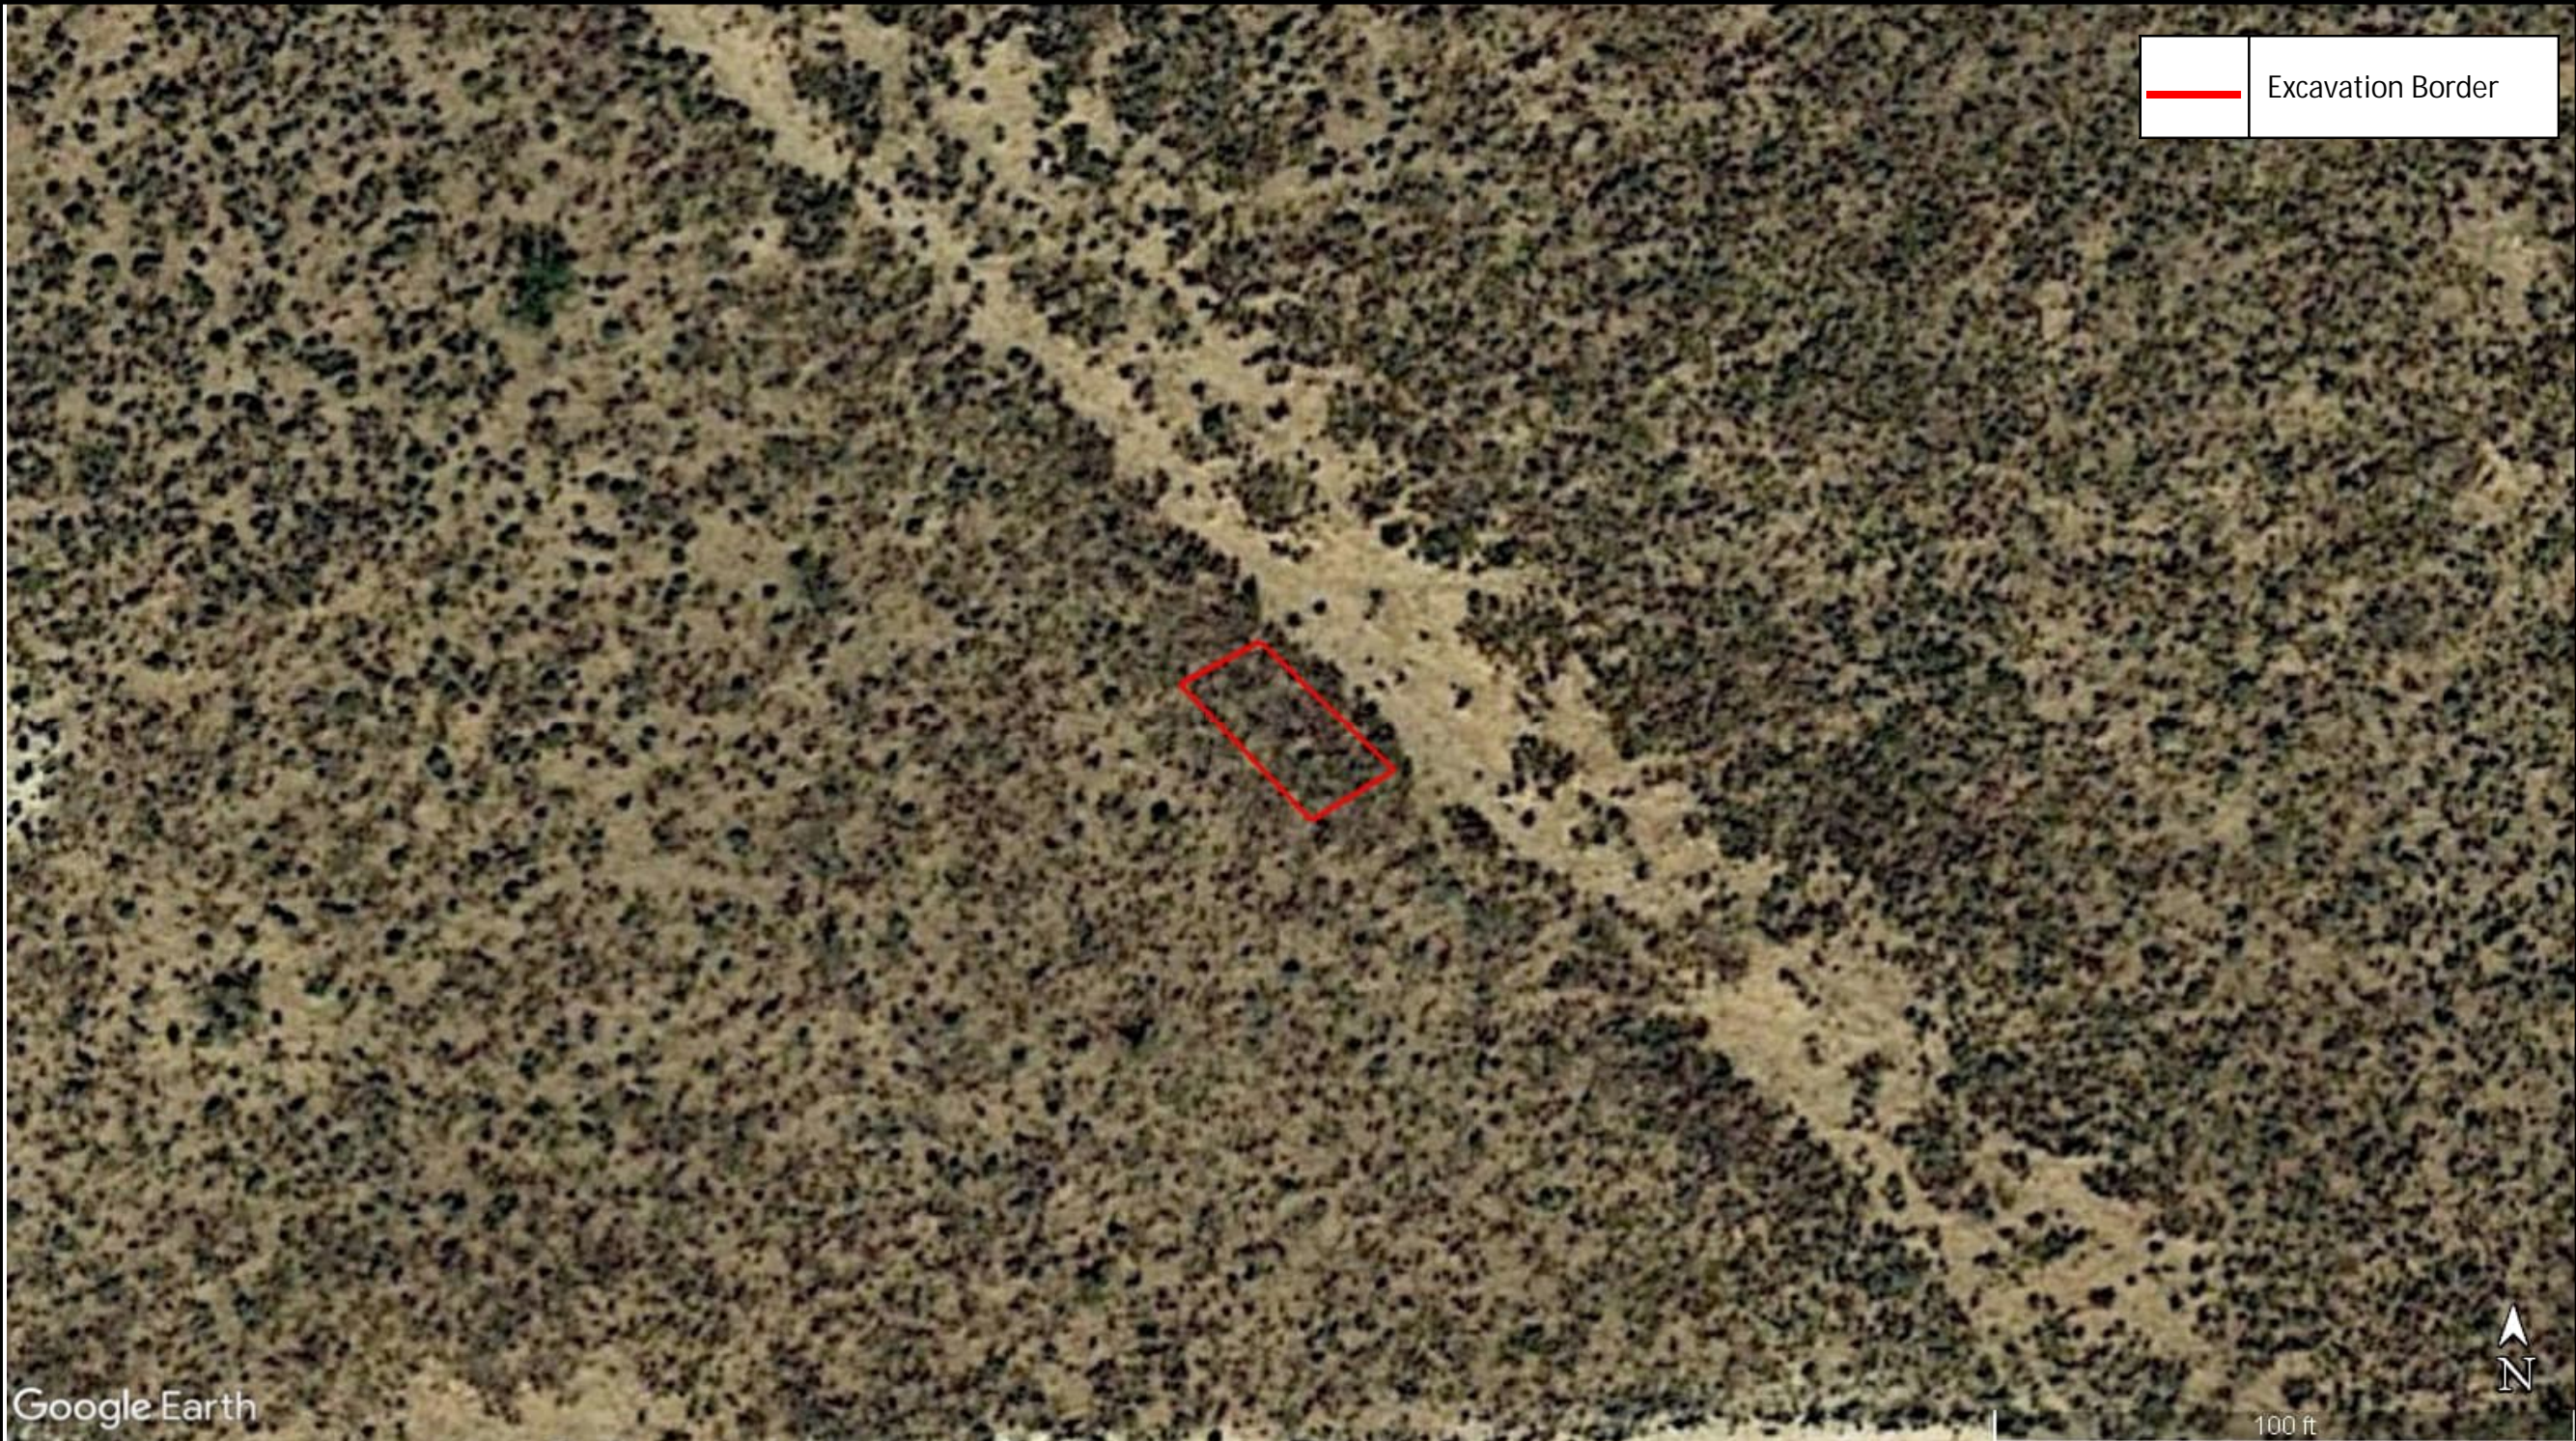
### Exhibit 1 – Topographic Map

**Mal-11-5 Fed AF 6" Poly Line LP**  
**32.77221, -103.80566**  
**Lea County, New Mexico**

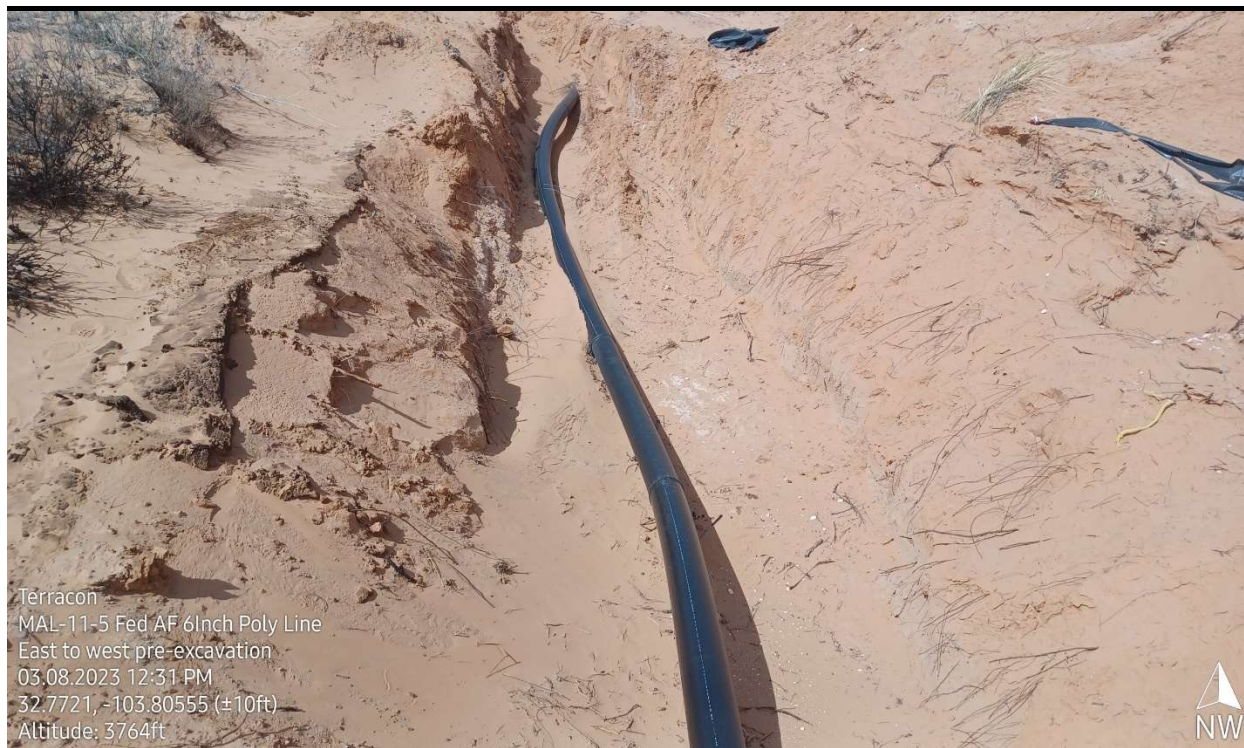
**PHOTO 1:** View of area before excavation

On March 20, 2023, Terracon mobilized to the site to meet Terracon's Remediation and Construction Services (RCS) personnel, who performed soil remediation activities. The areas exhibiting visual impacts were excavated to a depth of approximately 4 to 5 feet bgs.

Approximately 76 cubic yards of soil were excavated and stockpiled atop a polyethylene liner pending waste characterization and disposal under an approved Form C-138. Excavation efforts ceased based on the removal of visually impacted material. Excavated materials were disposed of at Lea Land Landfill.

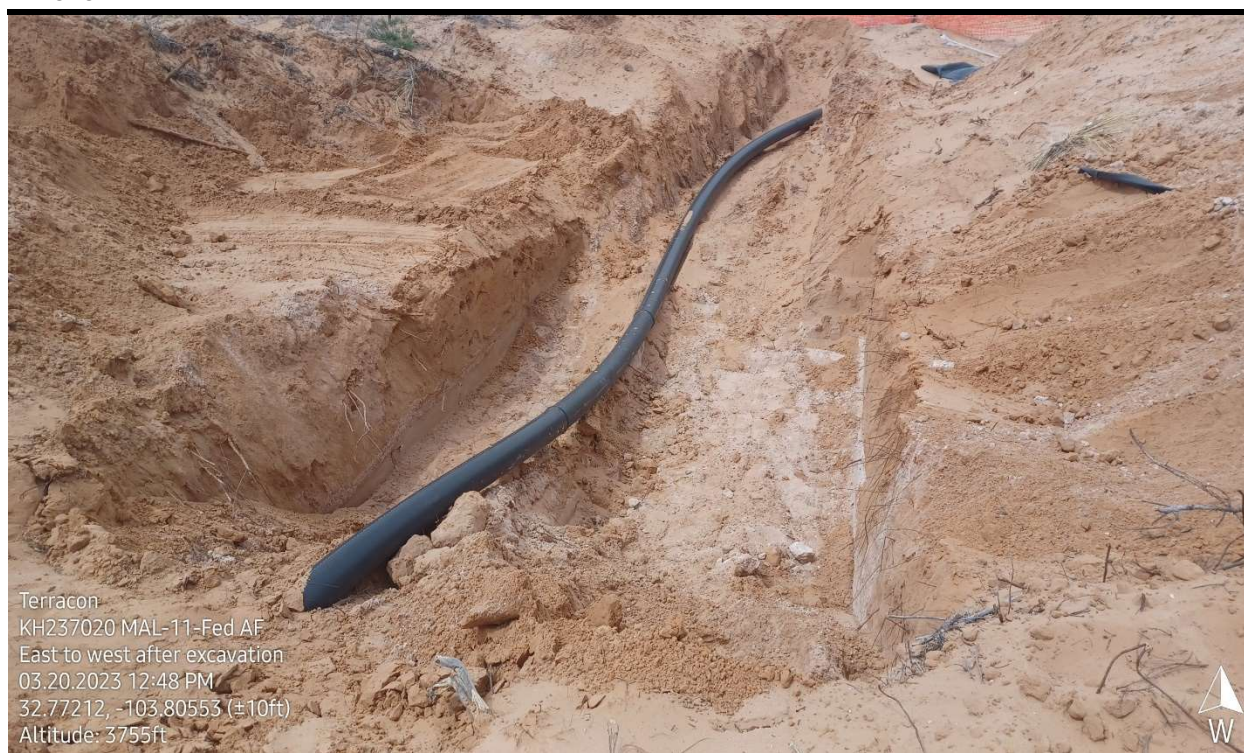
**PHOTO 2:** View of area after excavation

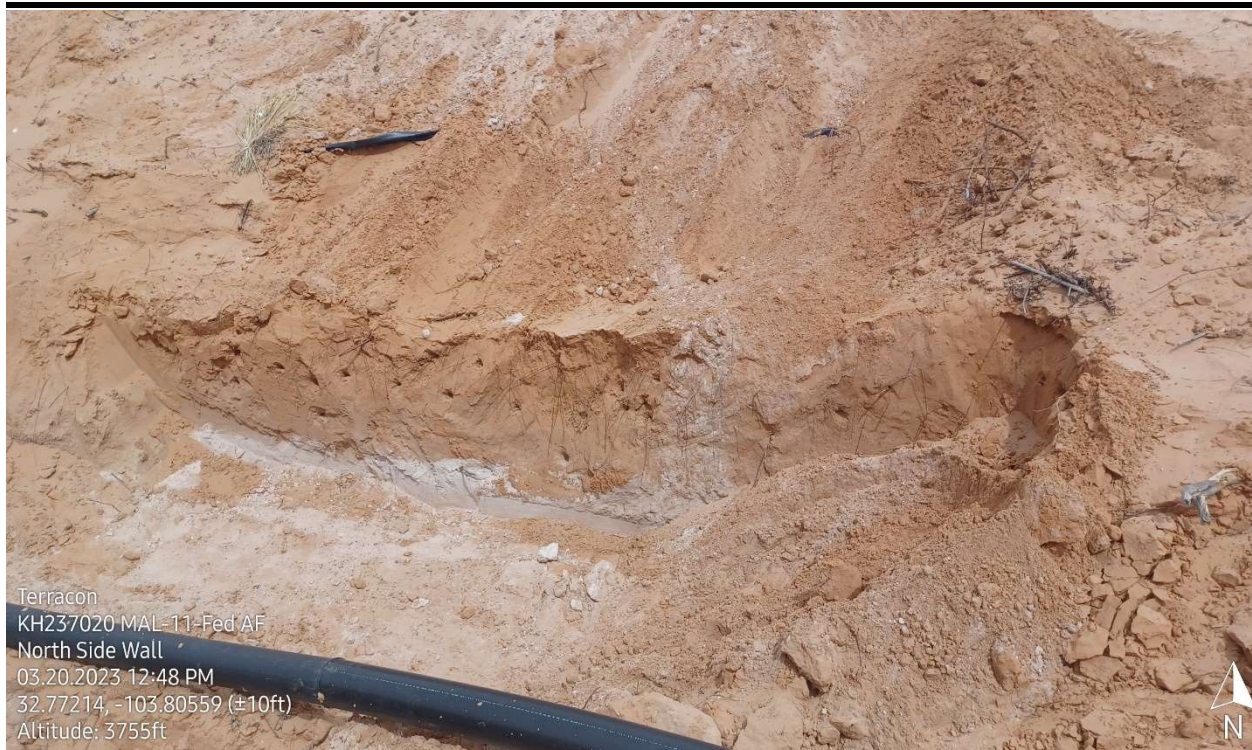
Terracon  
KH237020 MAL-11-Fed AF  
North Side Wall  
03.20.2023 12:48 PM  
32.77214, -103.80559 (±10ft)  
Altitude: 3755ft

**PHOTO 3:** View of North Wall before excavation
