Remediation Summary and Closure Request

Frontier Field Services, LLC Mal 7-11-7 Lea County, New Mexico Unit Letter "J", Section 25, Township 18 South, Range 33 East Latitude 32.715770 North, Longitude 103.614959 West NMOCD Incident # nAPP2234336585

Hungry Horse, LLC 4024 Plains Hwy Lovington, NM 88260 Office: (575) 393-3386

May 2023

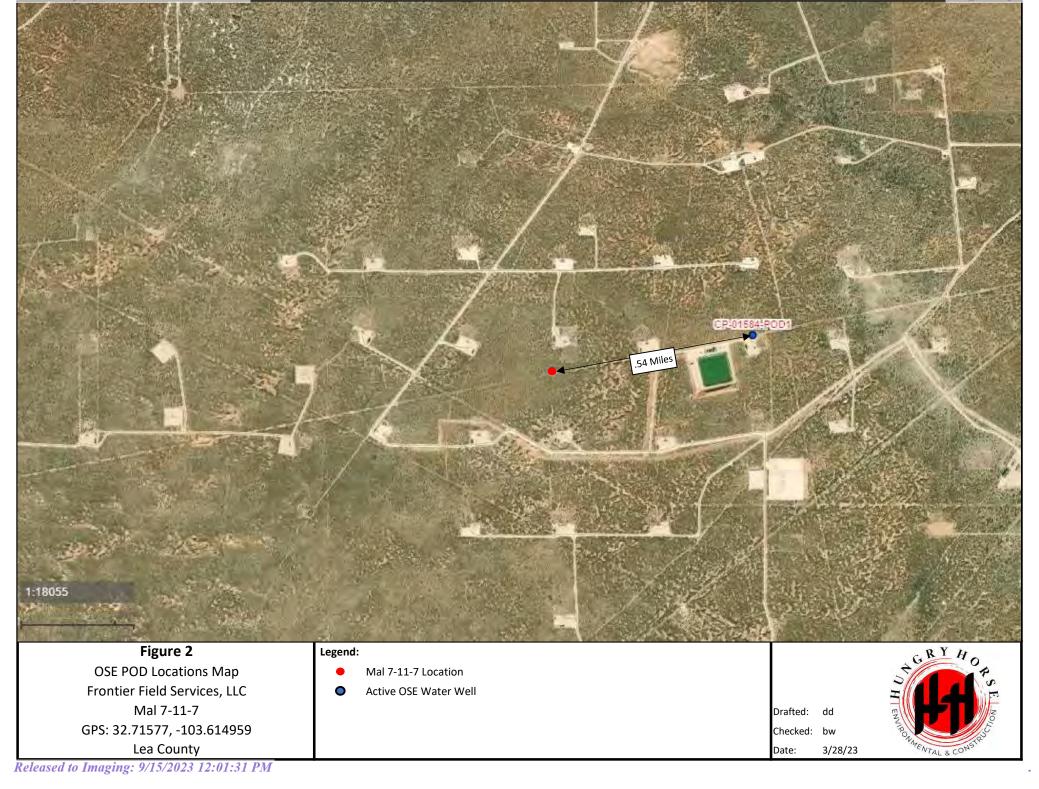
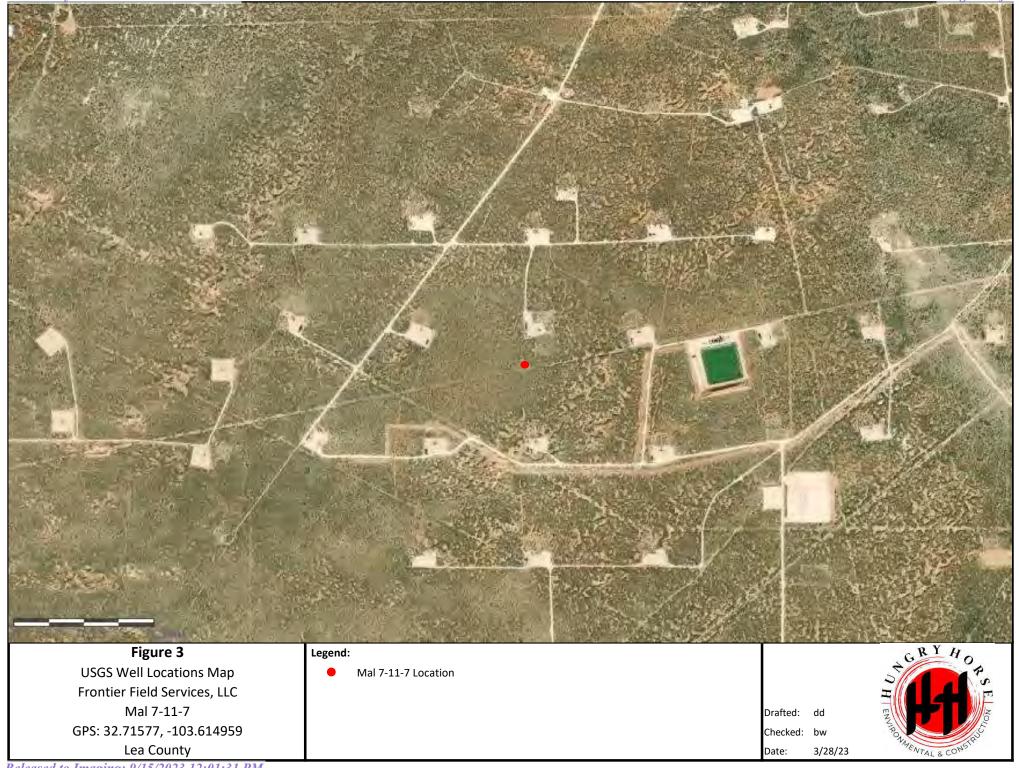
A search of the New Mexico Office of the State Engineer (NMOSE) and United States Geological Survey (USGS) groundwater databases was completed in an effort to determine the horizontal distance to known water sources within a half mile radius of the Release Site. Approximate depth to groundwater was determined using maintained and published water well data. Karst mapping indicates the site is not located in a Karst designated area. Karst and Wetland Maps are provided as Attachment I. Depth to groundwater information is provided as Attachment IV and the results are depicted on Figures 2 & 3.

No water wells were located within a half mile of the release area, therefore depth to groundwater could not be determined. Consequently, the site was delineated and further remediated according to the strictest NMOCD Closure Criteria. Utilizing this information, the NMOCD Closure Criteria for the Site were determined as follows:

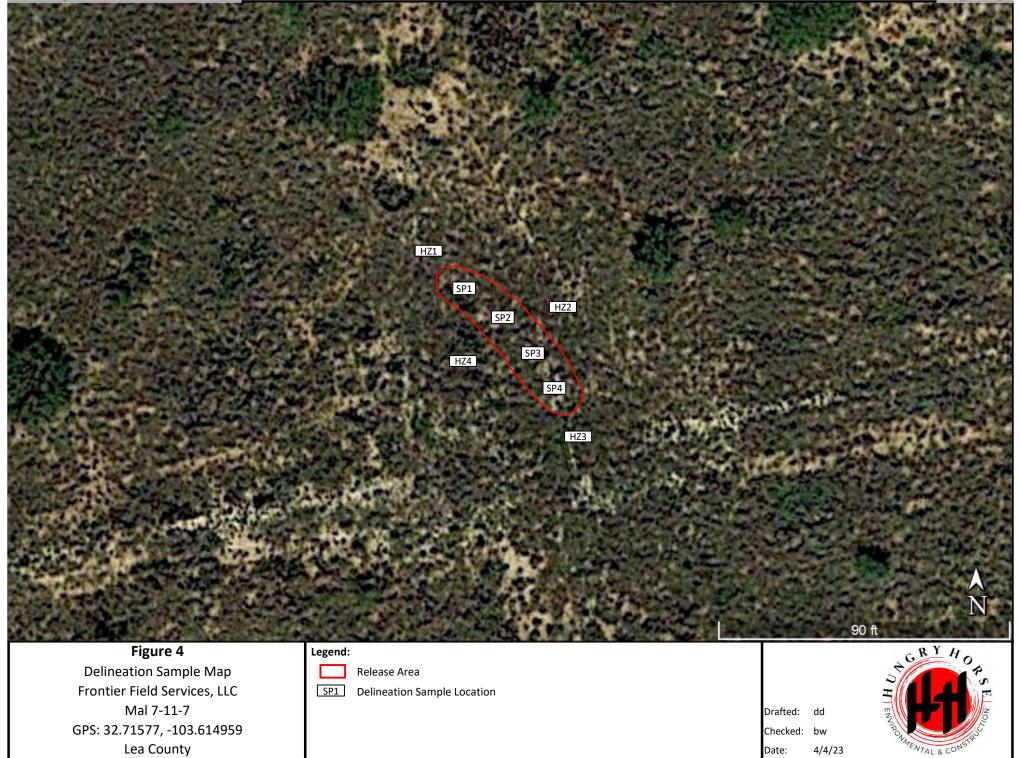
Based on field observations and field test data noted above and provided in Attachment V, sixteen representative soil samples, two from each sample location, were selected for laboratory analysis. Delineation soil samples SP1 through SP4, and HZ1 through HZ4, were submitted to the laboratory for analysis of BTEX, TPH, and chloride. Laboratory analytical results indicated contaminant concentrations were below the NMOCD Closure Criteria in each of the submitted samples, with the exception of SP3 and SP4, at Surface, which exhibited TPH concentrations in excess of NMOCD Closure Criteria.

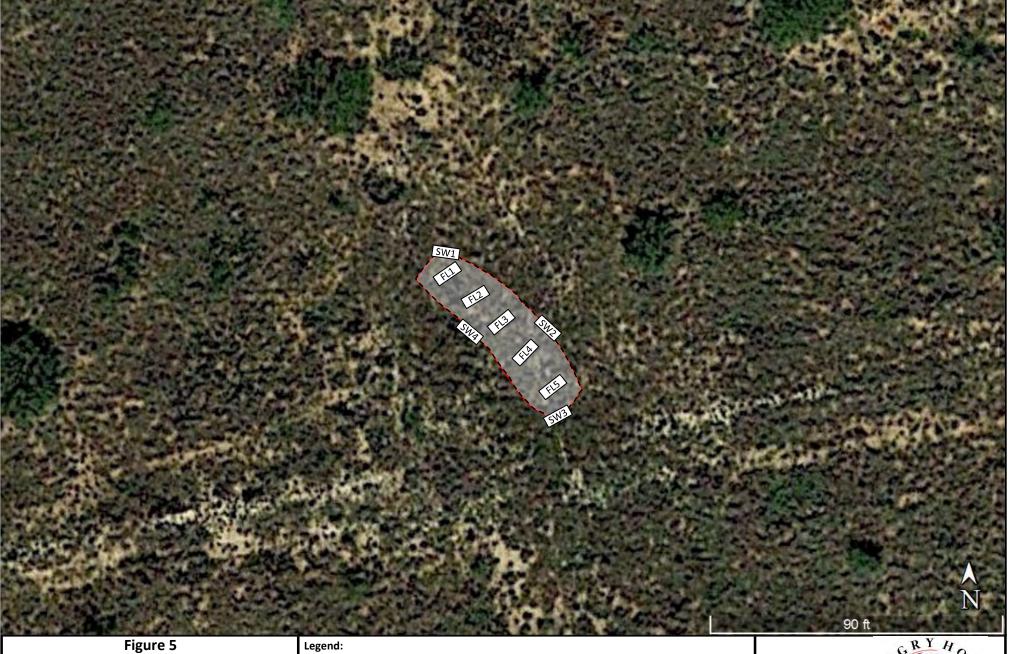
Figure 5	
untion Sampl

On April 13, 2023, nine composite confirmation soil samples were collected from the excavation floor and sidewalls, every 200 square feet and every 50 linear feet, respectively. Soil samples FL1 through FL5 and SW1 through SW4 were submitted to the laboratory for analysis of BTEX, TPH, and chloride. Laboratory analytical results indicated BTEX and chloride contaminant concentrations were below the NMOCD Closure Criteria in each of the submitted samples with the exception of FL3 at ten feet bgs and FL5 at four feet bgs, which exhibited TPH concentrations in excess of NMOCD Closure Criteria.

On April 24, 2023, after the areas characterized by samples FL3 and FL5 were excavated further, two composite confirmation soil samples were collected. Soil samples FL3b at ten and half feet bgs and FL5b at four and half feet bgs, were submitted to the laboratory for analysis of BTEX, TPH, and chloride. Laboratory analytical results indicated BTEX and chloride contaminant concentrations were below the NMOCD Closure Criteria in each of the submitted samples.

Excavation Sample Map Frontier Field Services, LLC Mal 7-11-7 GPS: 32.71577, -103.614959 Lea County

From April 4-11, 2023, the excavation was expanded. Excavated soil was temporarily stockpiled on site, atop plastic, before transport to an NMOCD approved disposal facility.
