J-8-2 LINE LEAK (03.18.22) Remediation Summary & Closure Report

NMOCD Incident No. nAPP2208155134
UL "F", Sec. 2, T18S, R35E
32.77818°, -103.42852°
Lea County, New Mexico

June 20, 2023

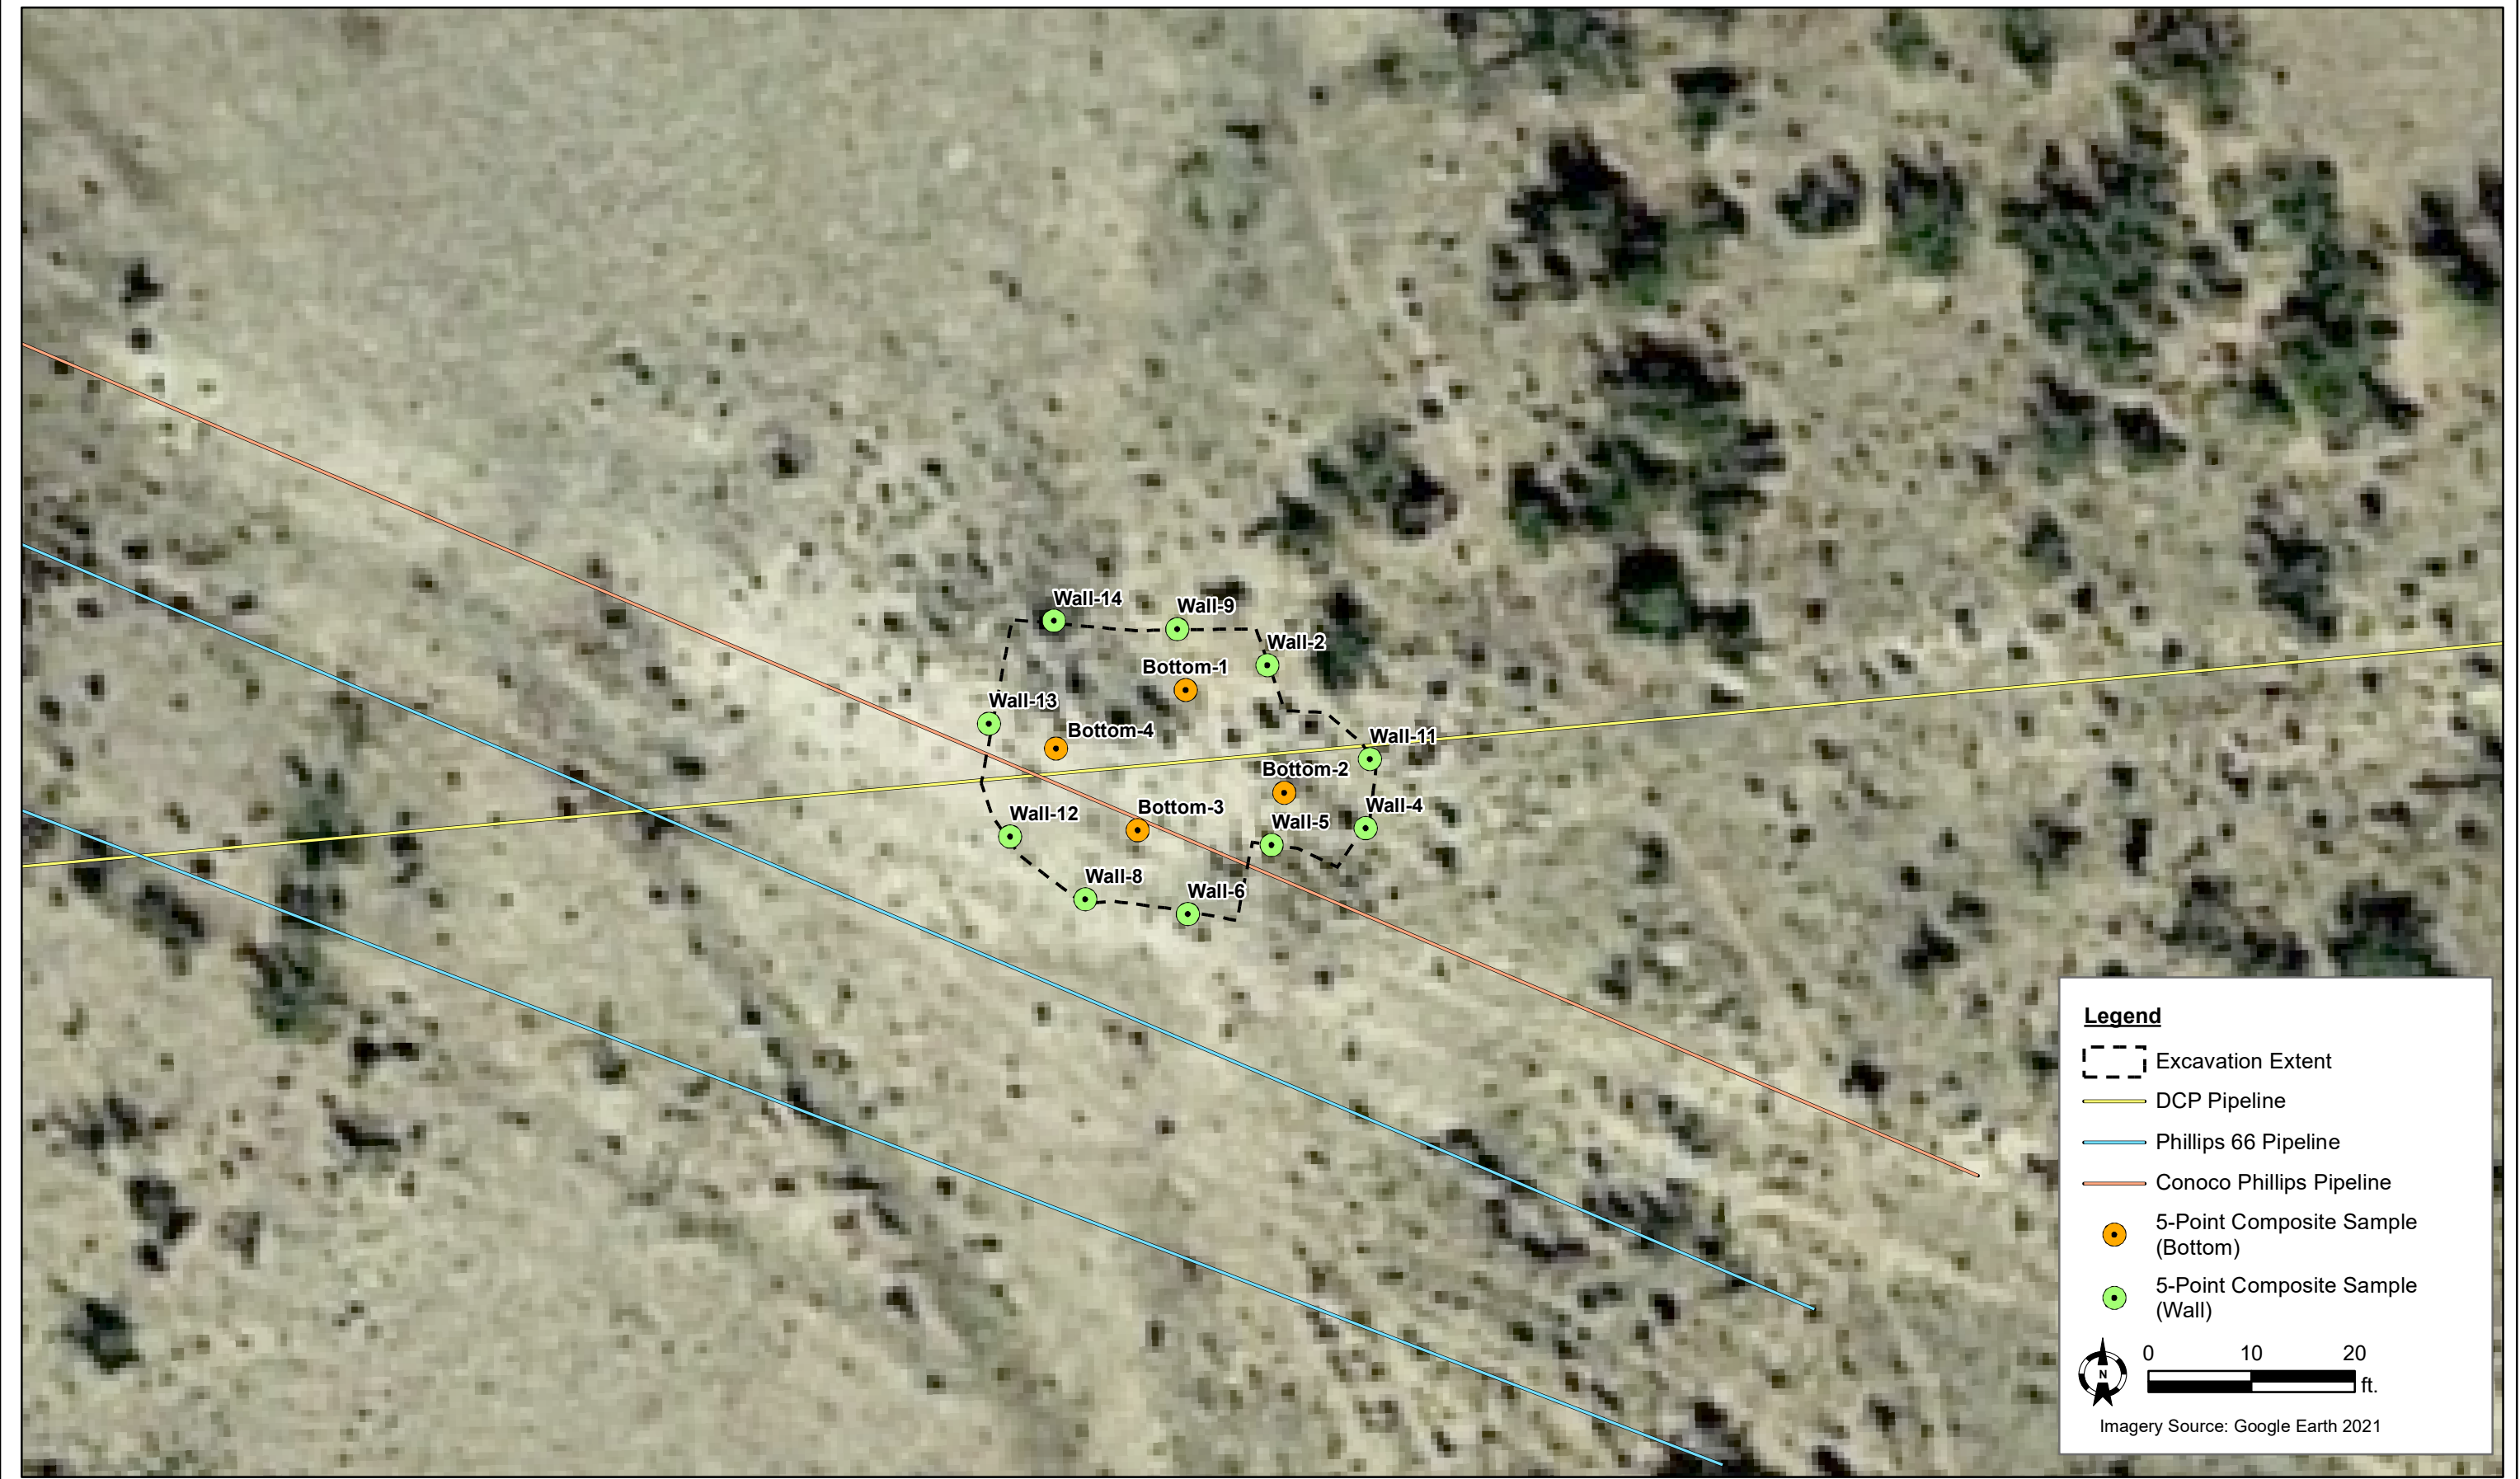
DCP Midstream, LP
J-8-2 Line Leak - nAPP2208155134
UL "F" Sec. 2, T18S, R35E
Lea County, New Mexico

Areas affected by the release and associated remediation activities were restored to the condition which existed prior to the release to the maximum extent possible. On June 14 – 16, 2022, the excavated areas were backfilled with non-impacted “like” material and contoured and/or compacted to achieve erosion control, stability, and preservation of surface water flow to the extent practicable.
