**Re: Closure Request
Rojo 7811 27 Federal Com 13H
Incident Number nCH1834763224
Lea County, New Mexico**

Ensolum, LLC (Ensolum), on behalf of BTA Oil Producers, LLC (BTA), has prepared this *Closure Request* to document delineation and soil sampling activities performed at the Rojo 7811 27 Federal Com 13H (Site), in accordance with an approved *Remediation Work Plan (Work Plan)* submitted June 8, 2023. The *Work Plan* proposed lateral and vertical delineation of the release. Based on the delineation activities completed and laboratory analytical results from the soil sampling events in accordance with the *Work Plan*, BTA is submitting this *Closure Request*, describing remediation that has occurred and requesting closure for Incident Number nCH1834763224.

BTA Oil Producers, LLC
Closure Request
Rojo 7811 27 Federal Com 13H

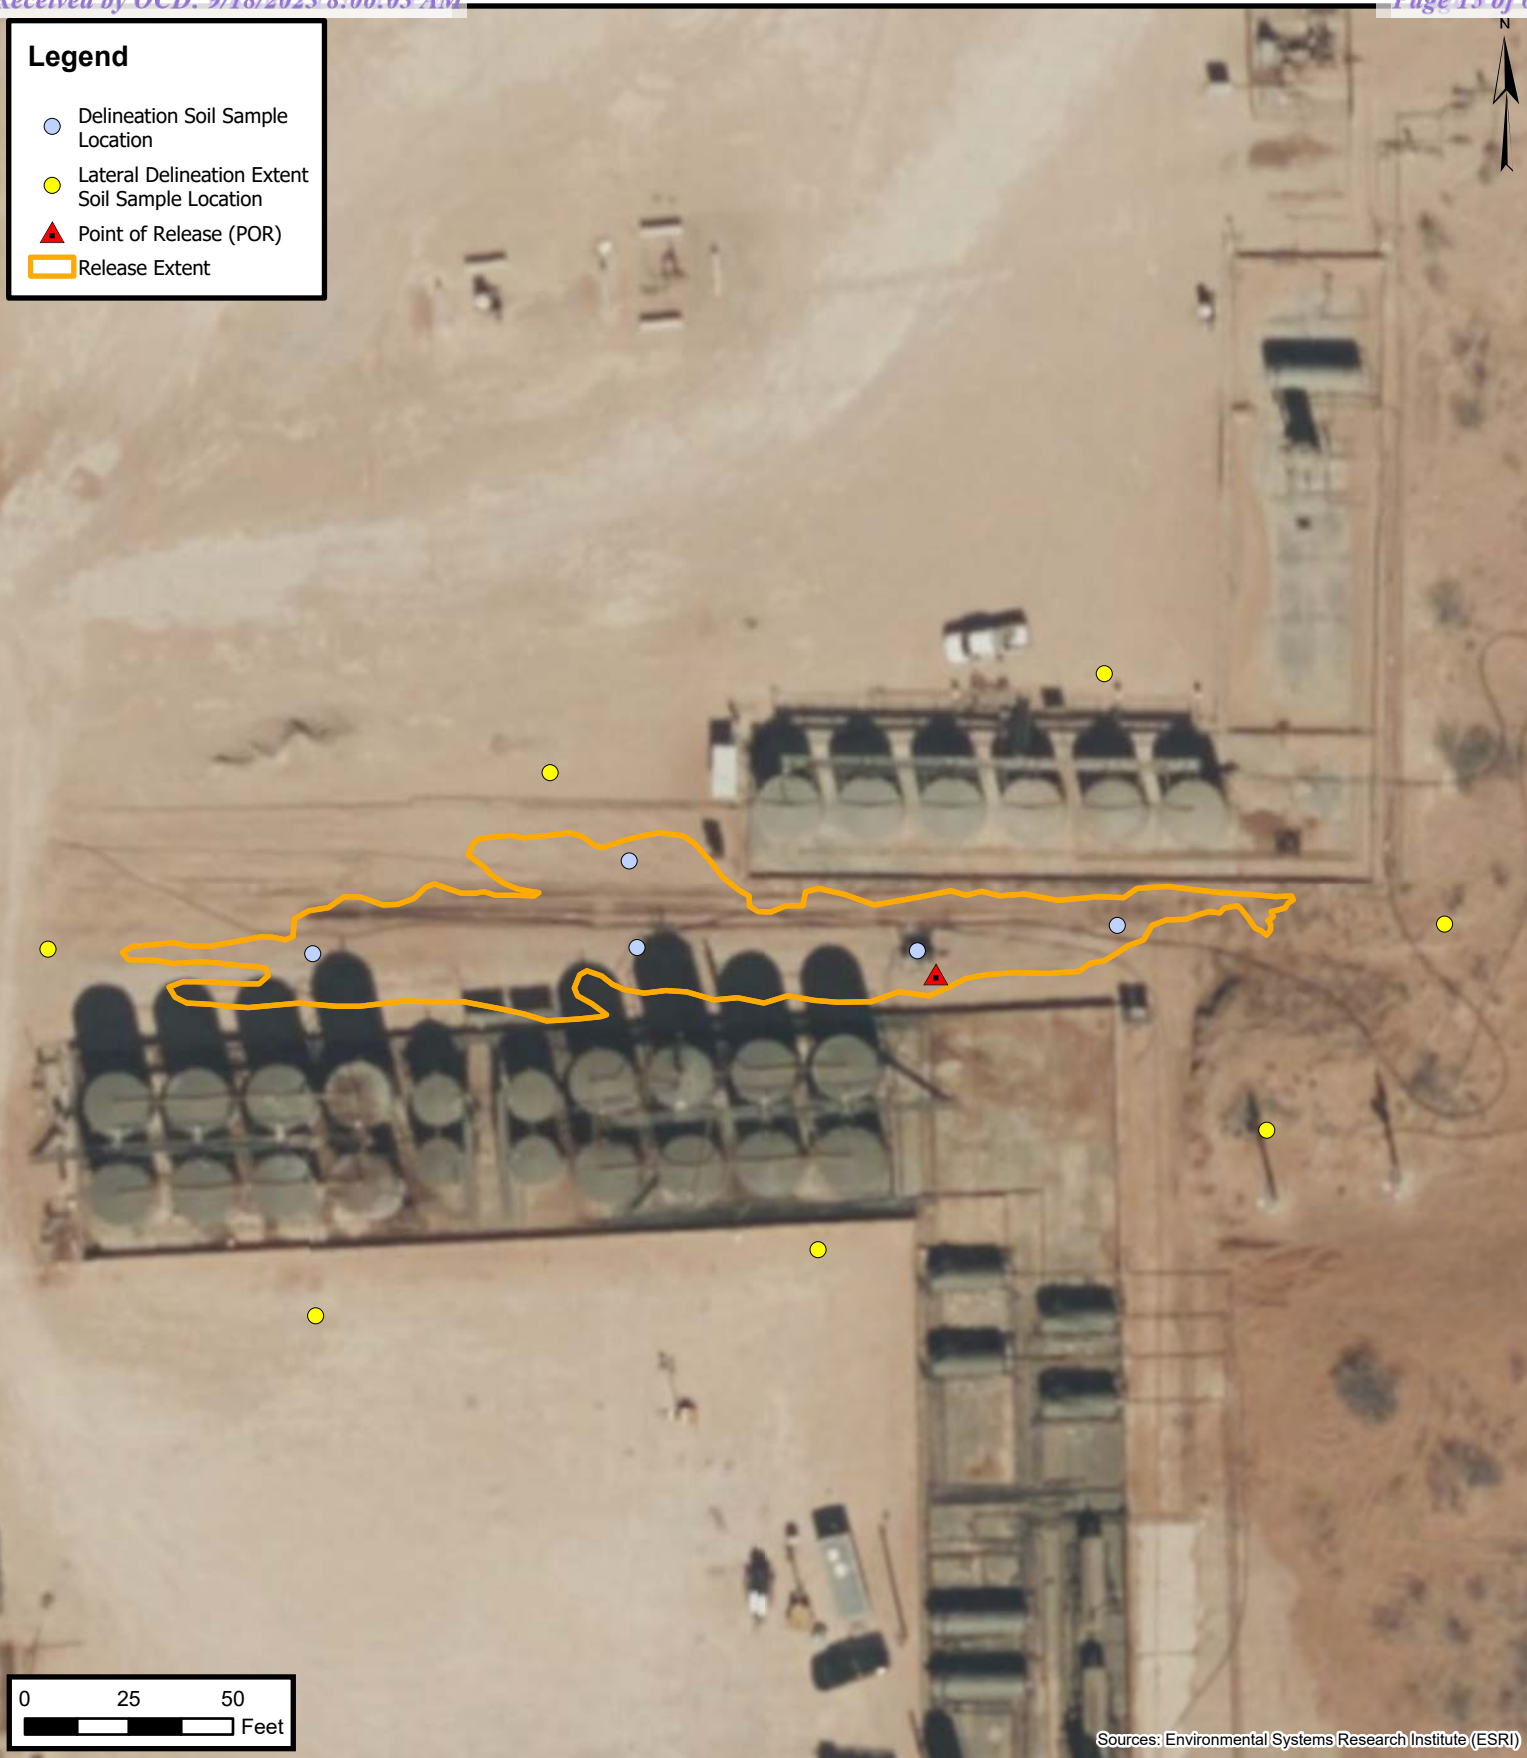
**Delineation Soil Sample Locations**

BTA Oil Producers, LLC
Rojo 7811 27 Federal Com 13H
Incident Number: nCH1834763224
Unit A, Sec 27, T25S, R33E
NA, Lea County, New Mexico

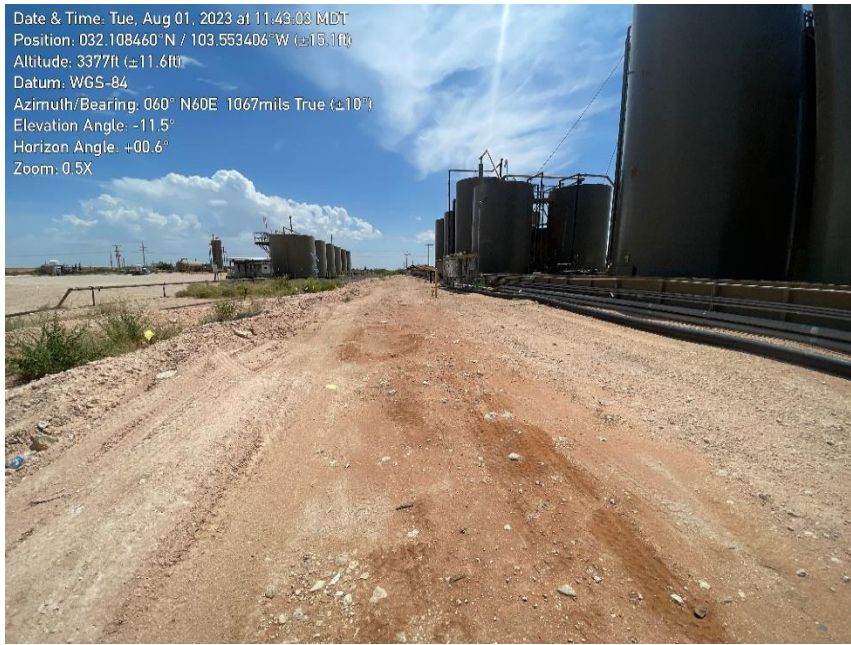
Photograph 1

Description: View of release extent during delineation activities. Facing East.
