Release Assessment and Closure

Sawbuck Water Transfer Station

Vertex File Number: 22E-00123-03

EOG Resources Inc.

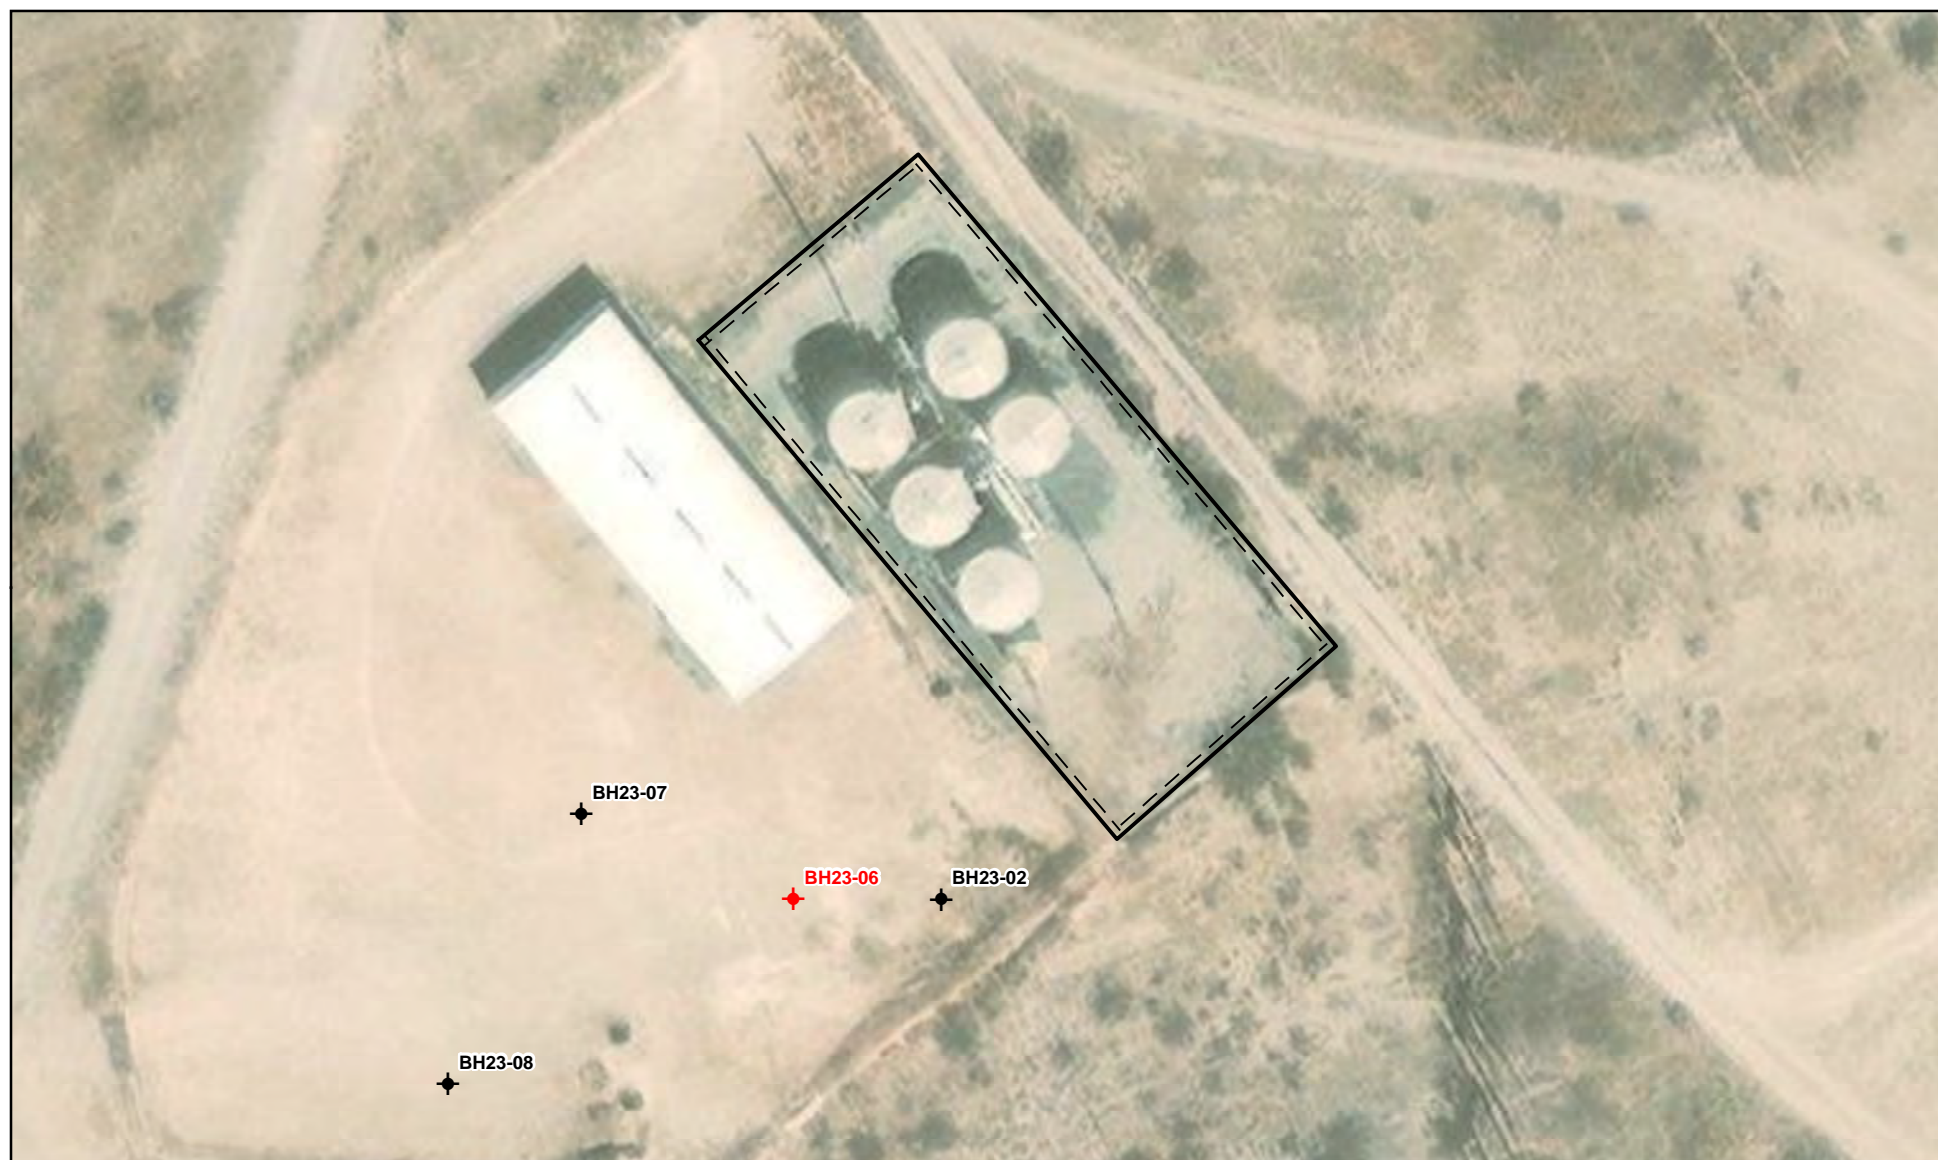
FIGURES

Borehole
 Excavation Area (~12,749 sq.ft.)
 Borehole (Not Collected)

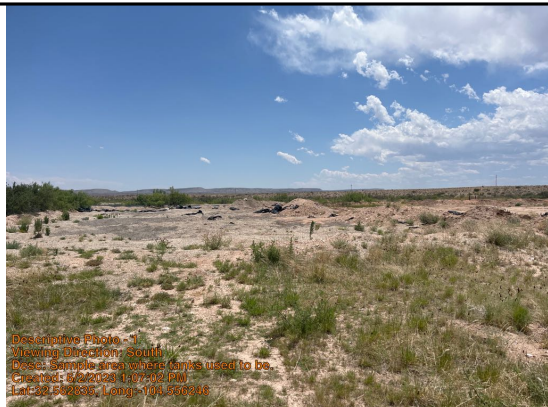
Descriptive Photo - 1
Viewing Direction: South
Desc: Sample area where tanks used to be.
Created: 8/2/2023 1:07:52 PM
Lat:32.582556, Long:-104.556374

Sample area where tanks used to be.

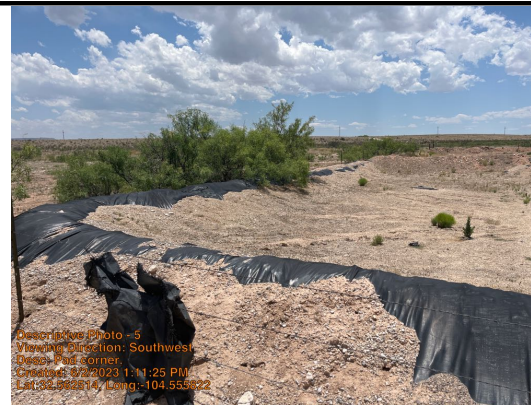
Viewing Direction: Southeast

Descriptive Photo - 5
Viewing Direction: Southwest
Desc: Pad corner
Created: 8/2/2023 1:11:25 PM
Lat:32.582514, Long:-104.556322

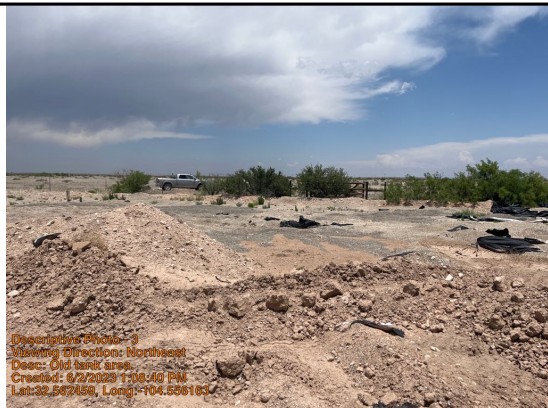
Descriptive Photo - 3
Viewing Direction: Northeast
Desc: Old tank area
Created: 8/2/2023 1:08:40 PM
Lat:32.582458, Long:-104.556183

Old tank area.

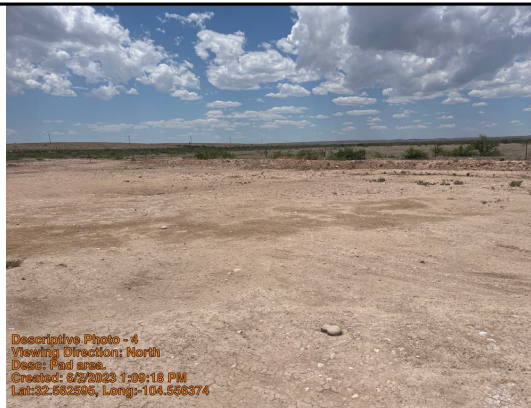
Descriptive Photo - 4
Viewing Direction: North
Desc: Pad area
Created: 8/2/2023 1:09:18 PM
Lat:32.582595, Long:-104.556374

Pad area.

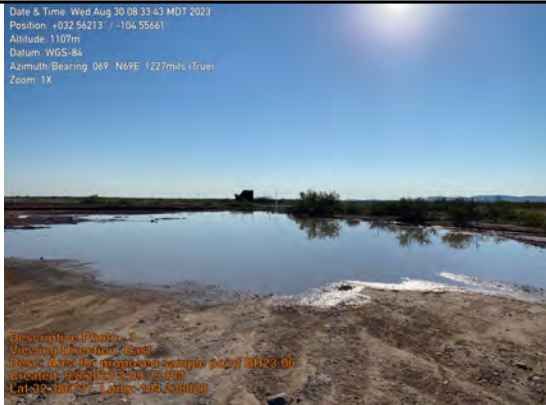
Descriptive Photo - 2
Viewing Direction: East
Desc: Area for proposed sample point BH23-06
Created: 8/30/2023 8:33:43 AM
Lat:32.542133, Long:-104.556602

Area for proposed sample point BH23-06

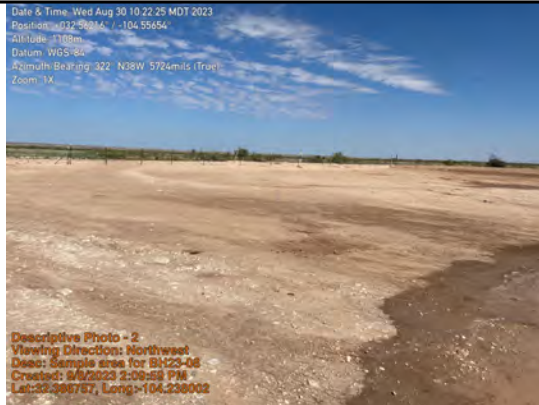
Descriptive Photo - 2
Viewing Direction: Northwest
Desc: Sample area for BH23-08
Created: 8/30/2023 2:06:59 PM
Lat:32.543137, Long:-104.556502

Sample area for BH23-08

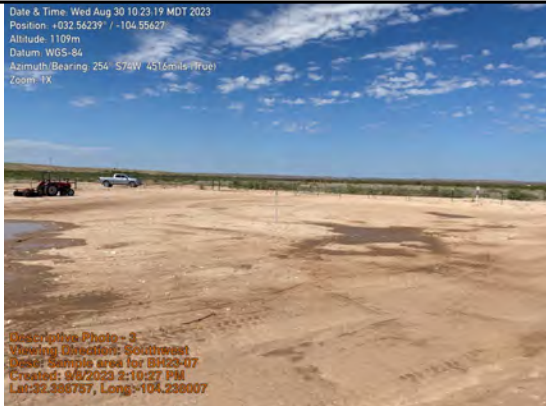
Descriptive Photo - 3
Viewing Direction: Southwest
Desc: Sample area for BH23-07
Created: 8/30/2023 2:10:27 PM
Lat:32.542387, Long:-104.556007

Sample area for BH23-07
