Release Notification

Site Name Gallegos Canyon Unit #207	Site Type Natural Gas Well
Date Release Discovered 9/5/2023	API# (if applicable) 30-045-11587

GCU #207
Project Map
Simcoe LLC

GCU #207
Photographic Log
Simcoe, LLC

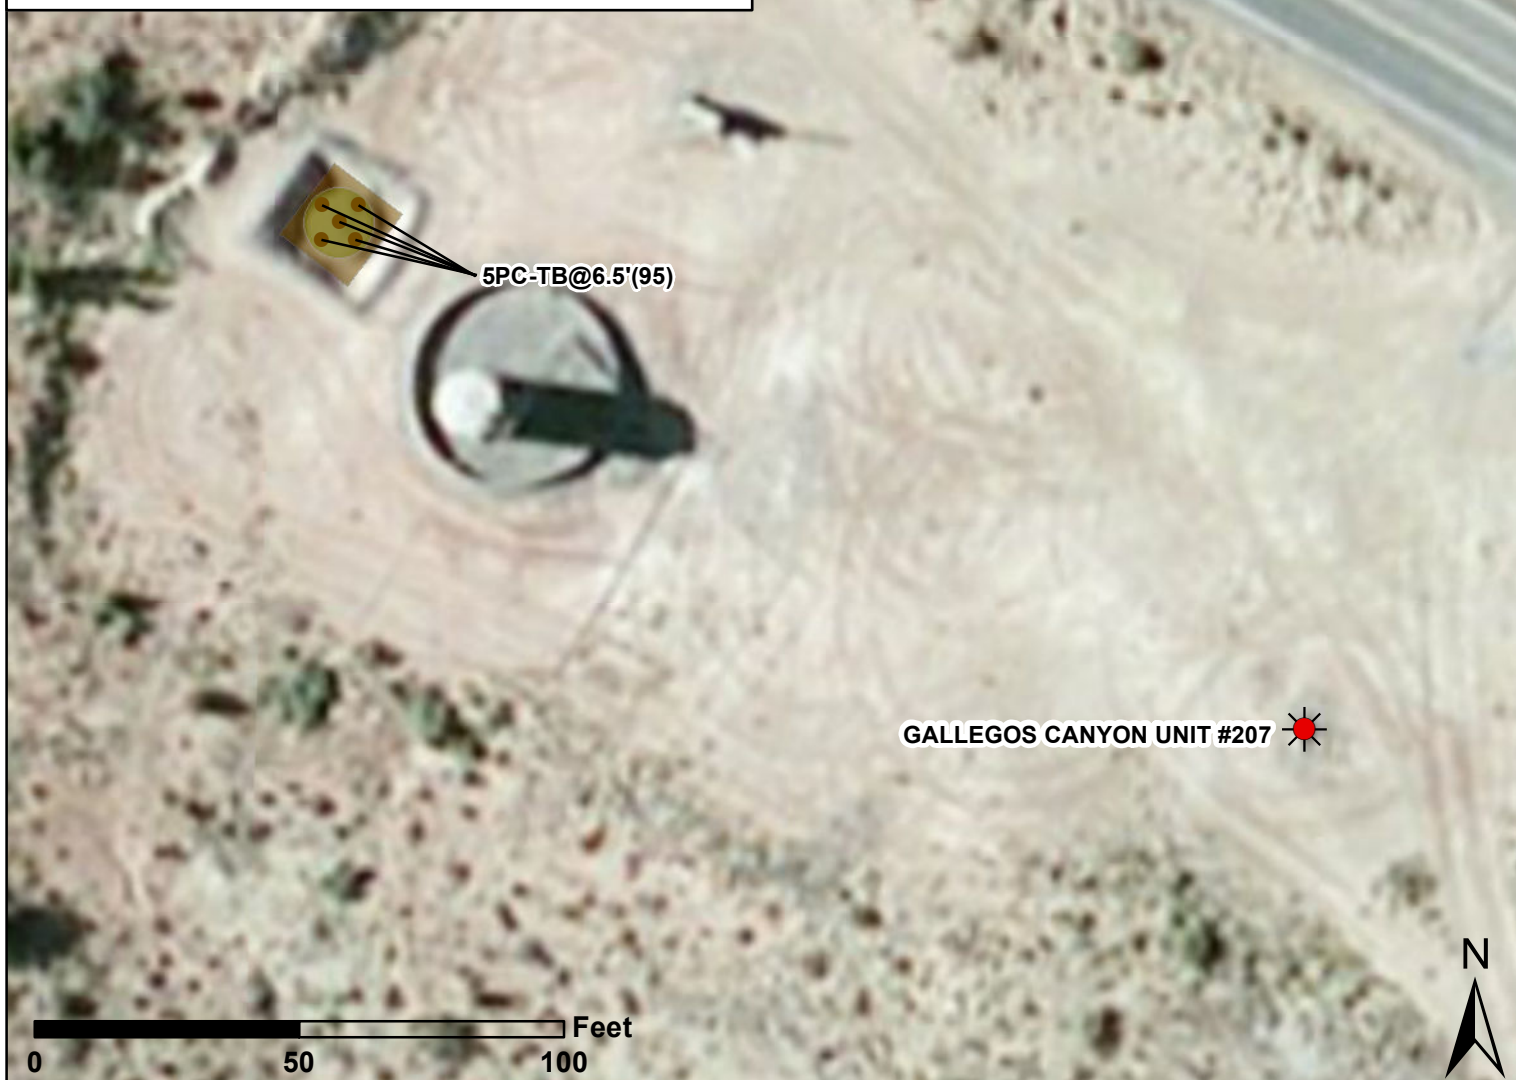
Notes: Sample collected 9/5/2023. 5PC-TB@6.5'(95) is a five-point composite sample.

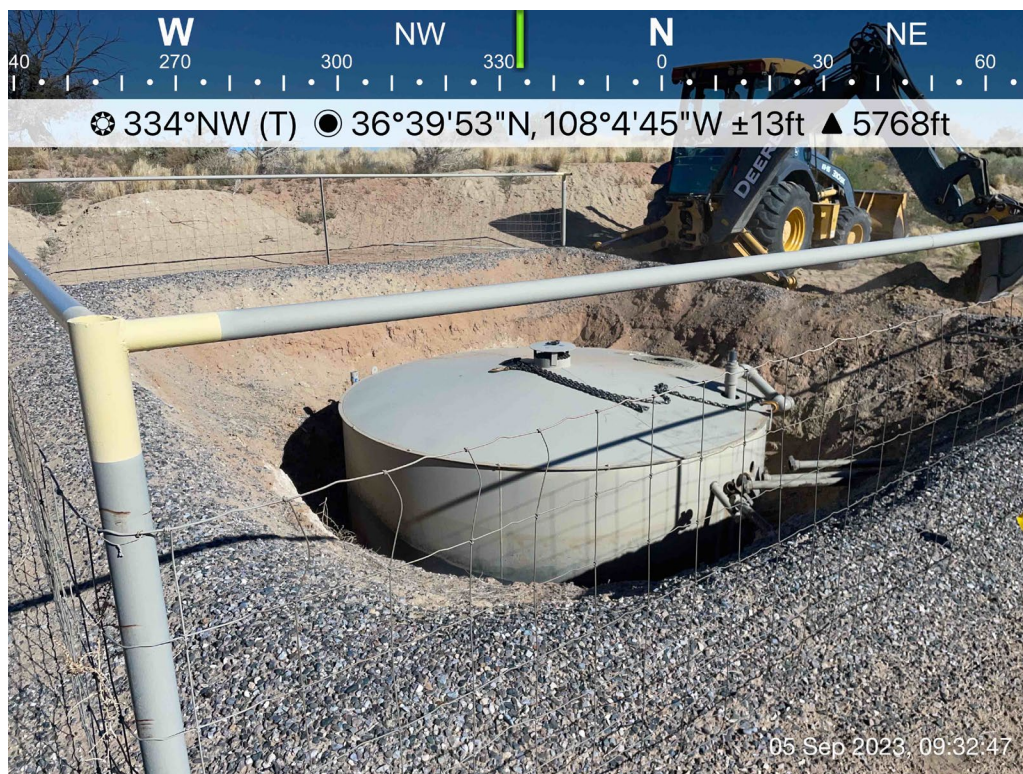
Photo 2: BGT prior to removal, 9/5/2023.

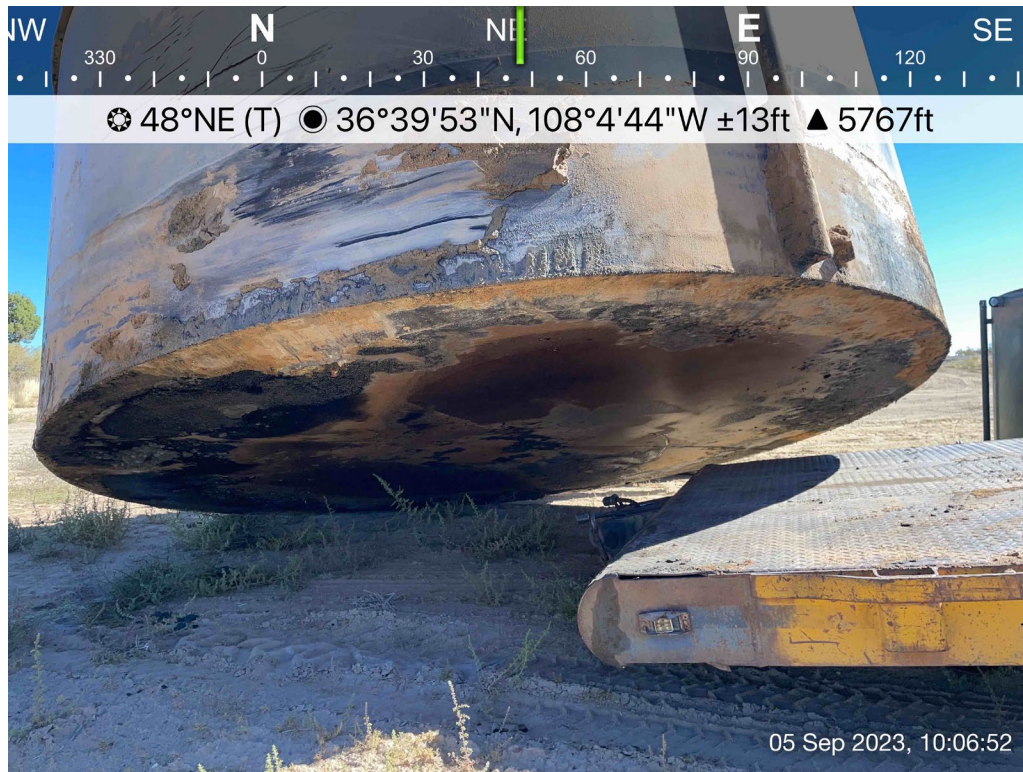
Cause of Release During replacement of the BGT on location, stained soils with a hydrocarbon odor were observed beneath the BGT. The BGT is being evaluated and the cause of release is currently under investigation.

Photo 5: Bottom of BGT following removal, 9/5/2023.
