Site Assessment and Closure Report

Dos Equis 12-13 Federal Com #047H
Incident# nAPP2300971099
Lea County, New Mexico

Subject: **Site Assessment and Closure Report**
Dos Equis 12-13 Federal Com #047H
Lea County, NM

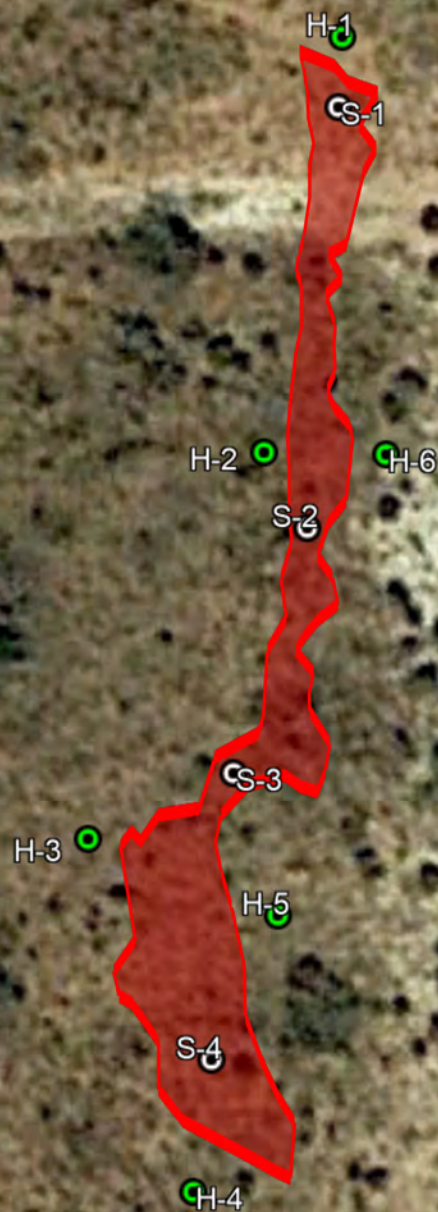
Cimarex Energy Co.
Lea County, NM
Site Assessment Map

H&R mobilized personnel to begin site assessment and sampling activities of the release area. Grab samples were obtained by way of hand auger inside and outside the release area in order to vertically and horizontally delineate the release. Samples collected were transported to Cardinal Laboratory for analysis and the results of that analysis are presented in the following data table. Initial site assessment sampling locations are illustrated on Site Assessment Map, [Appendix I](#). Photographic documentation of the release area and sample points are attached in [Appendix IV](#). Complete laboratory reports can be found in [Appendix V](#).

- Horizontal Sample
- Initial Spill Boundary
- Vertical Sample

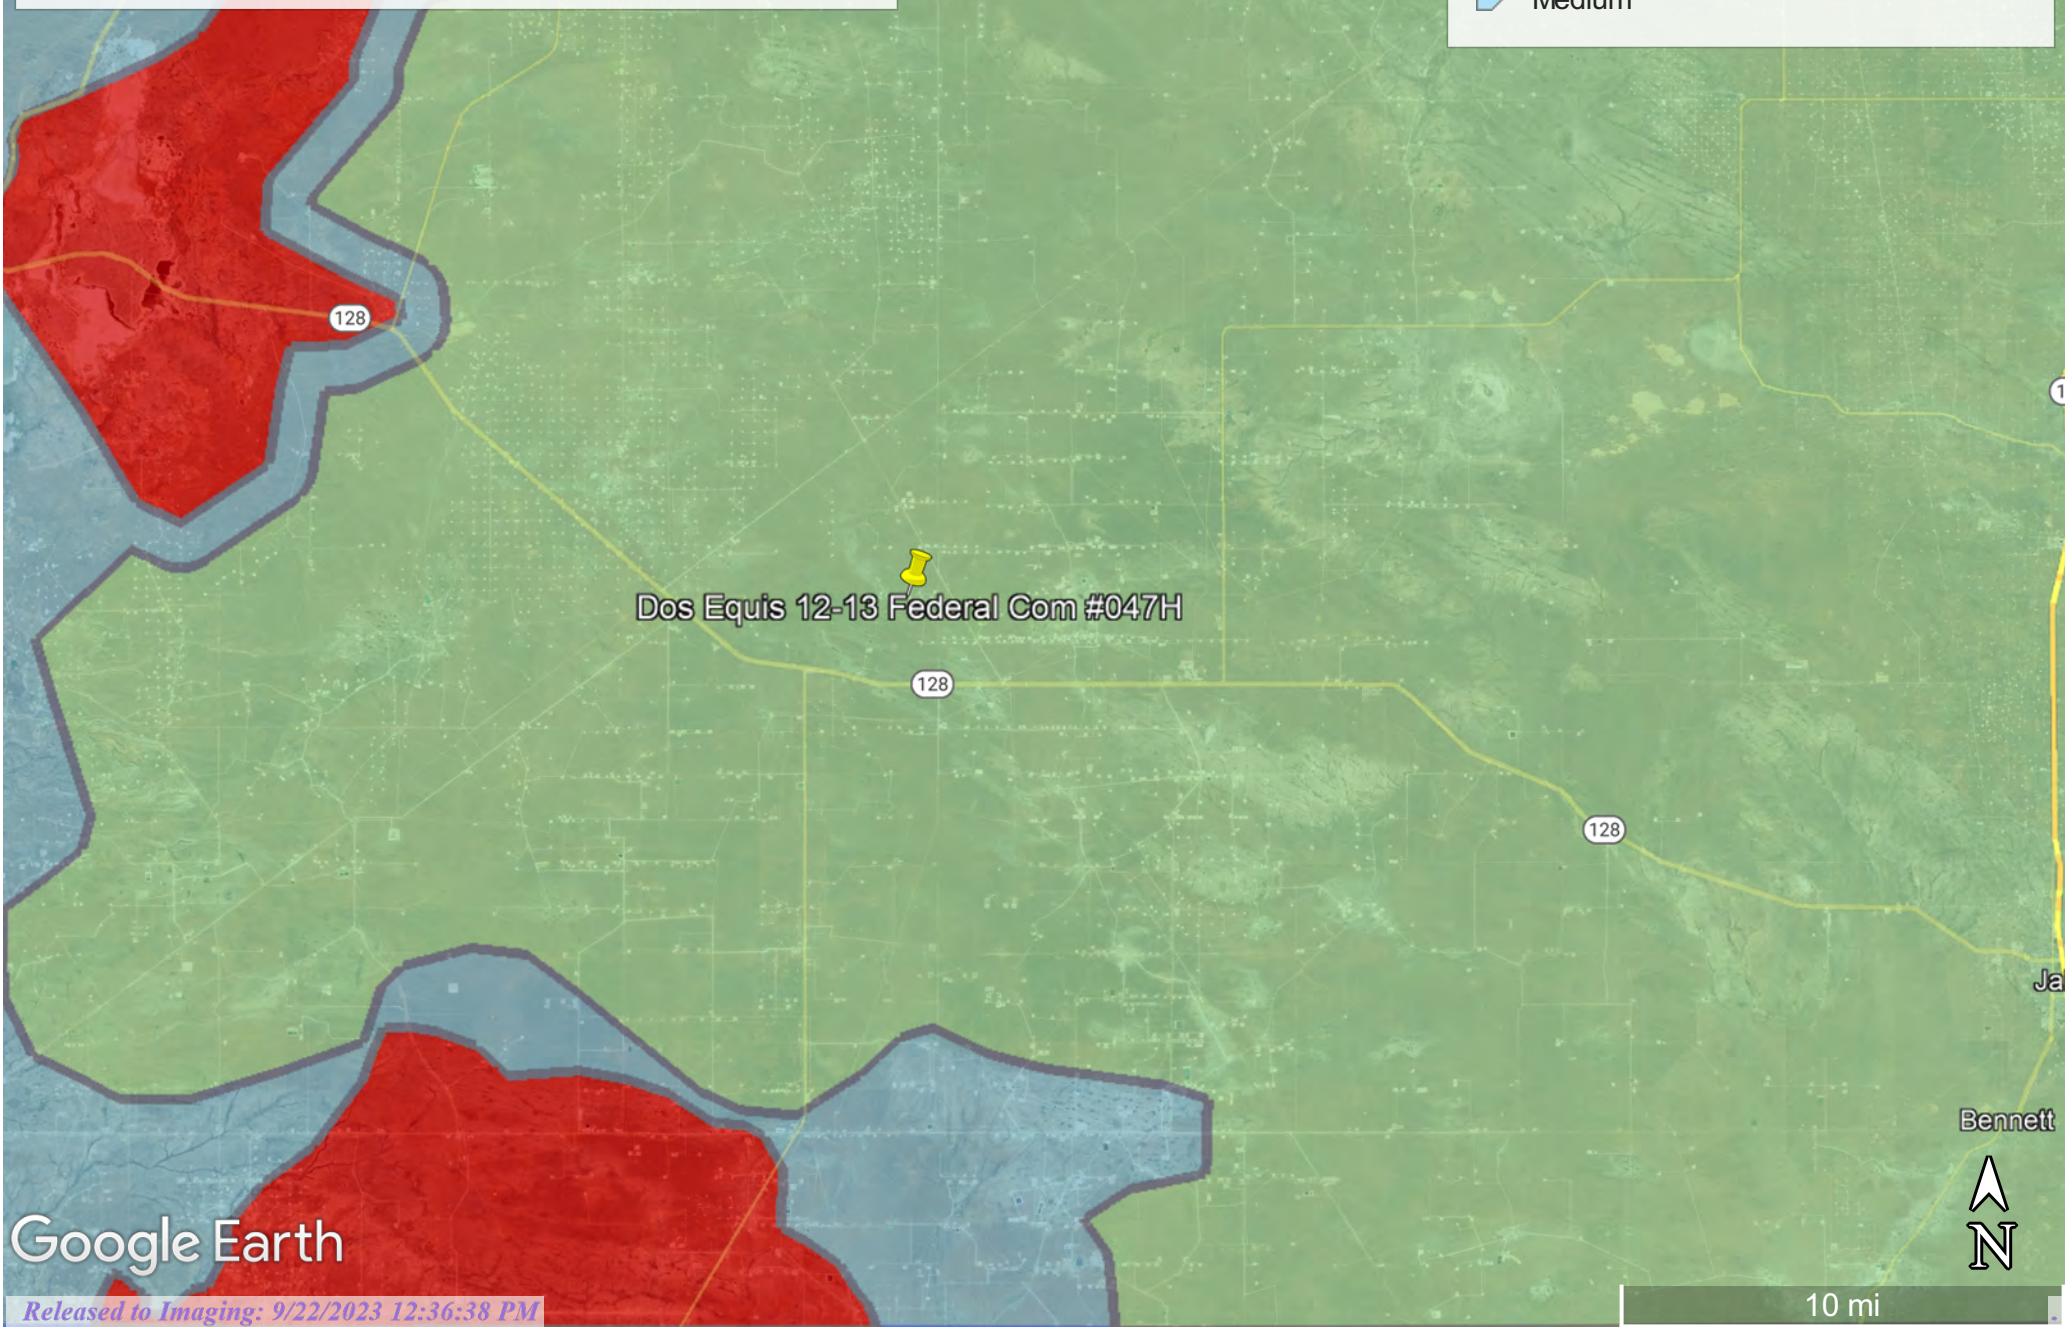
Cimarex Energy Co.
Incident# nAPP2300971099
Lea County, NM
Karst Map

According to the soil survey provided by the United States Department of Agriculture Natural Resources Conservation Service, the soil in this area is made up of Pyote and Maljamar fine sands, 0 to 3 percent slopes. The referenced soil data is attached in [Appendix II](#). Drainage courses in this area are typically dry. The project site is not located in a high Karst potential area (Karst Map, [Appendix I](#)).

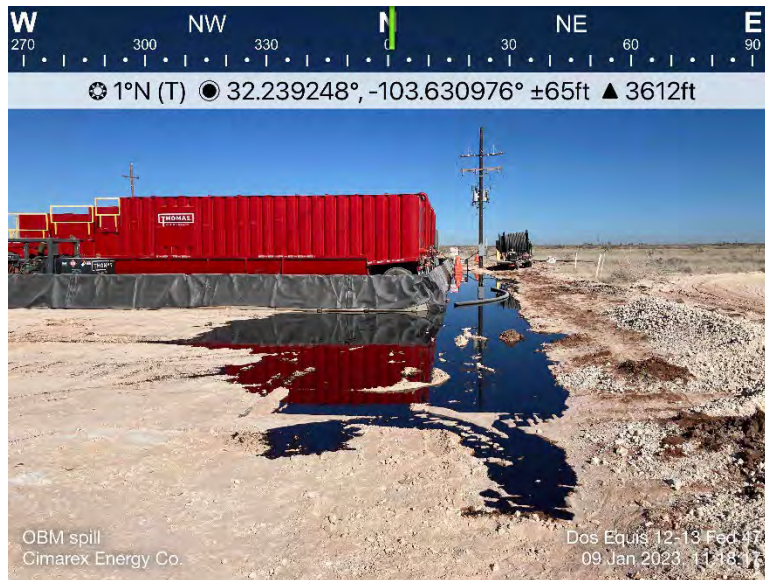
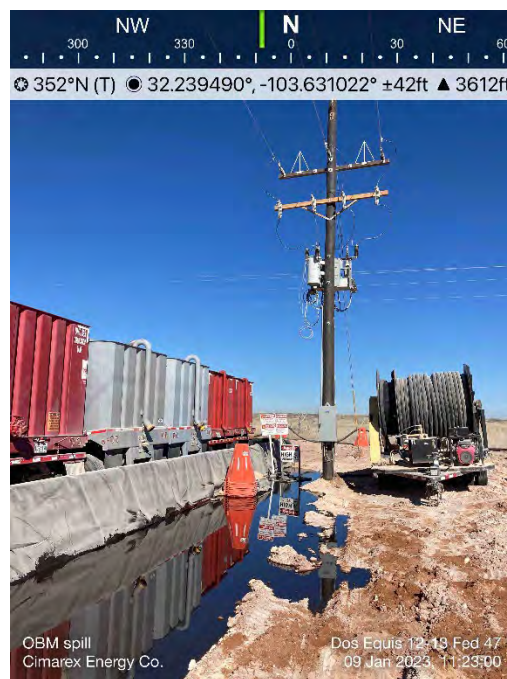
INITIAL PHOTOGRAPHS

On January 09, 2023, while transferring fluid from the frac tank, the farm hose was improperly hooked up to an Oil Based Mud (OBM) tank causing the tank to run over into the lined containment and onto the well pad. All fluid remained on the well pad. A total of 65 barrels (bbls) of OBM was released with 38 bbls inside the containment and 25 bbls on the well pad being recovered via vac truck. 2 bbls of OBM was unable to be recovered.

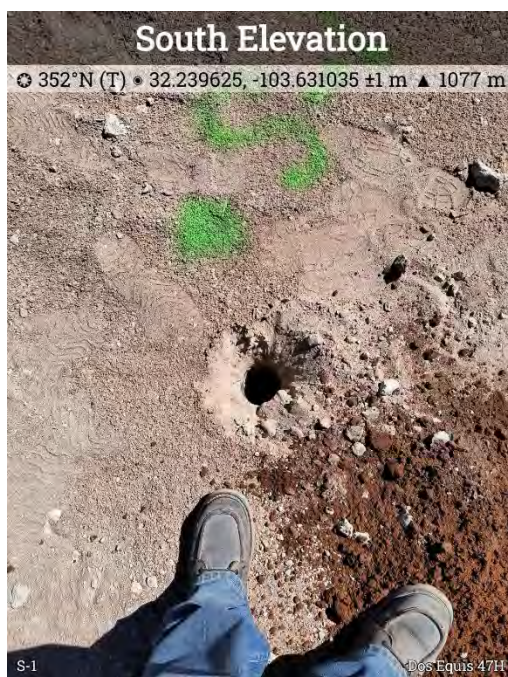
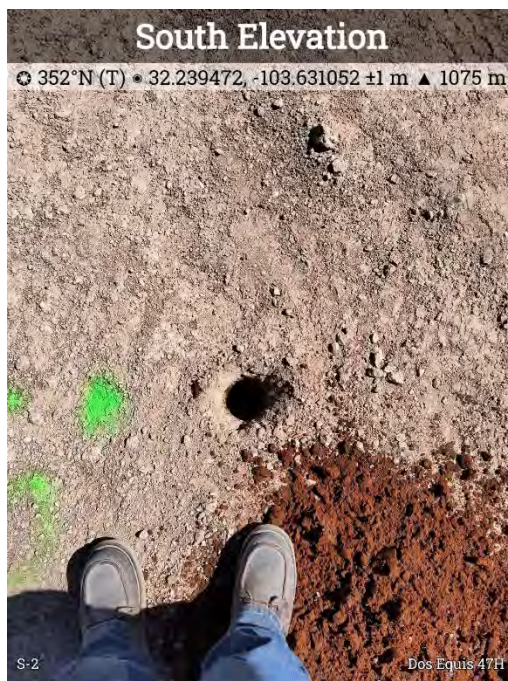
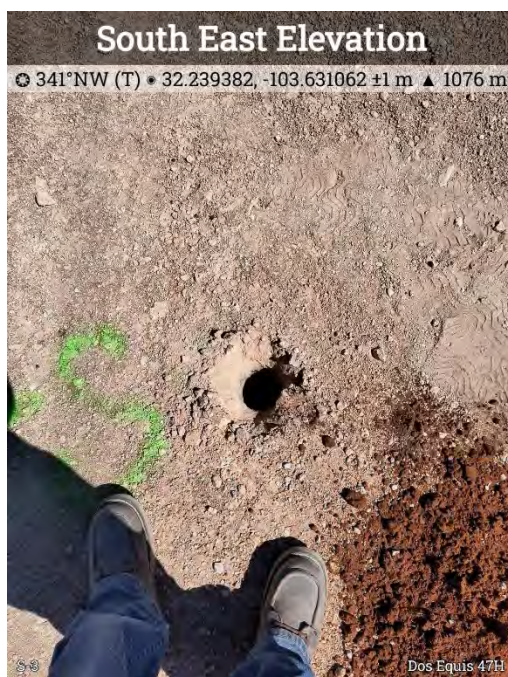
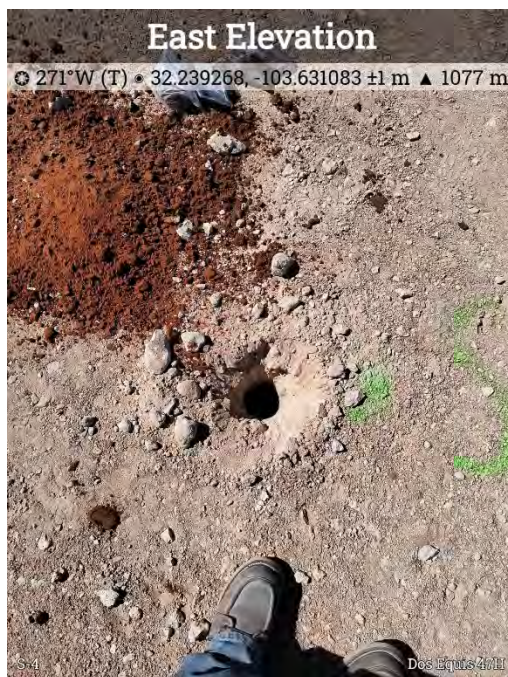
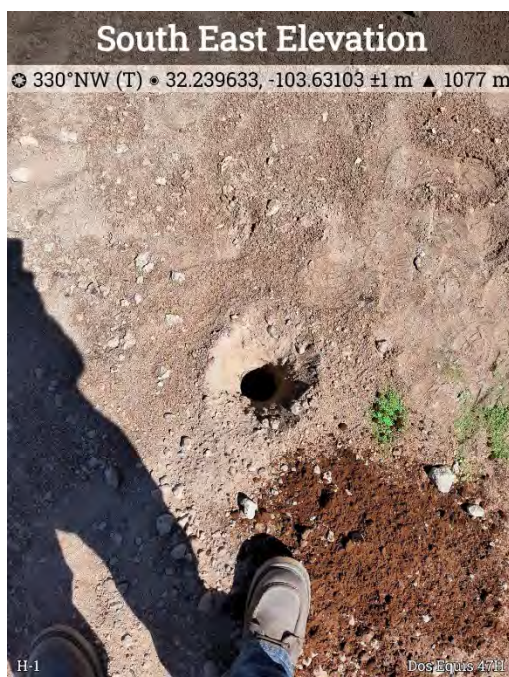
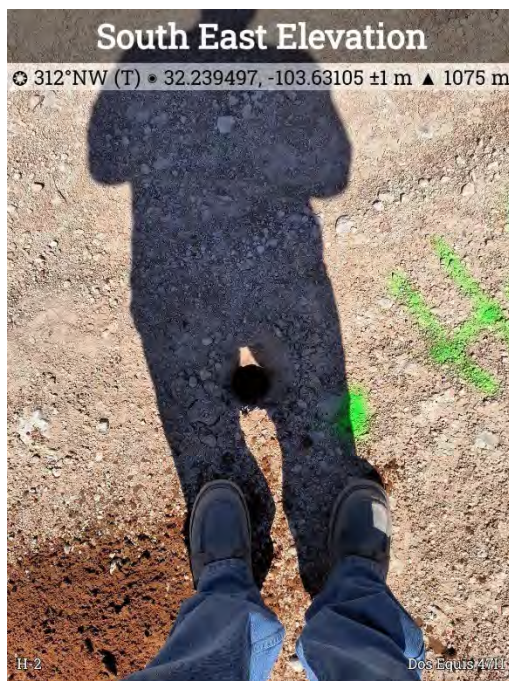
ASSESSMENT PHOTOGRAPHS

Based on the results of our site assessment, it was determined that no further actions are needed as closure criteria was not exceeded.

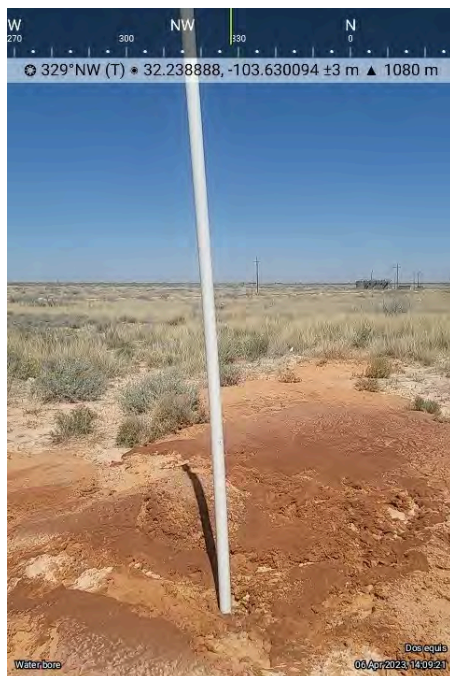
EXPLORATORY WATER BORE PHOTOGRAPHS

Due to groundwater data being outside the recommended 0.5-mile distance from the release, an exploratory water bore was drilled approximately 349-feet away from the release on the Dos Equis 12 Federal Com #003 well pad to a total depth of 105-feet BGS. No groundwater was encountered on the day of drilling nor 72-hours later when gauging was performed. The closure criteria for this site are as follows:
