## Release Notification

## CLOSURE REPORT

**Hammond #47R (04/20/23)**  
Unit Letter F, S35 T27N R08W  
San Juan County, New Mexico

**New Mexico EMNRD OCD Incident ID No. NAPP2311048689**

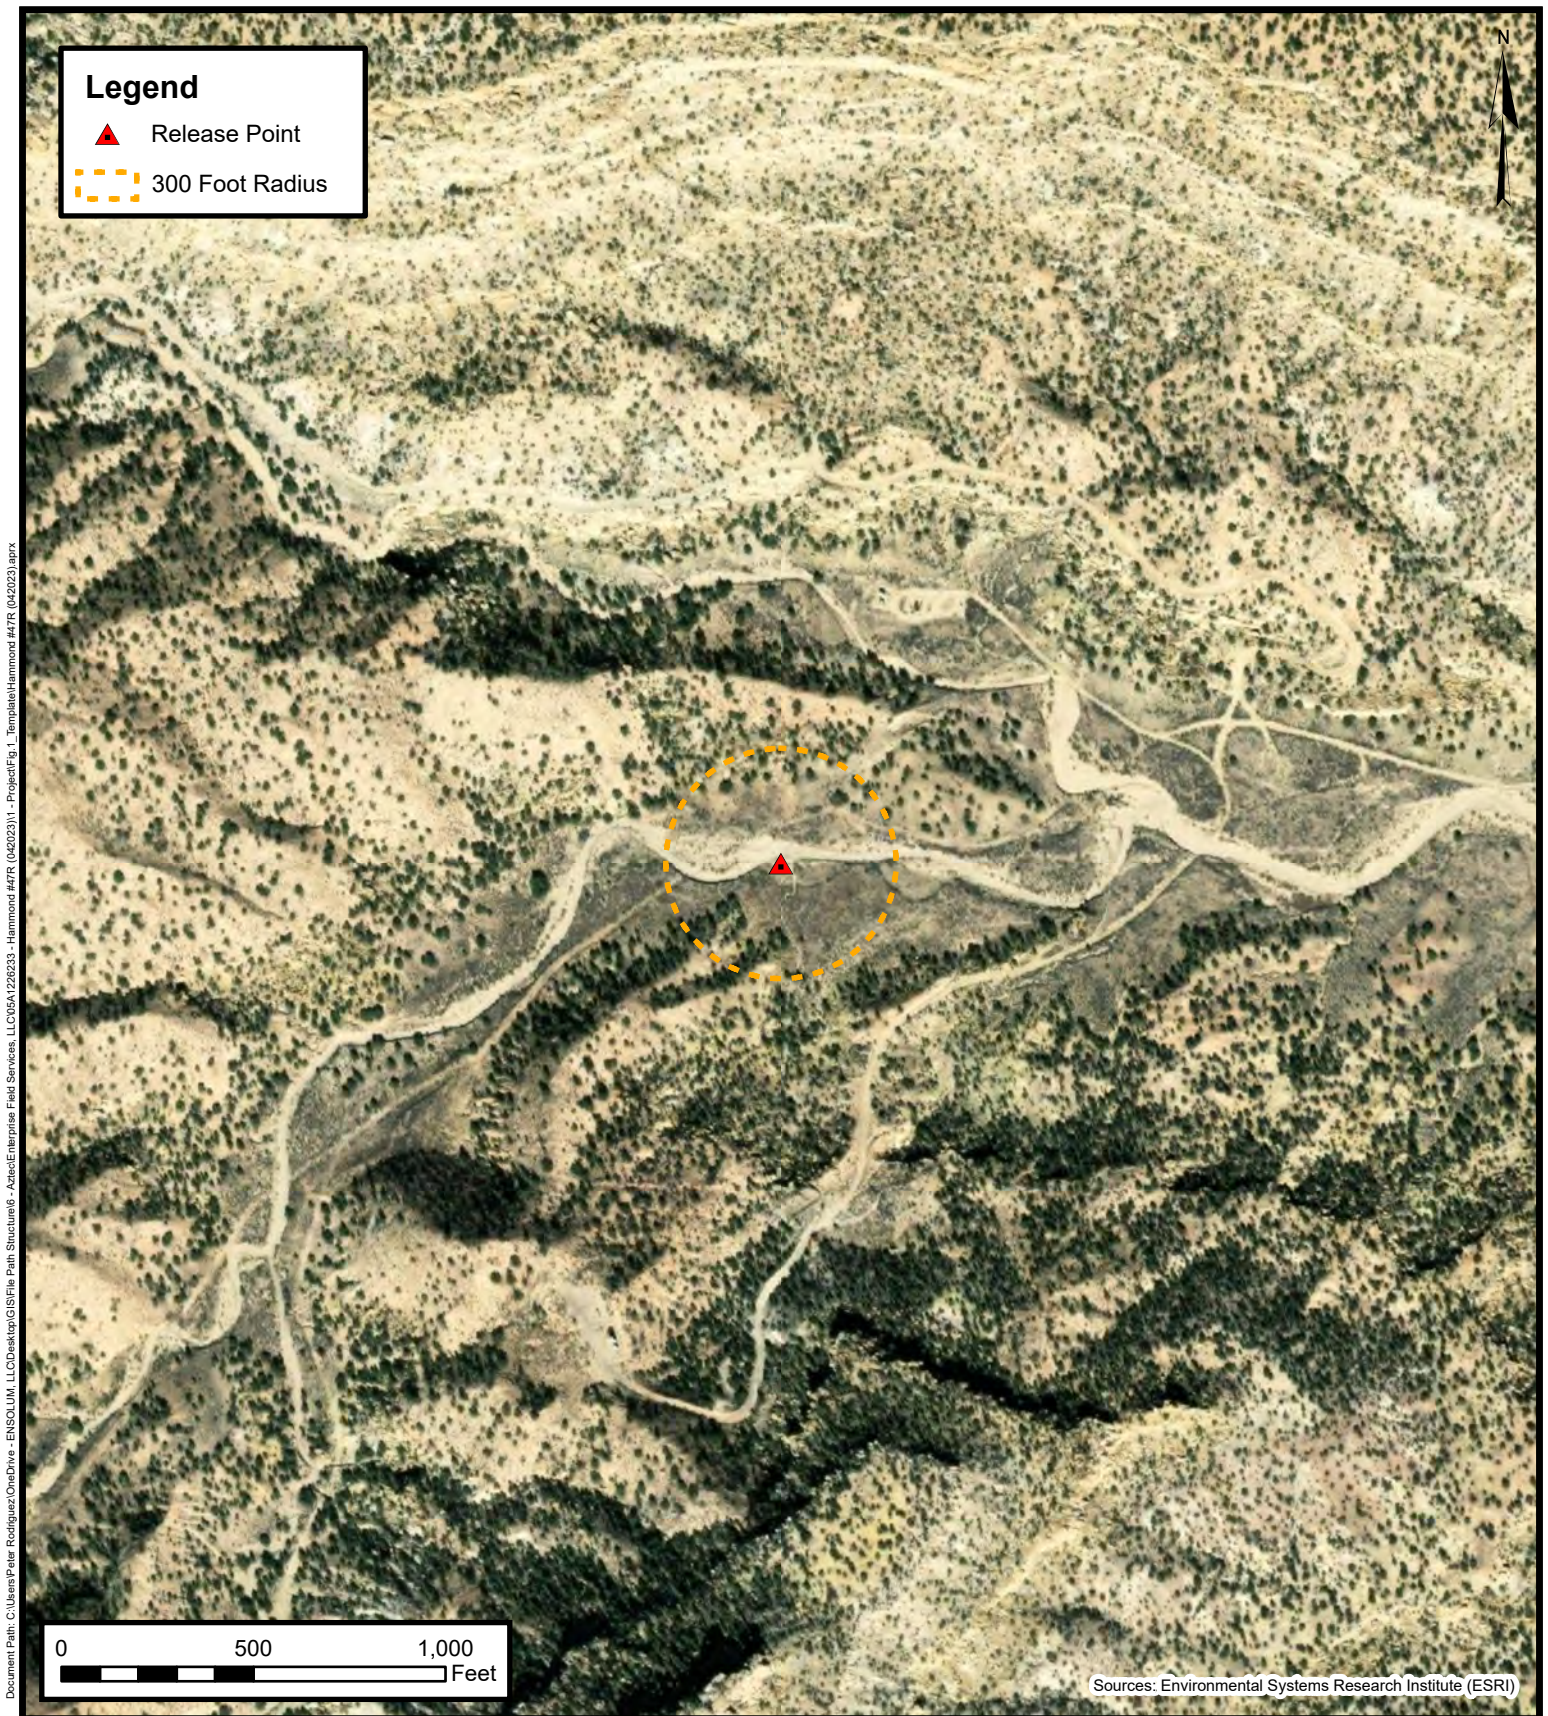
FIGURE  
D

- The Site is not located within 200 feet of a lakebed, sinkhole, or playa lake.
- The Site is not located within 300 feet of a permanent residence, school, hospital, institution, or church (**Figure D, Appendix B**).

### 300 Foot Radius Occupied Structure Identification

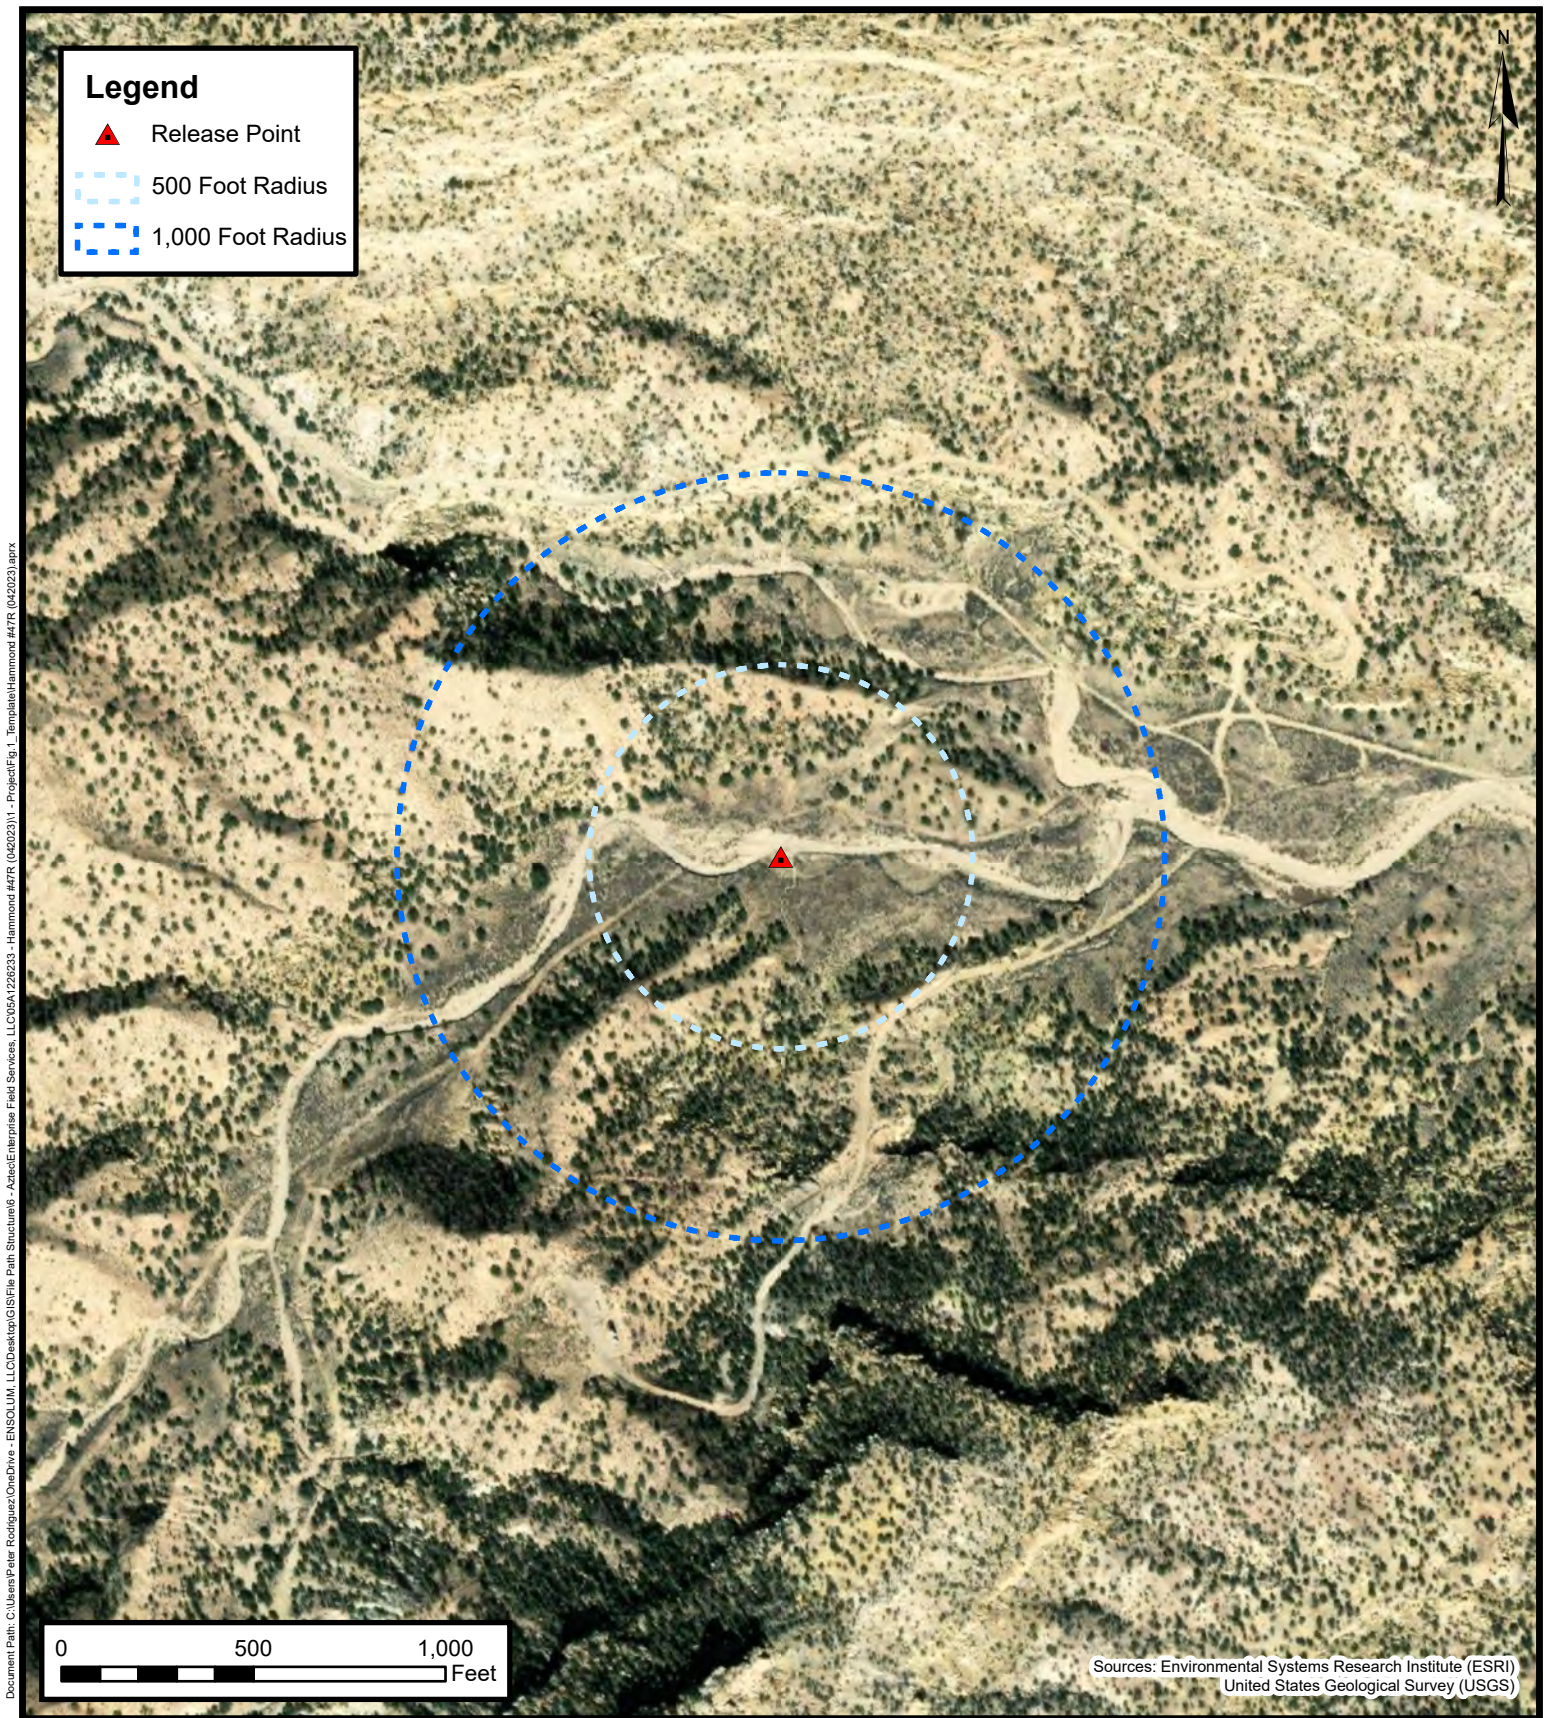
**FIGURE  
E**

- No springs, or private domestic freshwater wells used by less than five households for domestic or stock watering purposes were identified within 500 feet of the Site (**Figure E, Appendix B**).

- No freshwater wells or springs were identified within 1,000 feet of the Site (**Figure E, Appendix B**).
- The Site is not located within incorporated municipal boundaries or within a defined municipal fresh water well field covered under a municipal ordinance adopted pursuant to New Mexico Statutes Annotated (NMSA) 1978, Section 3-27-3.

## Water Well and Natural Spring Location

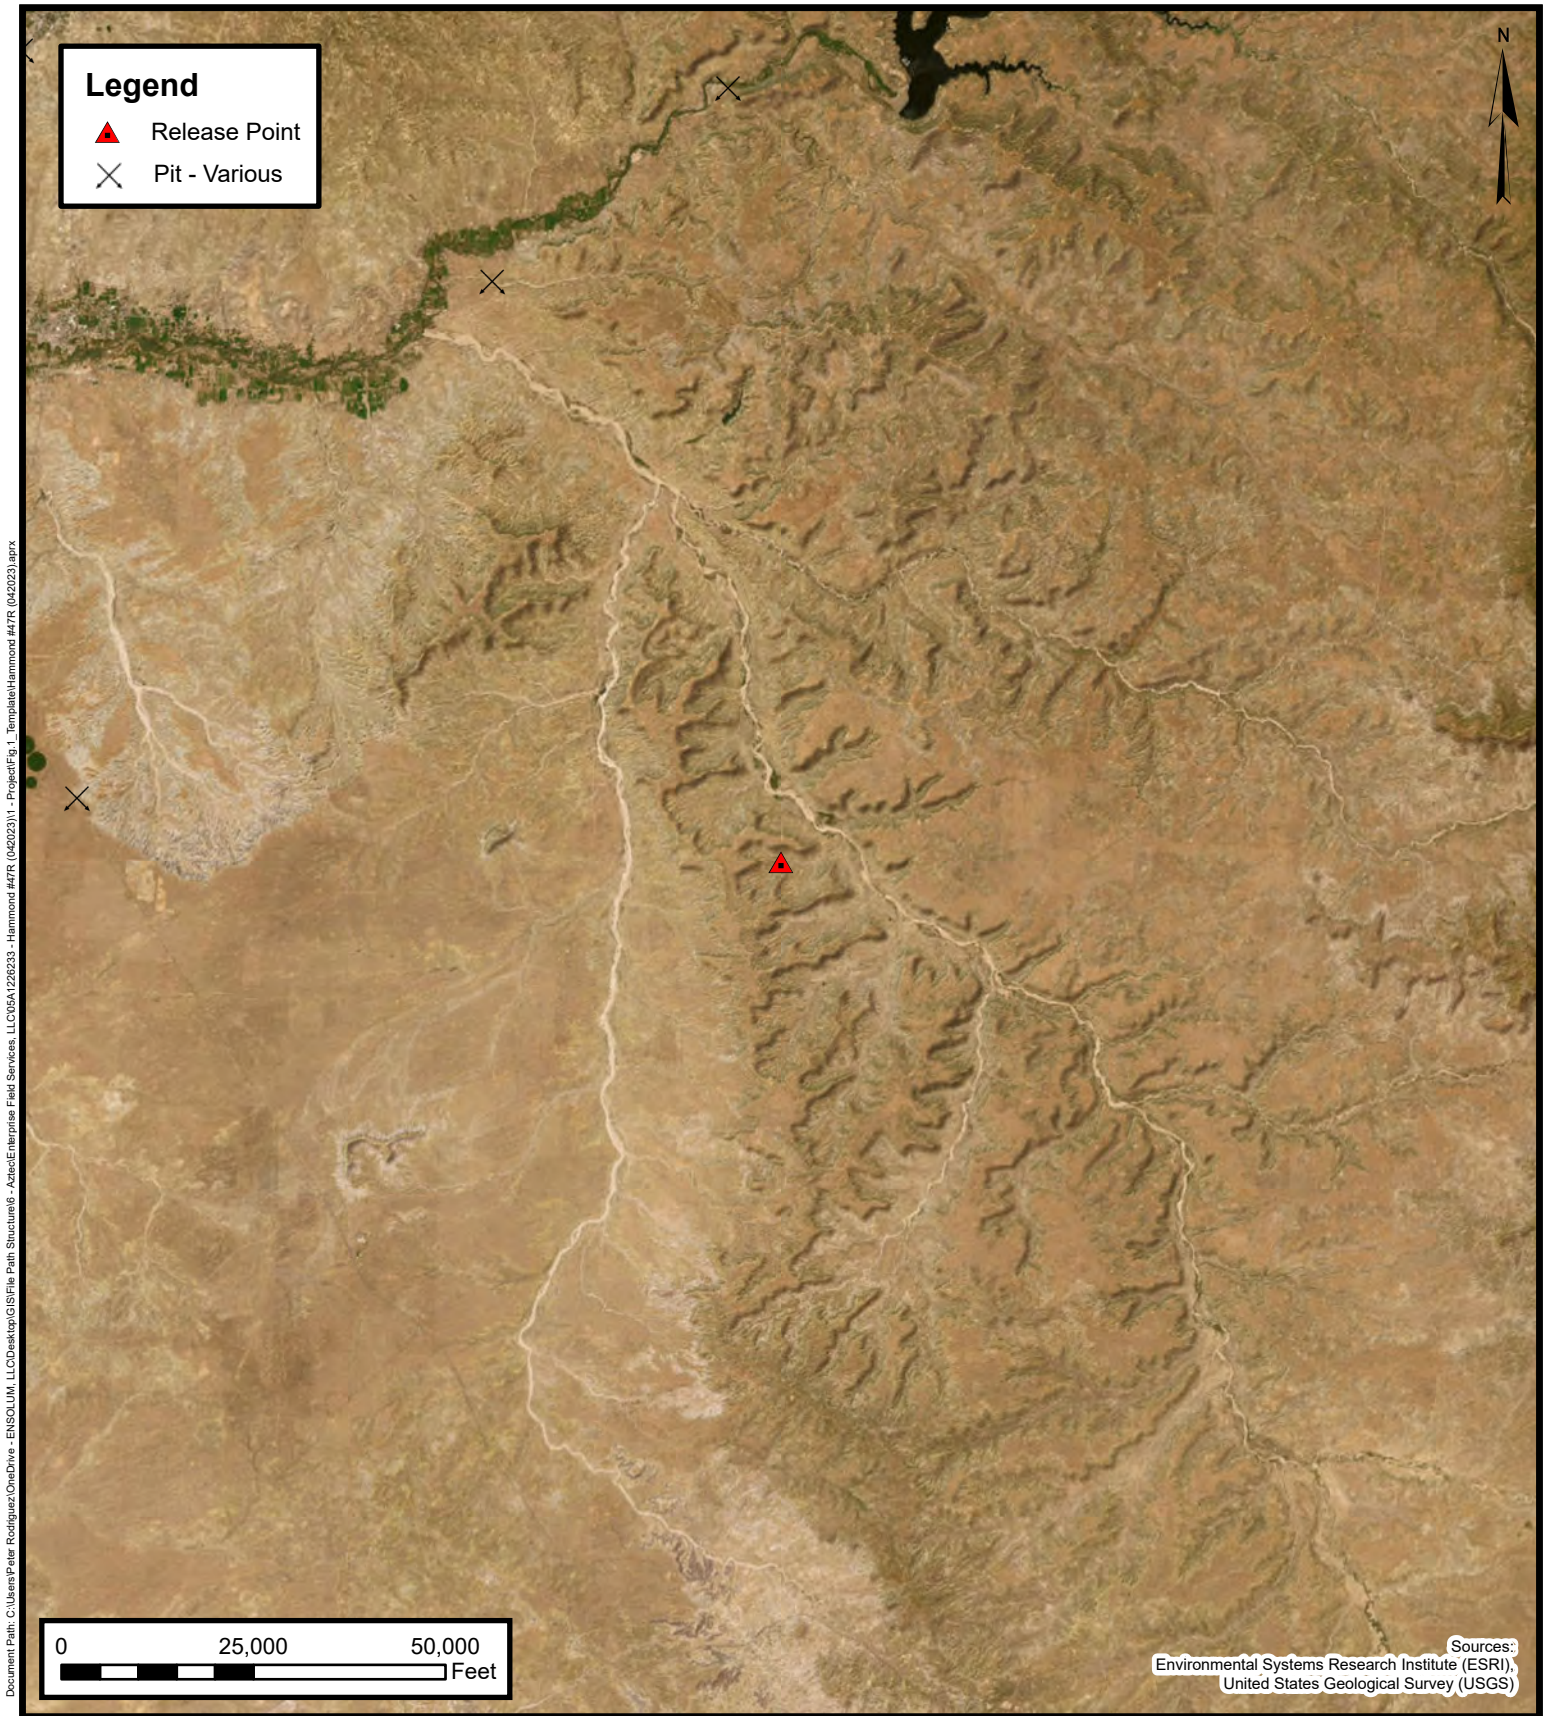
FIGURE

- Based on information identified in the NM Mining and Minerals Division's Geographic Information System (GIS) Maps and Mine Data database, the Site is not within an area overlying a subsurface mine (**Figure G, Appendix B**).

## Mines, Mills, and Quarries

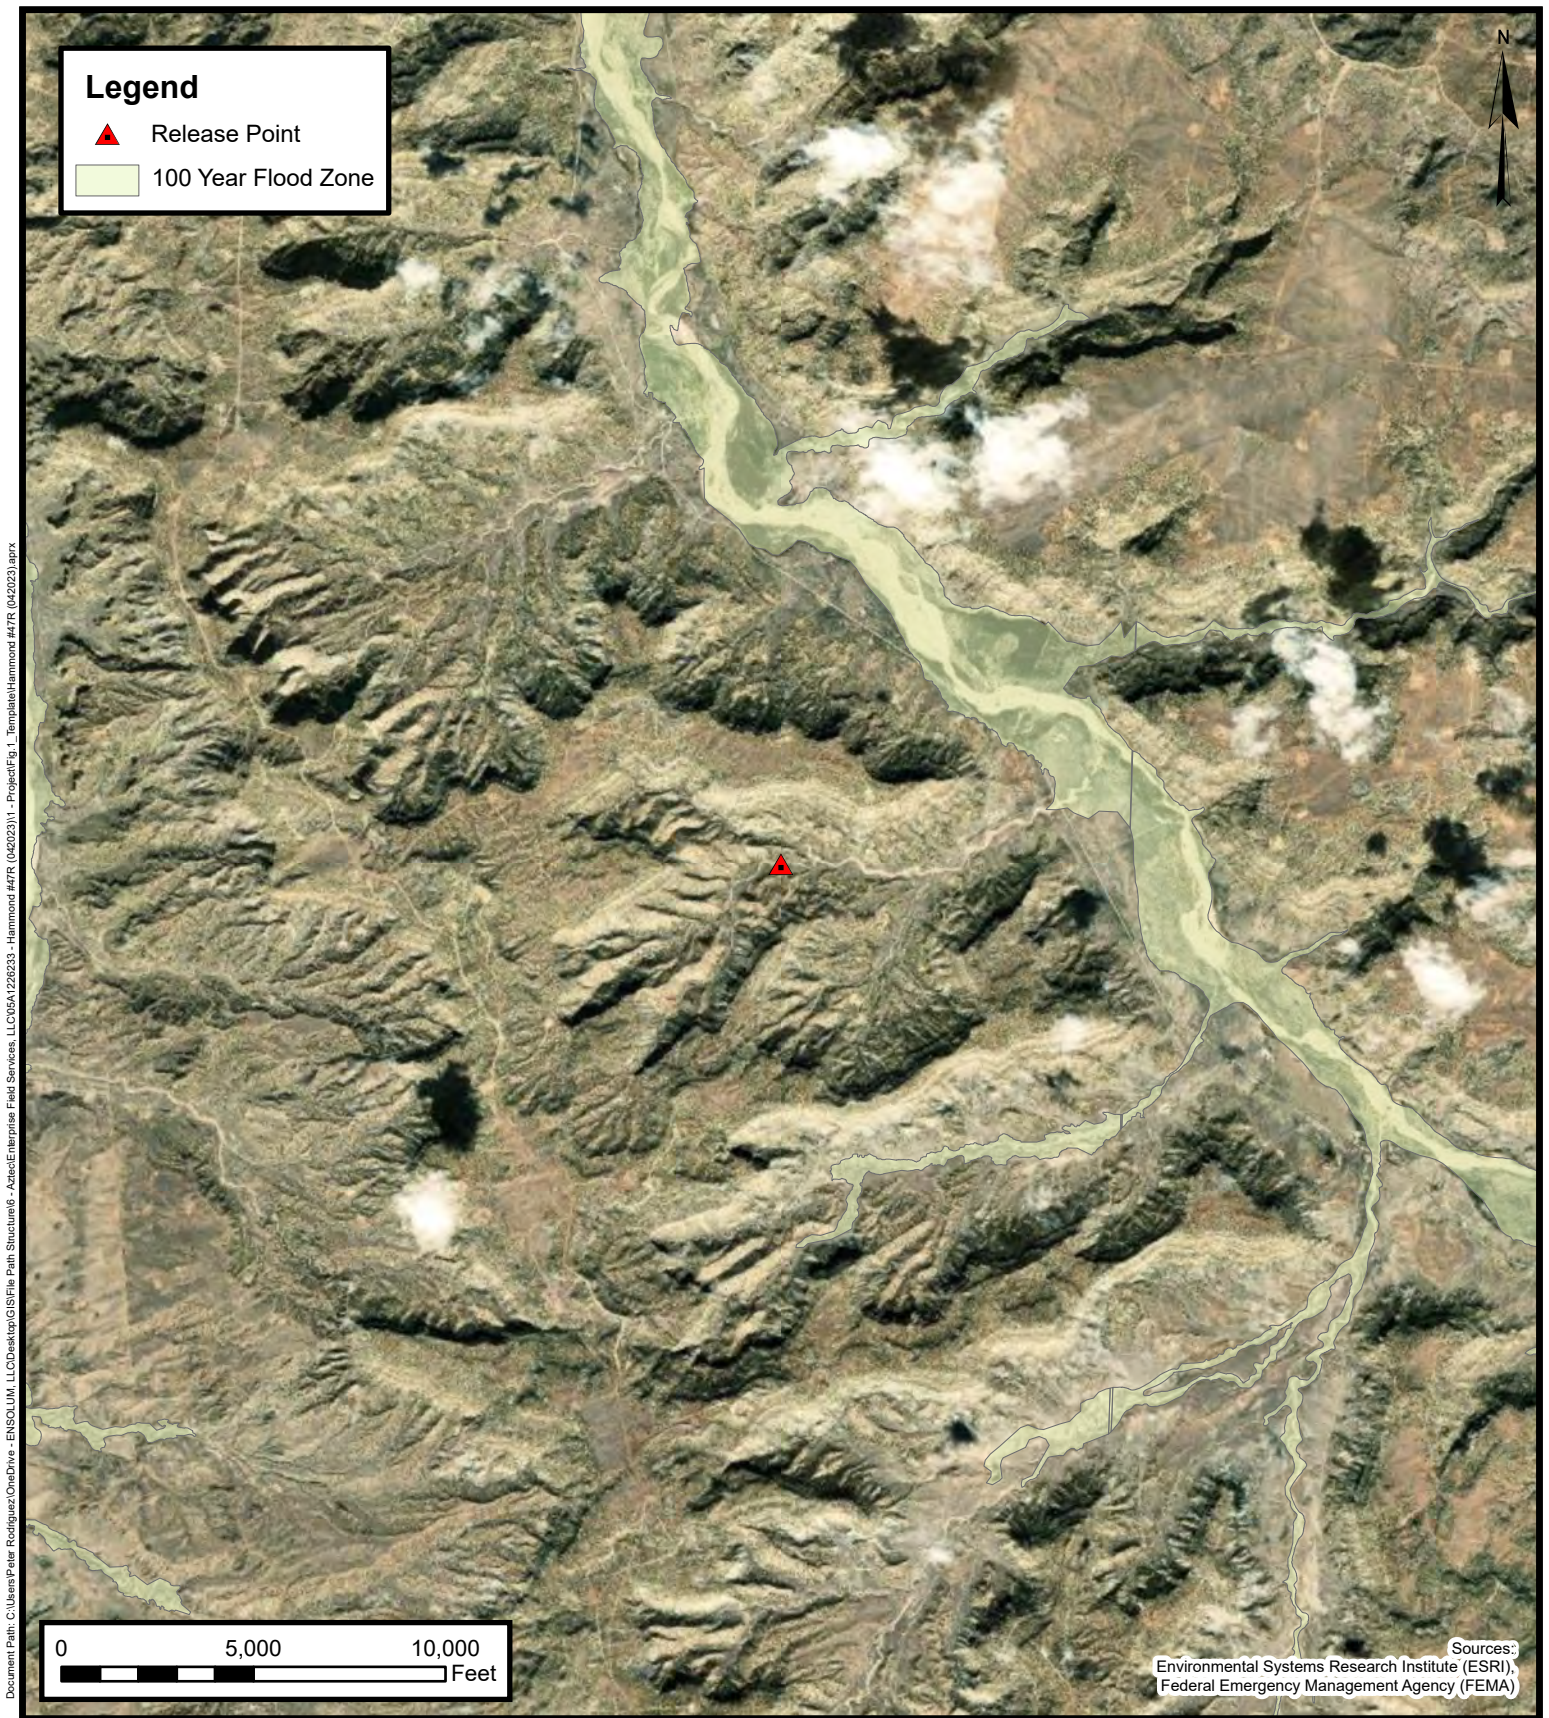
FIGURE

- The Site is not located within an unstable area per Paragraph (6) of Subsection U of 19.15.2.7 NMAC.
- Based on information provided by the Federal Emergency Management Agency (FEMA) National Flood Hazard Layer (NFHL) geospatial database, the Site is not within a 100-year floodplain (**Figure H, Appendix B**).

## 100-Year Flood Plain Map

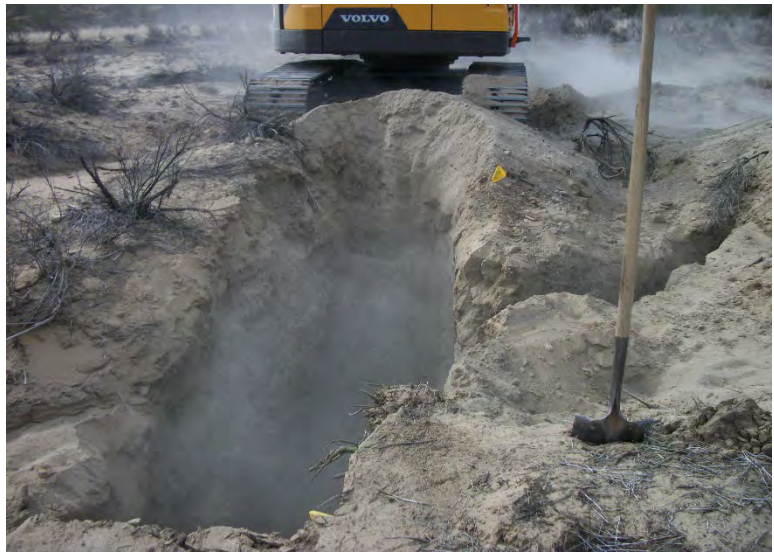
**Photograph 1**

Photograph Description: View of the in-process excavation activities.

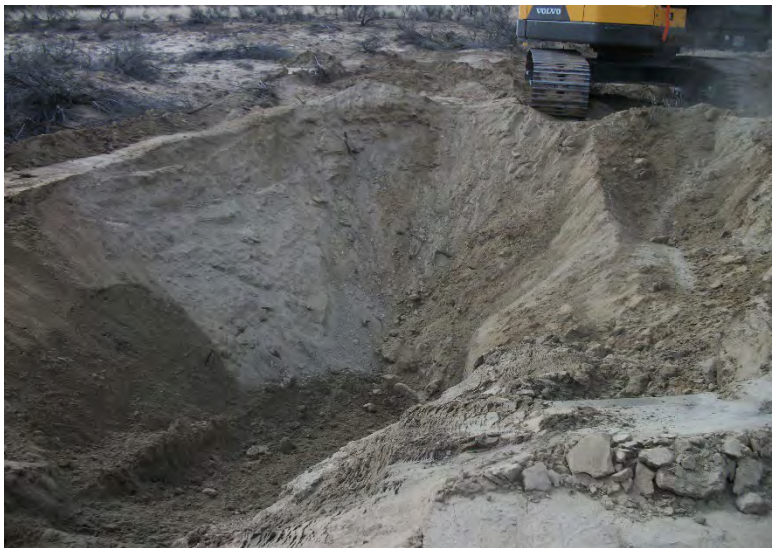
**Photograph 2**

Photograph Description: View of the in-process excavation activities.

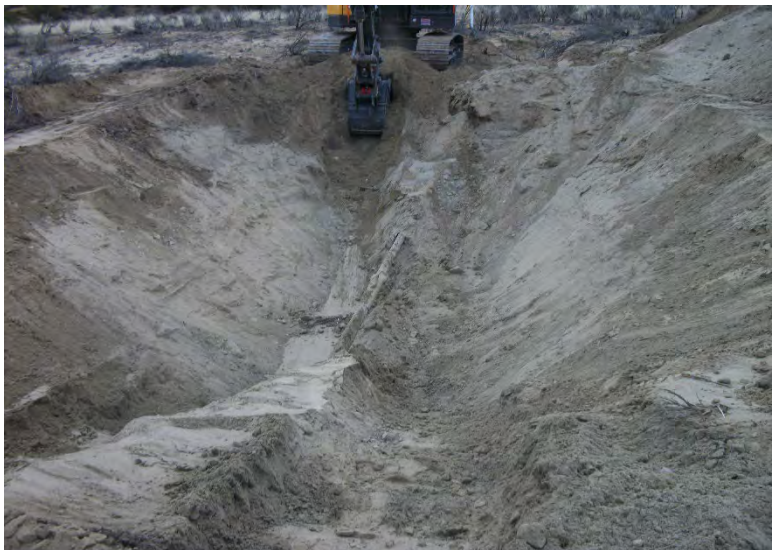
**Photograph 3**

Photograph Description: View of the in-process excavation activities.

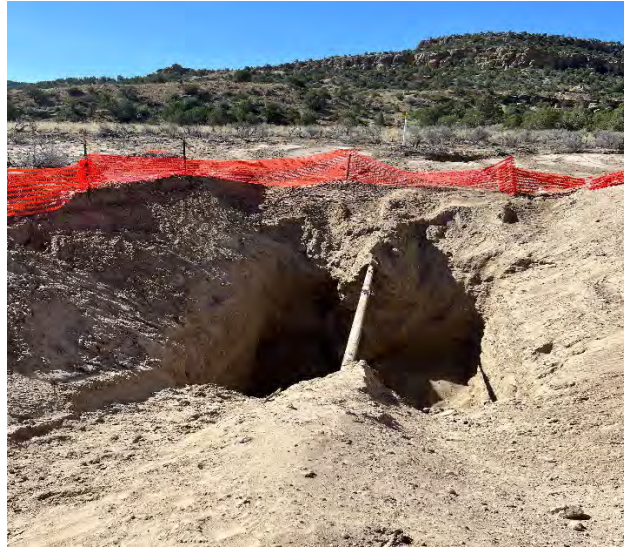
**Photograph 4**

The final excavation measured approximately 15 feet long and 15 feet wide at the maximum extents. The maximum depth of the excavation measured approximately 17 feet bgs. The lithology encountered during the completion of remediation activities consisted primarily of sand and gravel.

Photograph Description: View of the final excavation.

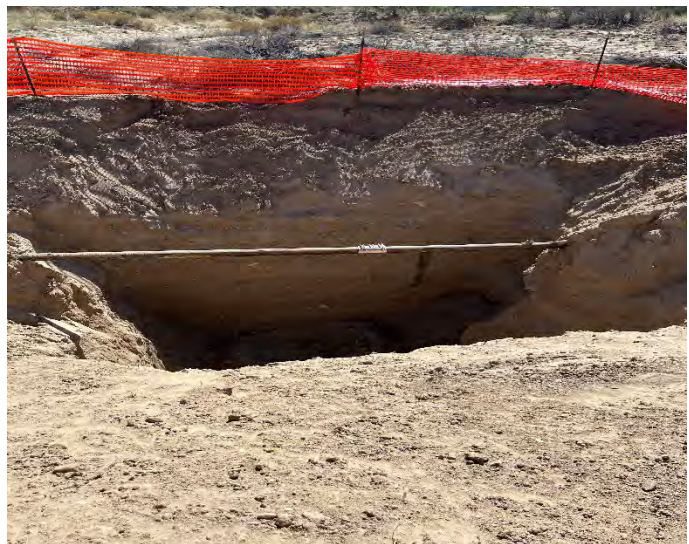
**Photograph 5**

Photograph Description: View of the final excavation.

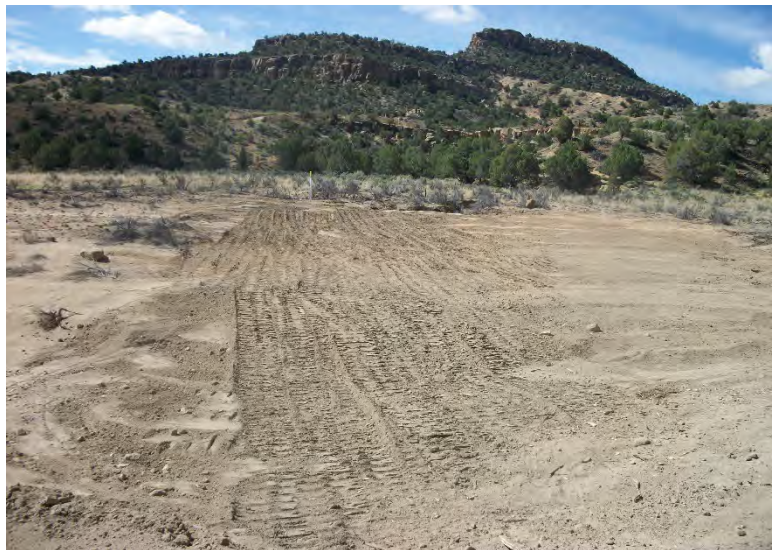
**Photograph 6**

Photograph Description: View of the site after initial restoration.

The excavation was backfilled with imported fill and then contoured to the surrounding topography.
