To: Nelson Velez, New Mexico Oil Conservation Division (NMOCD)  
From: Mitch Killough, Hilcorp Energy Company (Hilcorp)  
Date: 7/3/2023  
Subject: Culpepper Martin 100S – Final Form C-141 Submittal (Closure Request)

**RE: CLEARANCE REPORT**  
**Culpepper Martin 100S Release**  
**Incident # NAPP2310736718**  
**API: 30-045-34394**  
**NE¼ SE¼, Section 20, T32N, R12W**  
**San Juan County, New Mexico**

## Culpepper Martin 100S Release Clearance Report

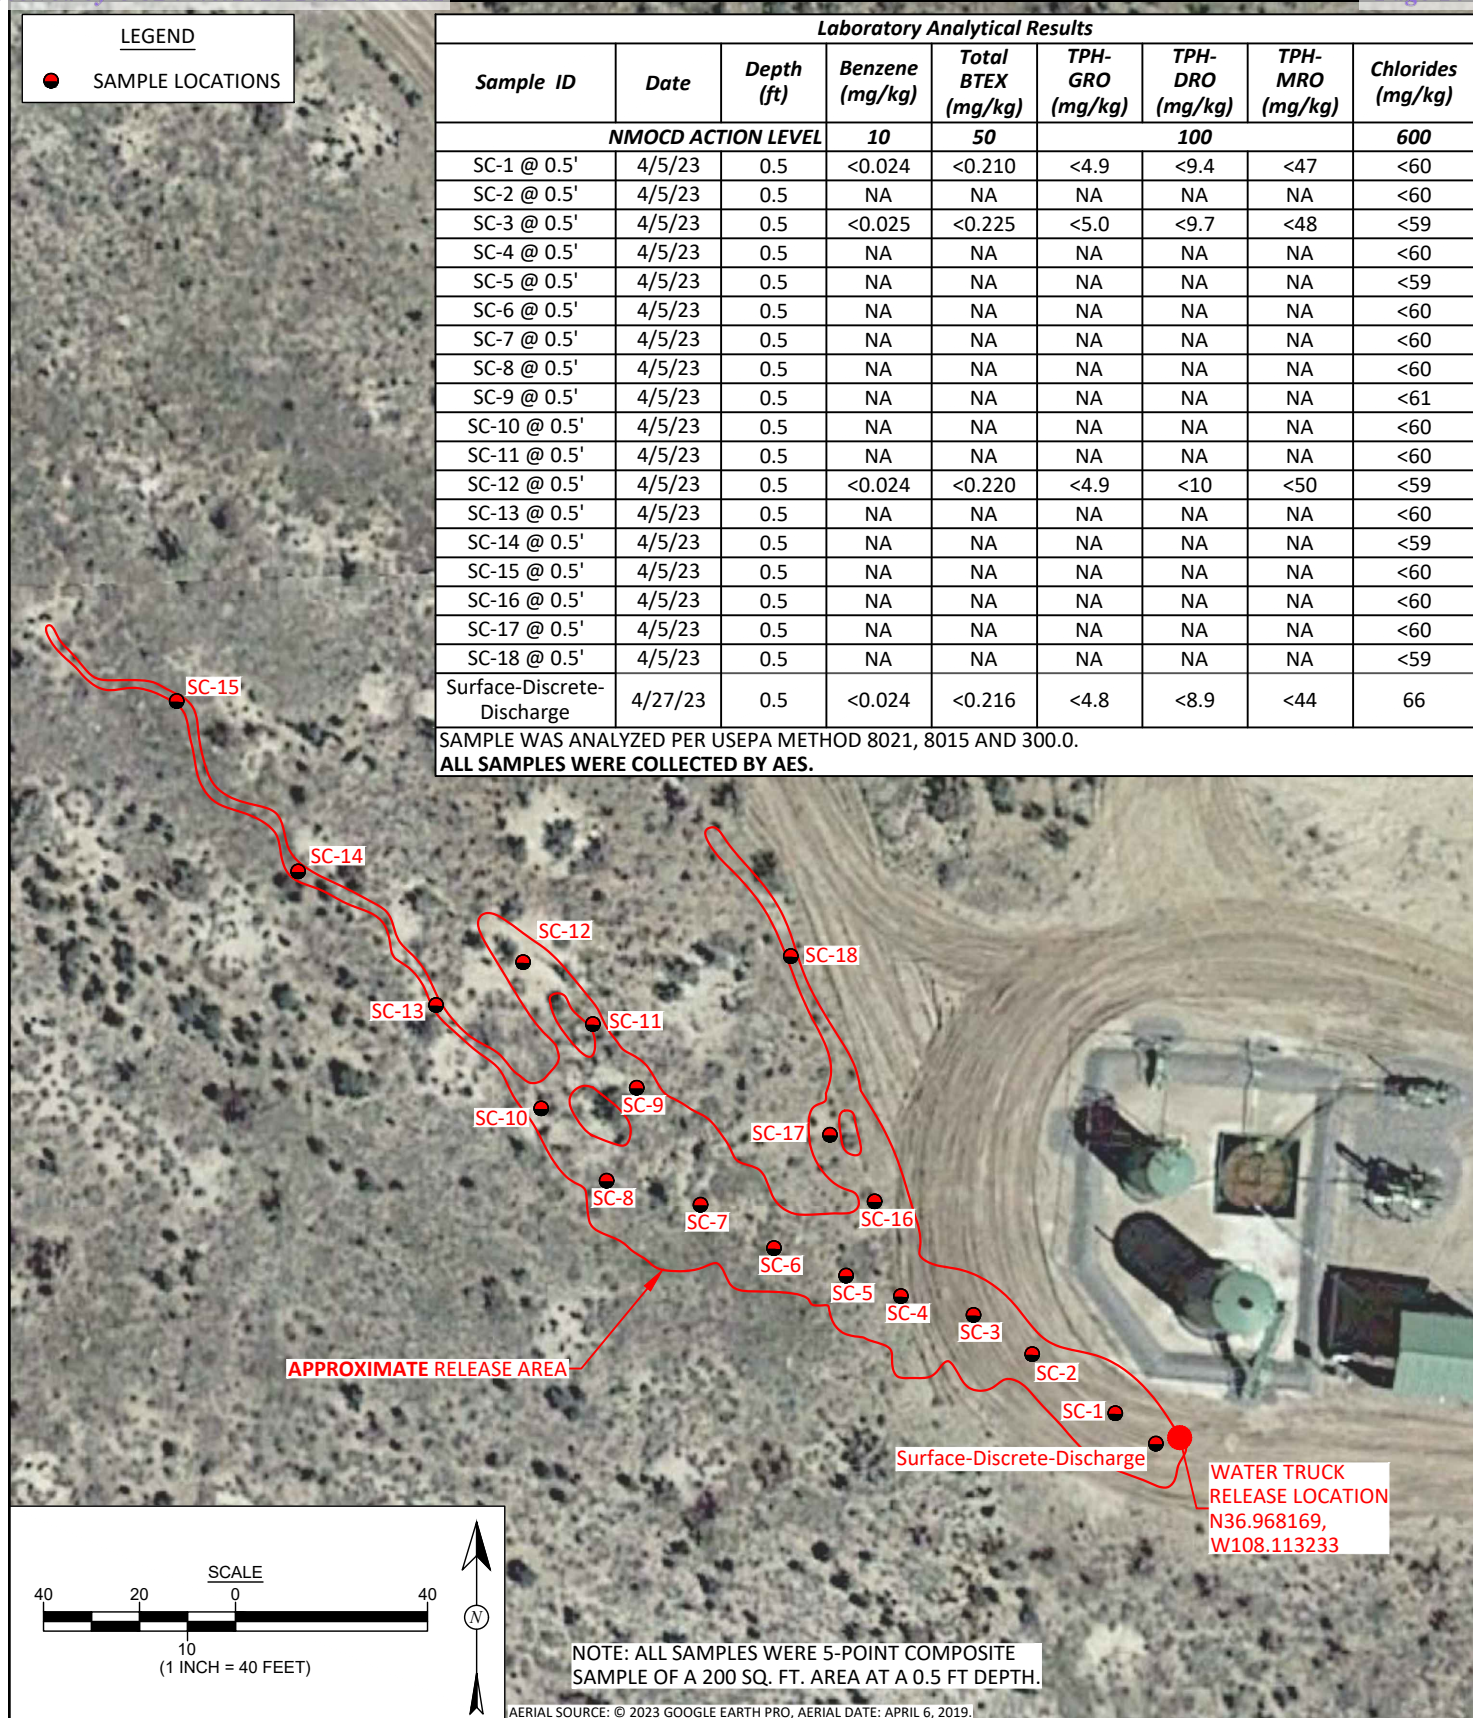
## FIGURE 3

All laboratory analytical results indicated benzene, total BTEX, TPH (as GRO, DRO, and MRO), and chlorides in all samples were below applicable action levels. Laboratory results are on Figure 3. The laboratory analytical report is attached.

**AERIAL SITE MAP AND SAMPLE LOCATIONS**

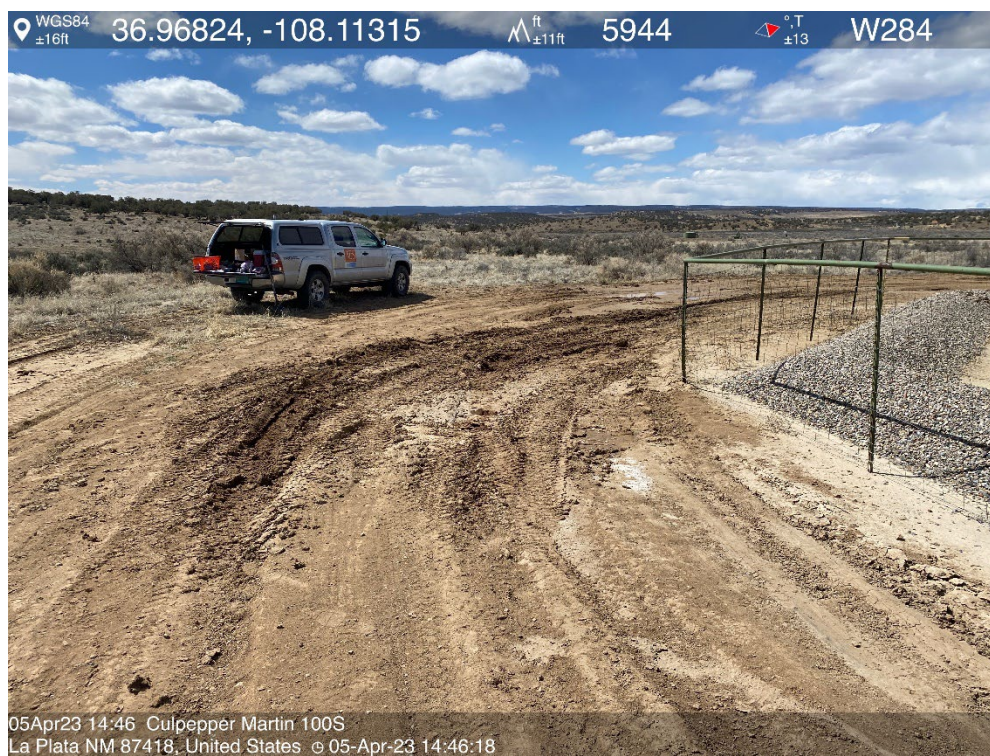
Photo 2: Release Location, 04/05/2023

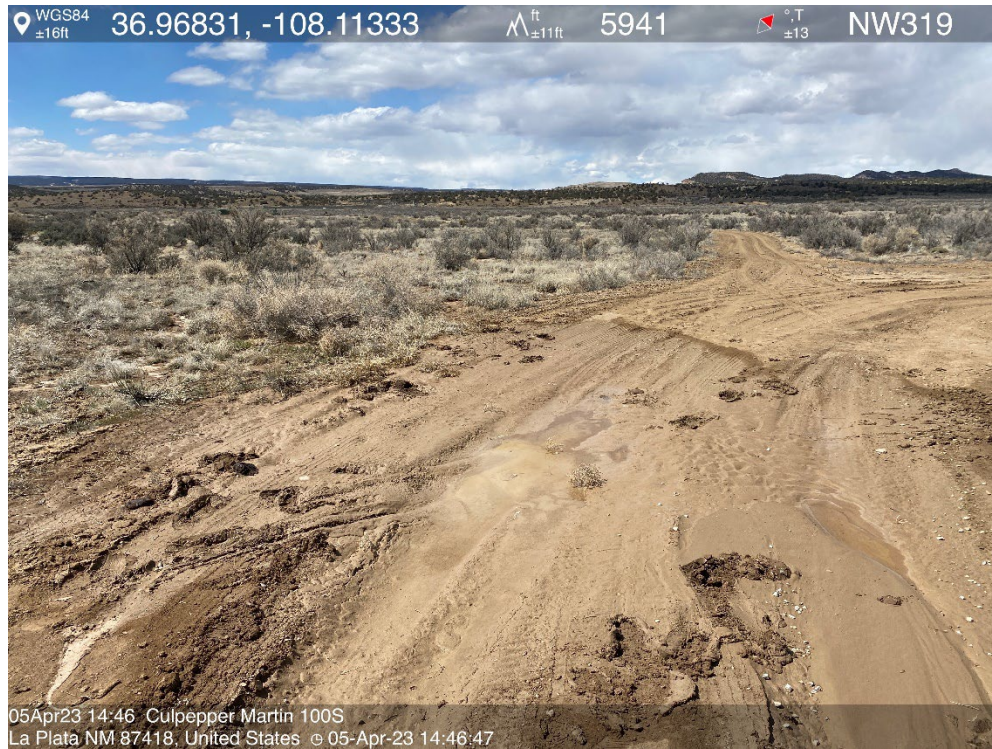
Photo 3: Area of pooling, 04/05/2023

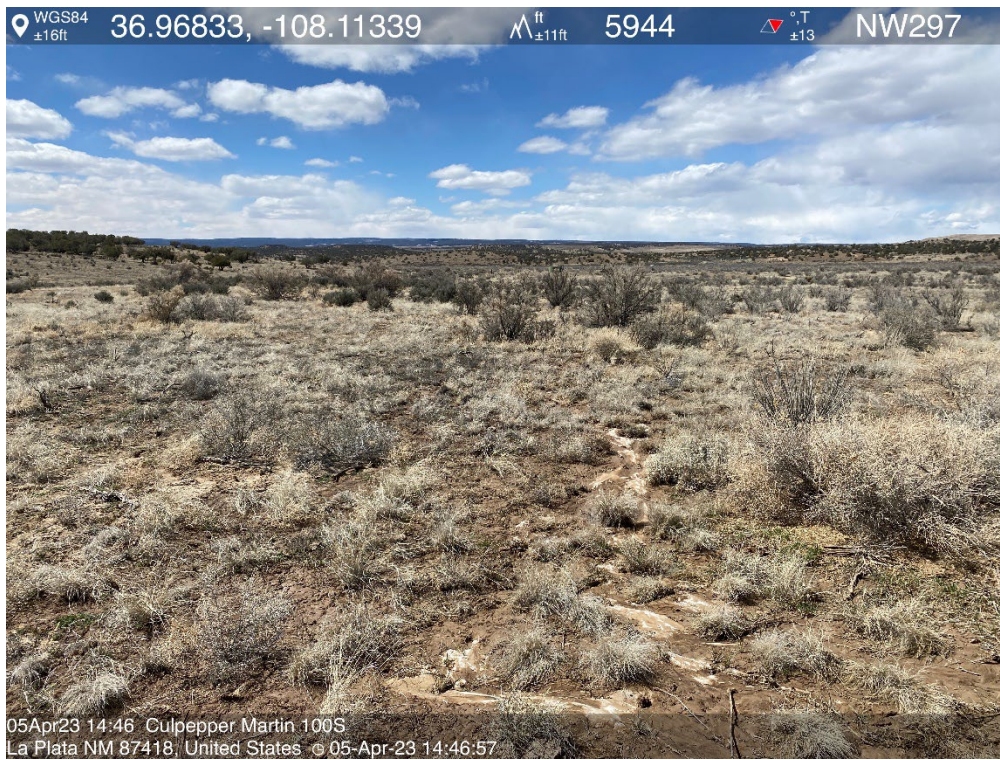
Photo 4: Spill path, 04/05/2023

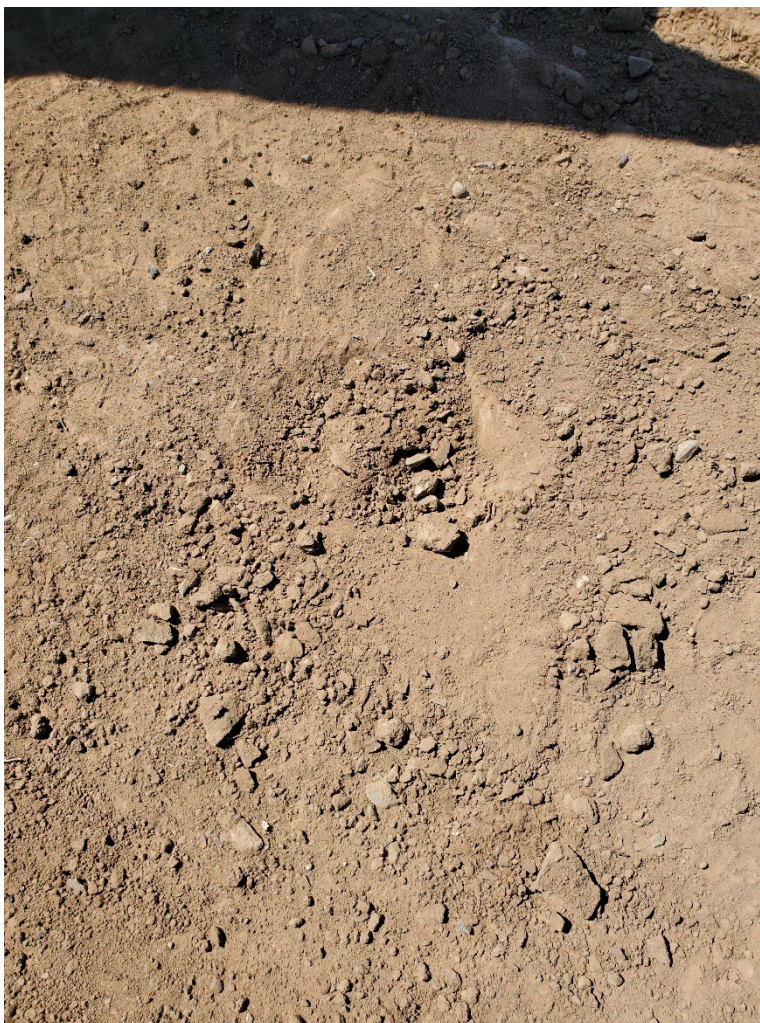
On April 24, 2023, AES provided notification of confirmation sampling to NMOCD and on April 27, 2023, AES collected one discrete grab sample from the surface at the release location.

Photo 5: Confirmation sampling at release location, 04/27/2023

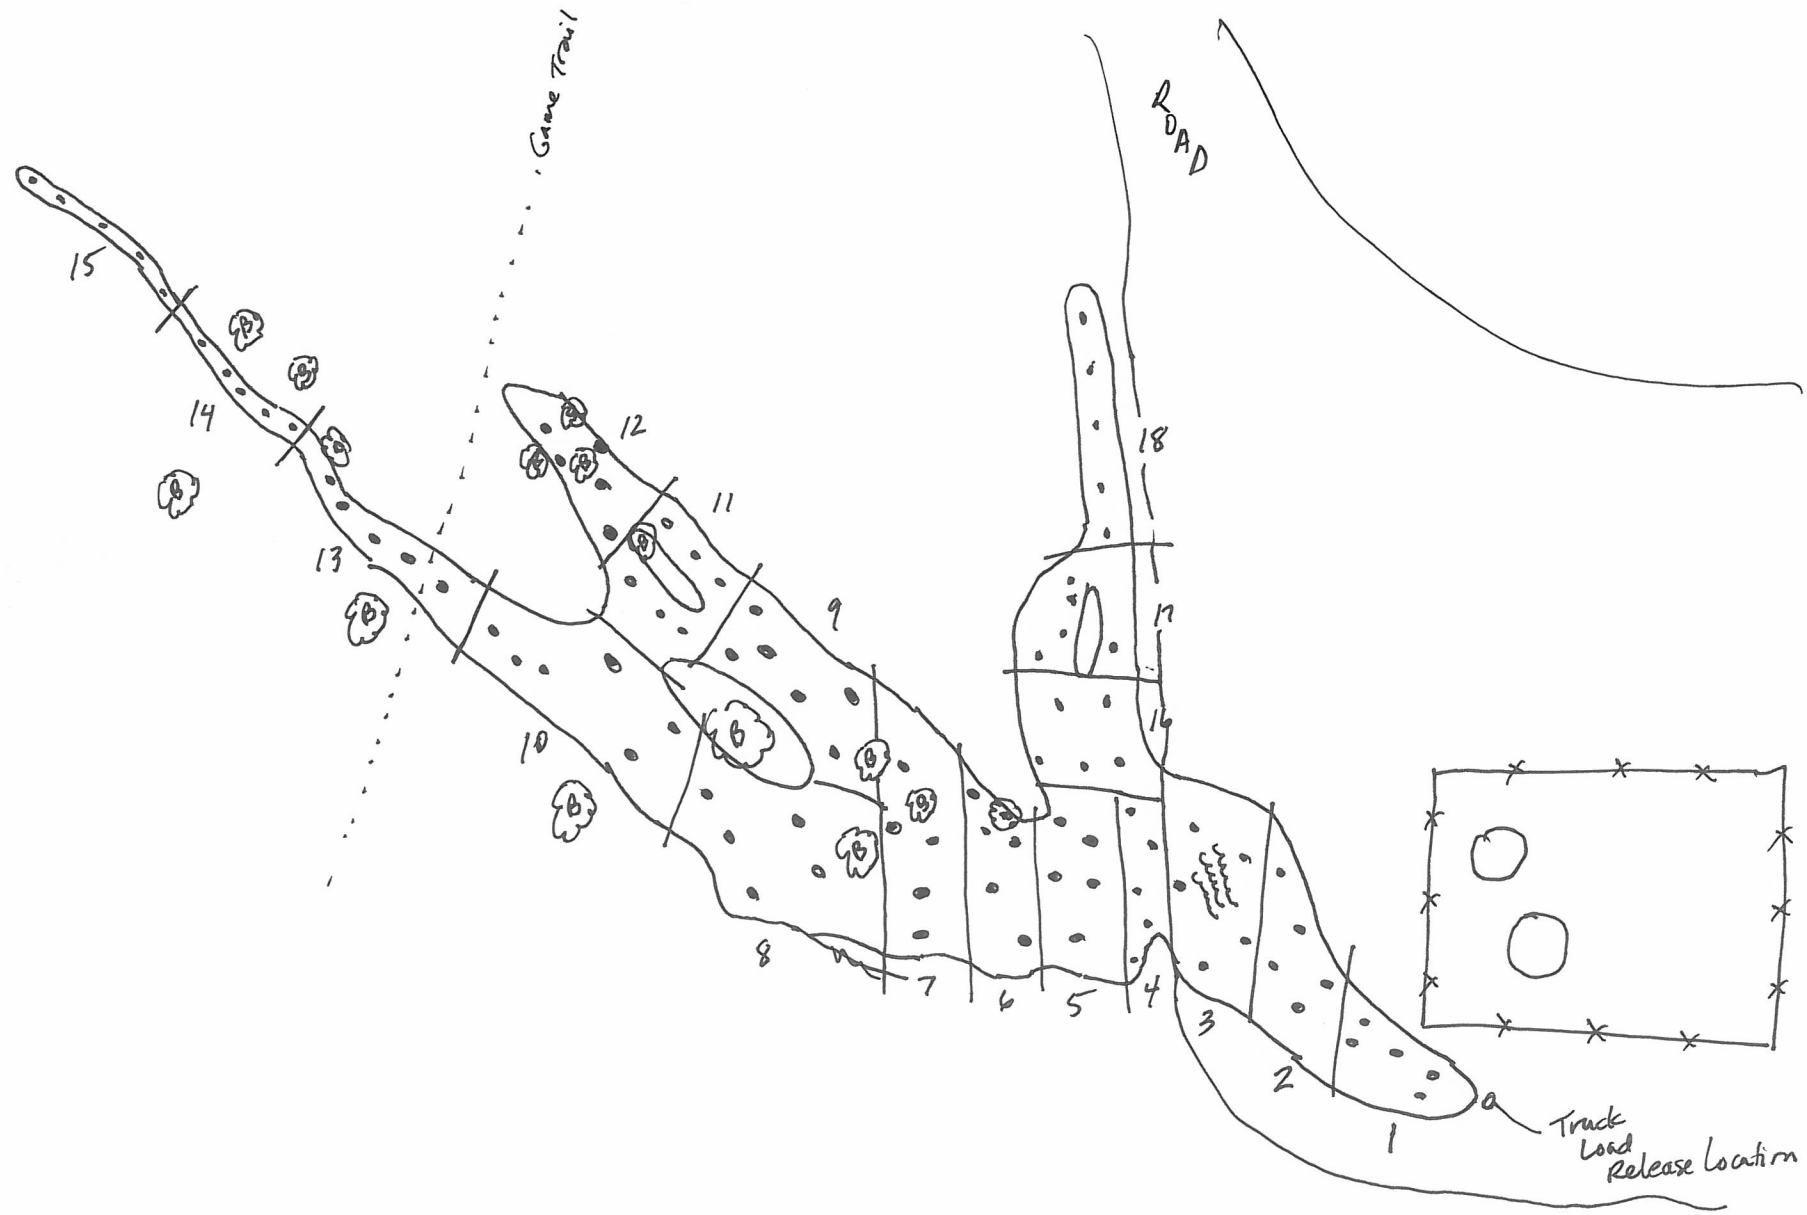
Sample Collection Location Sketch/Site Map:

Sample ID	Sample Date	Sample Time	Sample Depth	Sample Location	Composite (Y/N)	Sample Observations (Soil Type, PID, Impacted, etc.)	NO - No odor NS - No stain
SC-1	4-5-23	14:16	0.5	C release spot (AS)	Y 5pt	OVM = 0.0 ppm @ 14:24 Tan-Brown, Sand w/ clay, No odor, No stains	
SC-2		14:21		NW of RS		OVM = 0.0 ppm @ 14:35 Brown, Sand w/ clay, NO, NS	
SC-3		14:34		Large pool NW of SC-2		OVM = 0.0 ppm @ 14:45 Standing H <sub>2</sub> O Area. Brown, Sand w/ clay, NO, NS	
SC-4		14:59		off site		OVM = 0.0 ppm @ 15:10 Tan-Brown, Sand, NO, NS	
SC-5		15:04		See Map pg 3		OVM = 0.0 ppm @ 15:26 S.A.A	
SC-6		15:08		See Map pg 2		OVM = 0.0 ppm @ 15:27 <del>S.A.A</del> Tan-Brown, Sand, NO, NS, organics (Roots)	
SC-7		15:18				OVM = 0.0 ppm @ 15:44 SAA	
SC-8		15:28				OVM = 0.0 ppm @ 15:45 SAA	
SC-9		15:35			6pt	OVM = 0.0 ppm @ 16:00 SAA 6pt (lost track)	
SC-10		15:40				OVM = 0.0 ppm @ 16:01 SAA 6pt (lost track)	
SC-11		15:43			6pt	OVM = 0.0 ppm @ 16:02 SAA 6pt (lost track)

SC-12		15:51				OVM = 0.0 ppm @ 16:25 SAA	
SC-13		15:54				OVM = 0.0 ppm @ 16:27 SAA	
SC-14		15:57				OVM = 0.0 ppm @ 16:28 SAA	
SC-15		16:10				OVM = 0.0 ppm @ 16:28 C end of Main flow SAA	
SC-16		16:16		Along Road		OVM = 0.0 ppm @ 16:29 SAA	
SC-17		16:19		Along Road		OVM = 0.0 ppm @ 16:30 SAA	
SC-18		16:22		Along Road		OVM = 0.0 ppm @ 16:31 C end of small flow SAA
