## **SITE REMEDIATION AND CLOSURE REPORT**

**JOHN AGU #1 BATTERY  
UNIT C, SECTION 14, TOWNSHIP 20S, RANGE 24E  
EDDY COUNTY, NEW MEXICO  
32.57897, -104.56104  
RANGER REFERENCE NO. 5375**

**SITE REMEDIATION AND CLOSURE REPORT  
JOHN AGU #1 BATTERY  
UNIT C, SECTION 14, TOWNSHIP 20S, RANGE 24E  
EDDY COUNTY, NEW MEXICO  
32.57897, -104.56104  
RANGER REFERENCE NO. 5375**

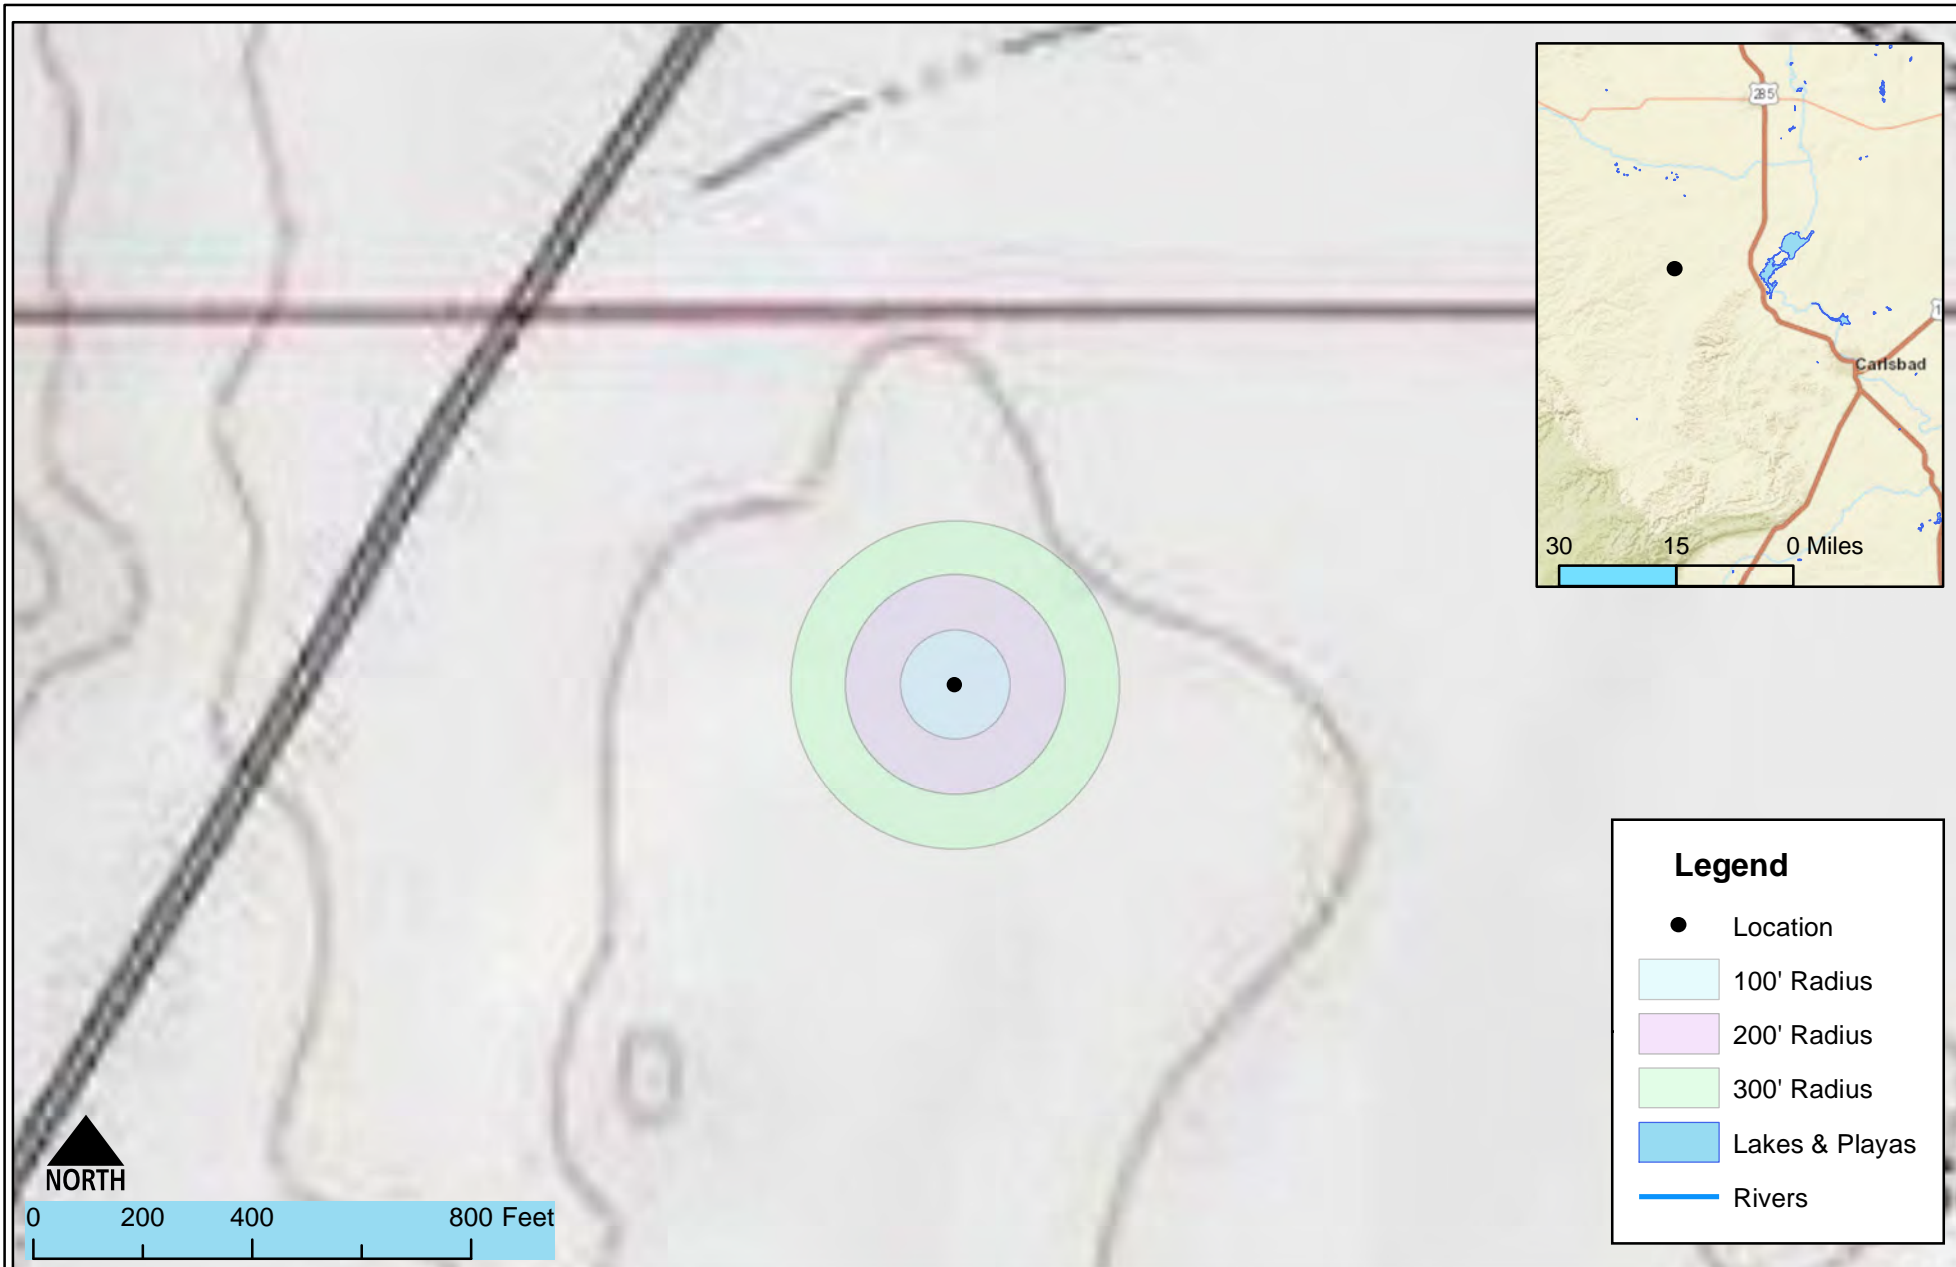
Figure 2

Surface Water Map  
 John AGU #1 Battery - EOG Resources  
 Sec. 14, T20S, R24E Eddy County, New Mexico

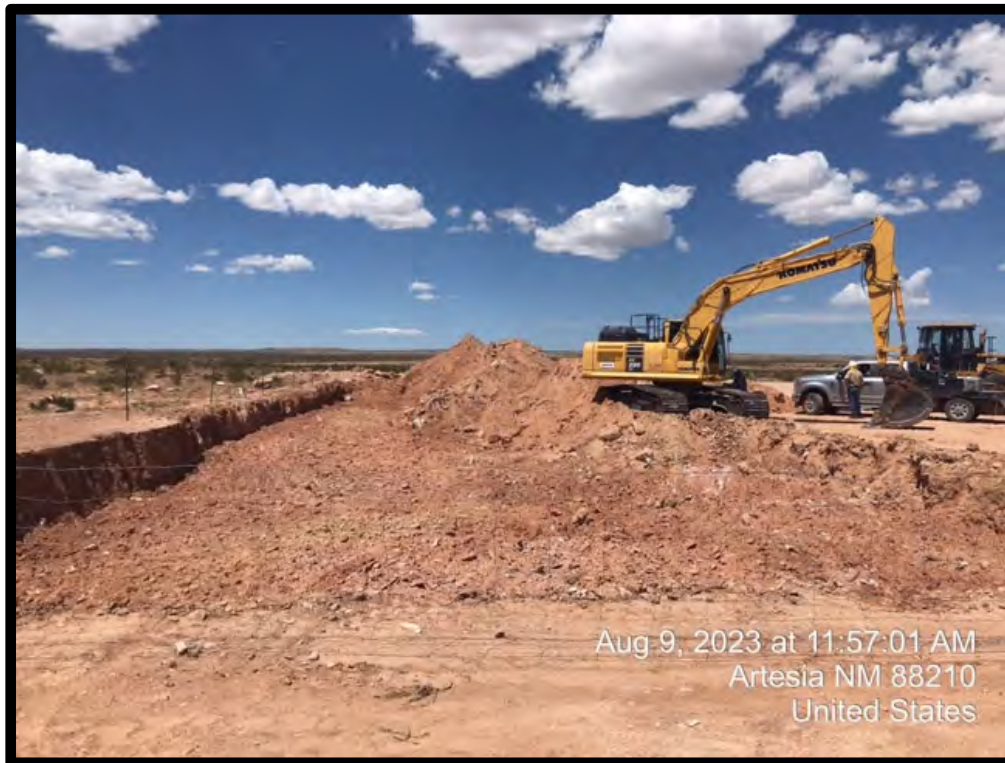
**PHOTOGRAPH NO. 1 – A view of the Site during the remedial excavation activities in. The view is towards the west.**

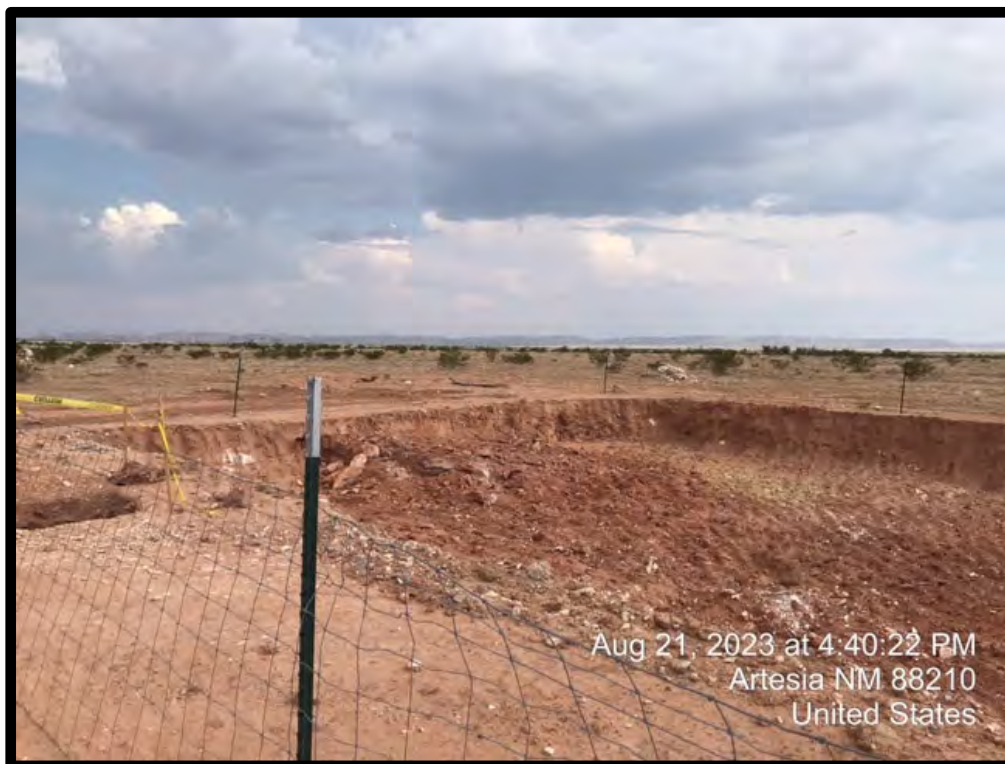
**PHOTOGRAPH NO. 2 – A view of the eastern excavation area where due to the encountered lithology, excavation was limited to a depth of one foot below ground surface. The view is towards the southeast.**

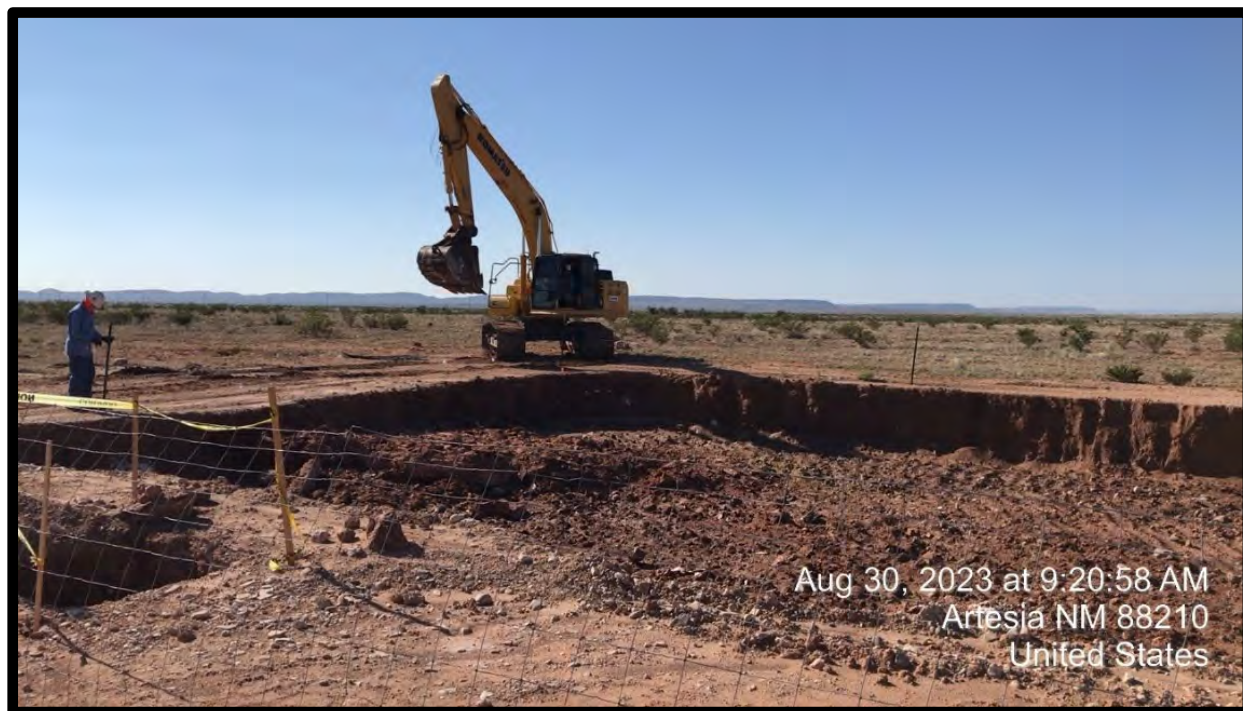
**PHOTOGRAPH NO. 3 – A view of the over-excavation activities in the “W-6” sample area on August 30, 2023. The view is towards the southeast. excavated area during the August 4, 2022 confirmation sampling activities. The view is towards the northeast.**  
(Approximate GPS: 32.579054, -104.560912)

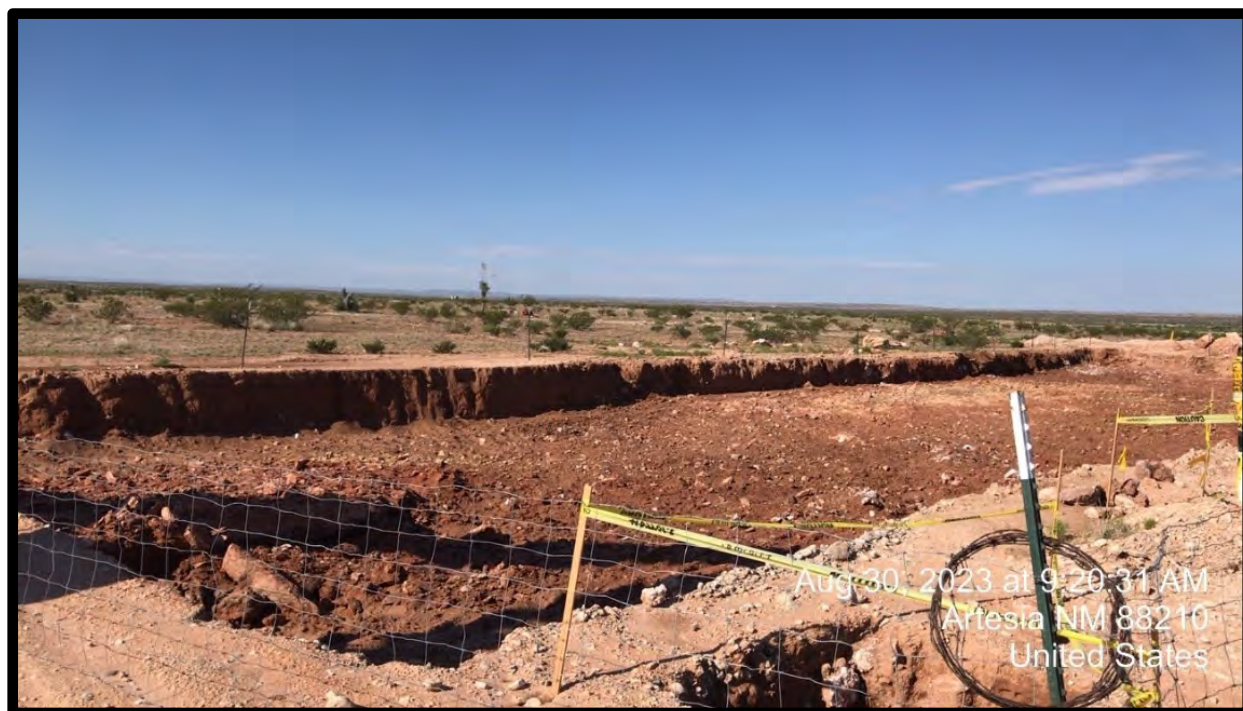
**PHOTOGRAPH NO. 4 – A view of final excavation extent on August 30, 2023. The view is towards the southwest.**

The final extent of the excavation was noted to have maximum dimensions of approximately 210 feet by 58 feet. A *Site Map* depicting the final excavation boundaries and the extent of the installed liner is attached.
