Release Notification

Re: Remediation Report and Closure Request

Culpepper Martin 103
San Juan County, New Mexico
Hilcorp Energy Company
NMOCD Incident Number: nAPP2312345903

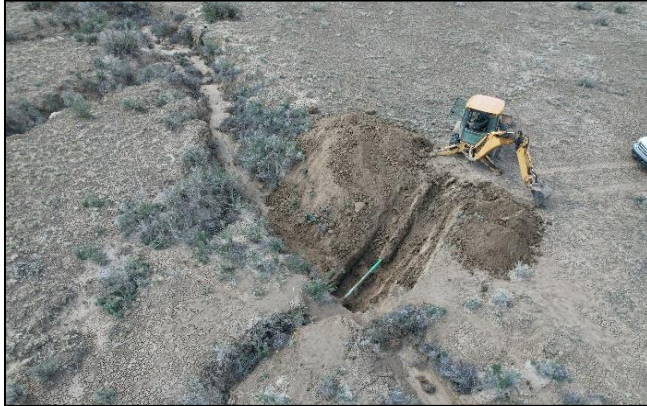
Photograph: 1 Date: 5/4/2023
Description: Excavation around pipeline and wash
View: Southwest

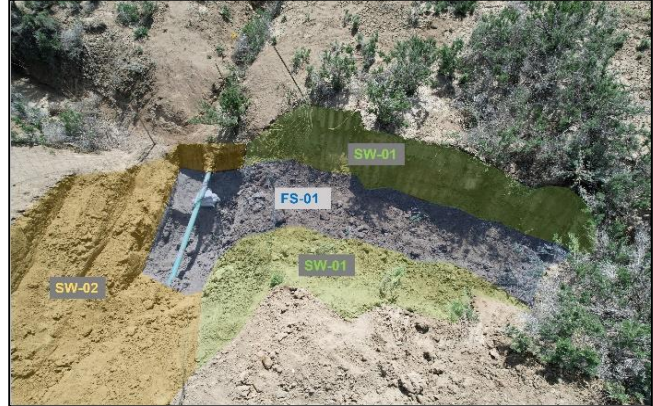
Photograph: 2 Date: 5/16/2023
Description: Sample locations
View: Drone photograph from above

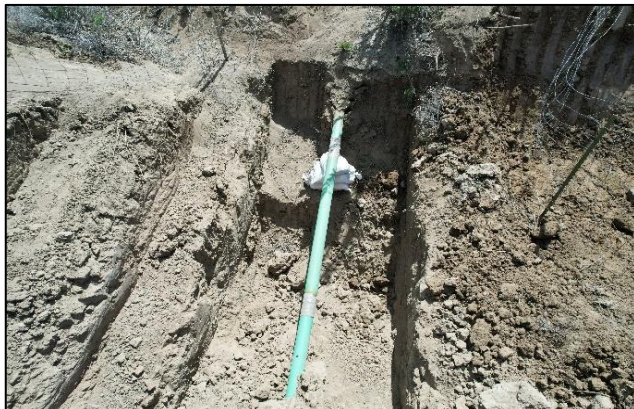
Photograph: 3 Date: 5/16/2023
Description: Excavation around pipeline
View: East

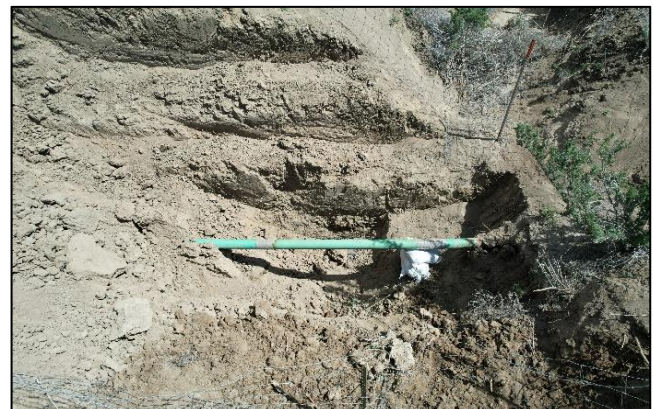
Photograph: 4 Date: 5/16/2023
Description: Pipeline and north wall
View: North
