## Closure Report

Pickard State 002H  
Lea County, New Mexico  
API ID # 30-025-41614  
**Incident #** NTO1419030269

Subject: **Closure Report**  
Pickard State 002H  
Lea County, New Mexico  
API ID # 30-025-41614  
Incident # NTO1419030269

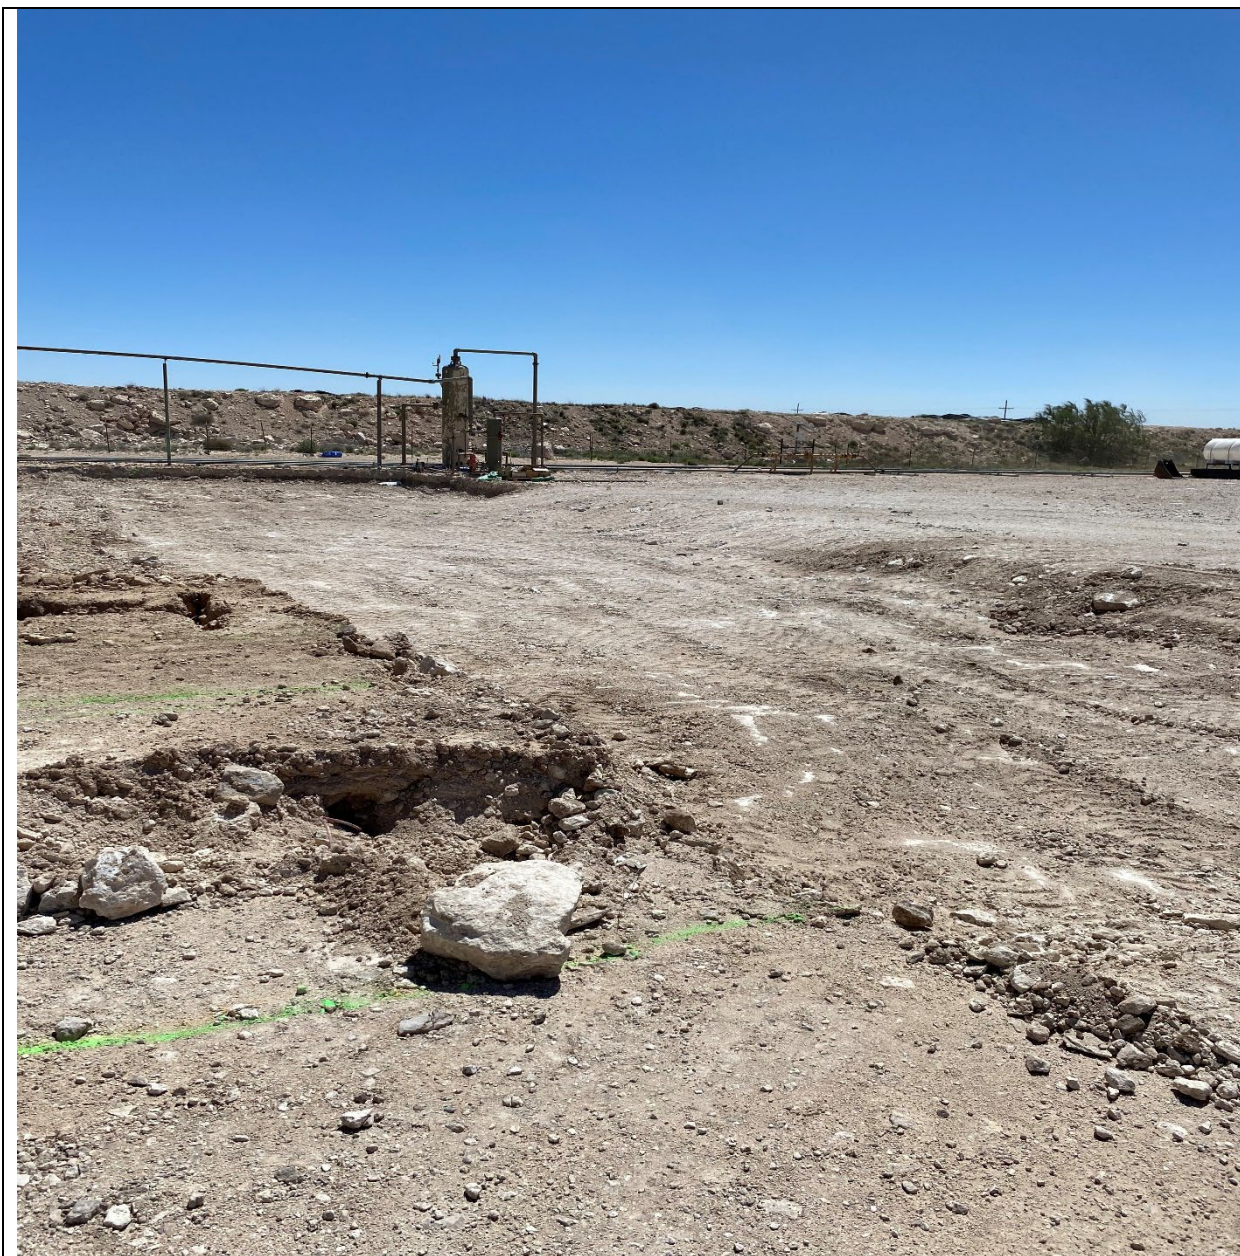
<b>Photograph No.1</b> <b>Description:</b>	Pickard Excavation.
---	---------------------

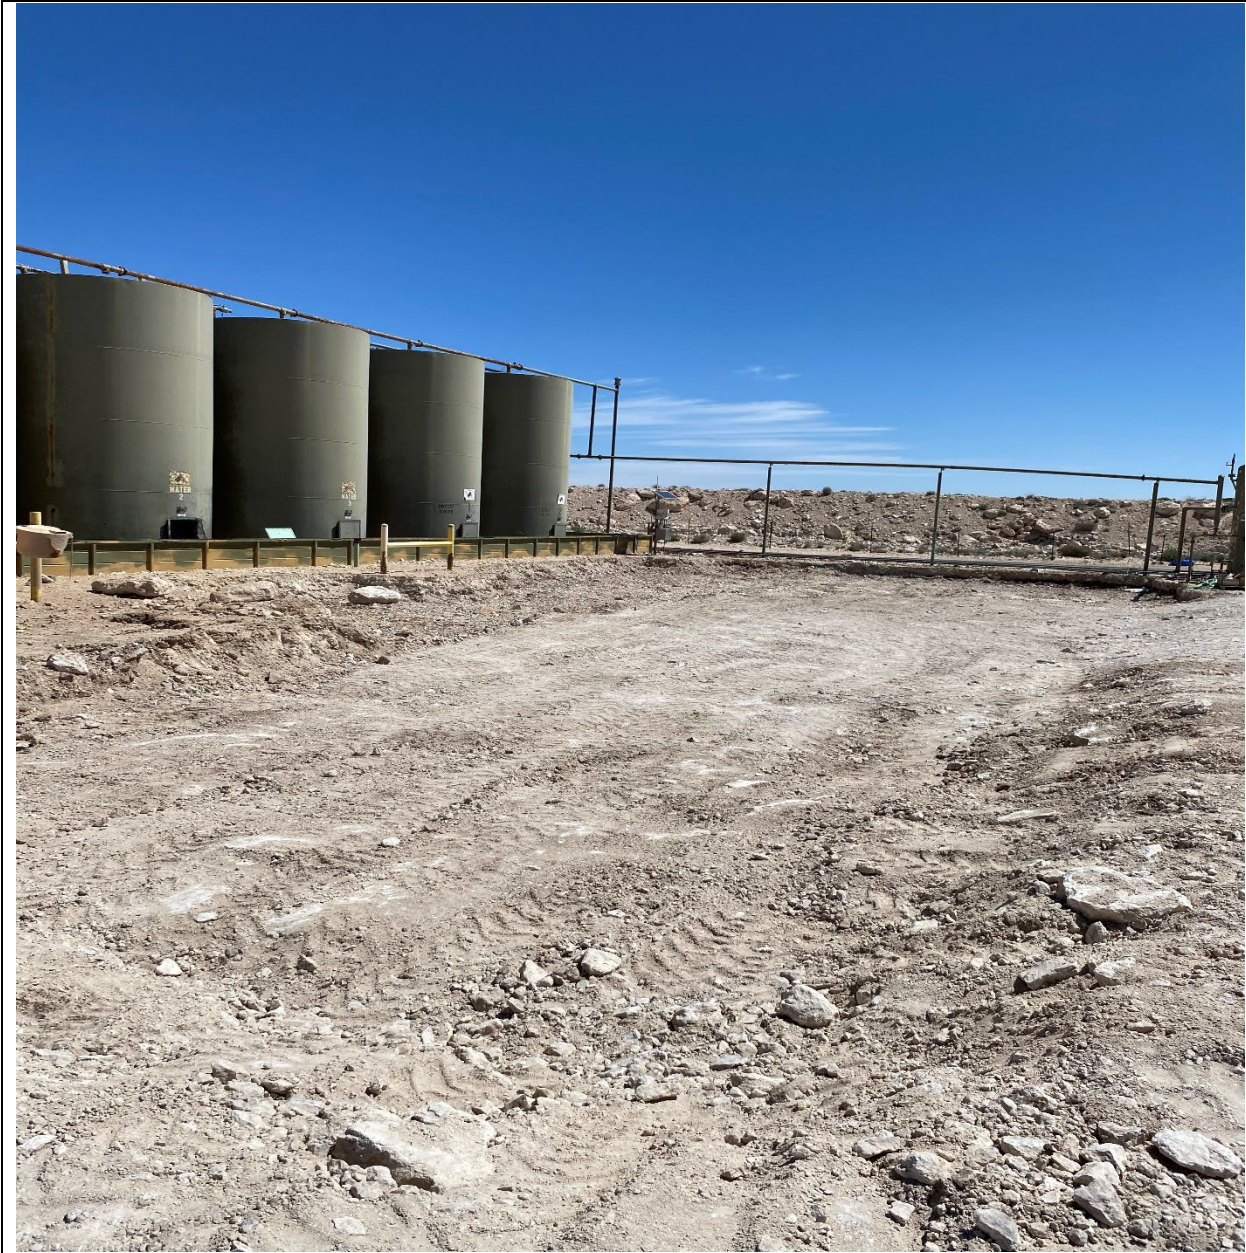
<b>Photograph No.2</b> <b>Description:</b>	Pickard Excavation.
---	---------------------

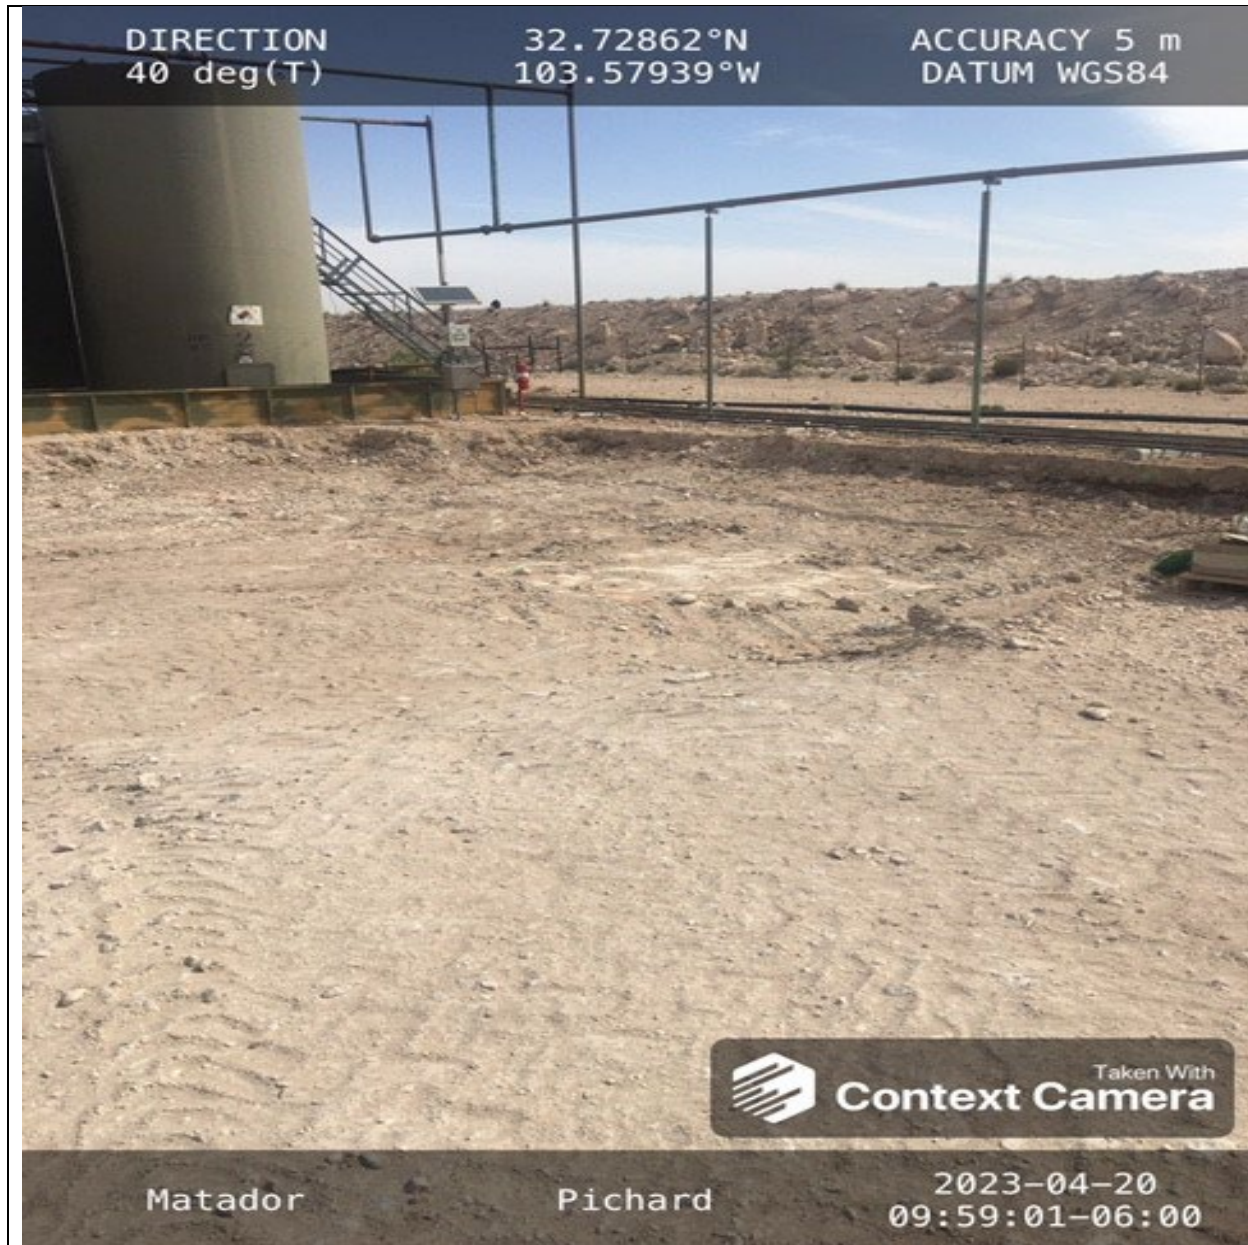
**Photograph No.4**  
**Description:**

Pickard Excavation.
