# **LINER INSPECTION AND CLOSURE REPORT**

## **REPORTABLE RELEASE**

**Spur Energy Partners**  
Oakmont 11-10 St Com TB  
Incident ID: nAPP2302728147  
Eddy County, NM

This report was prepared by Paragon Environmental LLC (Paragon) in response to the release for Spur Energy Partners (Spur) at the **Oakmont 11-10 St Com TB (Oakmont)**.

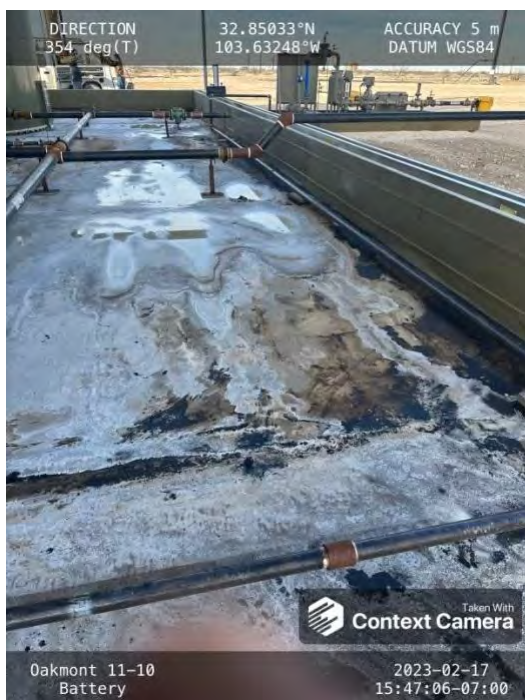
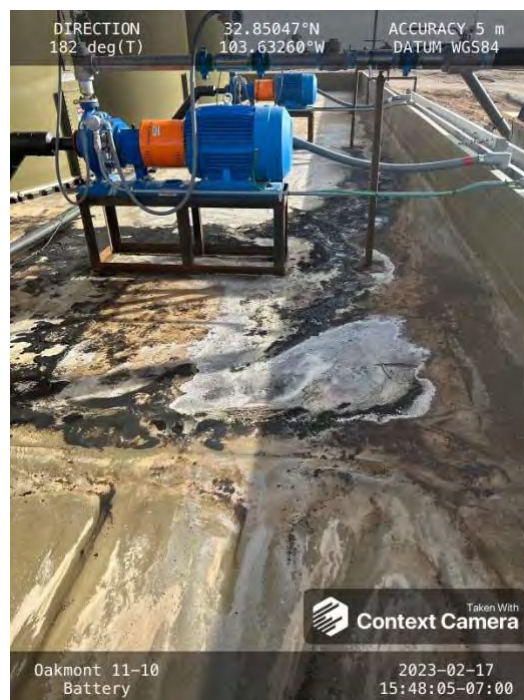
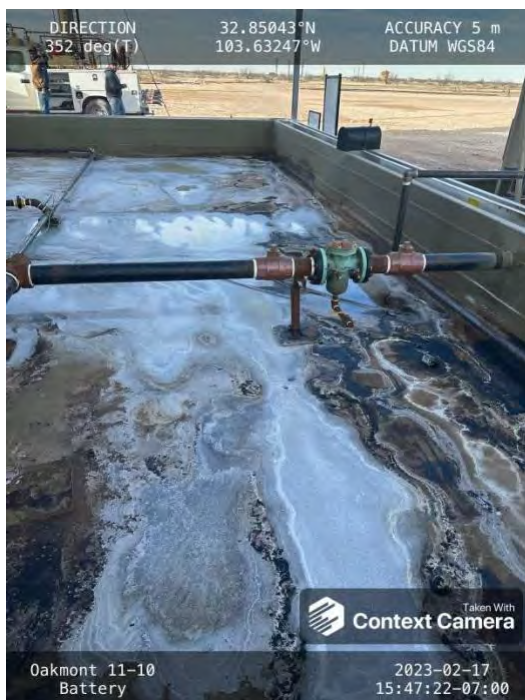
### Before Remediation

This release was due to equipment failure. The PLC power issues caused a water tank to overflow. This resulted in the release of 207 bbls of produced water in the Lined Containment. A vacuum truck was dispatched and recovered 165 bbls of the fluids.

On February 17, 2023, Paragon went to the site and conducted a liner inspection. A 48-hour notification was sent to the NMOCD on February 15, 2023. The liner inspection concluded that the liner's integrity was intact and in good condition however, there was a large spill covering up the liner. See Appendix D for the email notification and liner report.

On February 20, 2023, Paragon returned to the site with equipment and personnel to conduct cleanup activities. We initially sprayed the affected area with a degreaser. We then power washed and squeegeed the runoff to where the vacuum truck could capture the fluids.

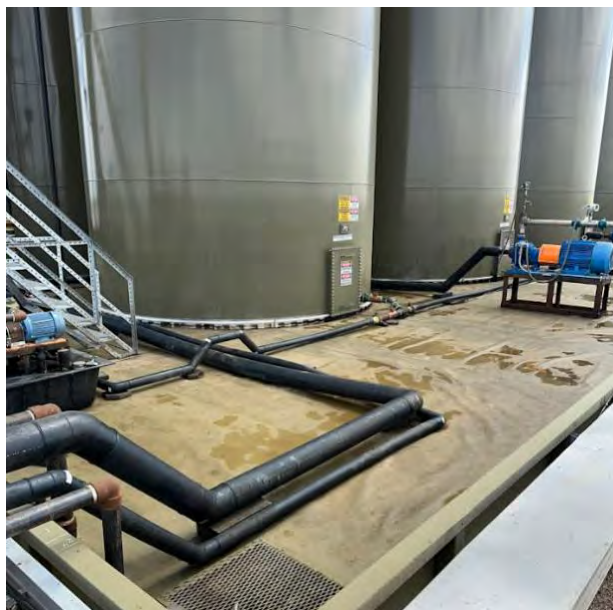
Post Remediation

On June 29, 2023, Paragon returned to the site to conduct a liner inspection. A 48-hour notification was sent to the NMOCD on June 26, 2023. The liner inspection concluded that the liner's integrity was intact and in good condition. The liner is clean and appears to have the ability to contain spills. See Appendix D for the email notification and liner report.

Visualization	Yes	No	Comments
Is there a tear in the liner?		x	
Are there holes in the liner?		x	
Is the liner retaining any fluids?		x	
Does the liner have integrity to contain a leak?	x
