Bond Lease

Site Assessment – Characterization & Remediation Plan

Lea County, New Mexico

Bond Lease – Site Assessment – Characterization & Remediation Plan**2023****1.0 FACILITY OR SPILL SITE CHARACTERIZATION**

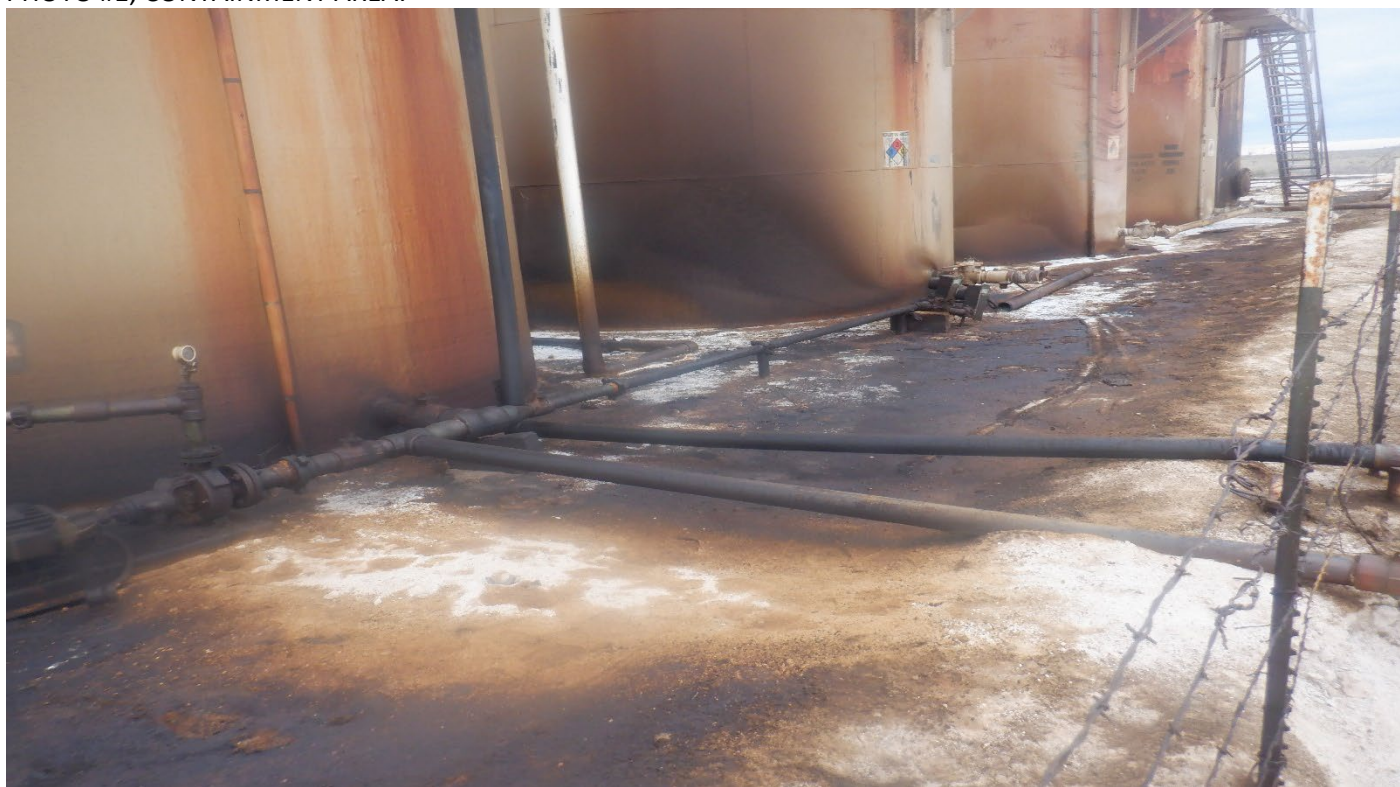
PHOTO #1; CONTAINMENT AREA:

On March 7, 2023, COMM Engineering conducted an initial site assessment. The inspector found oil and chloride spillage immediately south and southeast of the containment area, with light oil spray to the east and southeast. There was also oil and chloride spillage throughout the containment area, around the gun-barrel and storage tanks.

- Utilizing heavy equipment and labor to excavate and remove the contaminated soil from the area south and southeast of the release point.
- Scrap and remove the surface oil spray in all areas impacted by wind-blown oil spillage.

- Use said heavy equipment to excavate where possible within containment and utilize manual labor to dig and remove contaminated soil from around the storage tanks and flow lines within containment.

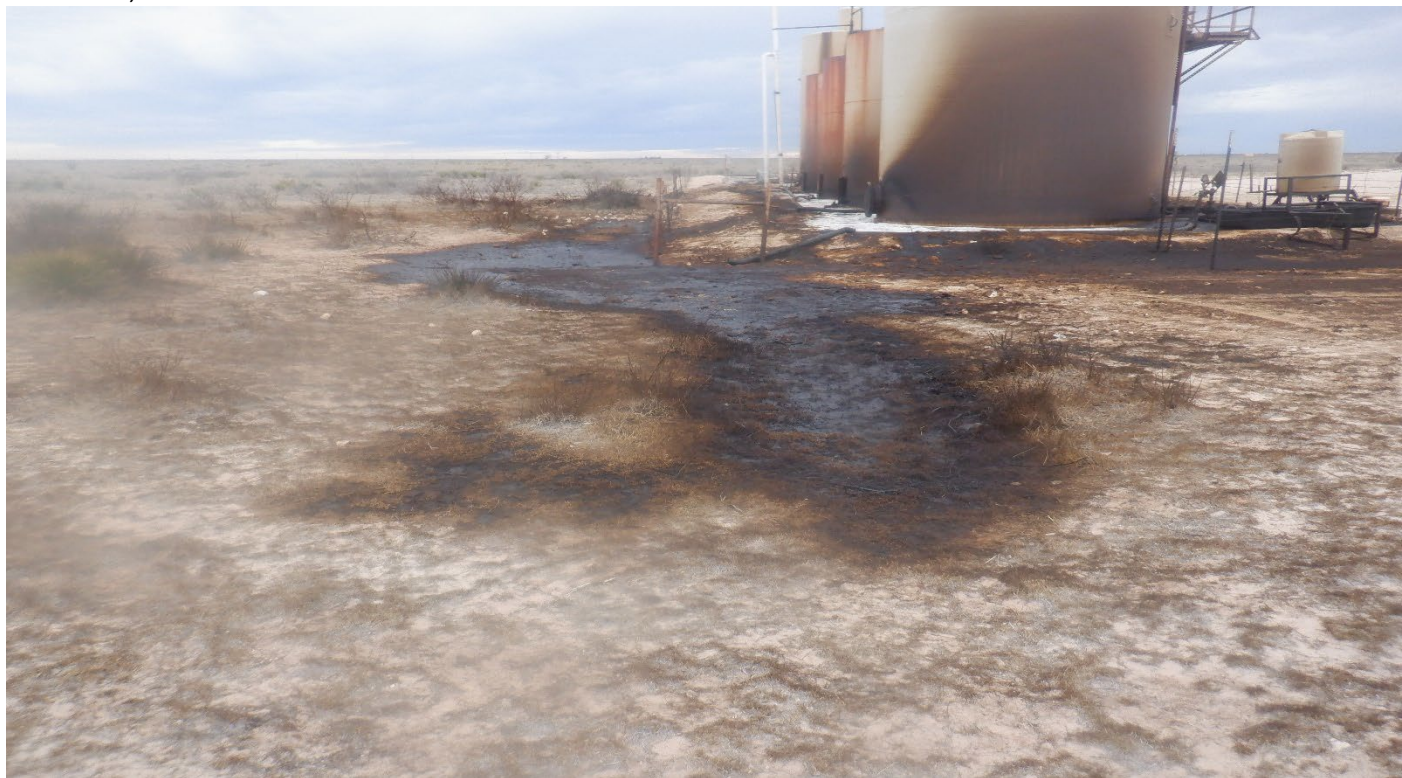
PHOTO #2; OUTSIDE THE CONTAINMENT AREA:

Along with the spill within containment, oil and produced water flowed over the southeast corner of the containment system and pooled outside the southeast corner, and flowed east for 90 feet. (See Photo #2)

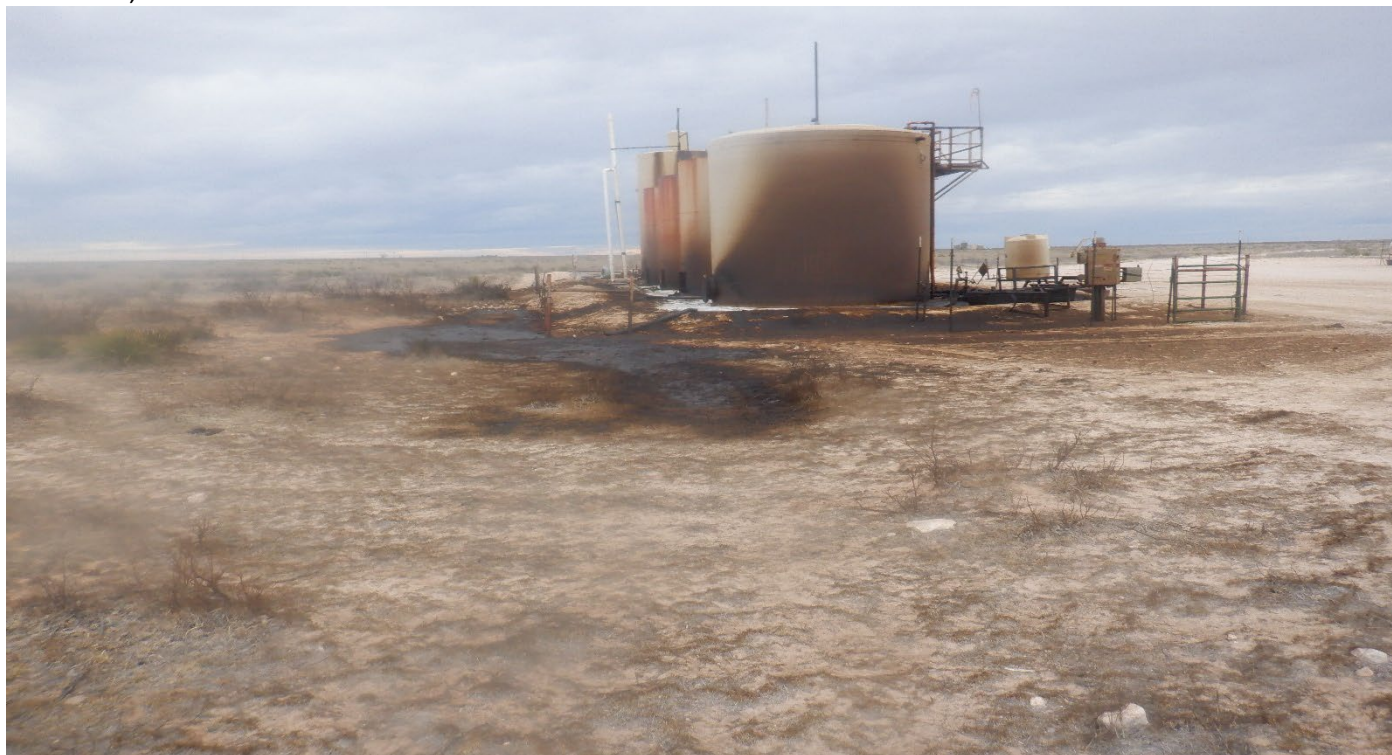
PHOTO #3; LIGHT OIL SPRAY OUTSIDE THE CONTAINMENT AREA:

Also, due to high winds on the day of the spill, light oil and produced water sprayed in various directions up to 150-feet from the initial spill release area. (See Photo #3)

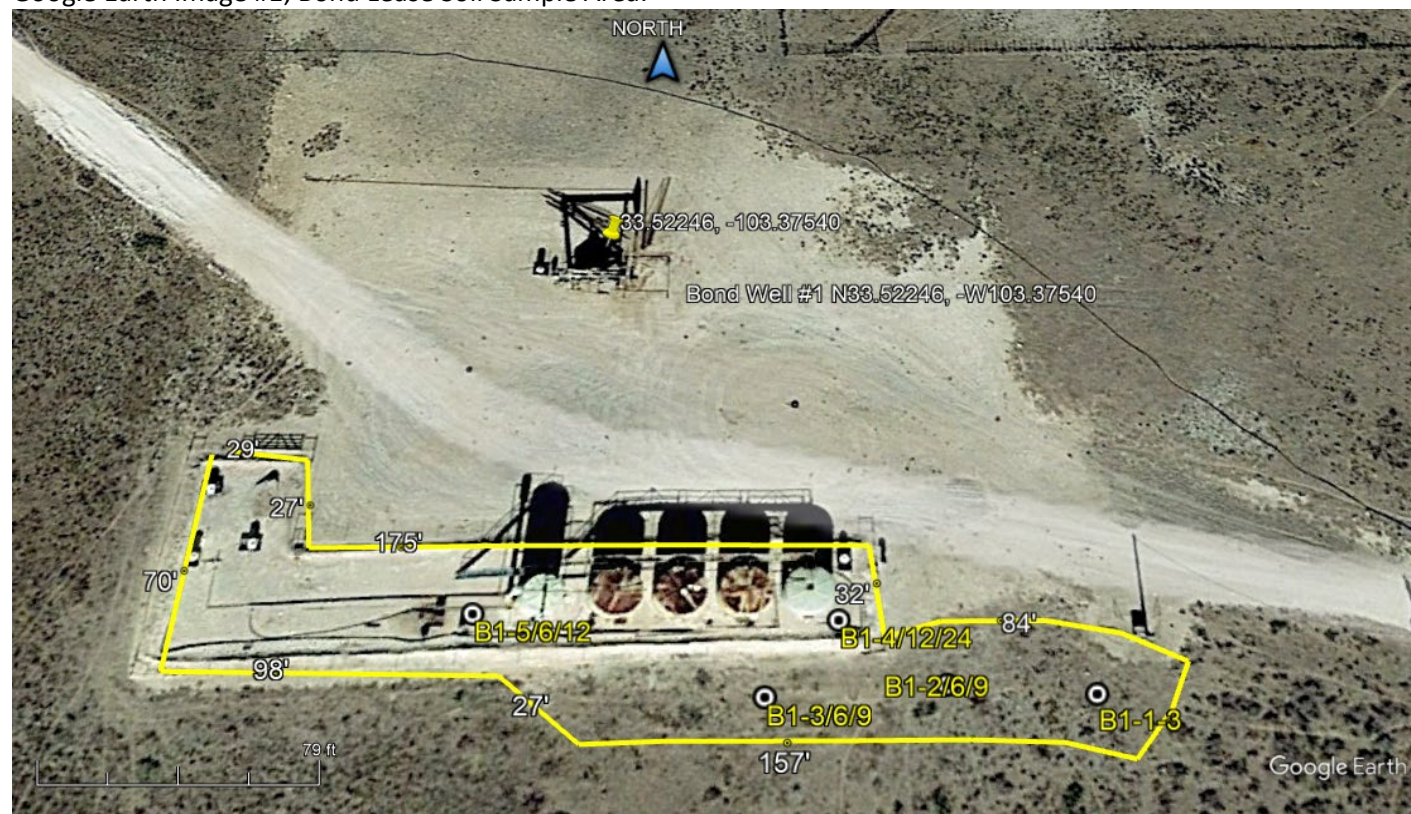
Google Earth Image #1; Bond Lease Soil Sample Area:

After inspecting the degree of spillage, a series of hand-augured soil bores were completed (B1-1-03 to B1-5-12) within the release spill areas. There were (9) samples collected and taken to Cardinal Labs in Hobbs, New Mexico, for analytical testing.

TEST BORE #	TEST BORE DEPTH	GPS LOCATION N	GPS LOCATION W
B1-1-3	3-Inches	33.522005	103.374911
B1-2-6	6-Inches	33.522012	103.375053
B1-2-9	9-Inches	33.522012	103.375053
B1-3-6	6-Inches	33.522	103.375226
B1-3-9	9-Inches	33.522	103.375226
B1-4-12	12-Inches	33.522065	103.375153
B1-4-24	24-Inches	33.522065	103.375153
B1-5-6	6-Inches	33.522070	103.375507
B1-5-12	12-Inches	33.522070	103.375507
