Incident ID	nAPP2311029101
District RP	
Facility ID	
Application ID

## Site Assessment/Characterization

Based on laboratory analytical results and field activities conducted to date, Etech recommends Mewbourne Oil Company provide copies of this *Remediation Summary & Soil Closure Request* to the appropriate agencies and request closure be granted to the Antelope release site.

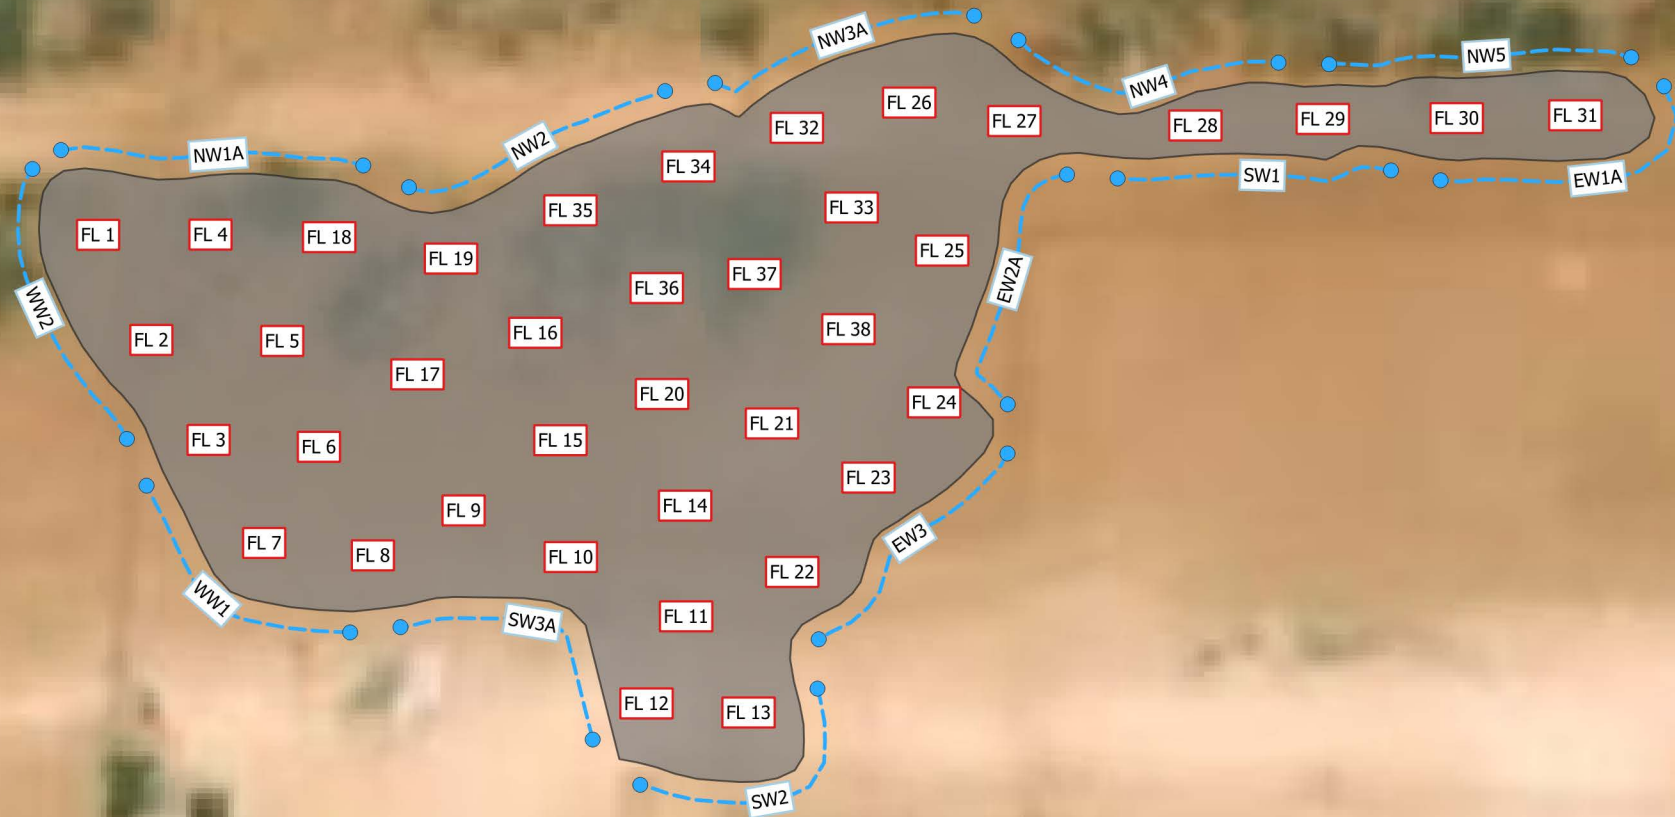
## **Figure 3**

### **Site & Sample Location Map**

- Excavation Extent
- Composite Floor Sample
- Composite Wall Sample

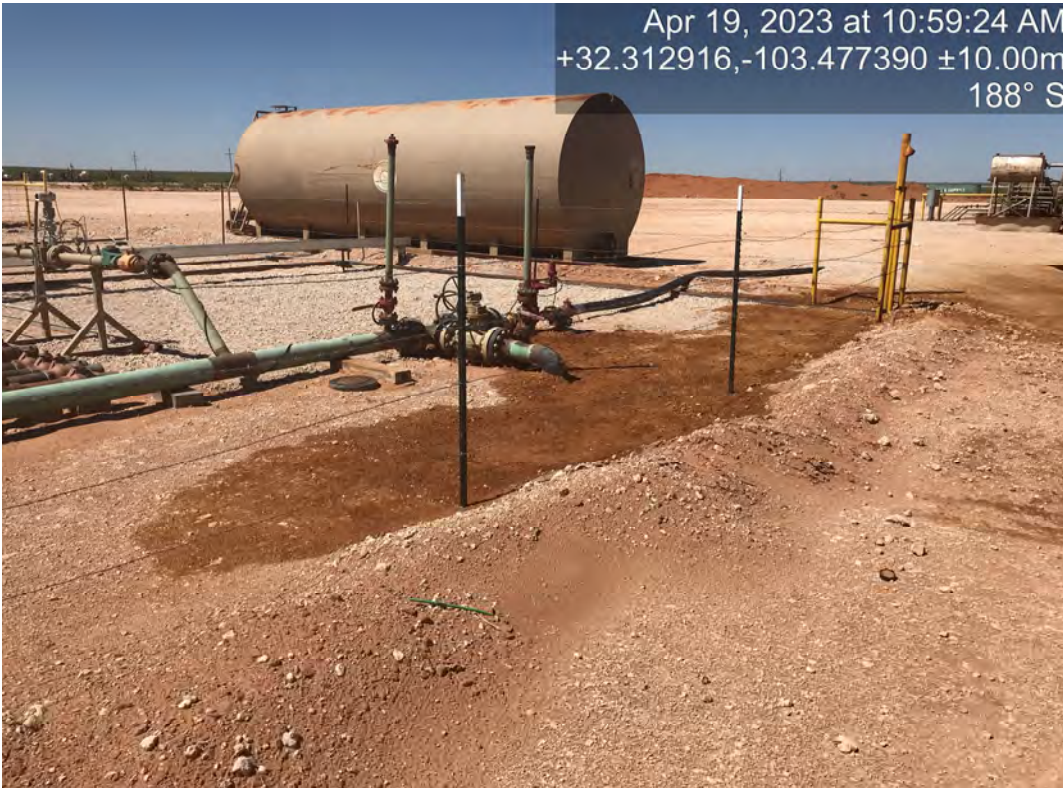
<b>Photo Number:</b> 1

<p>Apr 19, 2023 at 10:59:24 AM +32.312916,-103.477390 ±10.00m 188° S</p>
<b>Photo Direction:</b> South	
<b>Photo Description:</b>  View of the affected area.

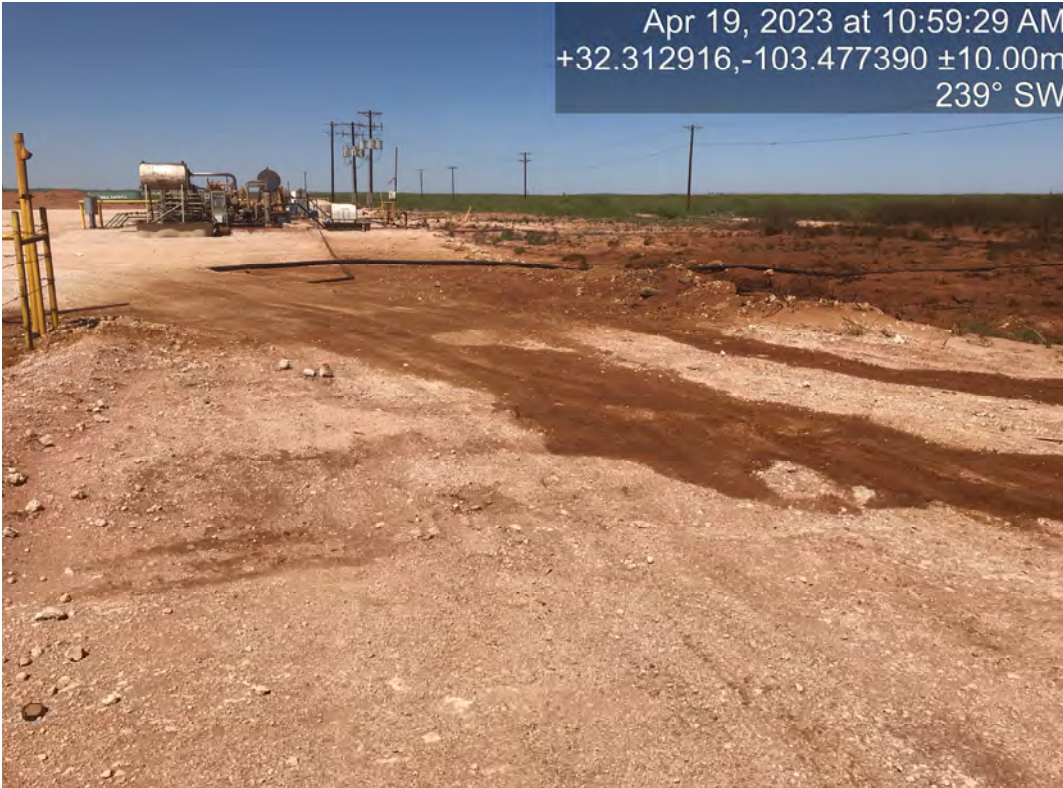
<b>Photo Number:</b> 2

<p>Apr 19, 2023 at 10:59:29 AM +32.312916,-103.477390 ±10.00m 239° SW</p>
<b>Photo Direction:</b> Southwest	
<b>Photo Description:</b>  View of the affected area.

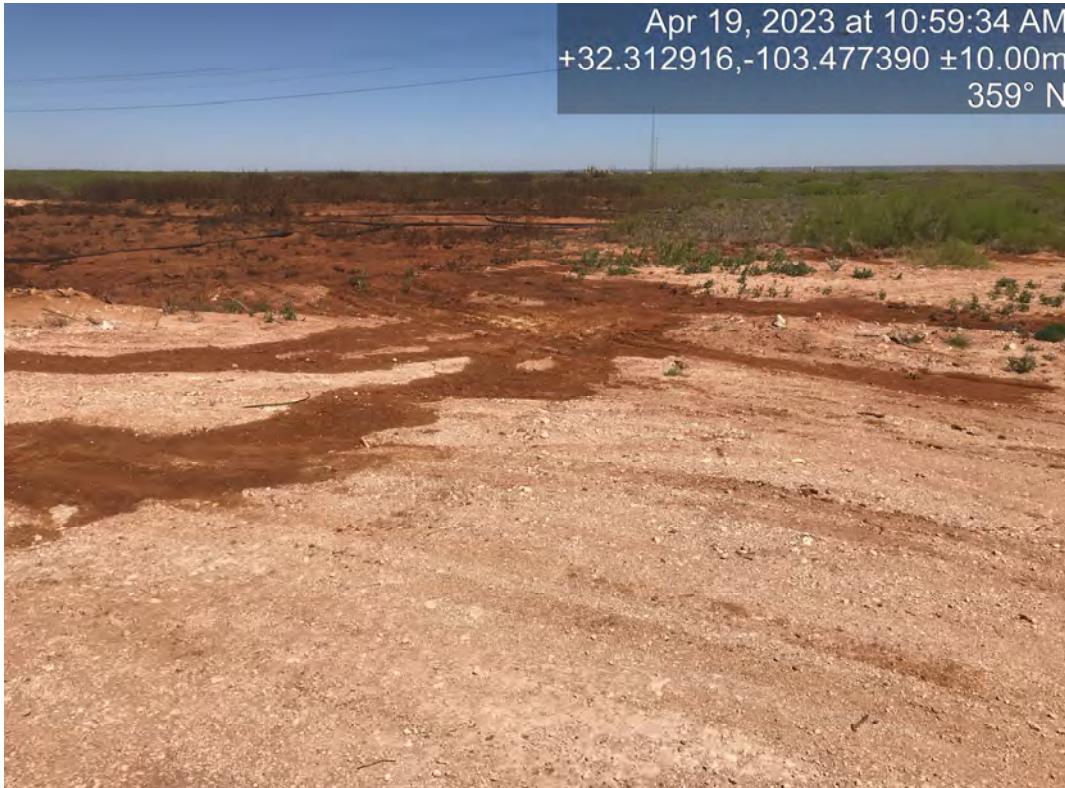
<b>Photo Number:</b> 3

<b>Photo Direction:</b> North	
<b>Photo Description:</b>  View of the affected area.

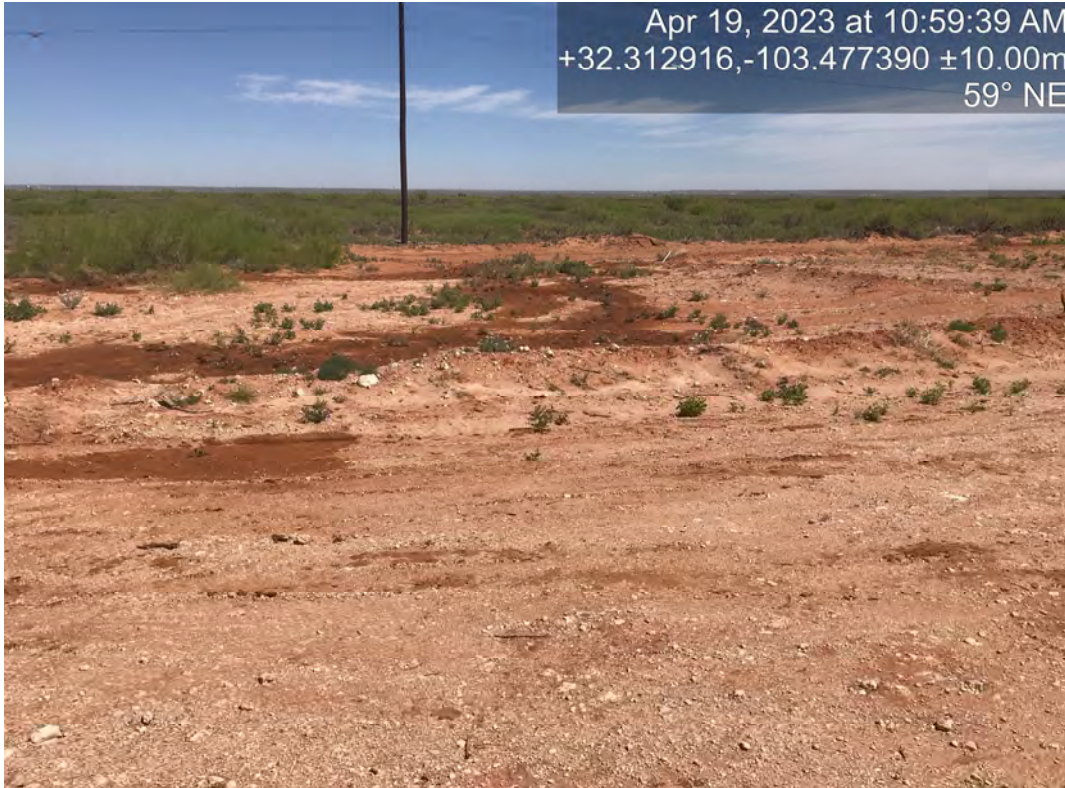
<b>Photo Number:</b> 4

<b>Photo Direction:</b> Northeast	
<b>Photo Description:</b>  View of the affected area.

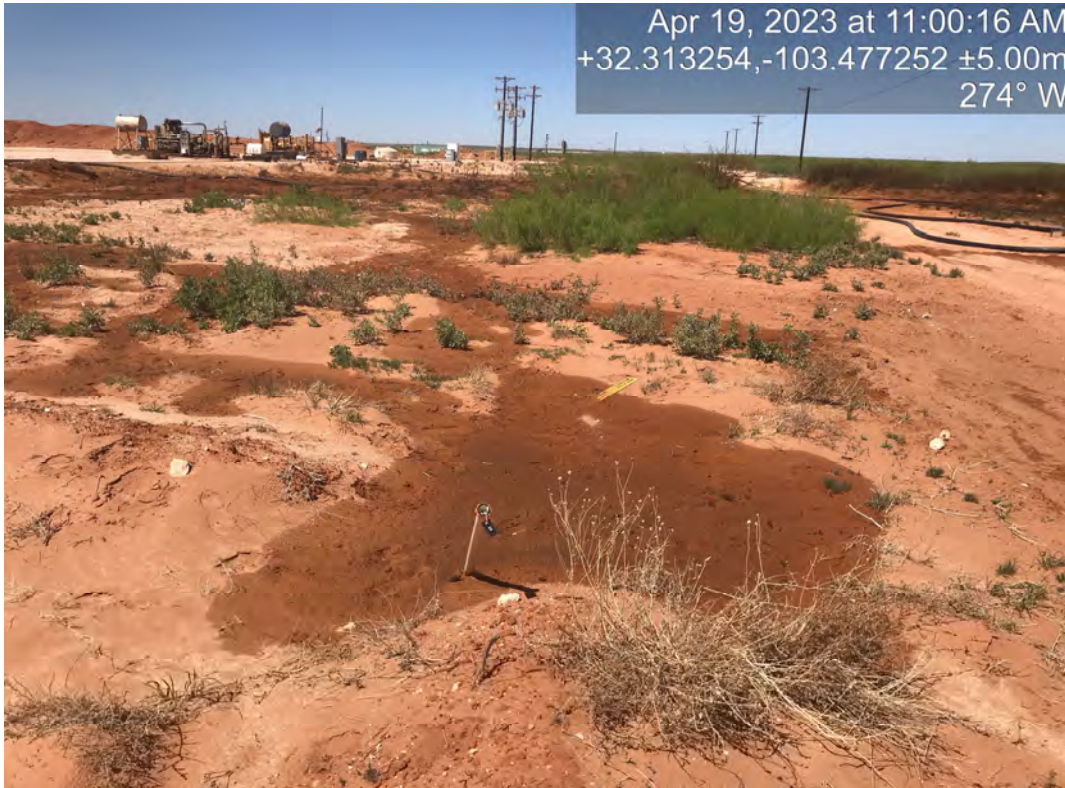
<b>Photo Number:</b> 5

<b>Photo Direction:</b> West	
<b>Photo Description:</b>  View of the affected area.

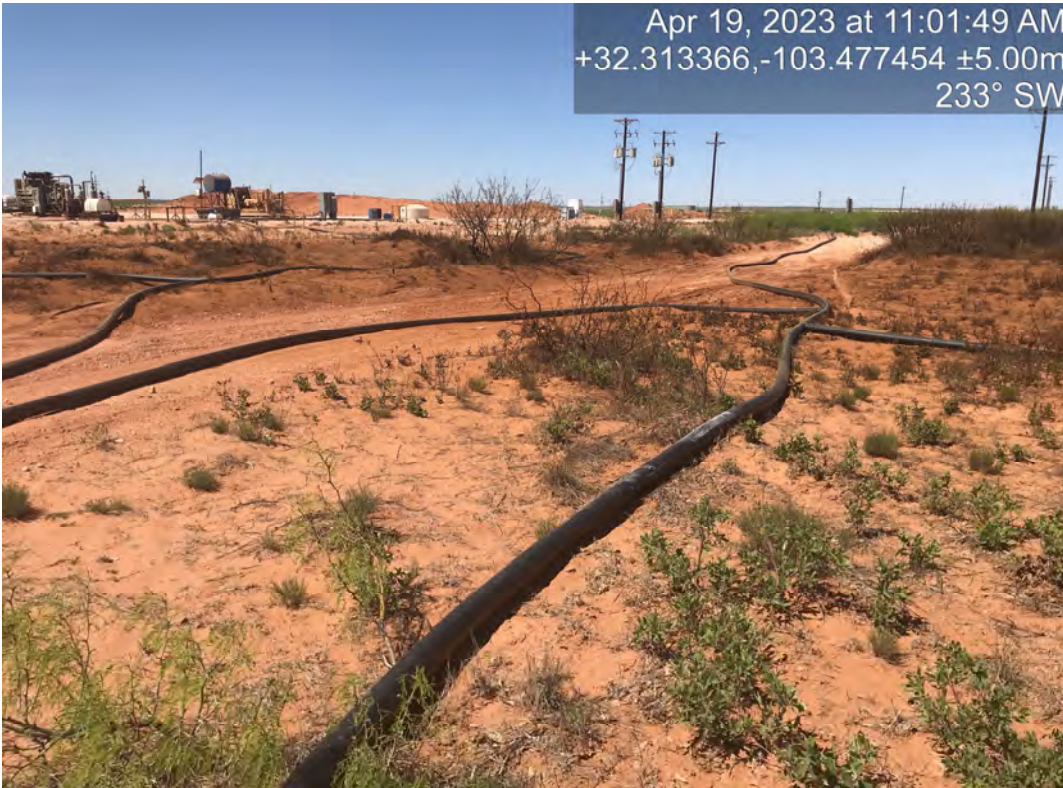
<b>Photo Number:</b> 7

<b>Photo Direction:</b> Southwest	
<b>Photo Description:</b>  View of the affected area.

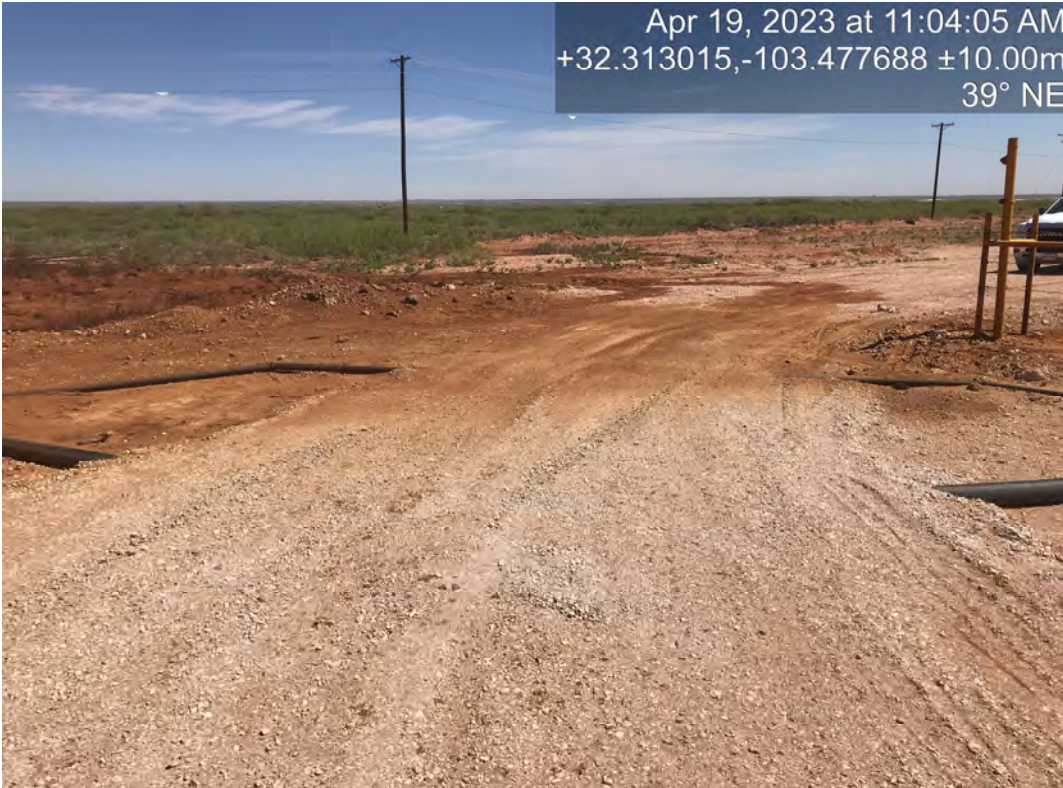
<b>Photo Number:</b> 8

<b>Photo Direction:</b> Northeast	
<b>Photo Description:</b>  View of the affected area.

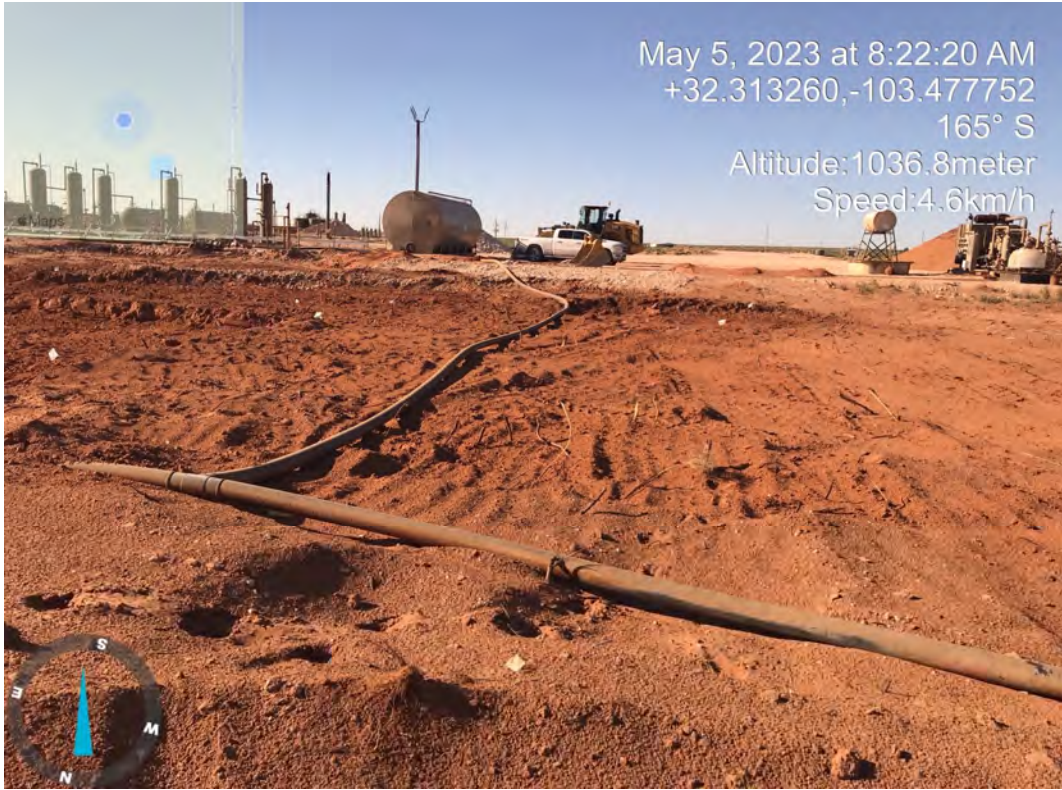
<b>Photo Number:</b> 10

<b>Photo Direction:</b> South	
<b>Photo Description:</b>  View of the excavated area.

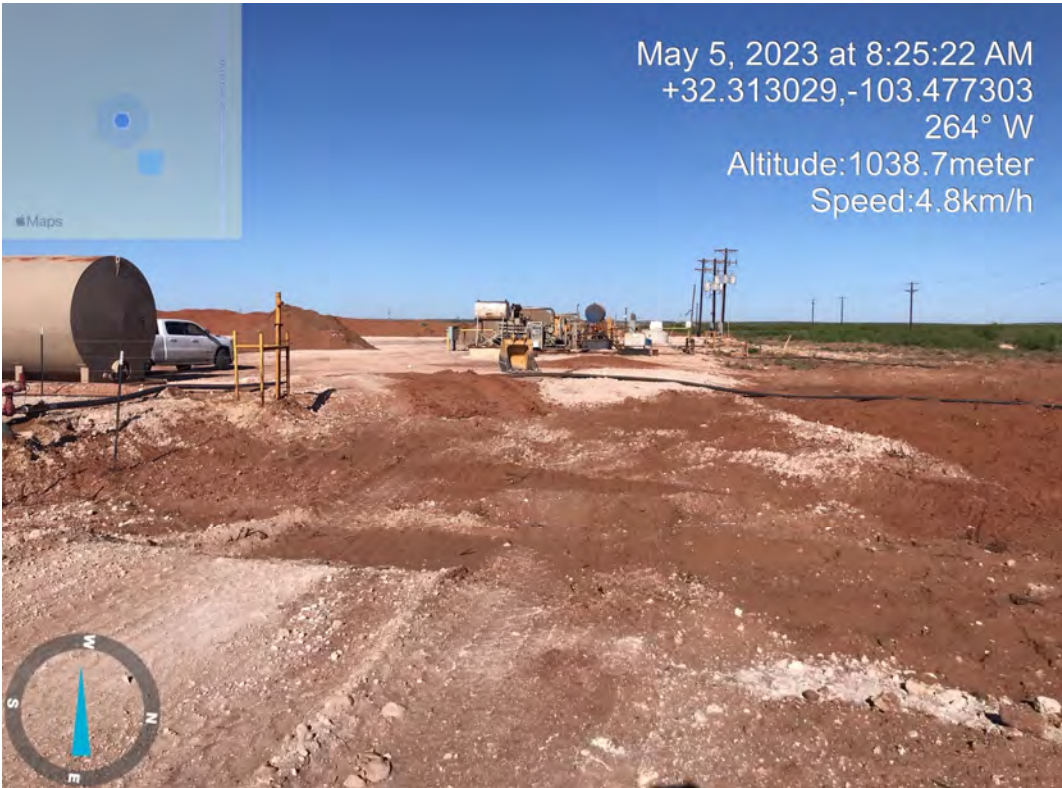
<b>Photo Number:</b> 15

<b>Photo Direction:</b> West	
<b>Photo Description:</b>  View of the excavated area.

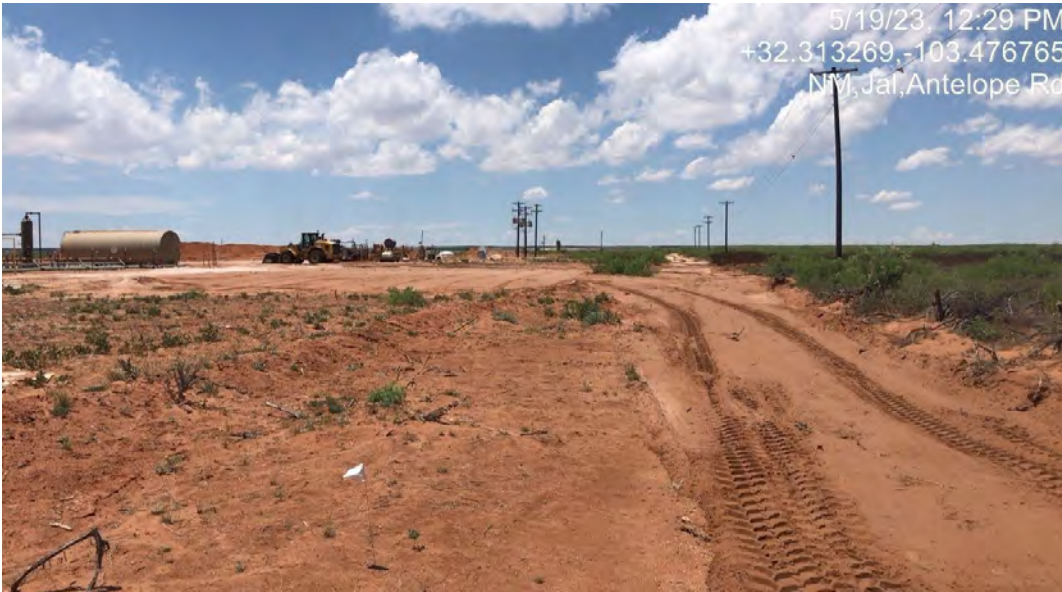
<b>Photo Number:</b> 16

<b>Photo Direction:</b> West	
<b>Photo Description:</b>  View of the remediated area after backfill and regrading.

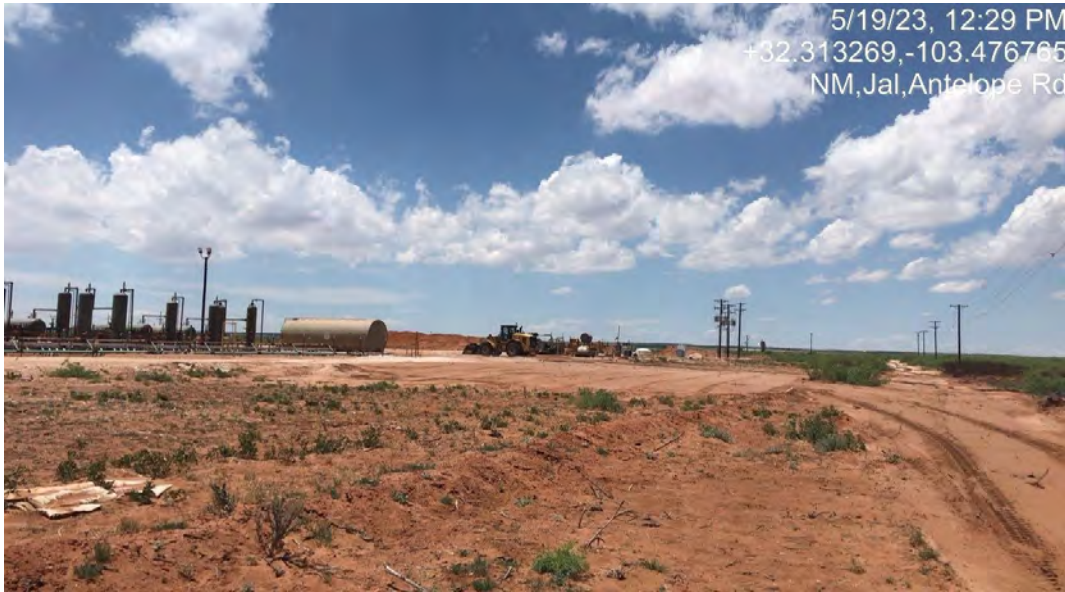
<b>Photo Number:</b> 17

<b>Photo Direction:</b> West	
<b>Photo Description:</b>  View of the remediated area after backfill and regrading.

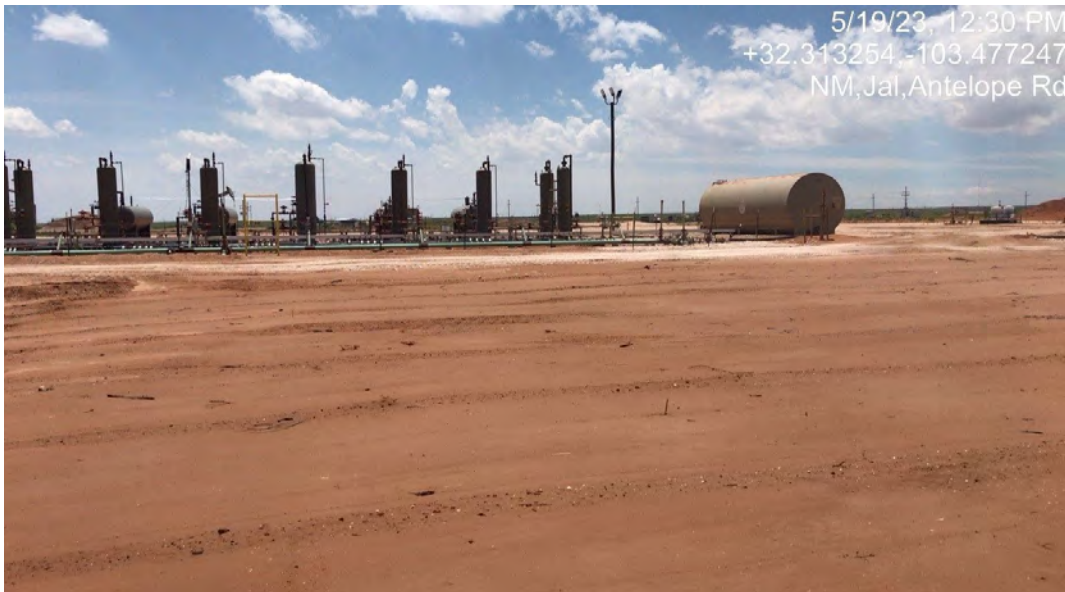
<b>Photo Number:</b> 18

<b>Photo Direction:</b> Southwest	
<b>Photo Description:</b>  View of the remediated area after backfill and regrading.

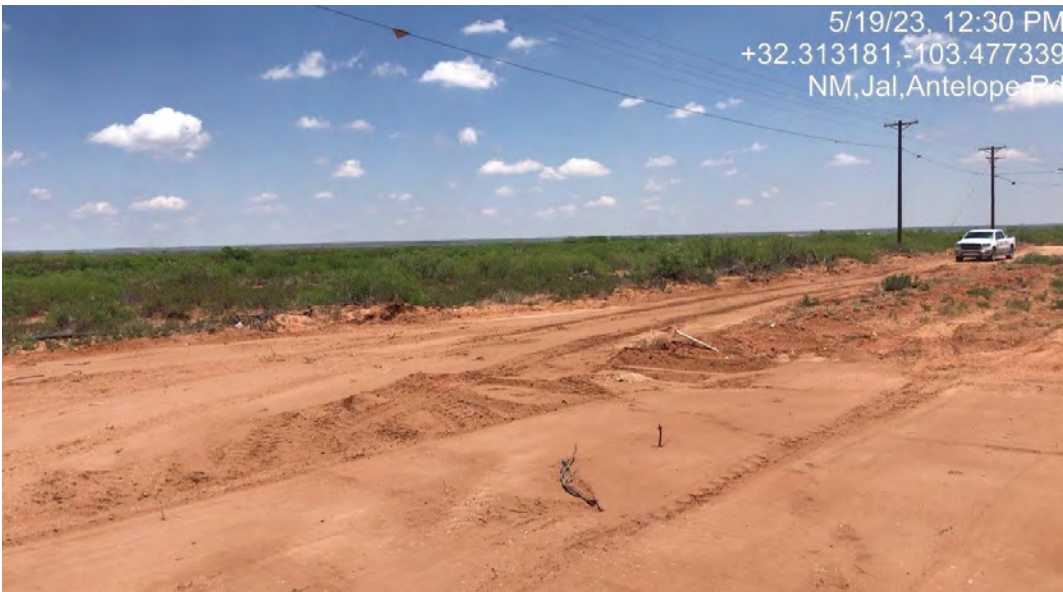
<b>Photo Number:</b> 20

<p>5/19/23, 12:30 PM +32.313181,-103.477339 NM,Jal,Antelope Rd</p>
<b>Photo Direction:</b> Northeast	
<b>Photo Description:</b>  View of the remediated area after backfill and regrading.

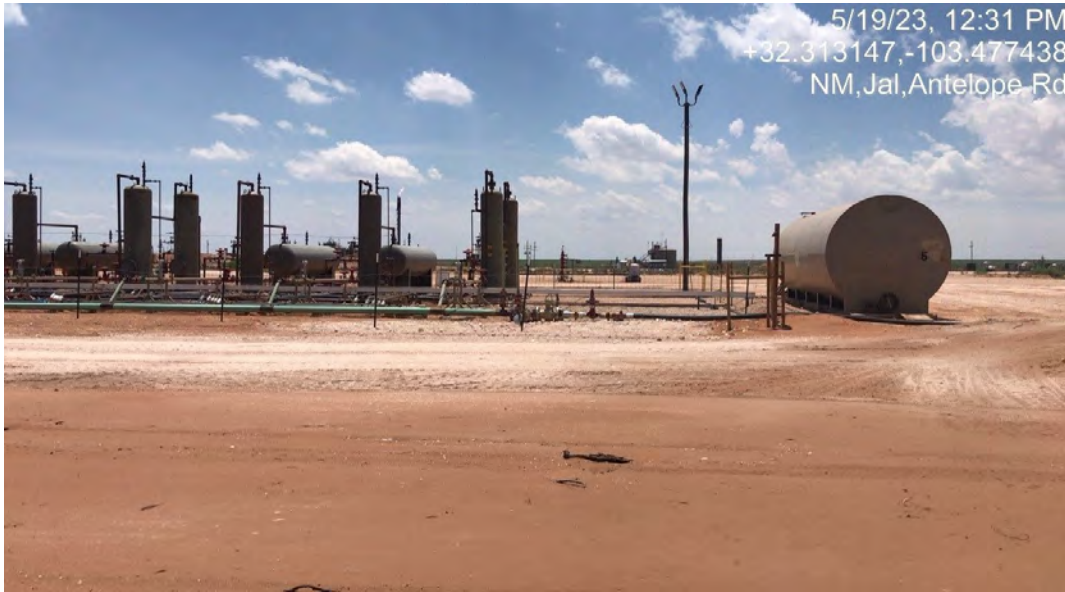
<b>Photo Number:</b> 21

<p>5/19/23, 12:31 PM +32.313147,-103.477438 NM,Jal,Antelope Rd</p>
<b>Photo Direction:</b> South	
<b>Photo Description:</b>  View of the remediated area after backfill and regrading.

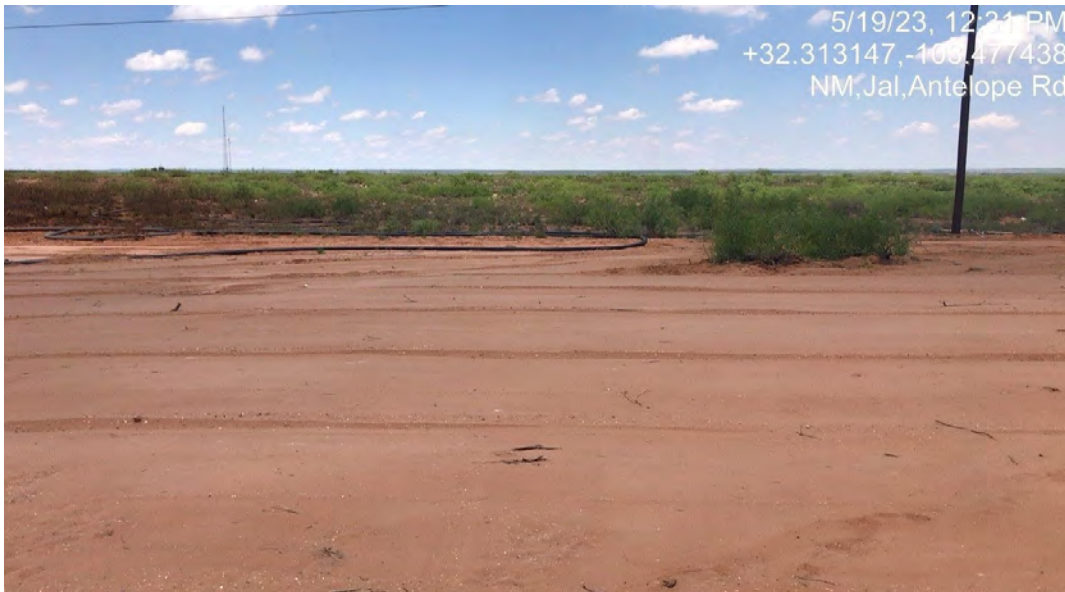
<b>Photo Number:</b> 22

<p>5/19/23, 12:31 PM +32.313147,-103.477438 NM,Jal,Antelope Rd</p>
<b>Photo Direction:</b> North	
<b>Photo Description:</b>  View of the remediated area after backfill and regrading.
