Re: Site Assessment, Remediation, and Closure Report
MCA #265
API No. 30-025-23686
GPS: Latitude 32.8190002 Longitude -103.790529
UL "K", Sec. 20, T17S, R32E
Lea County, NM
NMOCD Ref. No. nAPP2311055764

Pima Environmental Services, LLC (Pima) has been contracted by Maverick Permian, LLC to perform a spill assessment, remediation activities, and submit this closure report for a crude oil release that occurred at the MCA #265 (MCA). The initial C-141 was submitted on April 21st, 2023 (Appendix C). This incident was assigned Incident ID nAPP2311055764, by the New Mexico Oil Conservation Division (NMOCD).

**SITE PHOTOGRAPHS
MAVERICK PERMIAN,
LLC MCA 265**

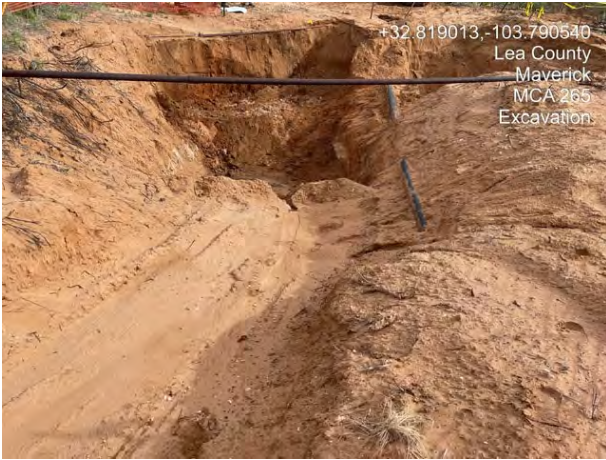
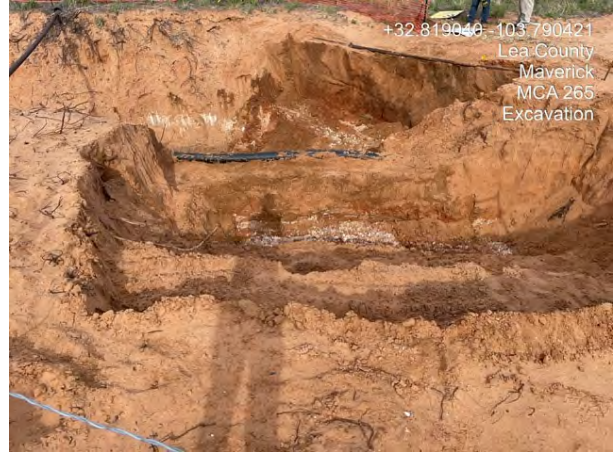
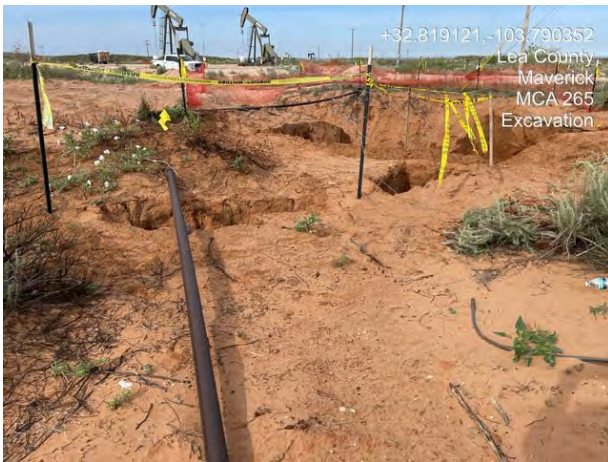
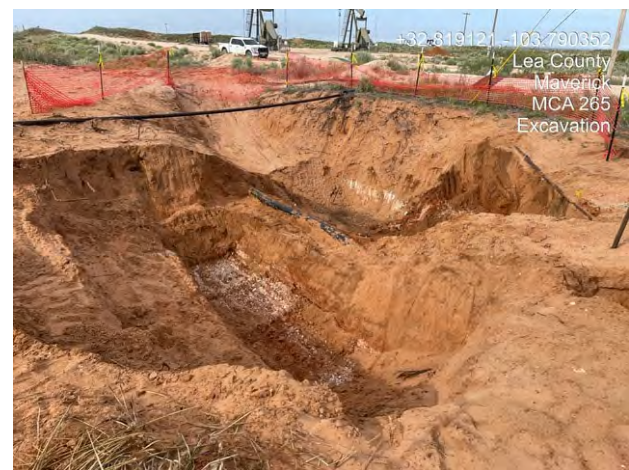
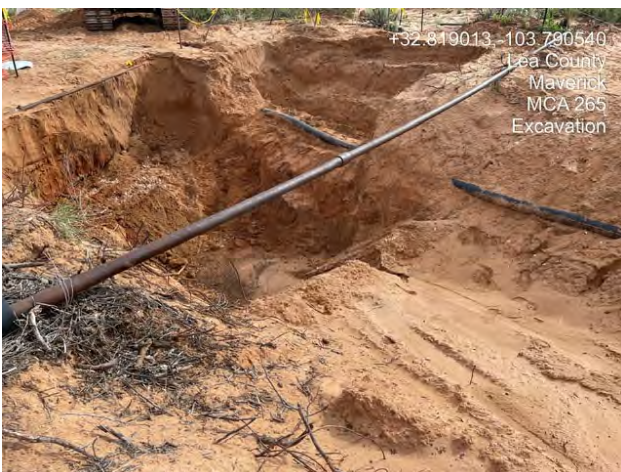
Excavation

On May 23rd, 2023, Pima mobilized personnel and equipment to conduct remedial activities. We excavated the area overlapping soil samples (S1-S2 and SW1-SW9) to a depth of 10 feet bgs. The total excavated area measures approximately 38 feet by 30 feet. Photographic documentation can be found in Appendix D.
