Re: Site Assessment, Remediation, and Closure Report
Vacuum Glorieta East Unit #001 06
API No. 30-025-20880
GPS: Latitude 32.80181 Longitude -103.45809
UL "P", Sec. 28, T17S, R35E
Lea County, NM
NMOCD Ref. No. NAPP2311748162

Pima Environmental Services, LLC (Pima) has been contracted by Maverick Permian, LLC to perform a spill assessment, remediation activities, and submit this closure report for a crude oil and produced water release that occurred at the Vacuum Glorieta East Unit #001 06 (VGEU). The initial C-141 was submitted on May 1st, 2023 (Appendix C). This incident was assigned Incident ID NAPP2311748162, by the New Mexico Oil Conservation Division (NMOCD).

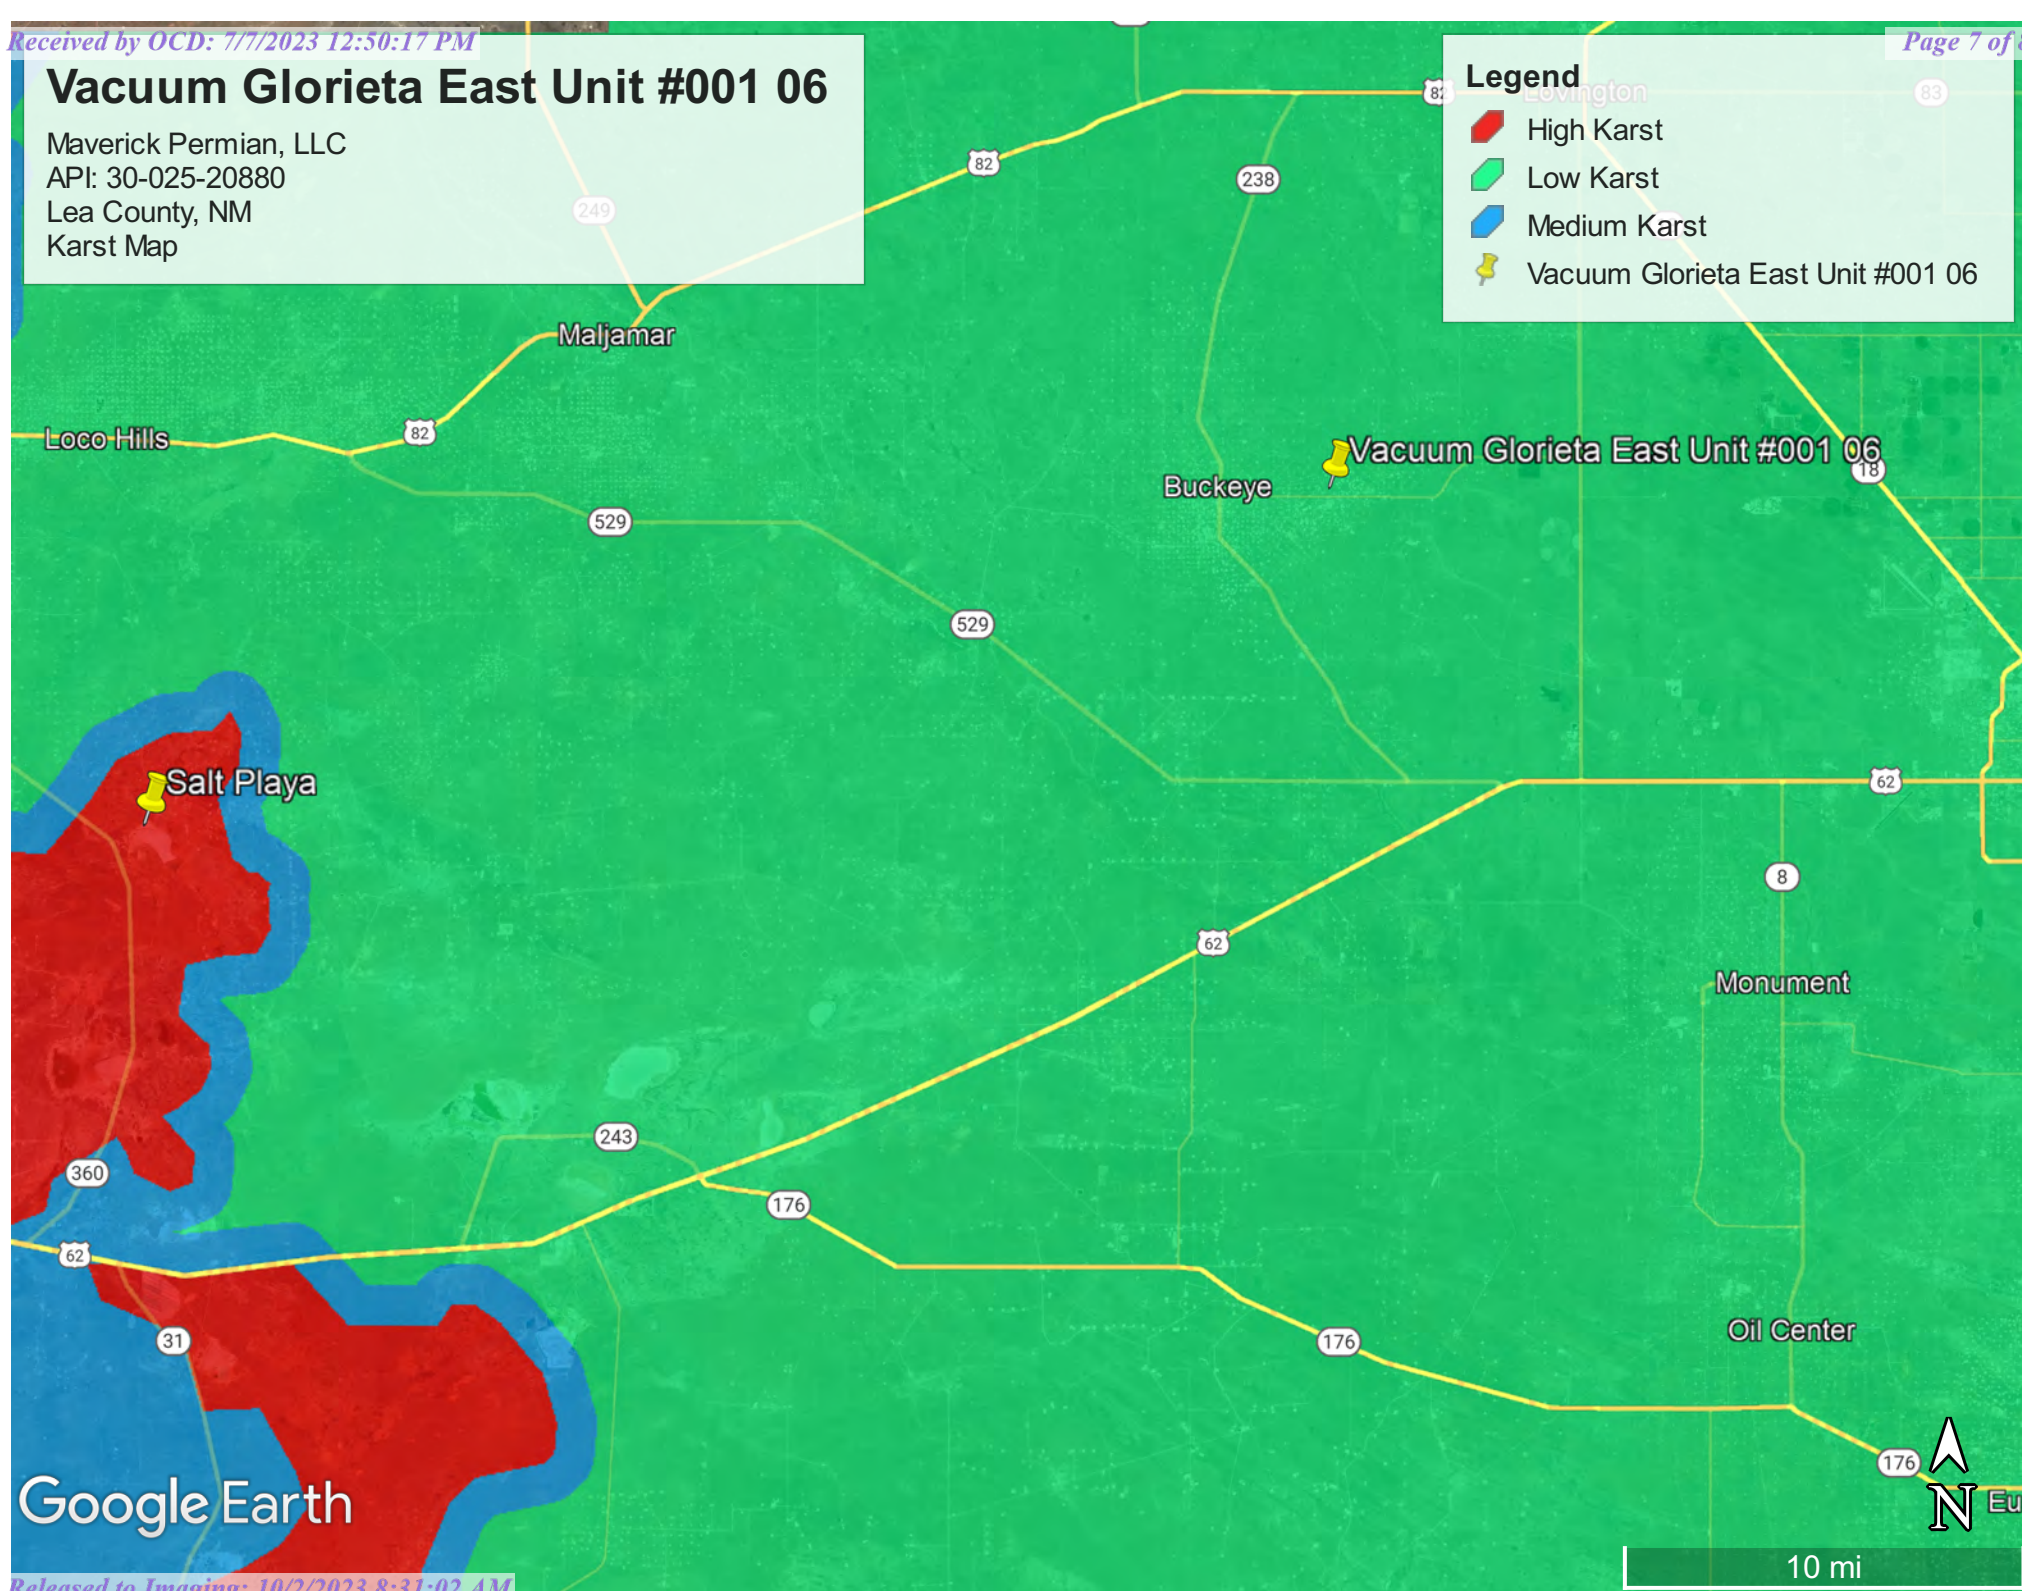
Maverick Permian, LLC
API: 30-025-20880
Lea County, NM
Karst Map

Per the New Mexico Bureau of Geology and Mineral Resources, the geology is in the Ogallala Formation (Lower Pliocene to middle Miocene). The soil in this area is made up of Kimbrough-Lea complex, dry, 0 to 3 percent slopes according to the United States Department of Agriculture Natural Resources Conservation Service soil survey (Appendix B). The drainage courses in this area are well-drained. There is a low potential for karst geology to be present around the VGEU (Figure 3).

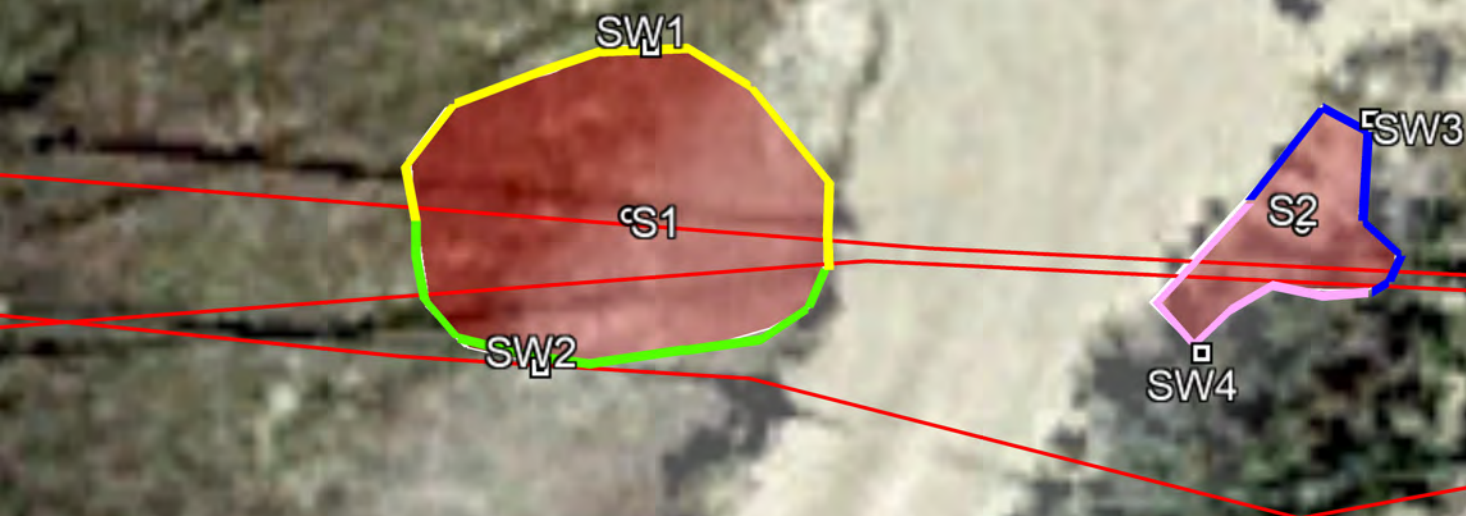
Maverick Permian, LLC
32.80181,-103.45809
NAPP2311748162
Lea County, NM
Initial Site Map

On April 26th and May 8th, 2023, Pima Environmental Services mobilized personnel to the site to conduct delineation activities. Pima collected a total of ten soil samples, two bottom samples (S1 and S2) to verify vertical delineation, and four side wall samples (SW1-SW4) to verify horizontal delineation. Sample results can be found in the table below. A site map can be found in Figure 4.

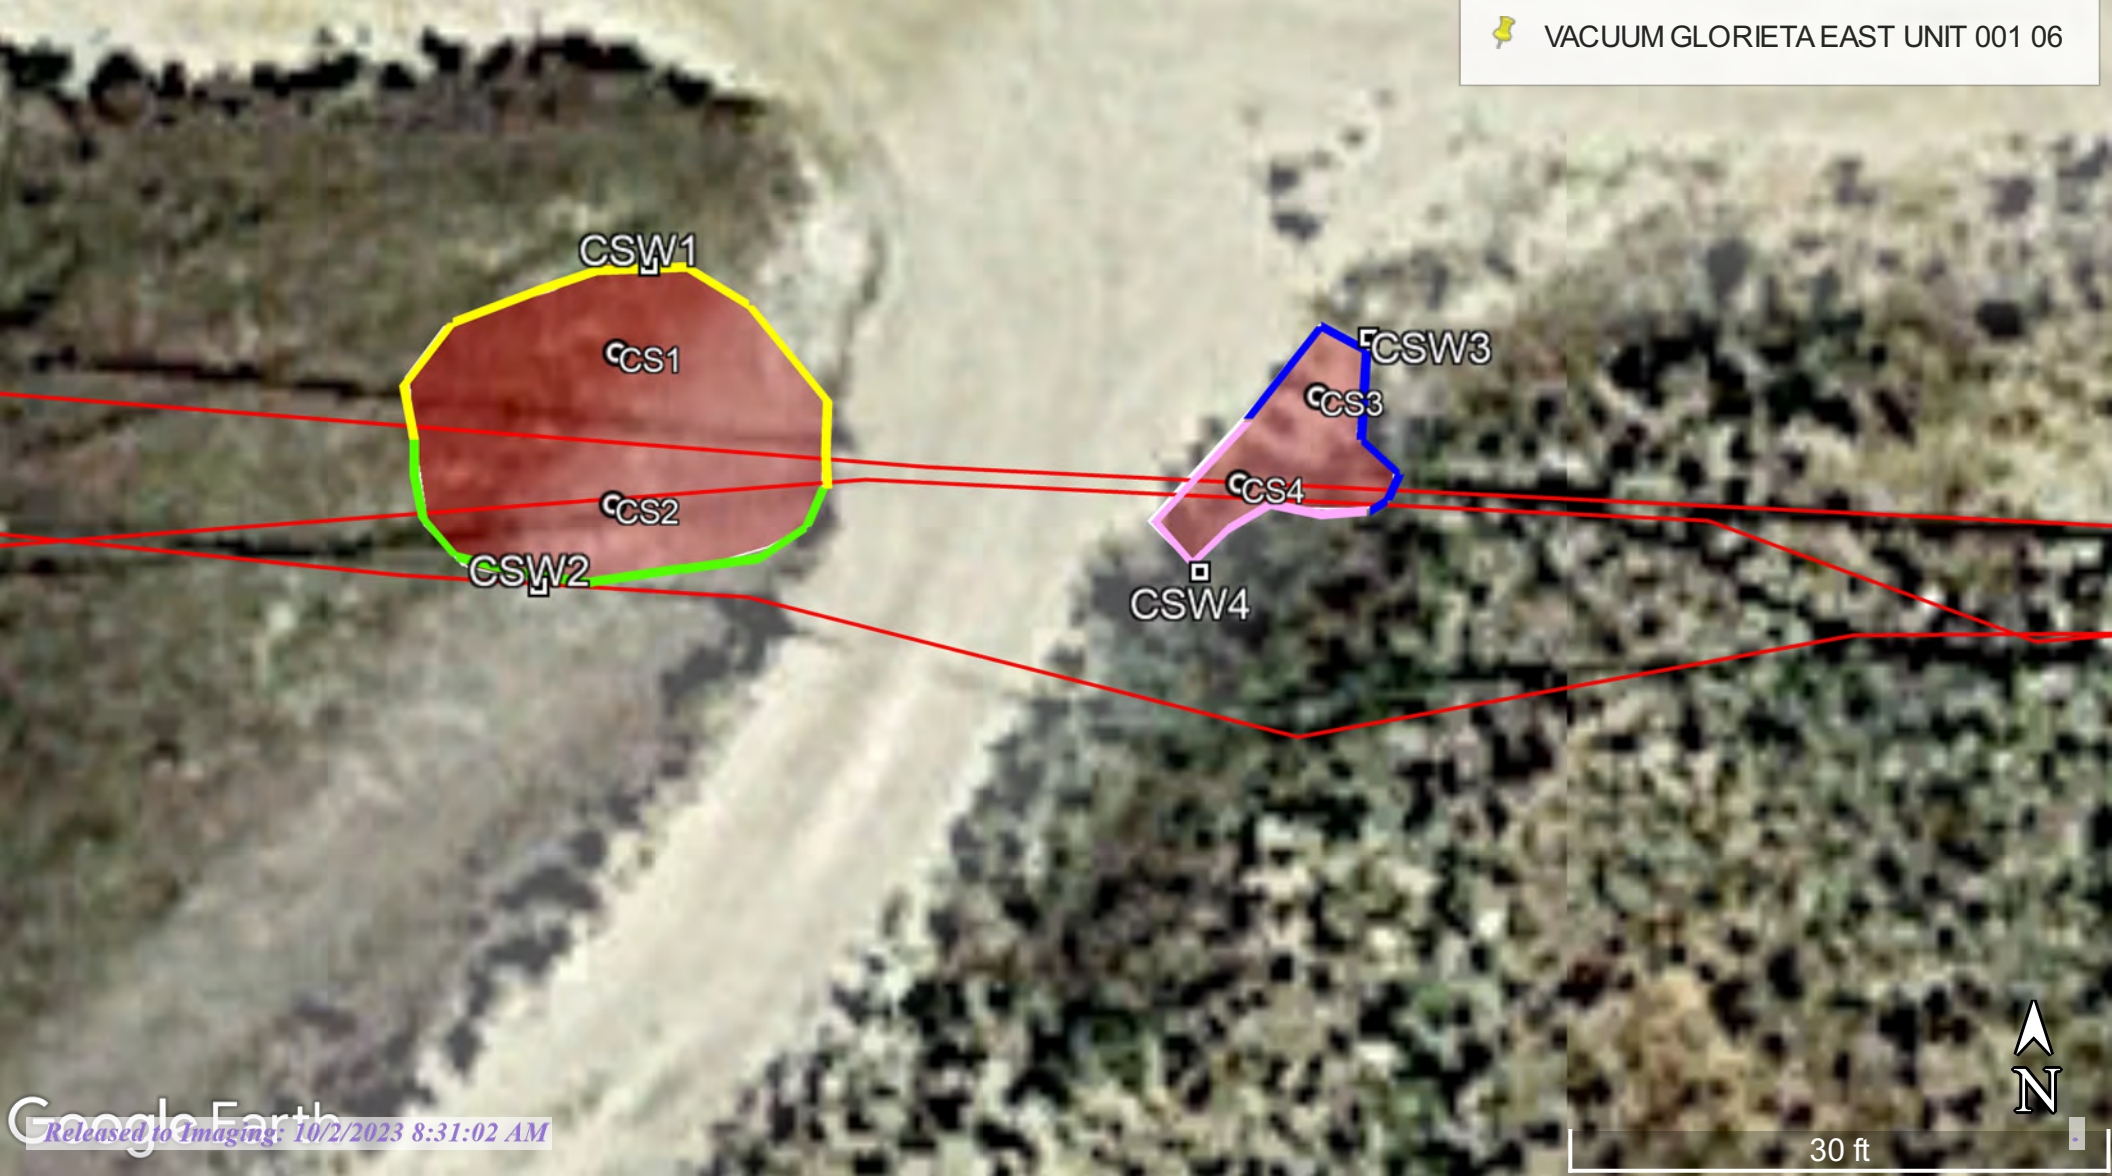
Maverick Permian, LLC
32.80181,-103.45809
NAPP2311748162
Lea County, NM
Confirmation Site Map

On May 24th, 2023, after submitting the 48-hour notification (Appendix C), Pima collected confirmation samples. The laboratory results of this sampling event can be found in the following data table. A confirmation site map can be found in Figure 5.

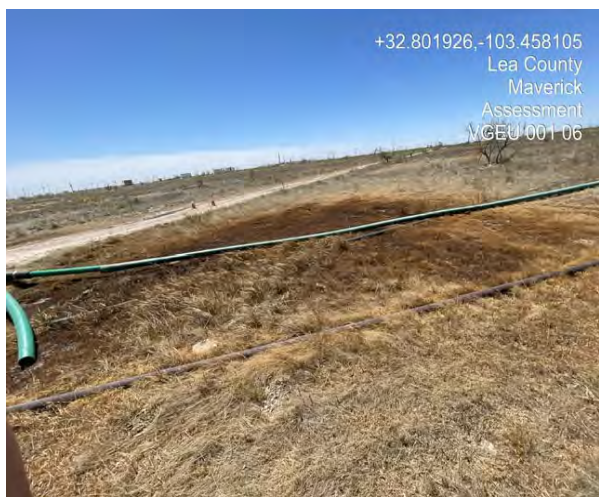
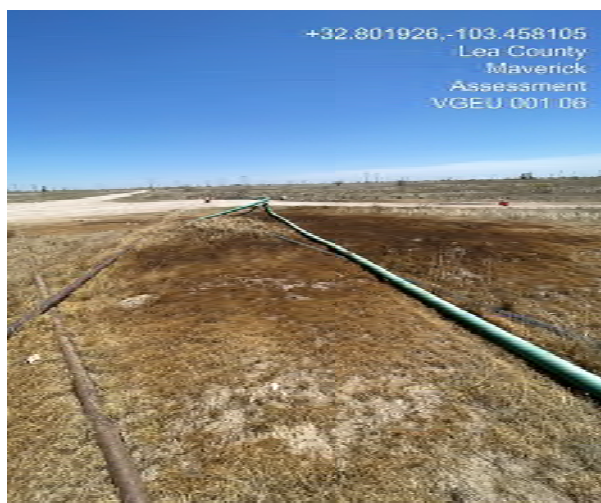
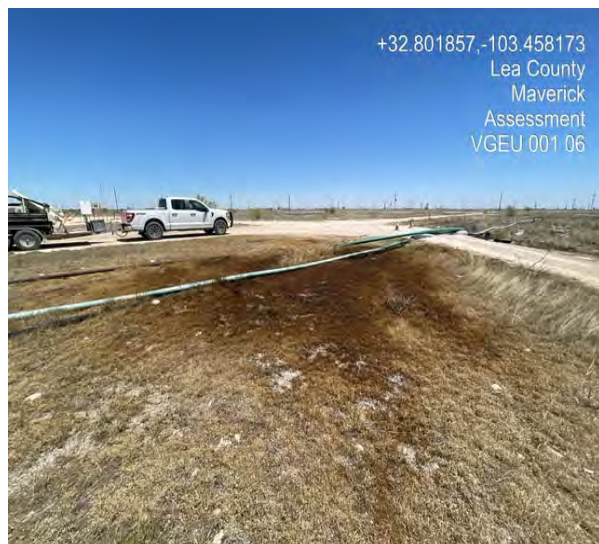
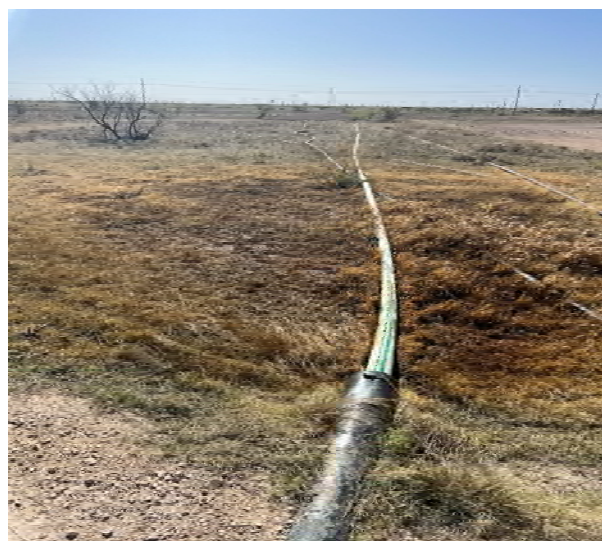
Site Assessment:

NAPP2311748162: On April 20th, 2023, A pin hole developed on a flowline, releasing approximately 1.16 barrels of crude oil and 2 barrels of produced water. An area measuring approximately 35 feet by 27 feet was affected. A vacuum truck was deployed and recovered all standing fluid.

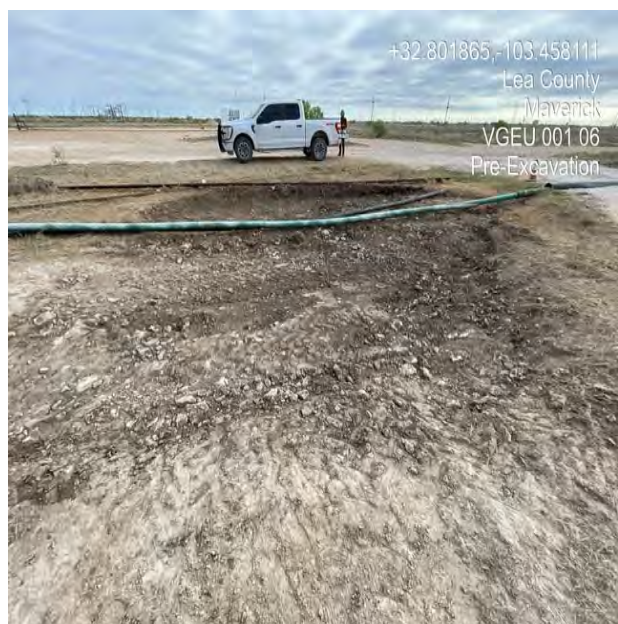
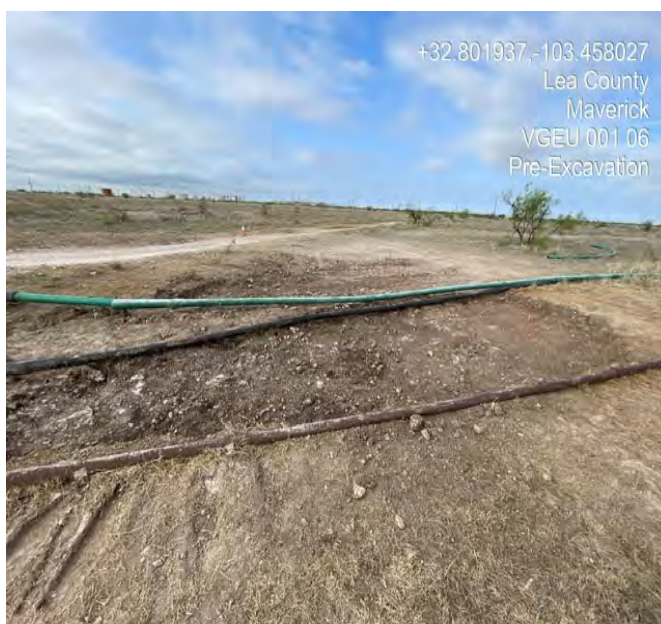
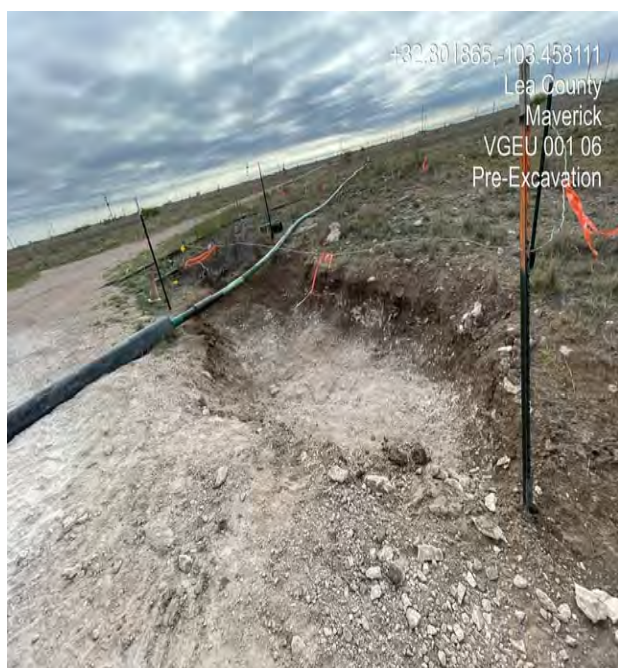
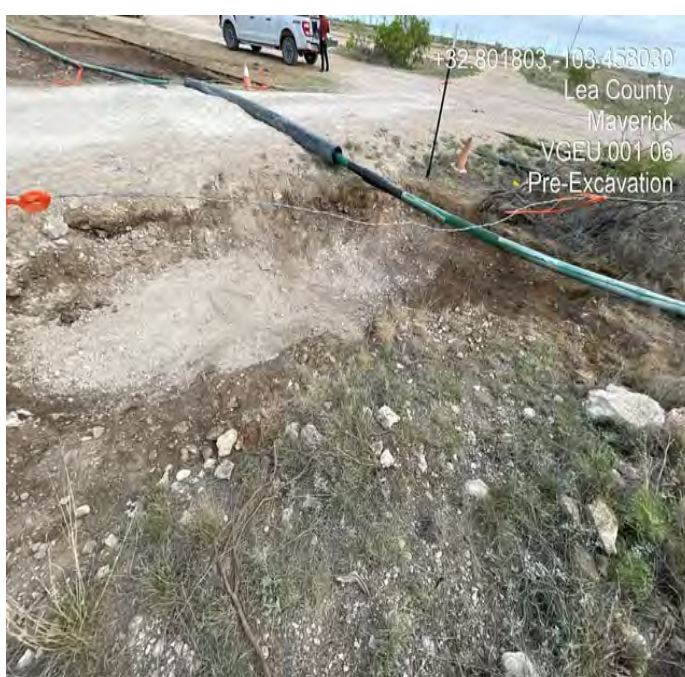
Excavation:

On May 22nd, 2023, Pima mobilized personnel and equipment to conduct remedial activities. We scraped the area overlapping soil samples (S1-S2) and (SW1-SW4) to a depth of two (2) feet bgs. Photographic documentation can be found in Appendix D.
