**Re: Release Characterization, Remediation and Closure Report  
ConocoPhillips  
Van Gogh Fee 101H Release  
Unit Letter B, Section 11, Township 24 South, Range 34 East  
DOR: 5/11/2023  
Lea County, New Mexico  
Incident ID: NAPP2314253030**

Release Characterization, Remediation and Closure Report  
July 5, 2023

ConocoPhillips

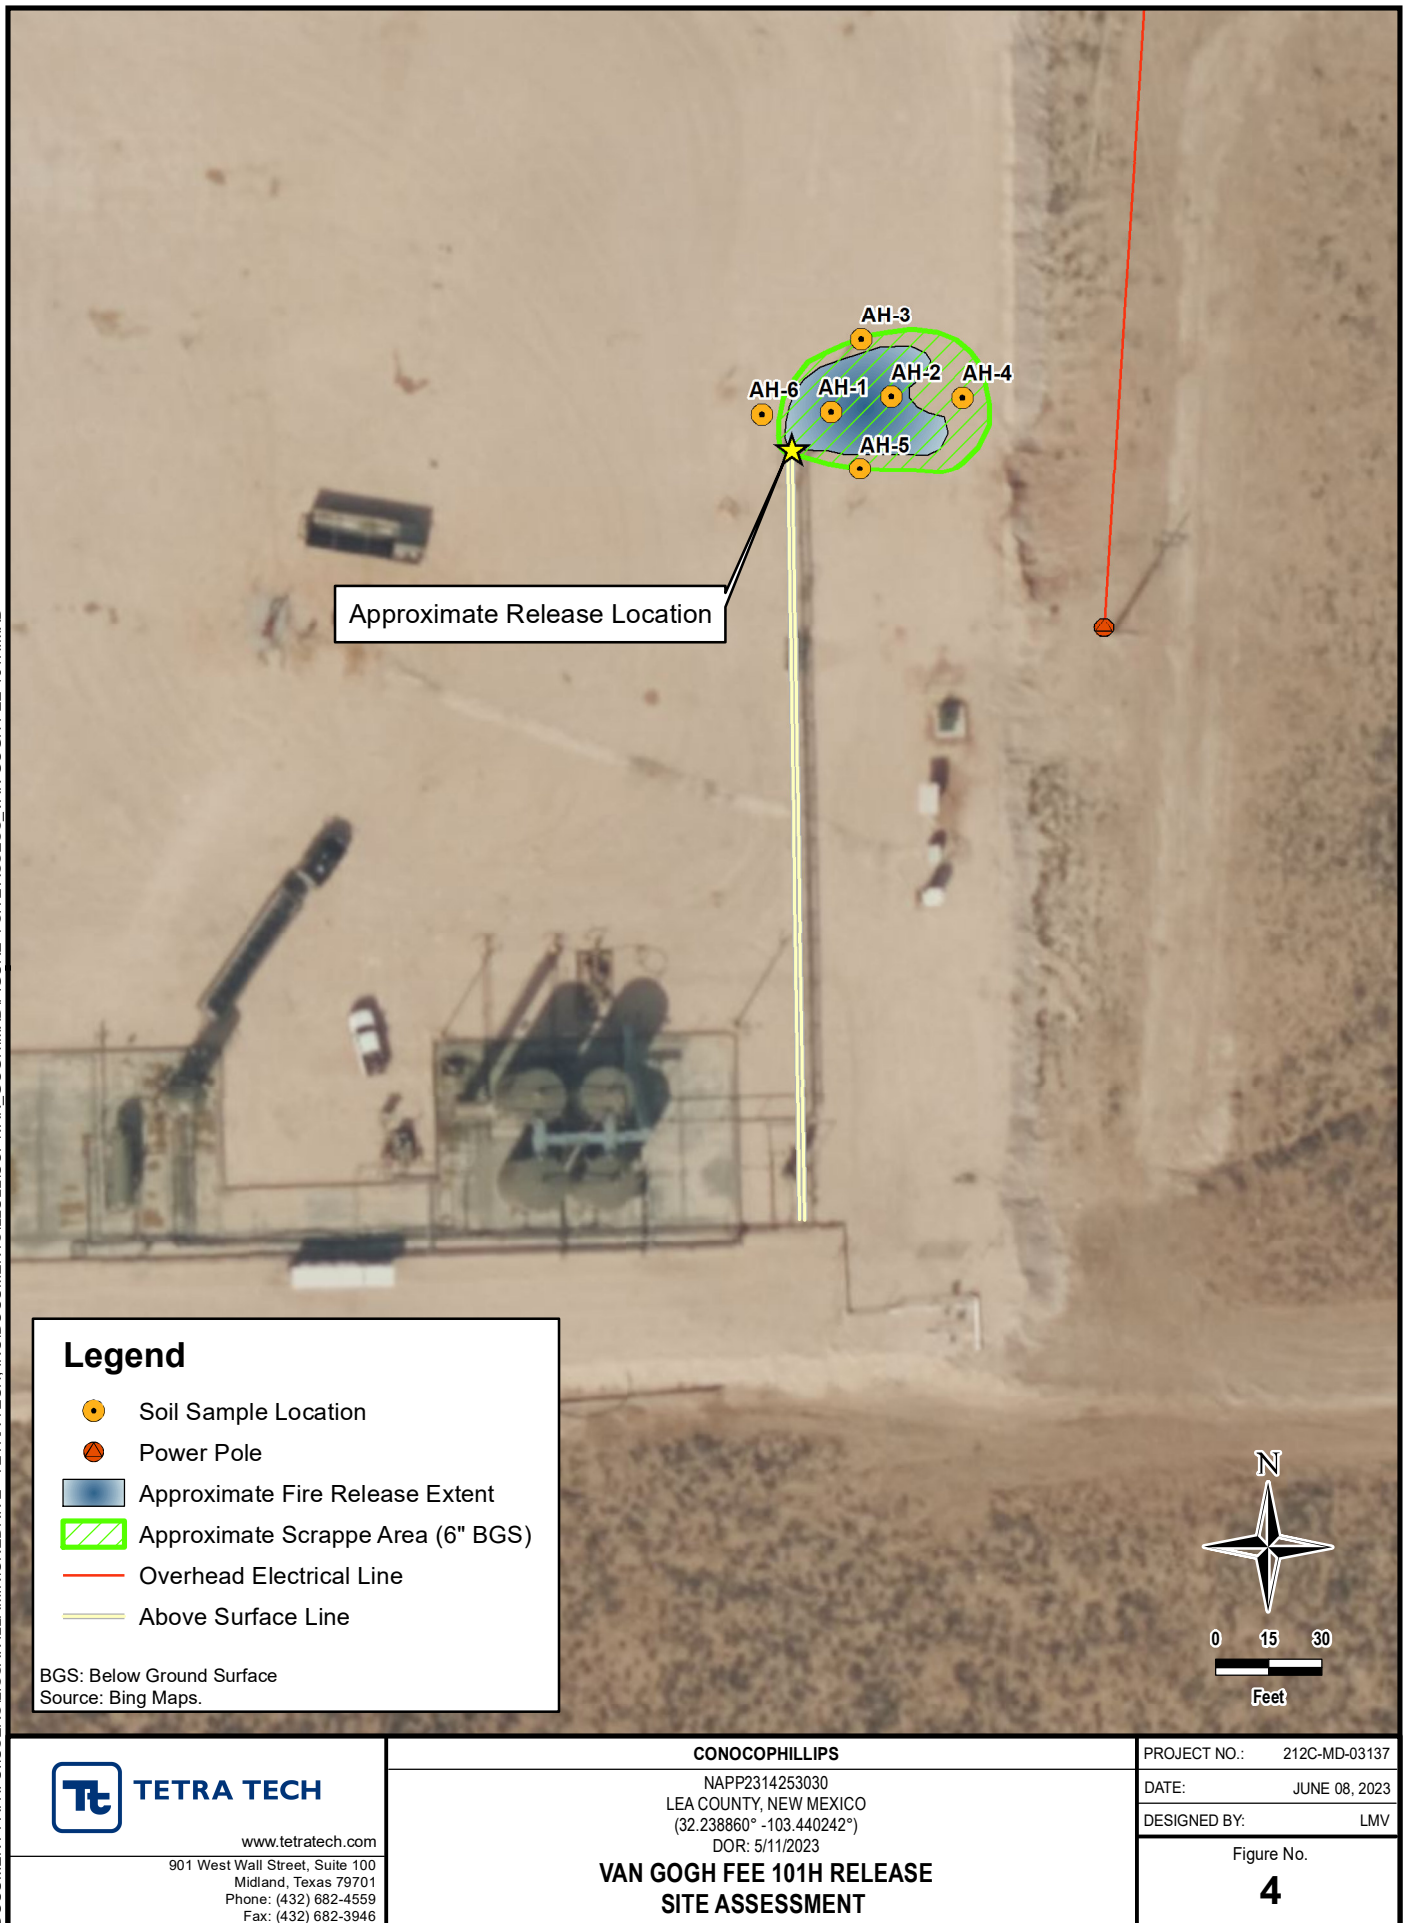
Tetra Tech personnel mobilized to the site on June 7, 2023, to collect confirmation samples, following the remedial activities completed by ConocoPhillips. A total of six (6) borings (AH-1 through AH-6) were installed in the boundaries of the scraped area and within the release footprint. Two (2) borings (AH-1 and AH-2) were installed to a depth of 2 feet bgs within the release area footprint to achieve vertical delineation and are representative of floor samples. Four (4) borings (AH-3 through AH-6) were installed to a depth of 1-foot bgs outside the release area footprint to achieve horizontal delineation and are representative of sidewall samples. Soil samples collected were field screened for salinity parts per million (ppm) using an ExStik II EC 400 meter. The approximate release extent and boring locations are shown in Figure 4.

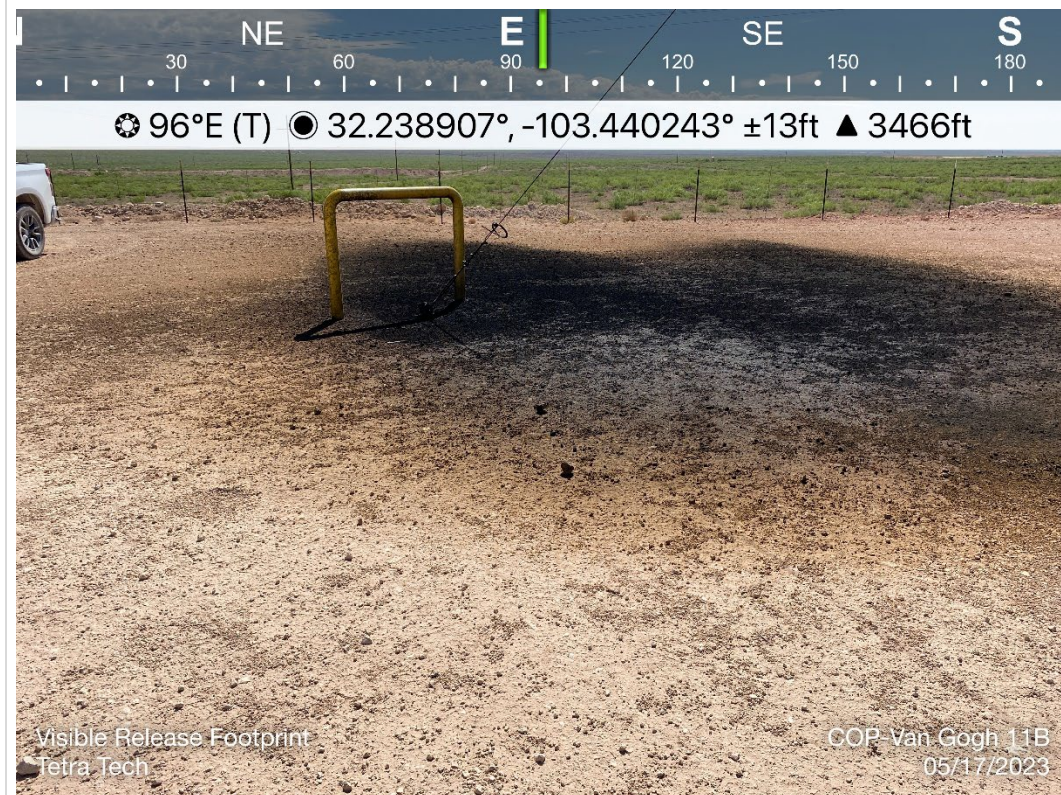
TETRA TECH, INC. PROJECT NO. 212C-MD-03137	DESCRIPTION	View east. Release extent from flare fire release.	4
	SITE NAME	COP – Van Gogh Fee 101H Release	5/17/2023

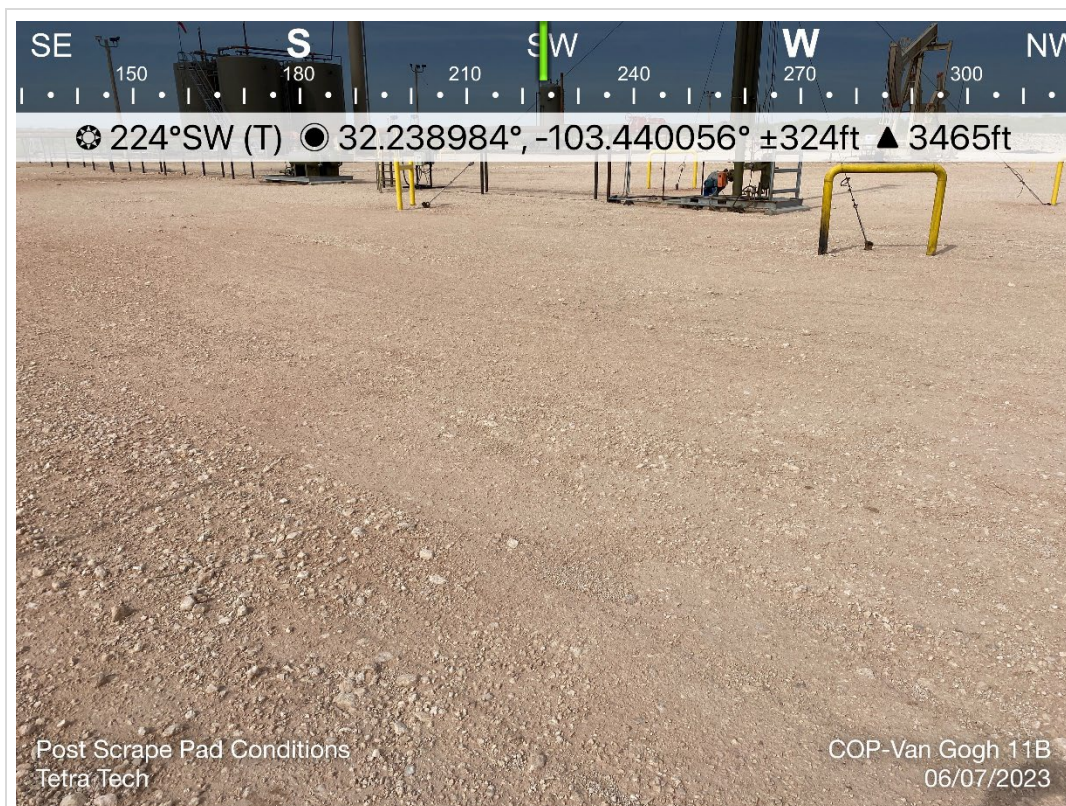
TETRA TECH, INC. PROJECT NO. 212C-MD-03137	DESCRIPTION	View southwest. Post remediation and backfill.	6
	SITE NAME	COP – Van Gogh Fee 101H Release	6/7/2023

In accordance with 19.15.29.8. B. (4) NMAC that states “the responsible party may commence remediation immediately after discovery of a release,” ConocoPhillips elected to begin remediation of the impacted area on May 19, 2023. The on-pad material was excavated by scraping the surface to a depth of 1 to 3 inches bgs, resulting in approximately 5 cubic yards of contaminated soil being removed and sent to R360 Halfway Facility in Hobbs, New Mexico. Following the remedial activities, the area was backfilled and compacted with clean caliche material. Photographic documentation of the release extent before and after the scrape is included in Appendix C. Waste manifests can be found in Appendix D and the initial response area is indicated in Figure 3.

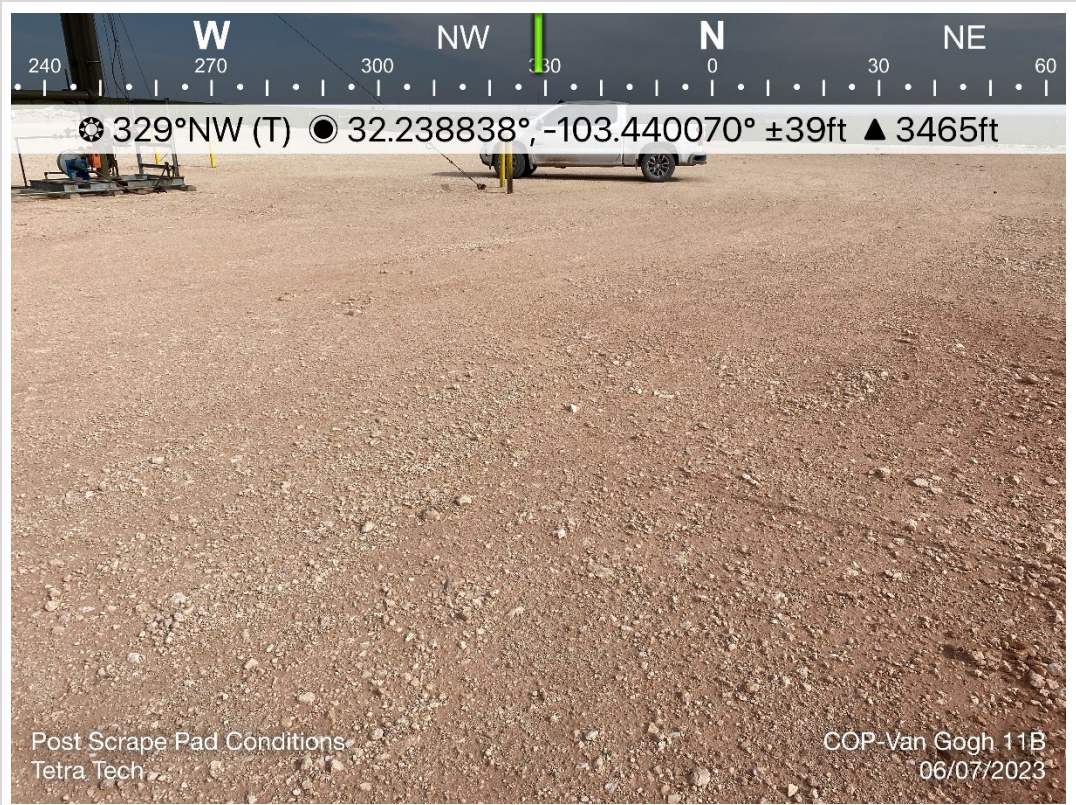
TETRA TECH, INC. PROJECT NO. 212C-MD-03137	DESCRIPTION	View north. Post remediation and backfill.	8
	SITE NAME	COP – Van Gogh Fee 101H Release	6/7/2023
