**Re: Site Assessment, Remediation, and Closure Report**  
**Encore M State Field**  
**API No. N/A**  
**GPS: Latitude 32.3664739 Longitude -103.1634795**  
**UL "H", Sec. 28, T22S, R37E**  
**Lea County, NM**  
**NMOCD Ref. No. NAPP2314649548**

Pima Environmental Services, LLC (Pima) has been contracted by Maverick Permian, LLC to perform a spill assessment, remediation activities, and submit this closure report for a crude oil release that occurred at the Encore M State Field (Encore). The initial C-141 was submitted on June 6<sup>th</sup>, 2023 (Appendix C). This incident was assigned Incident ID NAPP2314649548, by the New Mexico Oil Conservation Division (NMOCD).

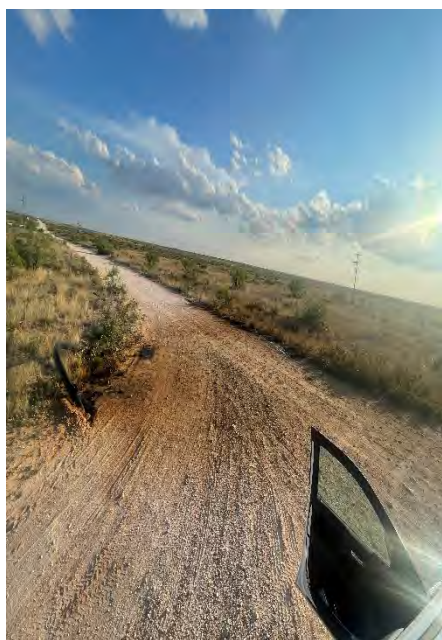
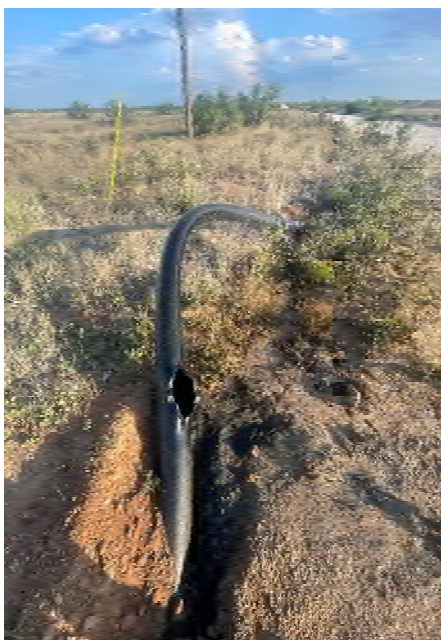
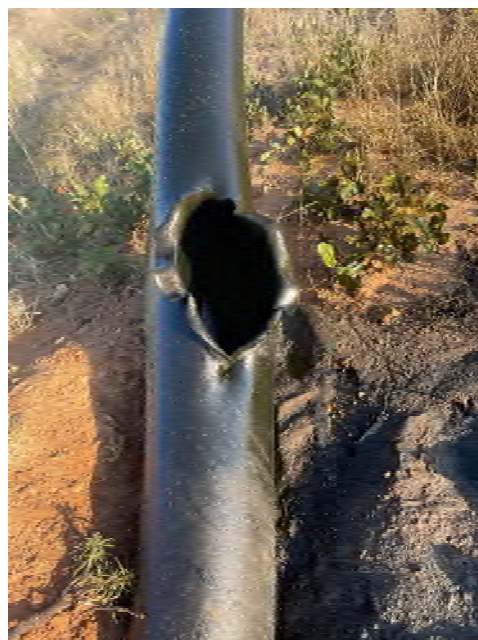
**Initial Release**

**NAPP2314649548:** On May 24<sup>th</sup>, 2023, a pin hole developed on a flowline leading to an overspray of crude oil. Maverick dispatched a crew to conduct remediation activities, all contamination was recovered.

A pin hole developed in a poly line leading to an overspray of crude oil. All contamination was recovered.
