**Re: Remediation Work Plan  
EVGSAU 2437-001  
Incident Number NAPP2303273838  
Lea County, New Mexico**

Ensolum, LLC (Ensolum) on behalf of Maverick Permian, LLC (Maverick), has prepared the following *Remediation Work Plan (Work Plan)* to document the site assessment and excavation activities completed to date and propose a work plan to address the historical impacted soil identified at the EVGSAU 2437-001 flow line release (Site). The following *Work Plan* proposes additional excavation of impacted soil and installation of a 20-mil impermeable liner in the floor of the excavation.

Maverick Permian, LLC  
Remediation Work Plan  
EVGSAU 2437-001

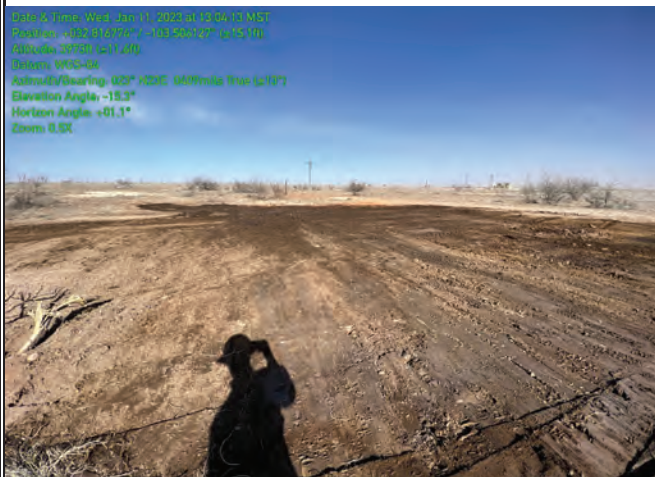
Photograph 1 Date: 01/11/23

Description: Soil staining in release footprint

View: Northeast

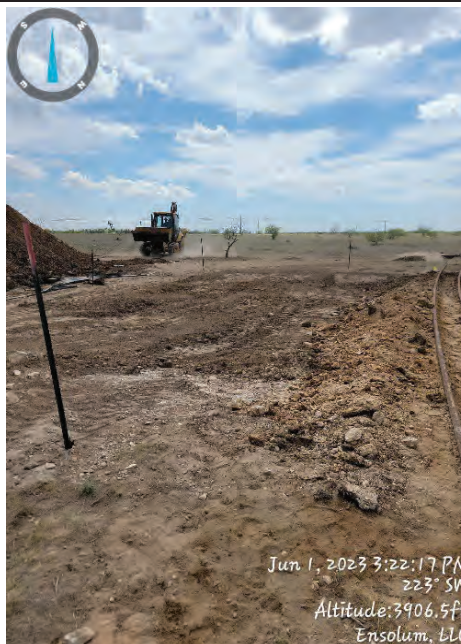
Photograph 2 Date: 06/01/23

Description: Excavation activities

View: Northwest

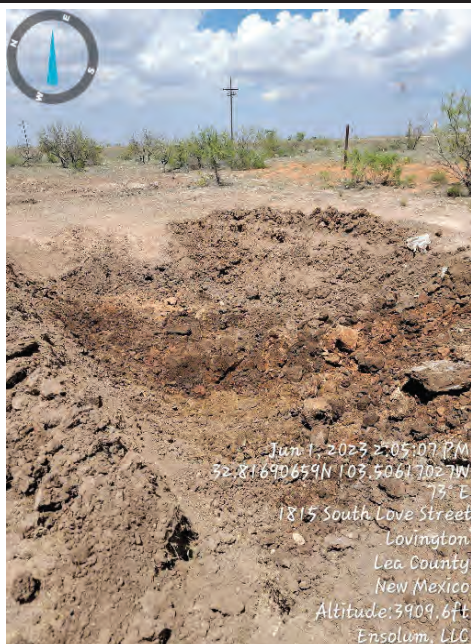
Photograph 3 Date: 06/01/23

Description: Historical pit

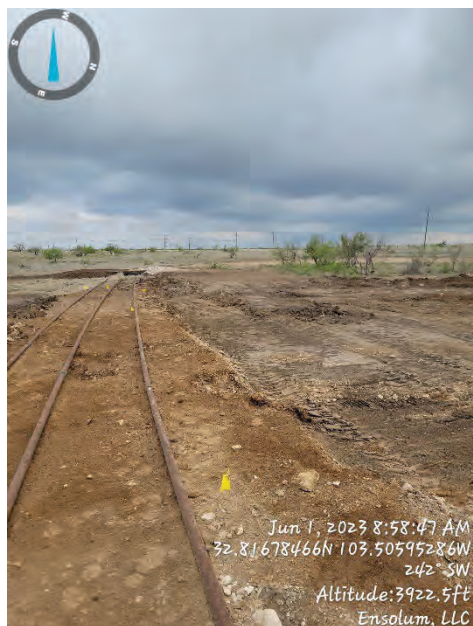
Photograph 1

Description: Excavation activities

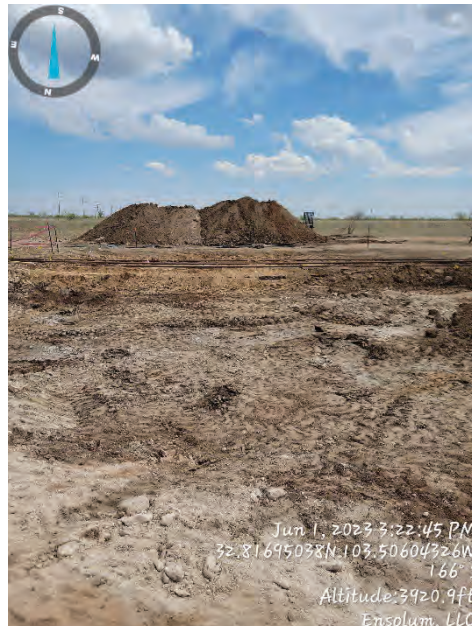
Photograph 2

Description: Excavation activities

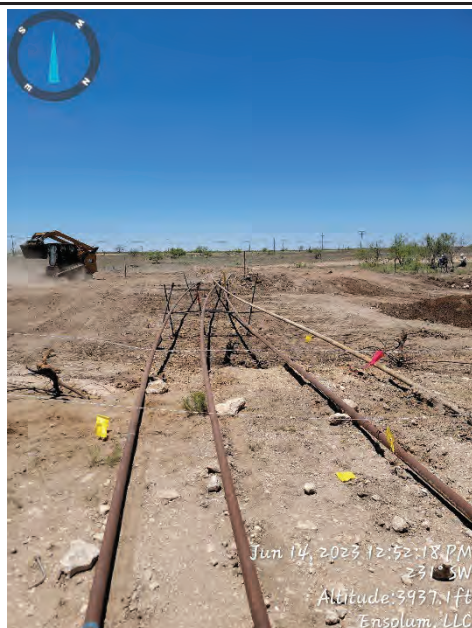
Photograph 3

Description: Excavation activities
