Incident ID	nAPP2312357379
District RP	
Facility ID	
Application ID

Based on laboratory analytical results and field activities conducted to date, Etech recommends Mewbourne Oil Company provide copies of this *Remediation Summary & Soil Closure Request* to the appropriate agencies and request closure be granted to the Ibex release site.

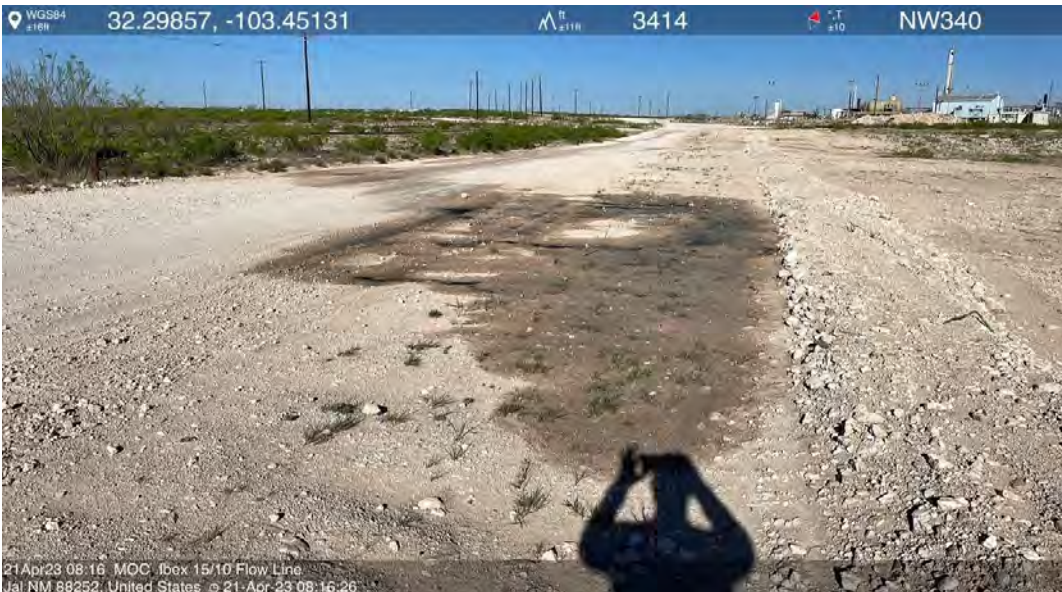
<b>Photo Number:</b> 2

<p>21Apr23 08:16 MOC Ibox 15/10 Flow Line Jal NM 88252, United States © 21-Apr-23 08:16:26</p>
<b>Photo Direction:</b> North-Northwest	
<b>Photo Description:</b>  View of the affected area.

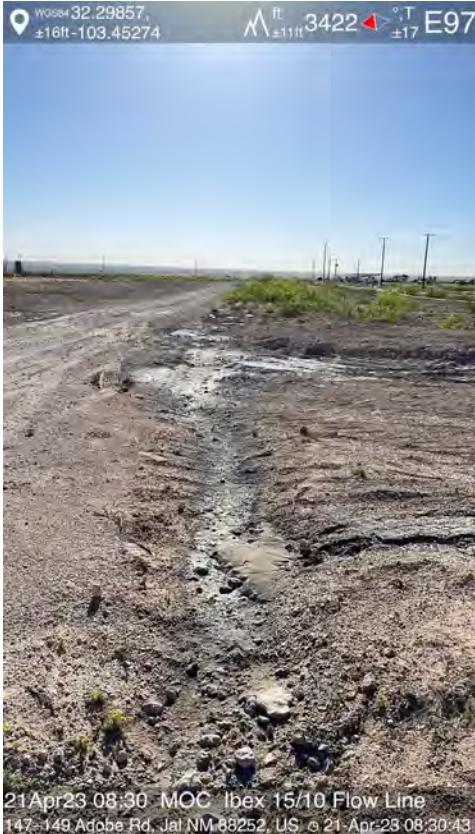
<b>Photo Number:</b> 5

<p>Metadata: WGS84 32.29857, ±16ft -103.45274; Alt 3422 ft ±11ft; Temp 71°F ±17; E97</p> <p>21 Apr 23 08:30 MOC Ibex 15/10 Flow Line 147-149 Adobe Rd, Jal NM 88252, US © 21-Apr-23 08:30:43</p>
<b>Photo Direction:</b> East	
<b>Photo Description:</b>  View of the affected area.

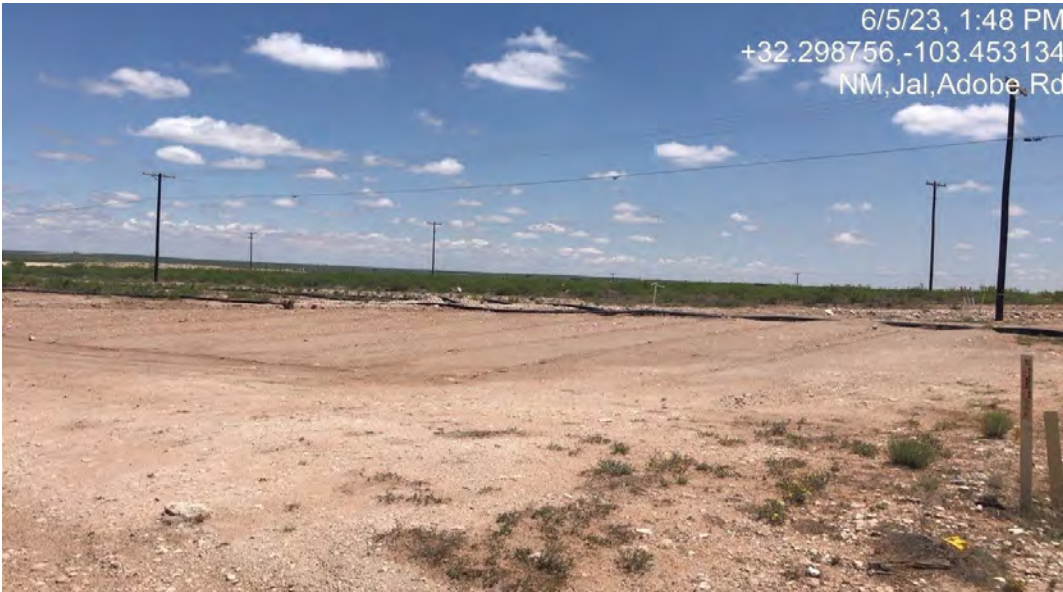
<b>Photo Number:</b> 11

<b>Photo Direction:</b> Southeast	
<b>Photo Description:</b>  View of the remediated area after backfill and regrading.

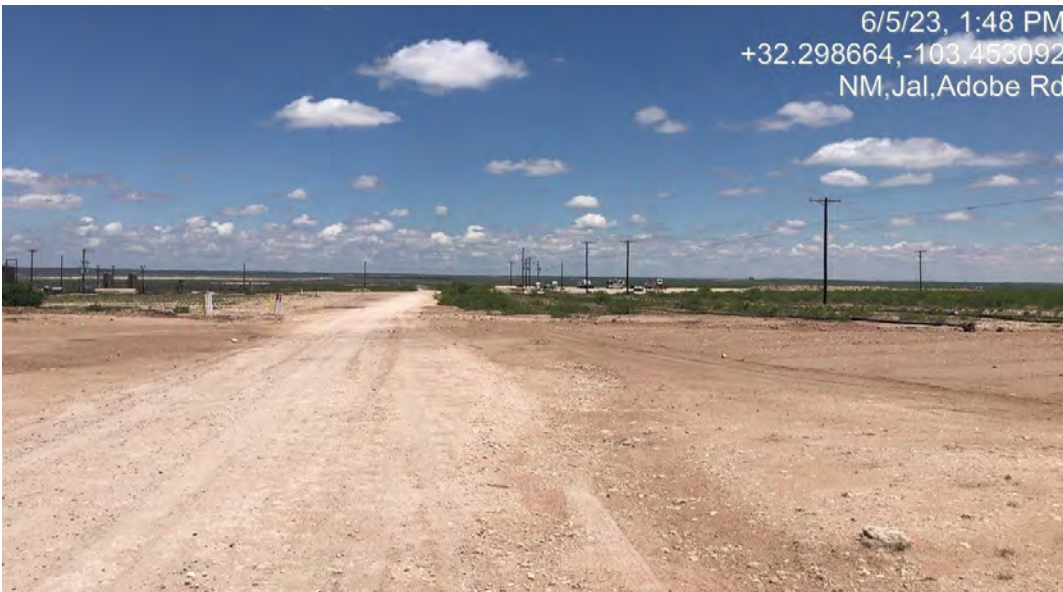
<b>Photo Number:</b> 12

<b>Photo Direction:</b> East	
<b>Photo Description:</b>  View of the remediated area after backfill and regrading.

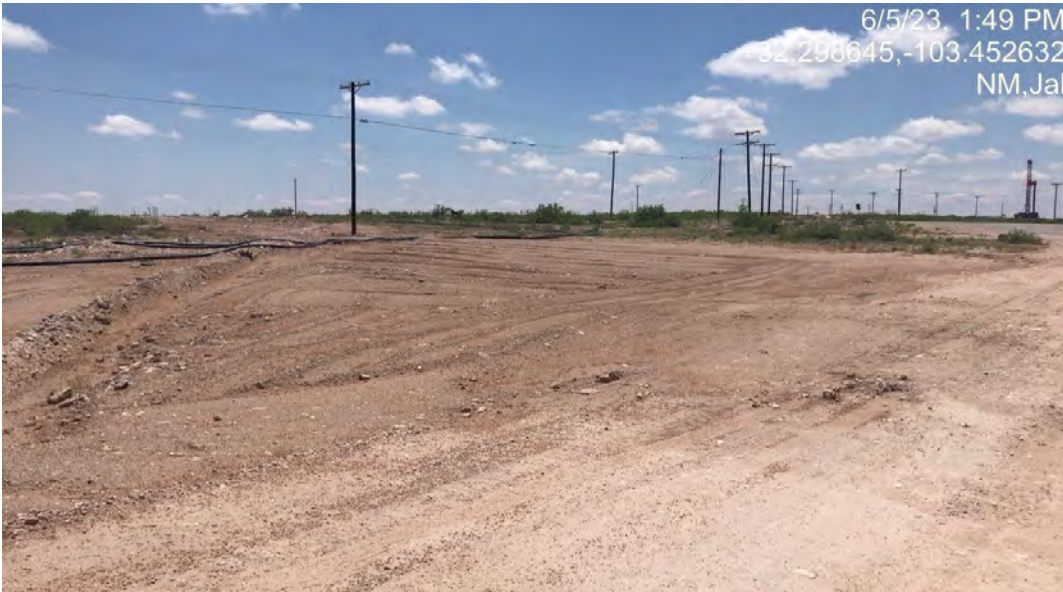
<b>Photo Number:</b> 13

<p>6/5/23, 1:49 PM +32.298645,-103.452632 NM, Jal</p>
<b>Photo Direction:</b> Southwest	
<b>Photo Description:</b>  View of the remediated area after backfill and regrading.
