Incident ID	nAPP2229871535
District RP	
Facility ID	
Application ID

Closure

Site Name Welcome to Golden Compressor Station	Site Type Gas Compressor Station
Date Release Discovered 10/25/2022	API# (if applicable)

Welcome to Golden Compressor Station

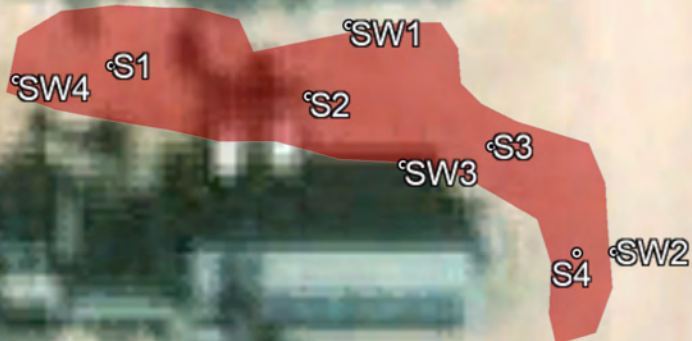
Soil Samples

On November 1st, 2022, Pima Environmental Services mobilized personnel to the site to conduct delineation activities. Pima sampled the area surrounding the point of release. Laboratory results of this sampling event can be found in the following data table and an initial site map can be found in Figure 4.

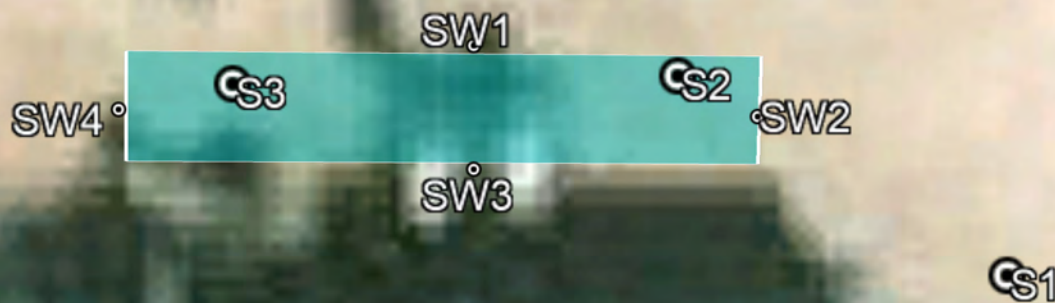
SCM Operations LLC
API: N/A
Eddy County
Secondary Site Map

On March 23rd, 2023, Pima personnel returned to the location and sampled the impacted area located in between the compressor units. A total of ten (10) samples were collected around the point of release and screened for Ethylene and Propylene Glycol, as requested by the NMOCD. Laboratory results of this sampling event can be found in the following data table. A secondary site map can be found in Figure 5.

Pima Environmental believes groundwater levels have been adequately characterized to be less than 50' bgs. Also, horizontal and vertical delineation has been successfully determined. A revised site map can be found in Figure 5.

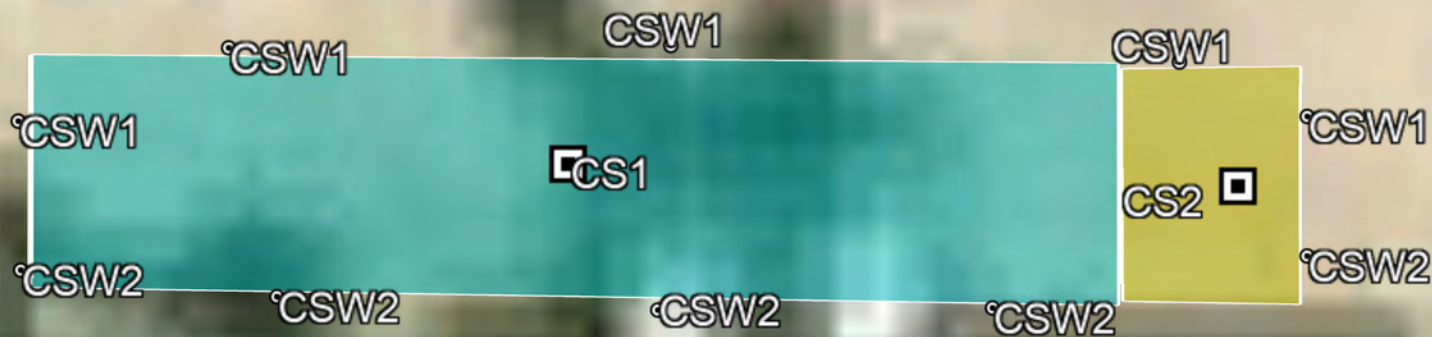
SCM Operations LLC
API: N/A
Eddy County
Confirmation Site Map

On April 27th, 2023, after submitting the 48-hour notification (Appendix C), Pima collected confirmation samples. The laboratory results of this sampling event can be found in the following data table. A confirmation site map can be found in Figure 6.

6" Excavation

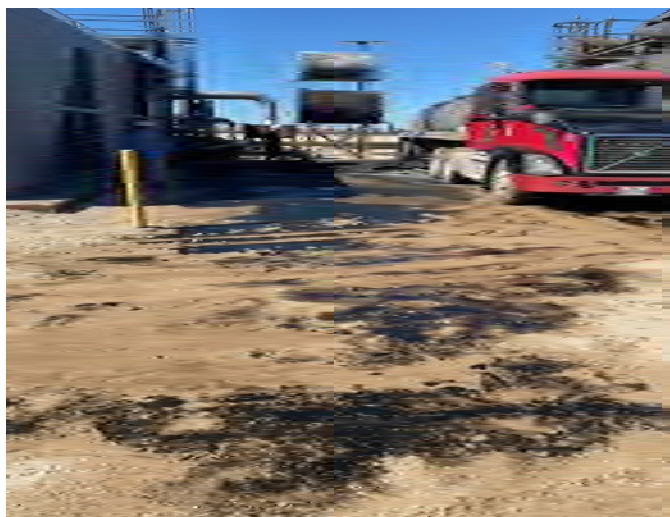
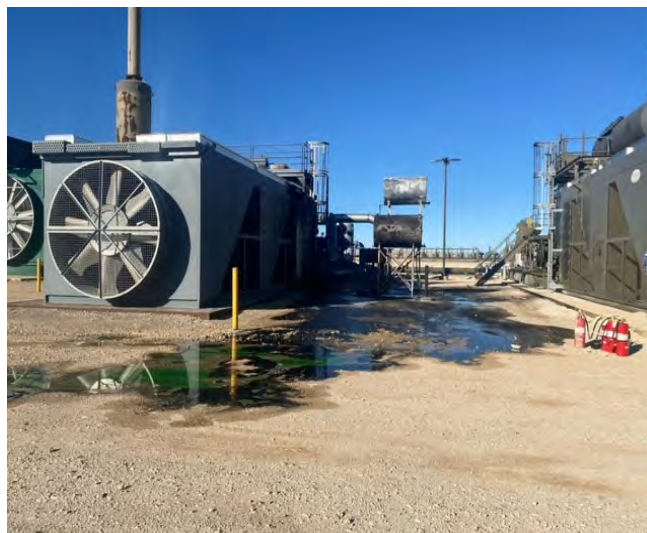
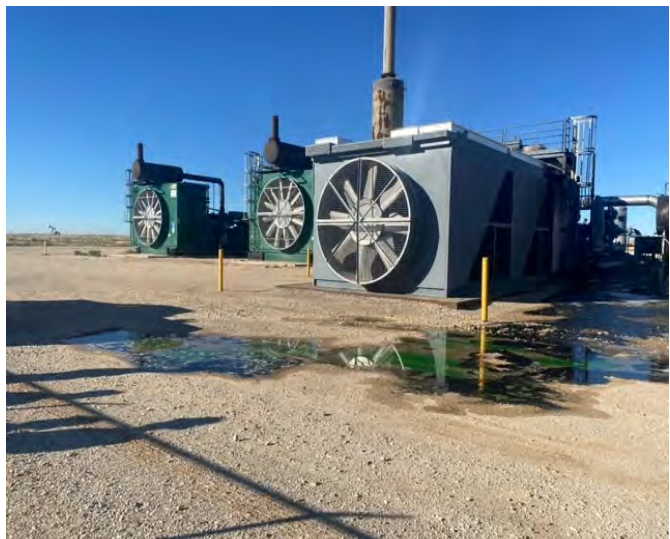
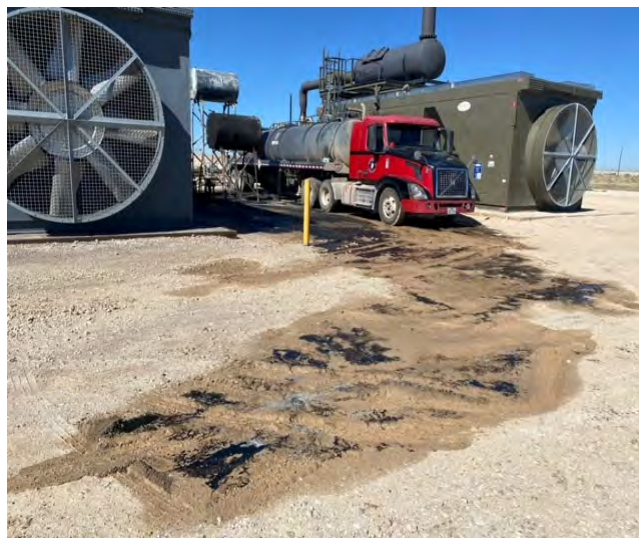
Pre-Excavation

Approximately 275 gal of the coolant / lube oil mixture was spilled onto the ground from the two day tanks—150 gal of coolant and 125 gal of lube oil. However, approximately 112 gal was recovered from the soil prior to infiltration using a vacuum truck. The remediated spill area was approximately 870 ft² and a depth up to 3 inches in some areas of the hard pack caliche soil (~163 gal).

NAPP2229871535: On October 25th, 2022, the unit three compressor liquid drain valve malfunctioned, allowing condensate to leak out of the blowdown line onto the unit four Compressor, the coolant day tank, and lube oil day tank. When the fluid hit the exhaust on the unit four compressor it ignited. The operator immediately hit the emergency shut down and used a fire extinguisher to contain the fire until the Fire Department arrived. Approximately 275 gal of the coolant/ lube oil mixture was spilled onto the ground from the two-day tanks—150 gal of coolant and 125 gal of lube oil. Approximately 112 gallons of standing fluid was recovered using a vacuum truck.

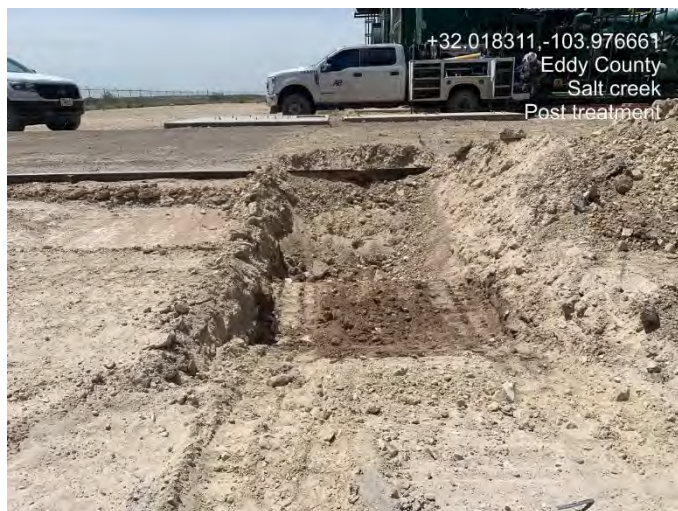
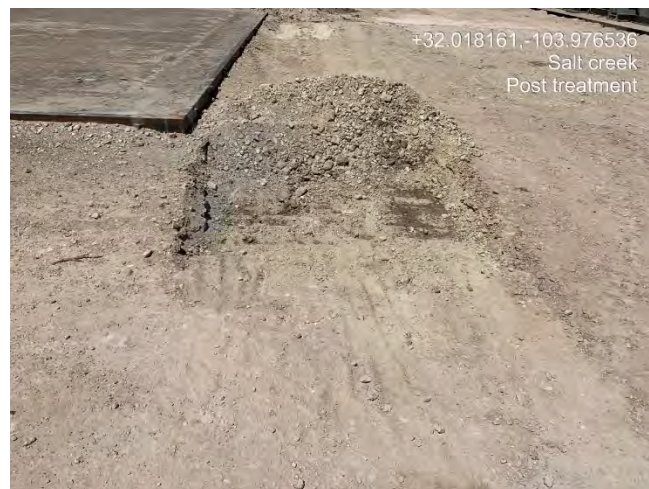
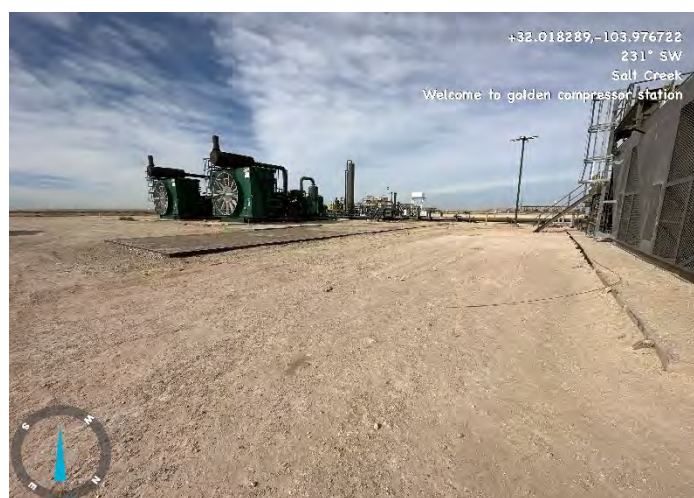
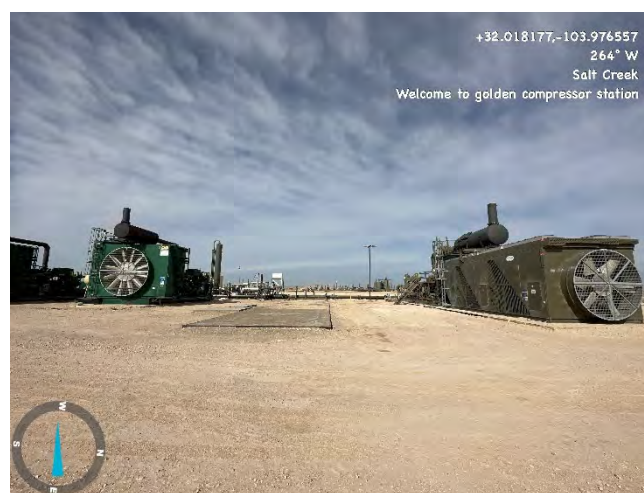
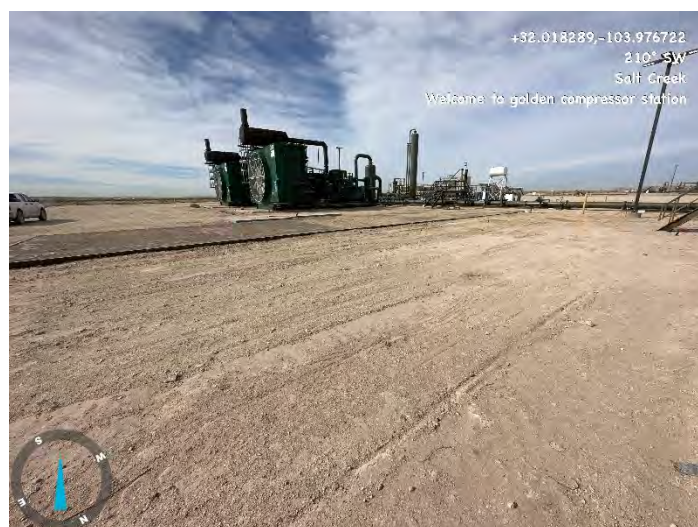
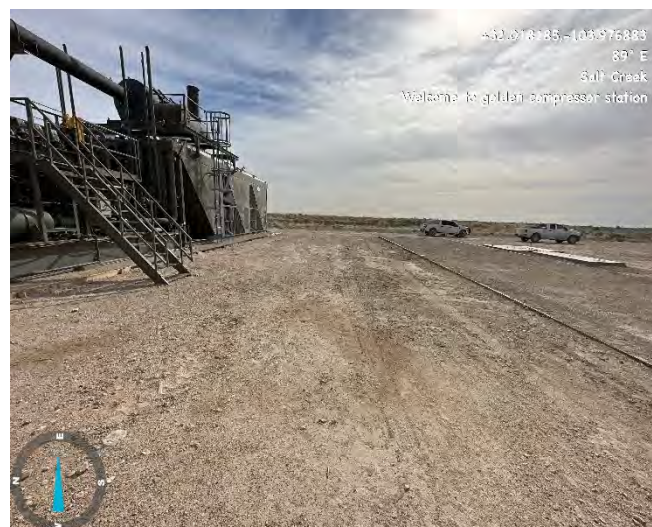
Post Excavation

On April 26th, 2023, Pima mobilized personnel and equipment to conduct remedial activities. We excavated the area overlapping soil sample (S2) to a depth of 1 foot, and the area overlapping (S3) was excavated to a depth of 6 inches bgs. Photographic documentation can be found in Appendix D.
