# Devon Energy

## Snapping 2 State 6 & 7 Battery

### CLOSURE REPORT

NAB1801849148

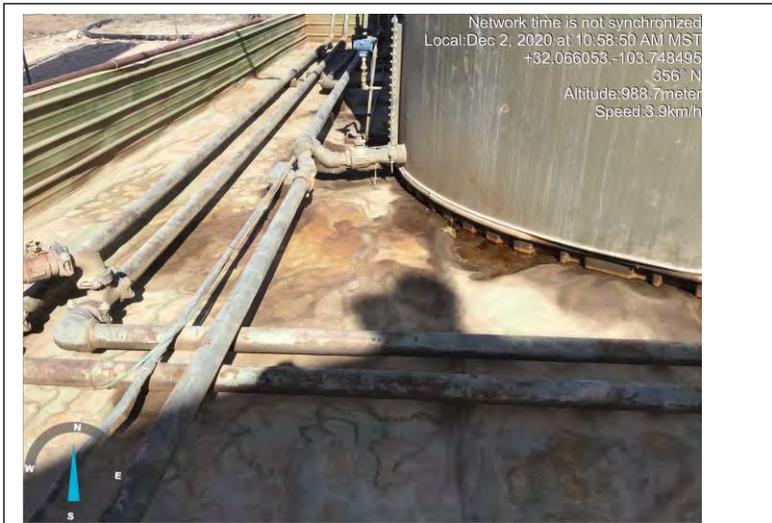
Stains at bottom of tank #2

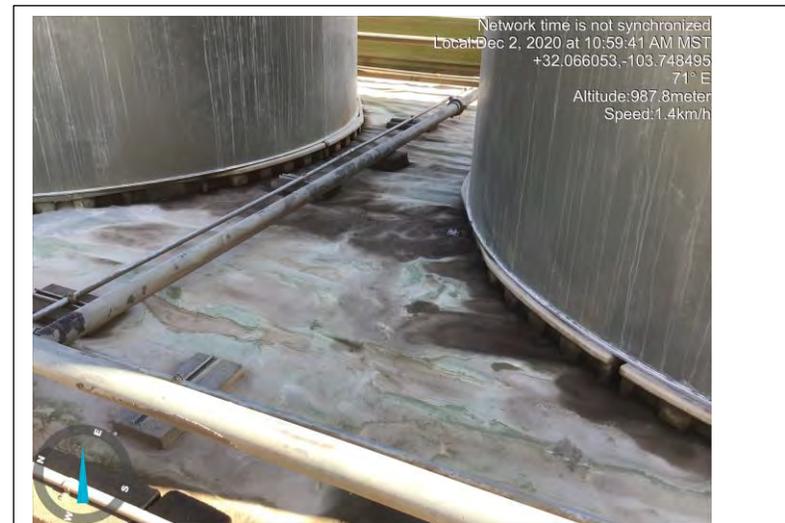
Stains at bottom of tanks #3 & #4

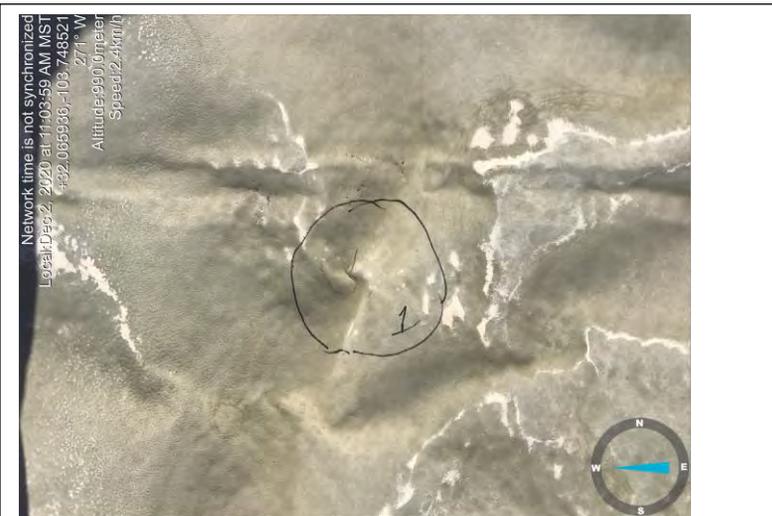
Hole in liner marked #1

On March 9, 2023, SESI collected soil samples below the liner in the locations repaired in March 2021. After the samples were taken, the liner was repaired. Samples were taken at the surface and 1-foot intervals until field testing indicated the samples to meet target levels. For liner samples #3 through #9, auger refusal was encountered at a depth of 5 and 8 inches, resulting in the collection of only surface soil samples immediately under the liner. Photo documentation is provided for your review.

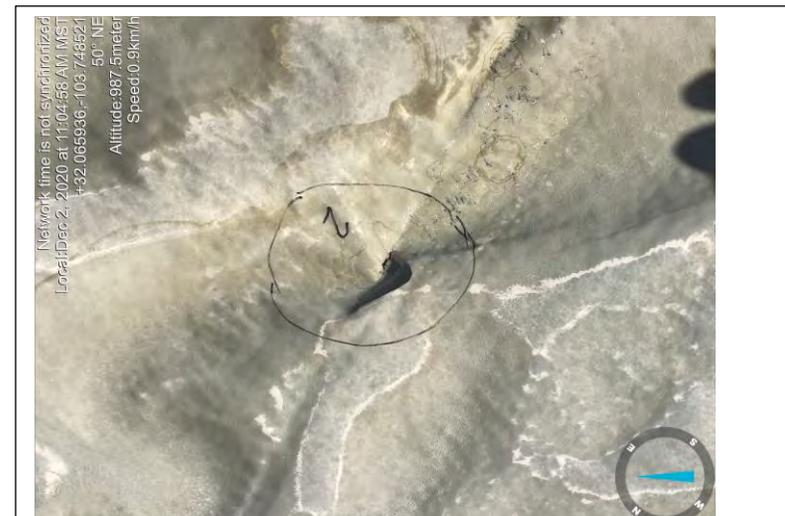
Hole in liner marked #2

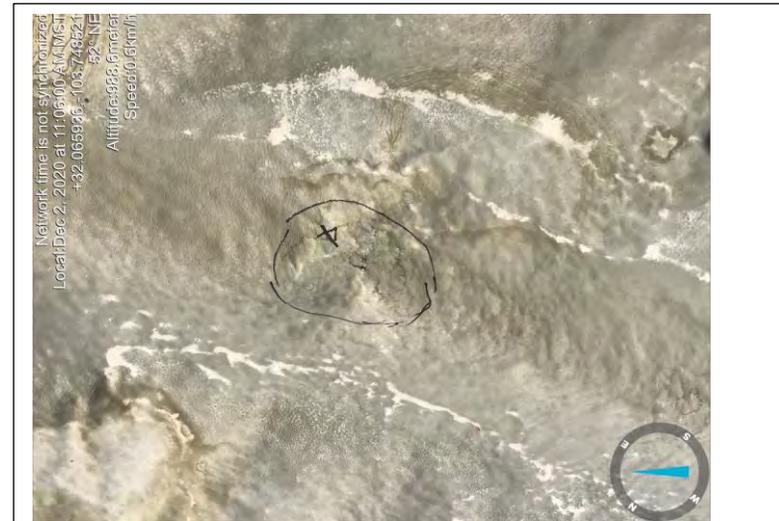
Hole in liner marked #4

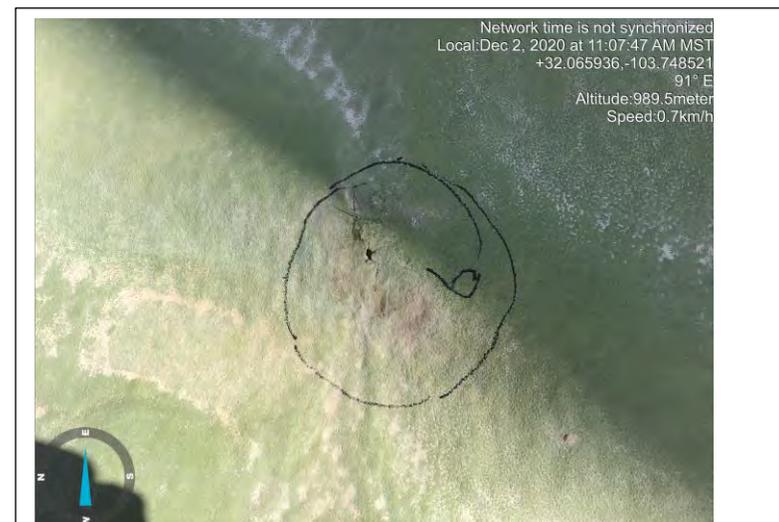
Hole in liner marked #6

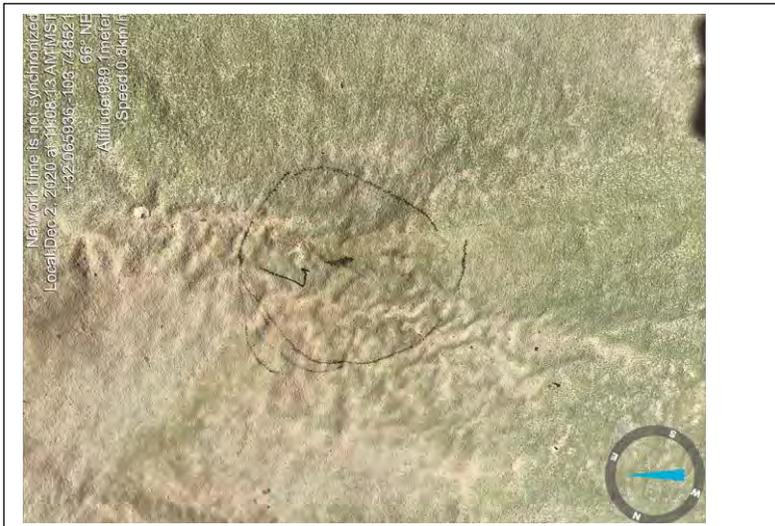
Hole in liner marked #7

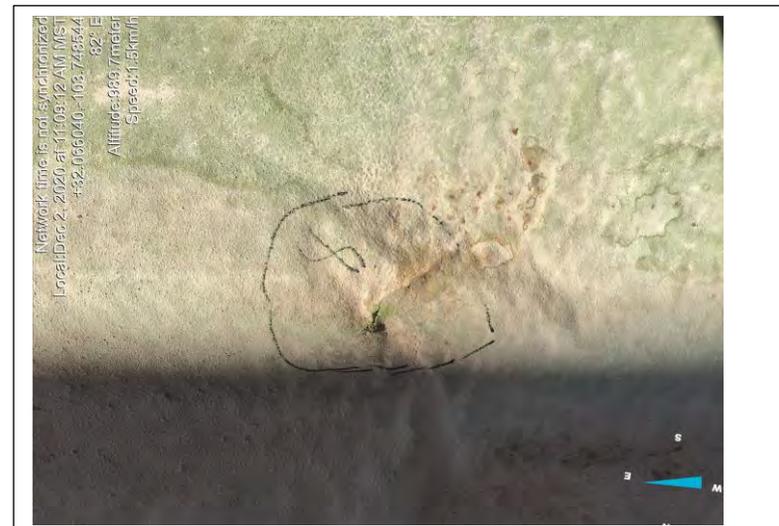
Hole in liner marked #8

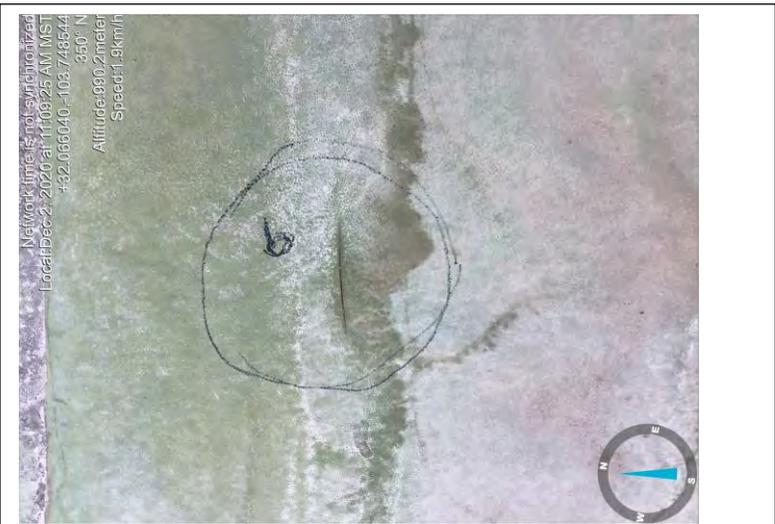
Hole in liner marked #9

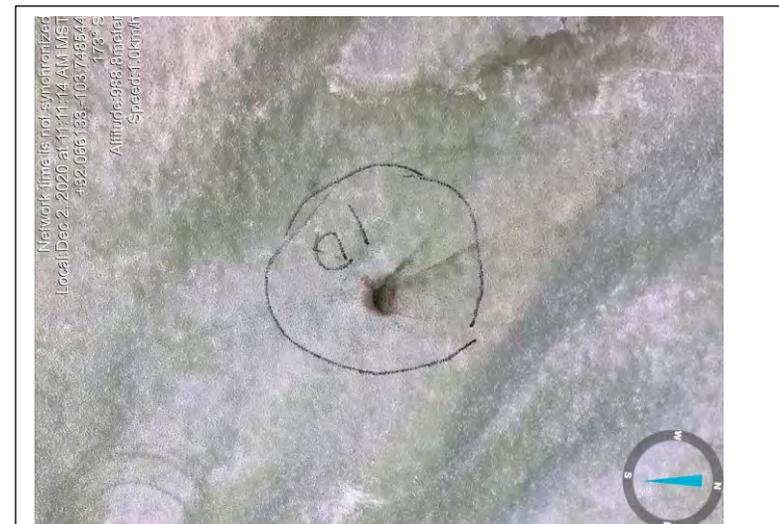
Hole in liner marked #10

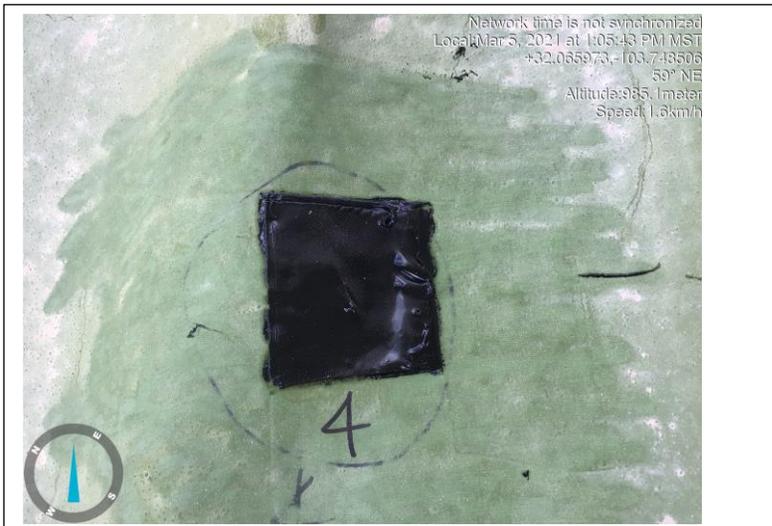
Patch repair-4

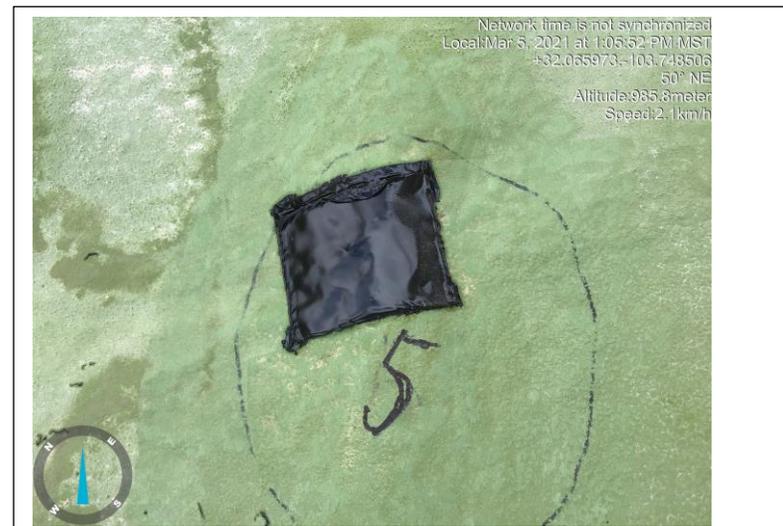
Patch repair-5

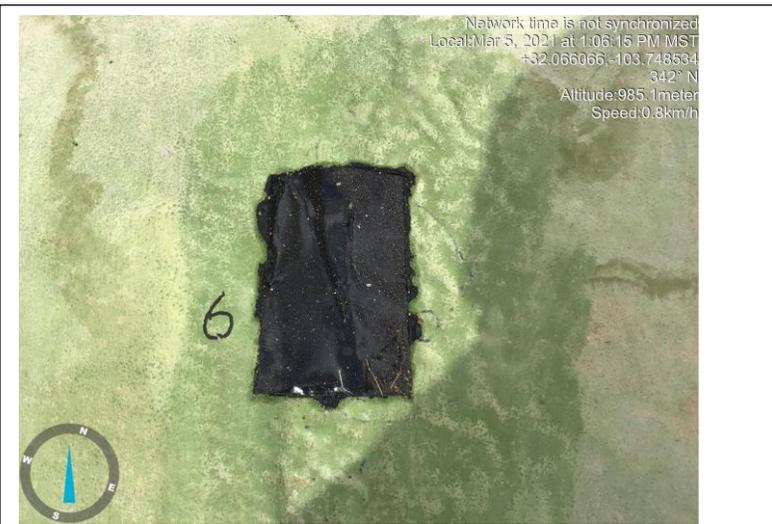
Patch repair-6

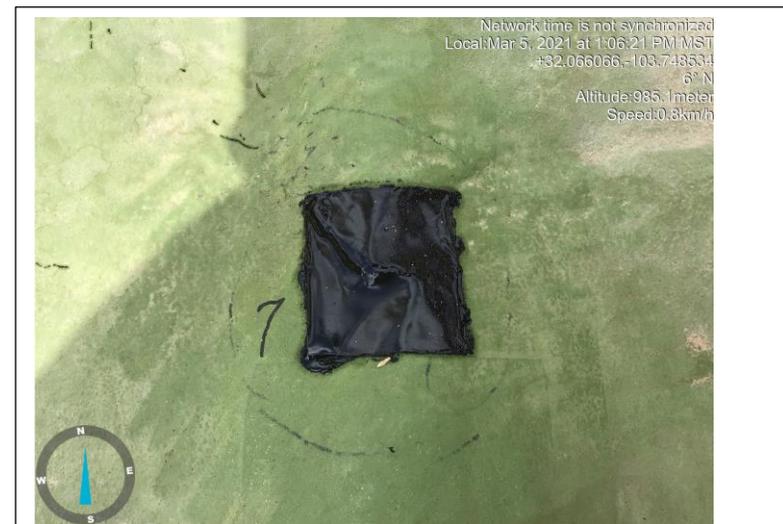
Patch repair-7

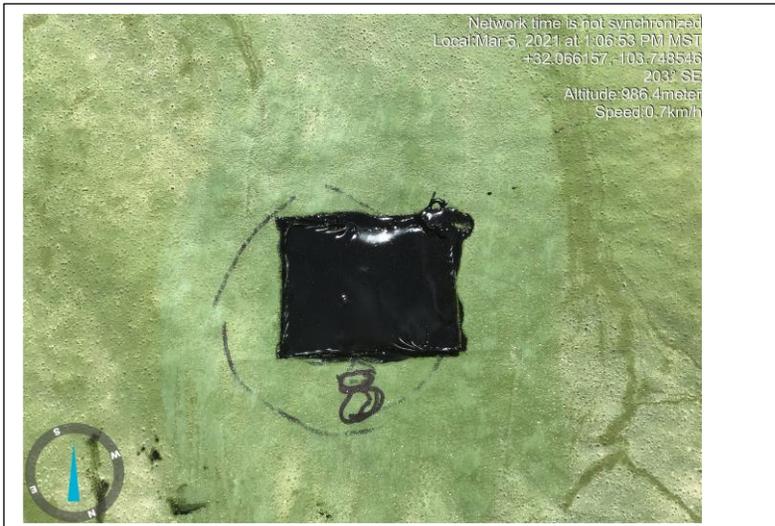
Patch repair-8

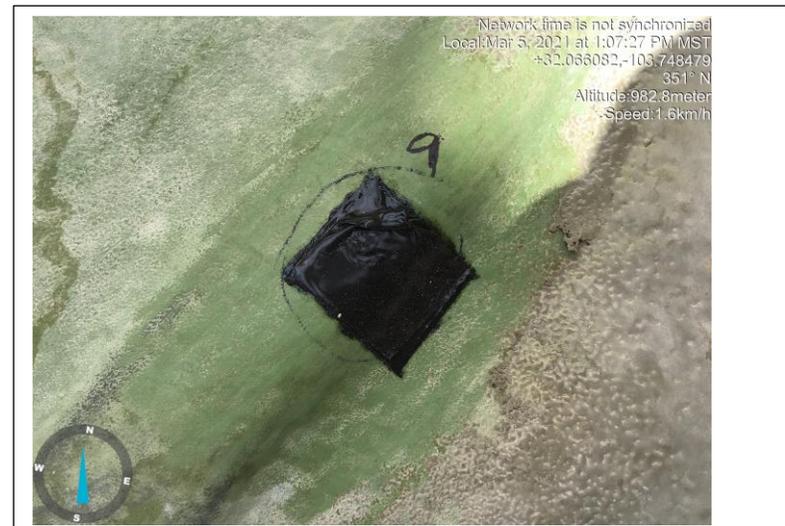
Patch repair-9
