Incident ID	nAPP2232057099
District RP	
Facility ID	
Application ID

State of New Mexico
Oil Conservation Division

Based on laboratory analytical results and field activities conducted to date, Etech recommends Spur Energy Partners, LLC, provide copies of this *Remediation Summary and Soil Closure Request* to the appropriate agencies and request closure be granted to the Halberd 27 State Com South site.

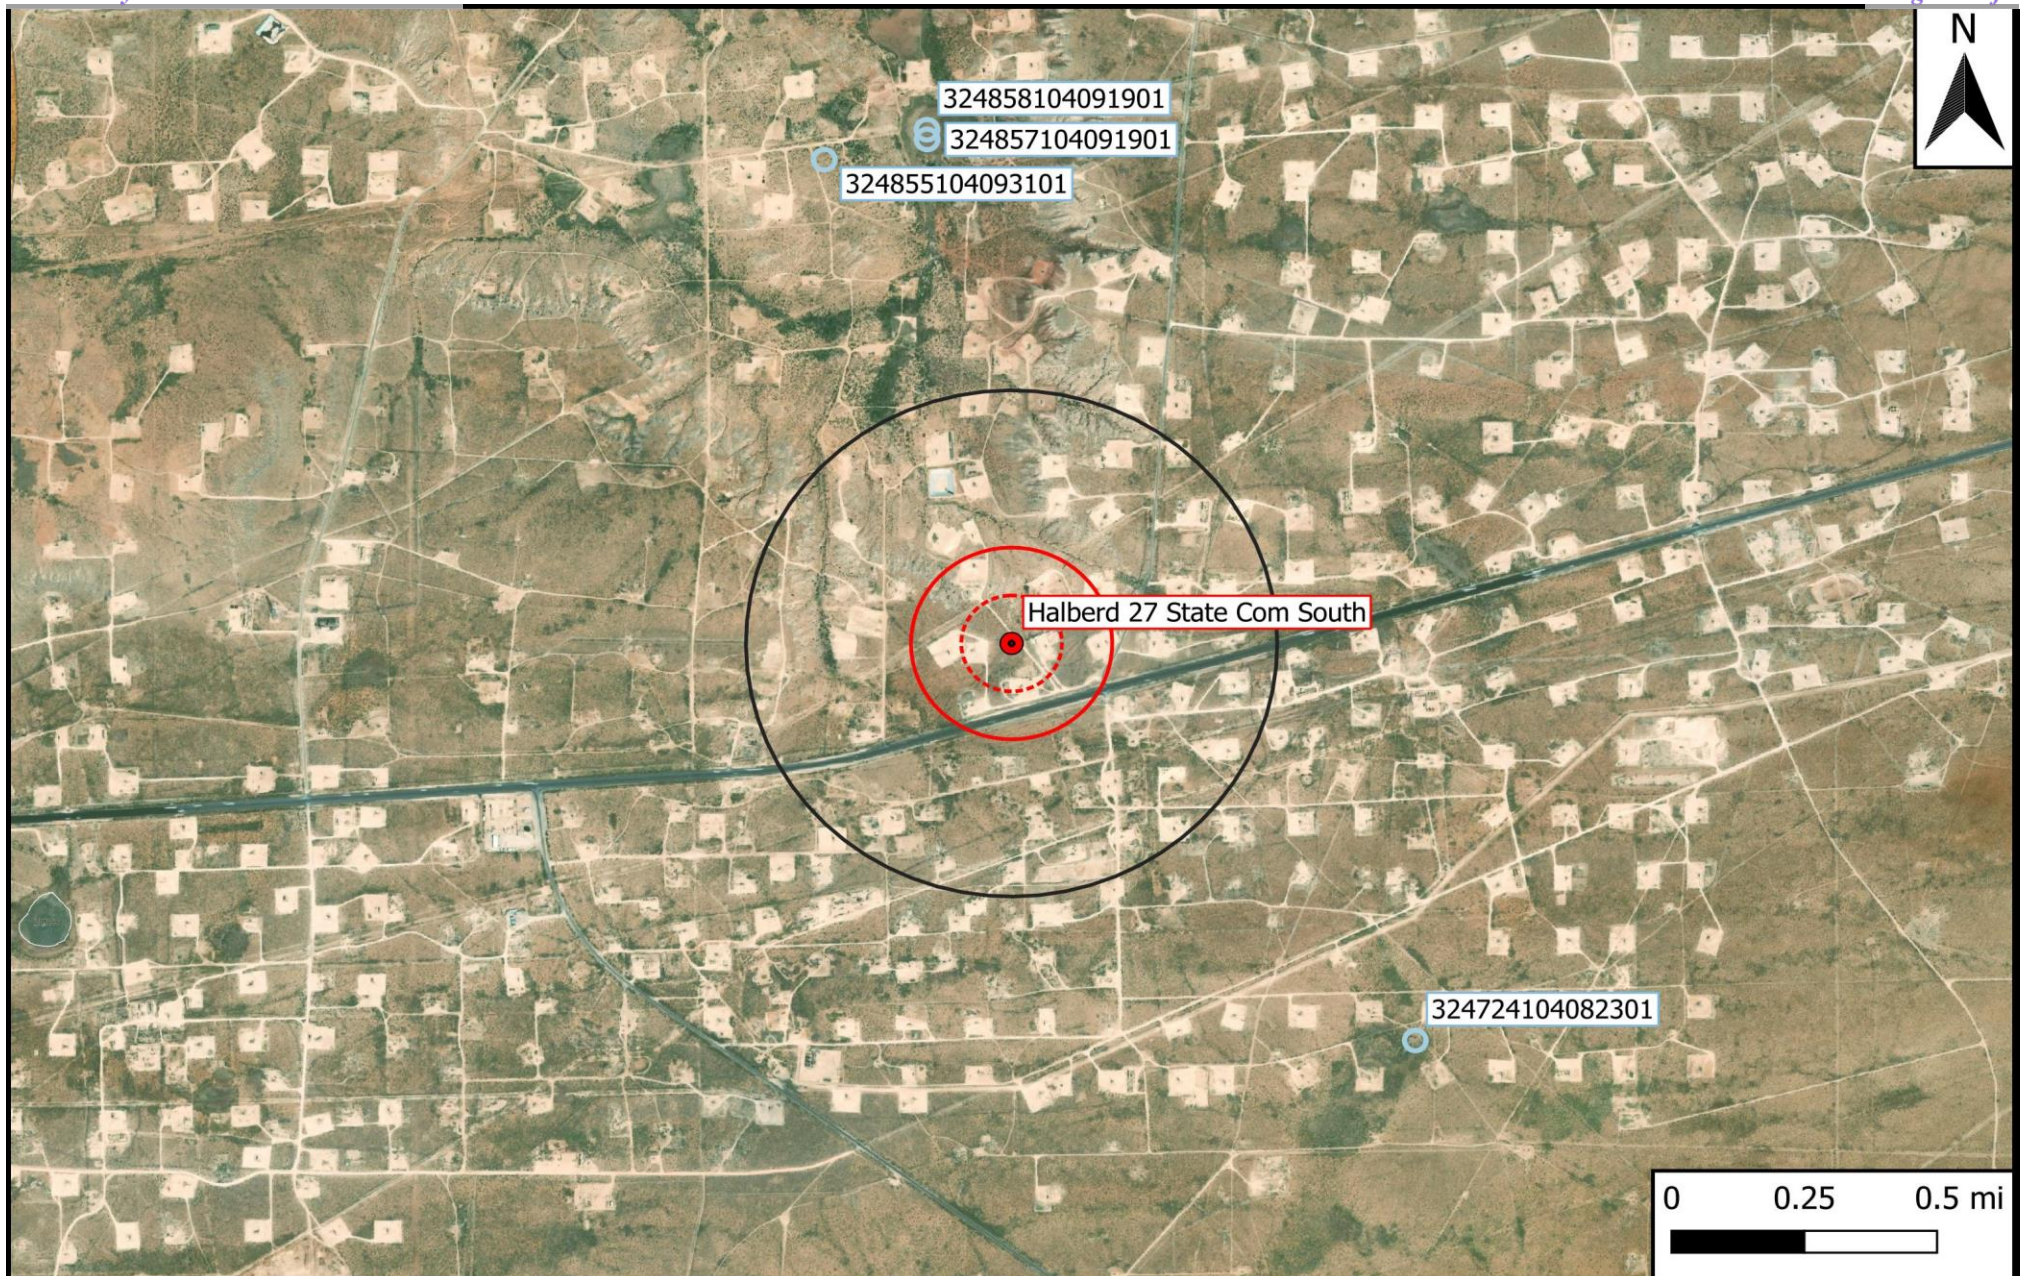
Figure 2

Aerial Proximity Map

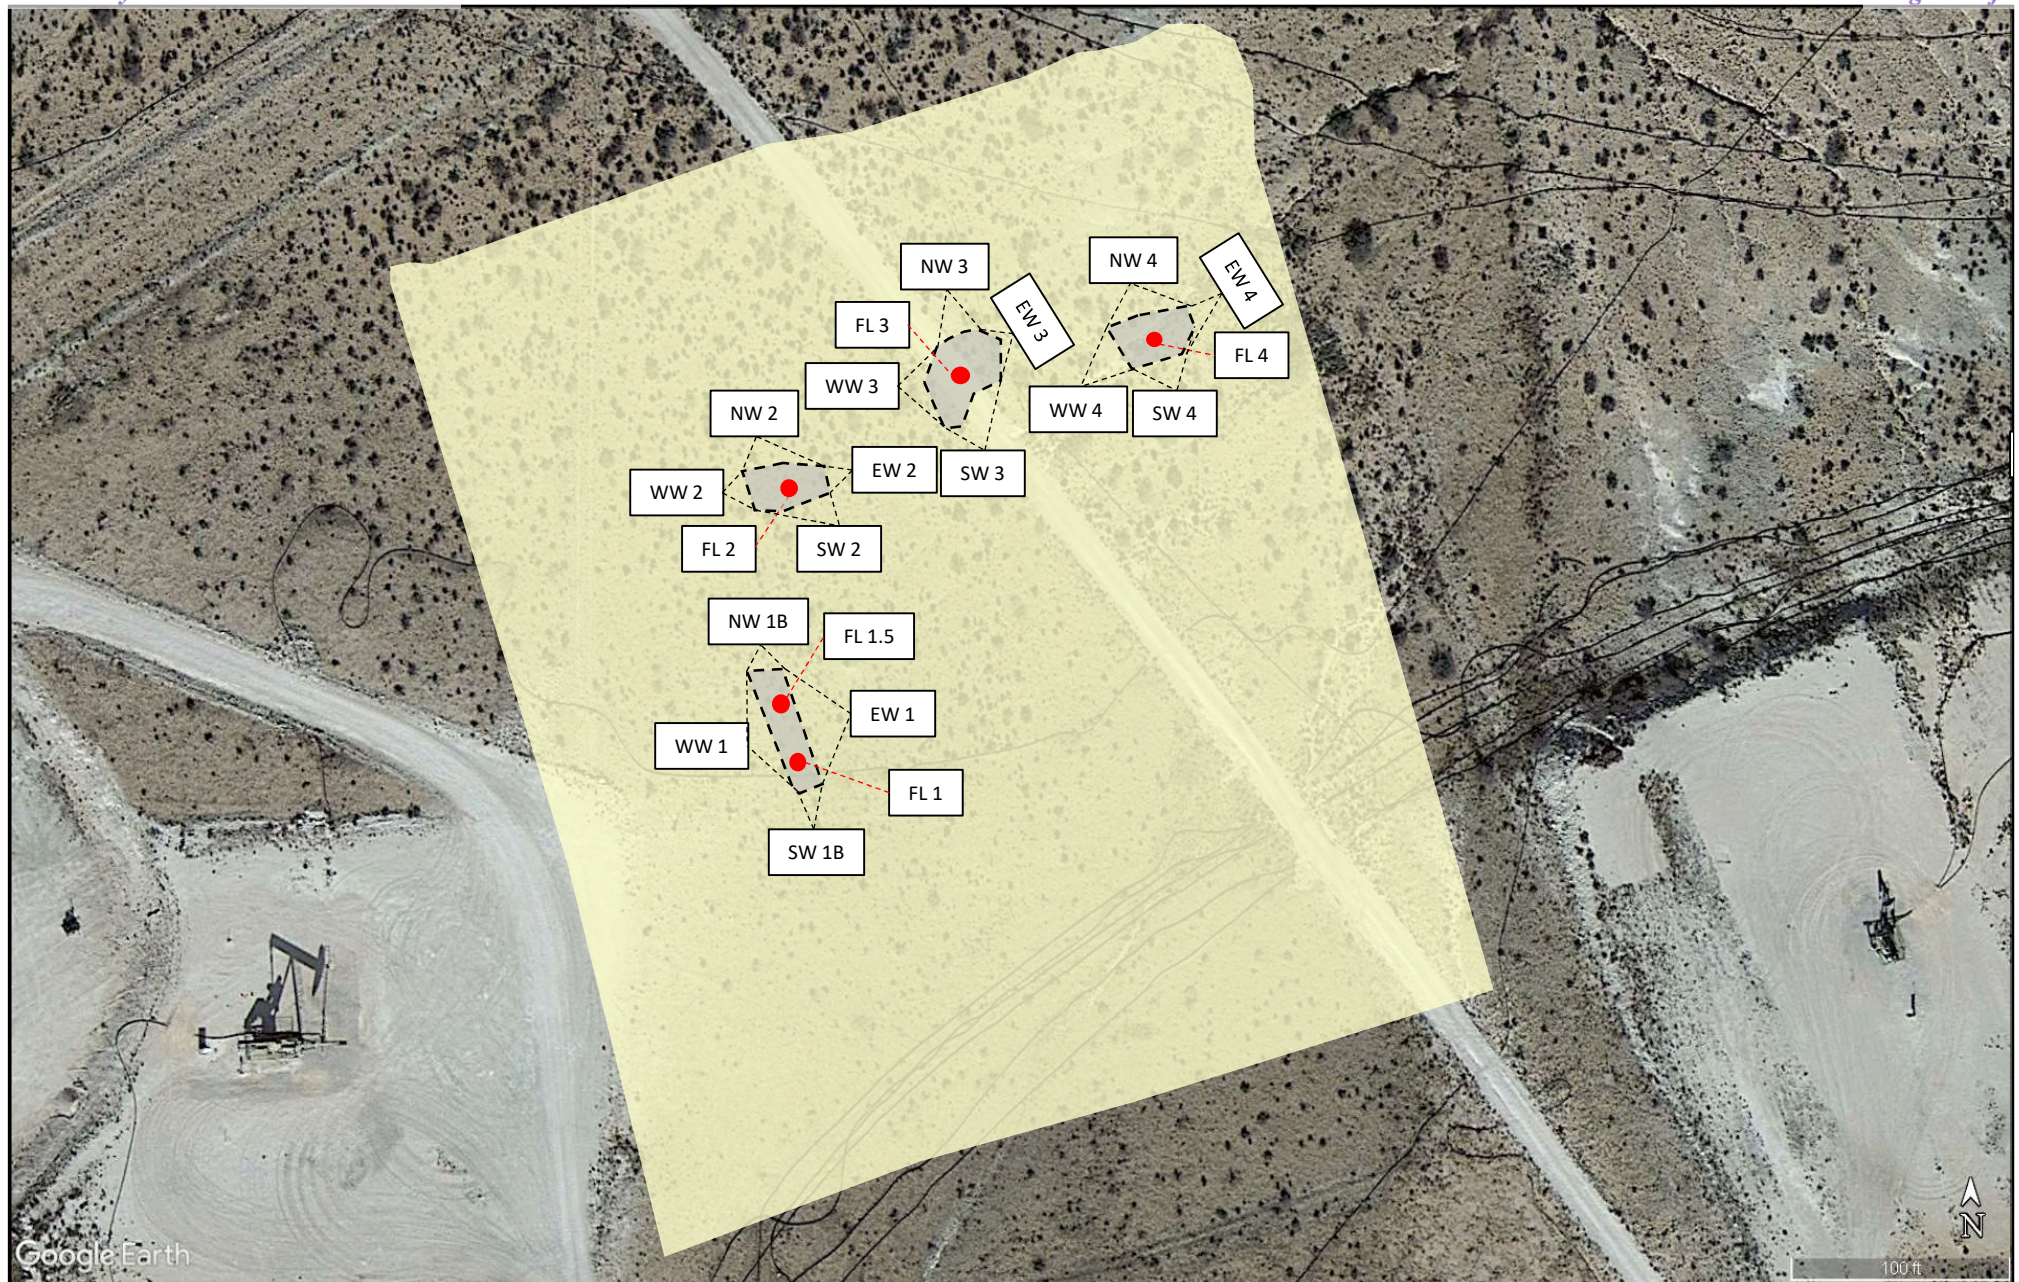
Figure 3

Site and Sample Location Map

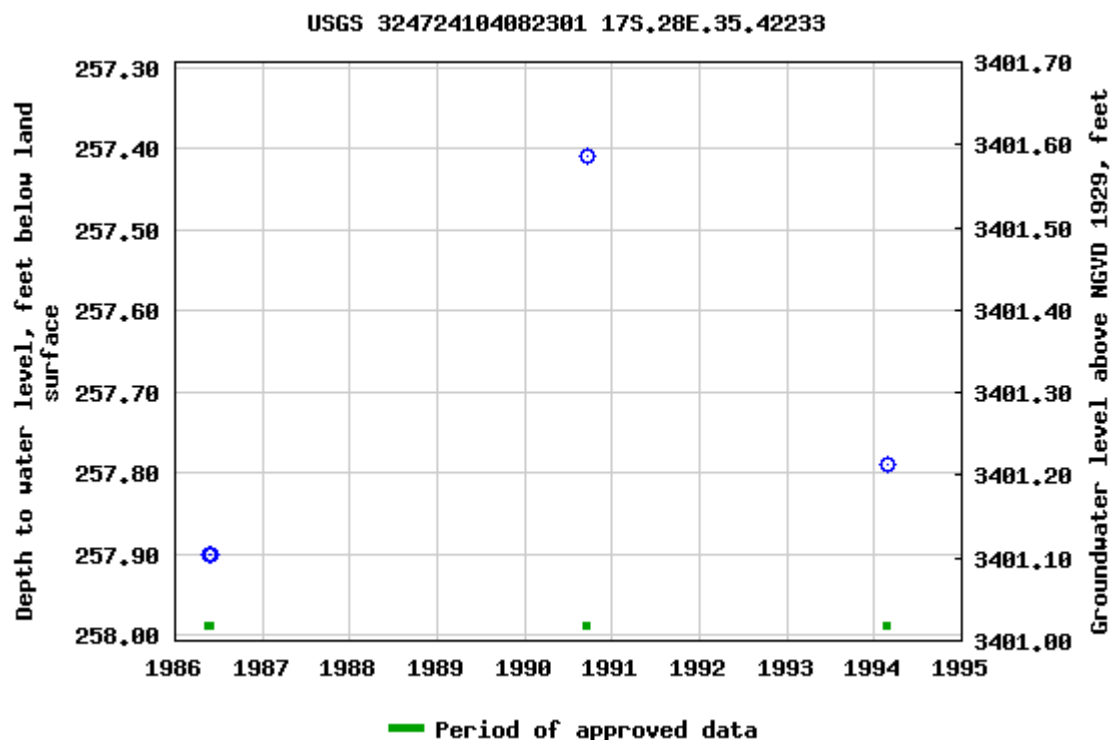
This well is completed in the Rustler Formation (312RSLR) local aquifer.

Breaks in the plot represent a gap of at least one year between field measurements.
