Re: Site Assessment, Remediation, and Closure Report
Cotton Draw Unit 219 CTB
API No. N/A
GPS: Latitude 32.152444 Longitude -103.743712
UL -- P, 2, T25S, R31E
Eddy County, NM
NMOCD Ref. No. NAPP2302324687

Cotton Draw Unit 219 CTB| [Devon Energy](#)

SITE PHOTOGRAPHS
DEVON ENERGY
COTTON DRAW 219 BATTERY

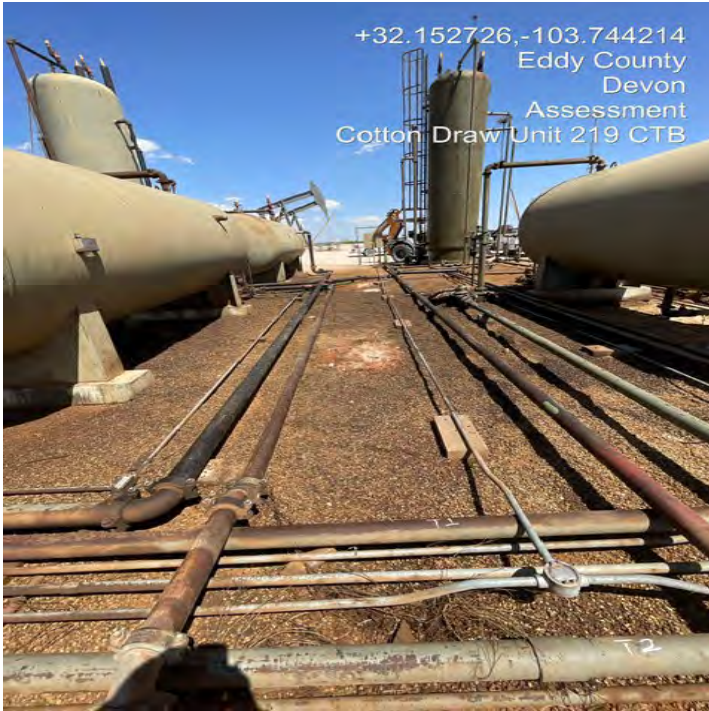
Site Assessment

NAPP2302324687: On January 20, 2023, a gasket on the manway developed a leak. The released fluids were calculated to be approximately 9 barrels (bbls) of crude oil. A vacuum truck was able to recover 8 bbls of standing fluid.

+32.152726,-103.744214
Eddy County
Devon
Assessment
Cotton Draw Unit 219 CTB

+32.152678,-103.744122
Eddy County
Devon
Assessment
Cotton Draw Unit 219 CTB

+32.152658,-103.744018
Eddy County
Devon
Assessment
Cotton Draw Unit 219 CTB

On May 2, 2023, the Devon Construction Department mobilized personnel and equipment to begin remediation activities. They began excavating the area to a depth of 2' BGS. Approximately 11 cubic yards of contaminated soil were hauled to an approved, lined disposal facility and clean backfill material was brought in.

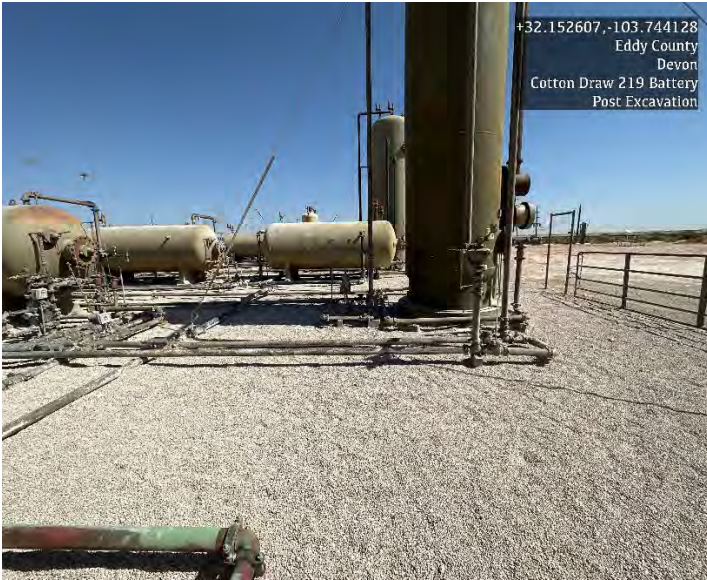
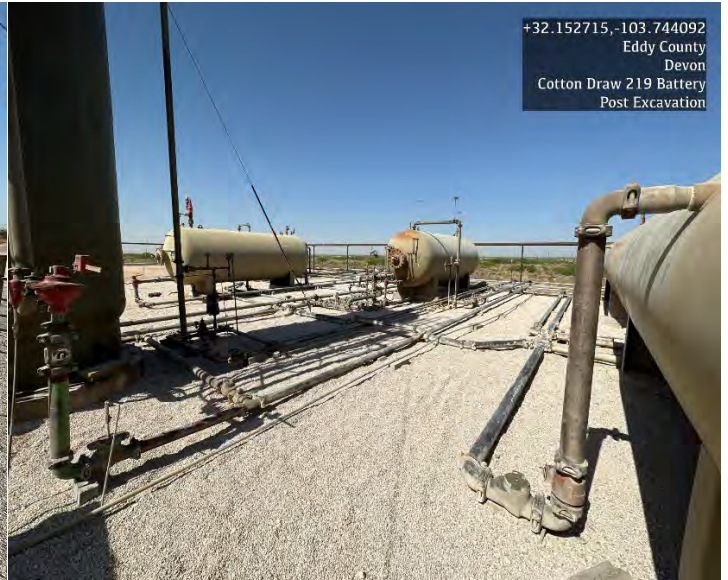
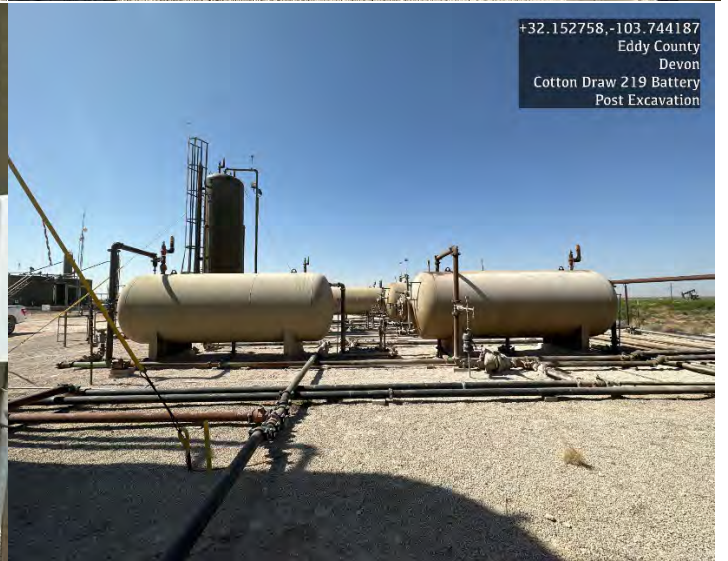
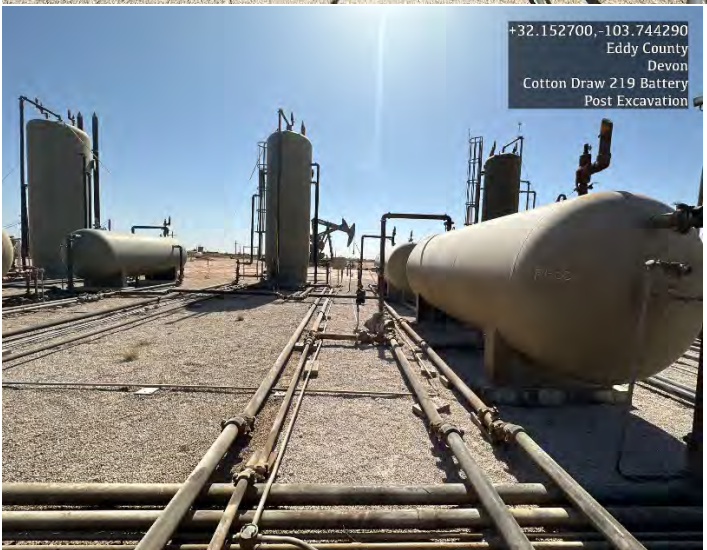
Post Excavation

Based on the sample results, the bottoms and sidewalls were below NMOCD Closure Criteria 19.15.29 NMAC. The contaminated material was removed then transported to an NMOCD approved disposal site. The excavation was then backfilled with clean like material, machine compacted and returned to its previous state. See Appendix D for Photographic Documentation.
