Incident ID	nAPP2310037542
District RP	
Facility ID	
Application ID

Fire gasket tube failure released a mix of oil and produced water into lined containment with a small overspray area outside containment.

Based on laboratory analytical results and field activities conducted to date, Etech recommends Spur Energy Partners, LLC, provide copies of this *Remediation Summary and Soil Closure Request* to the appropriate agencies and request closure be granted to the Arkansas 23 Fee #004 site.

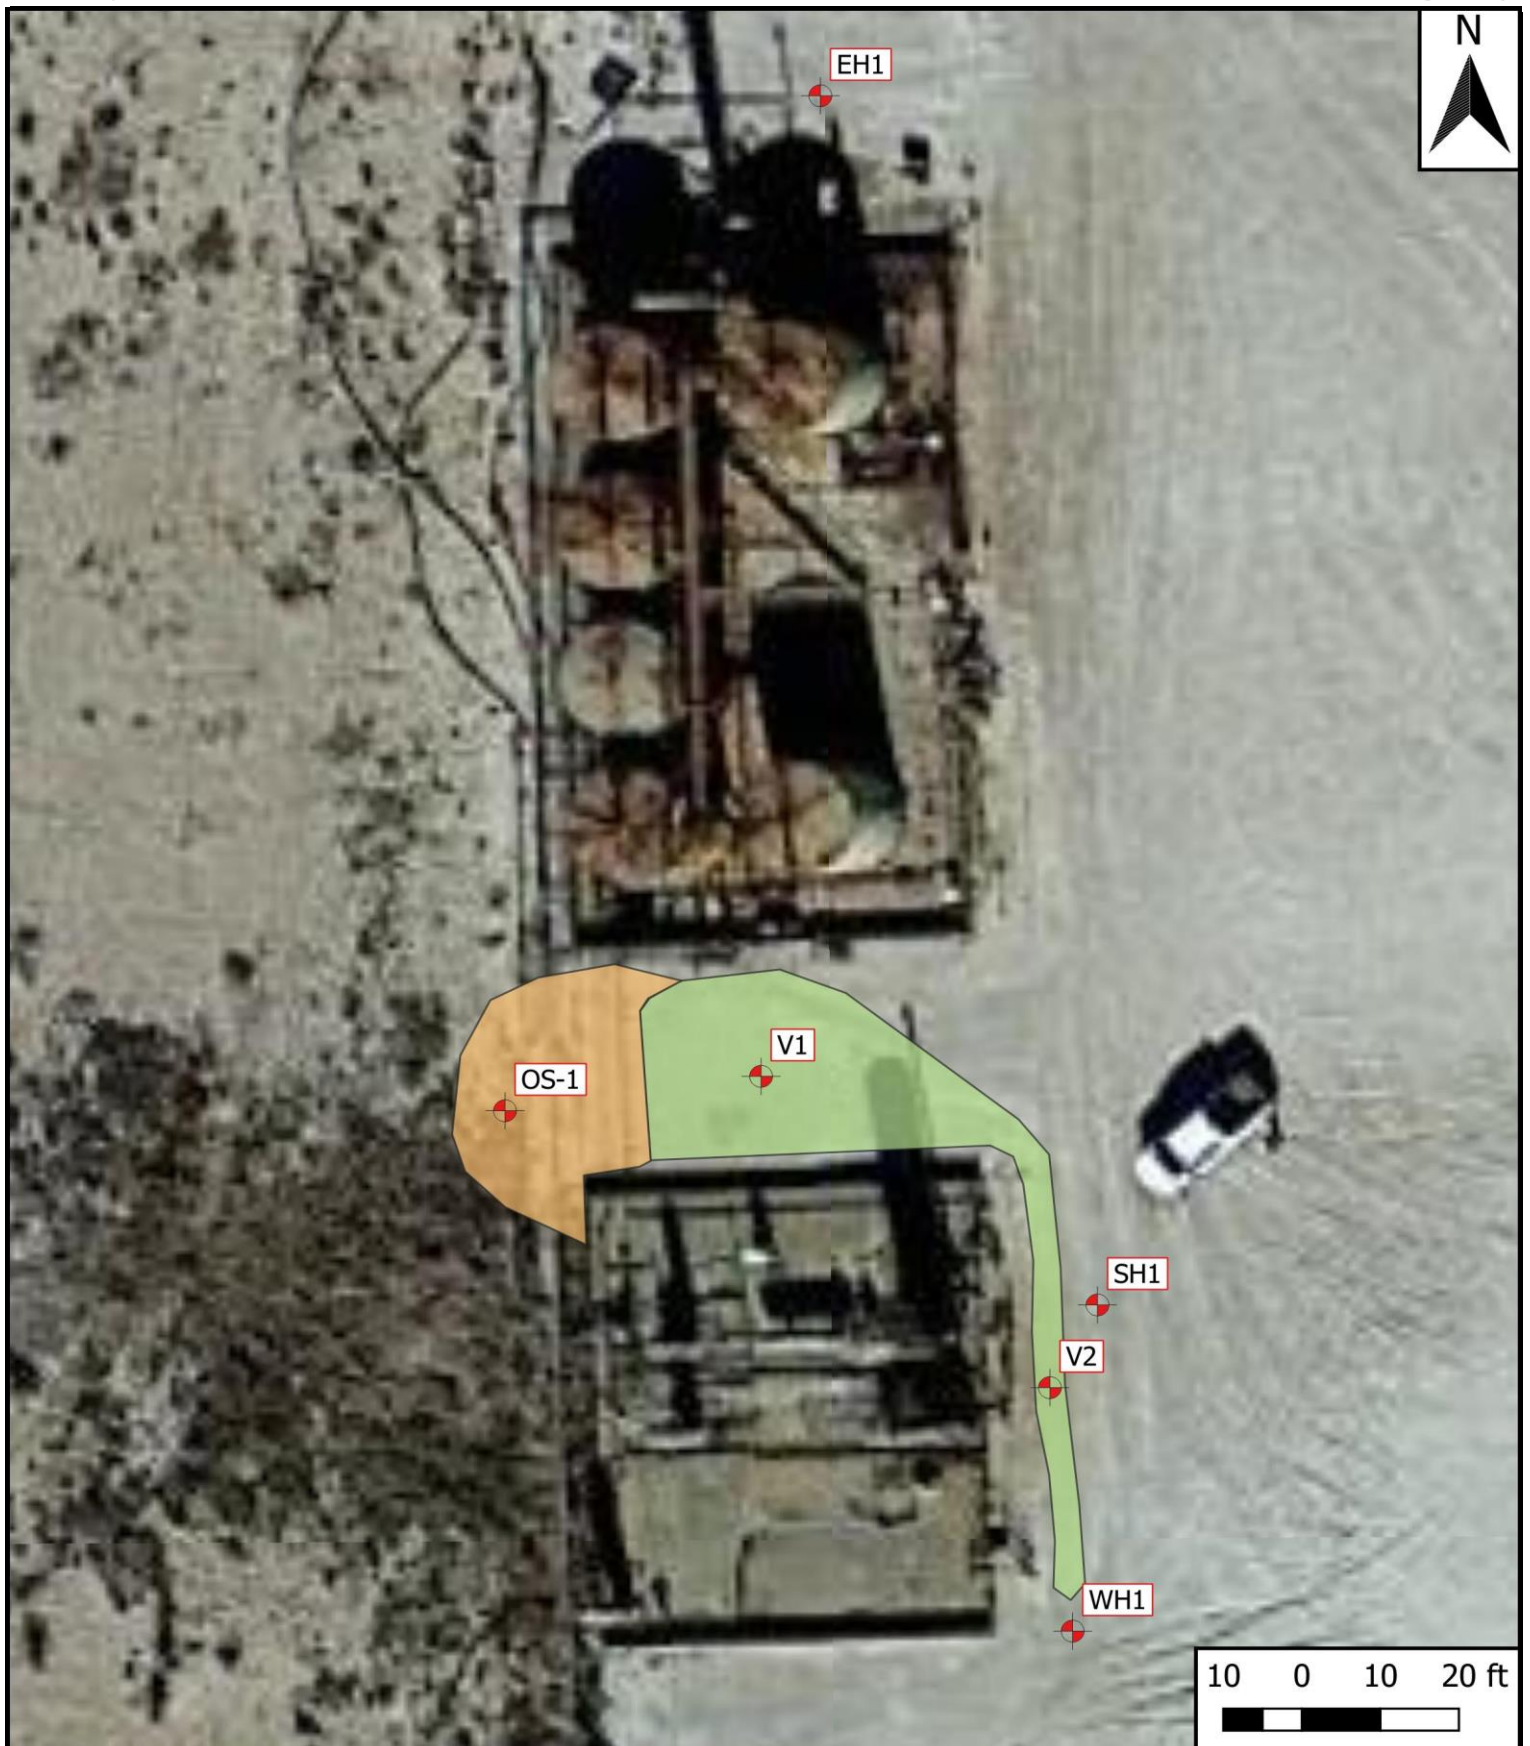
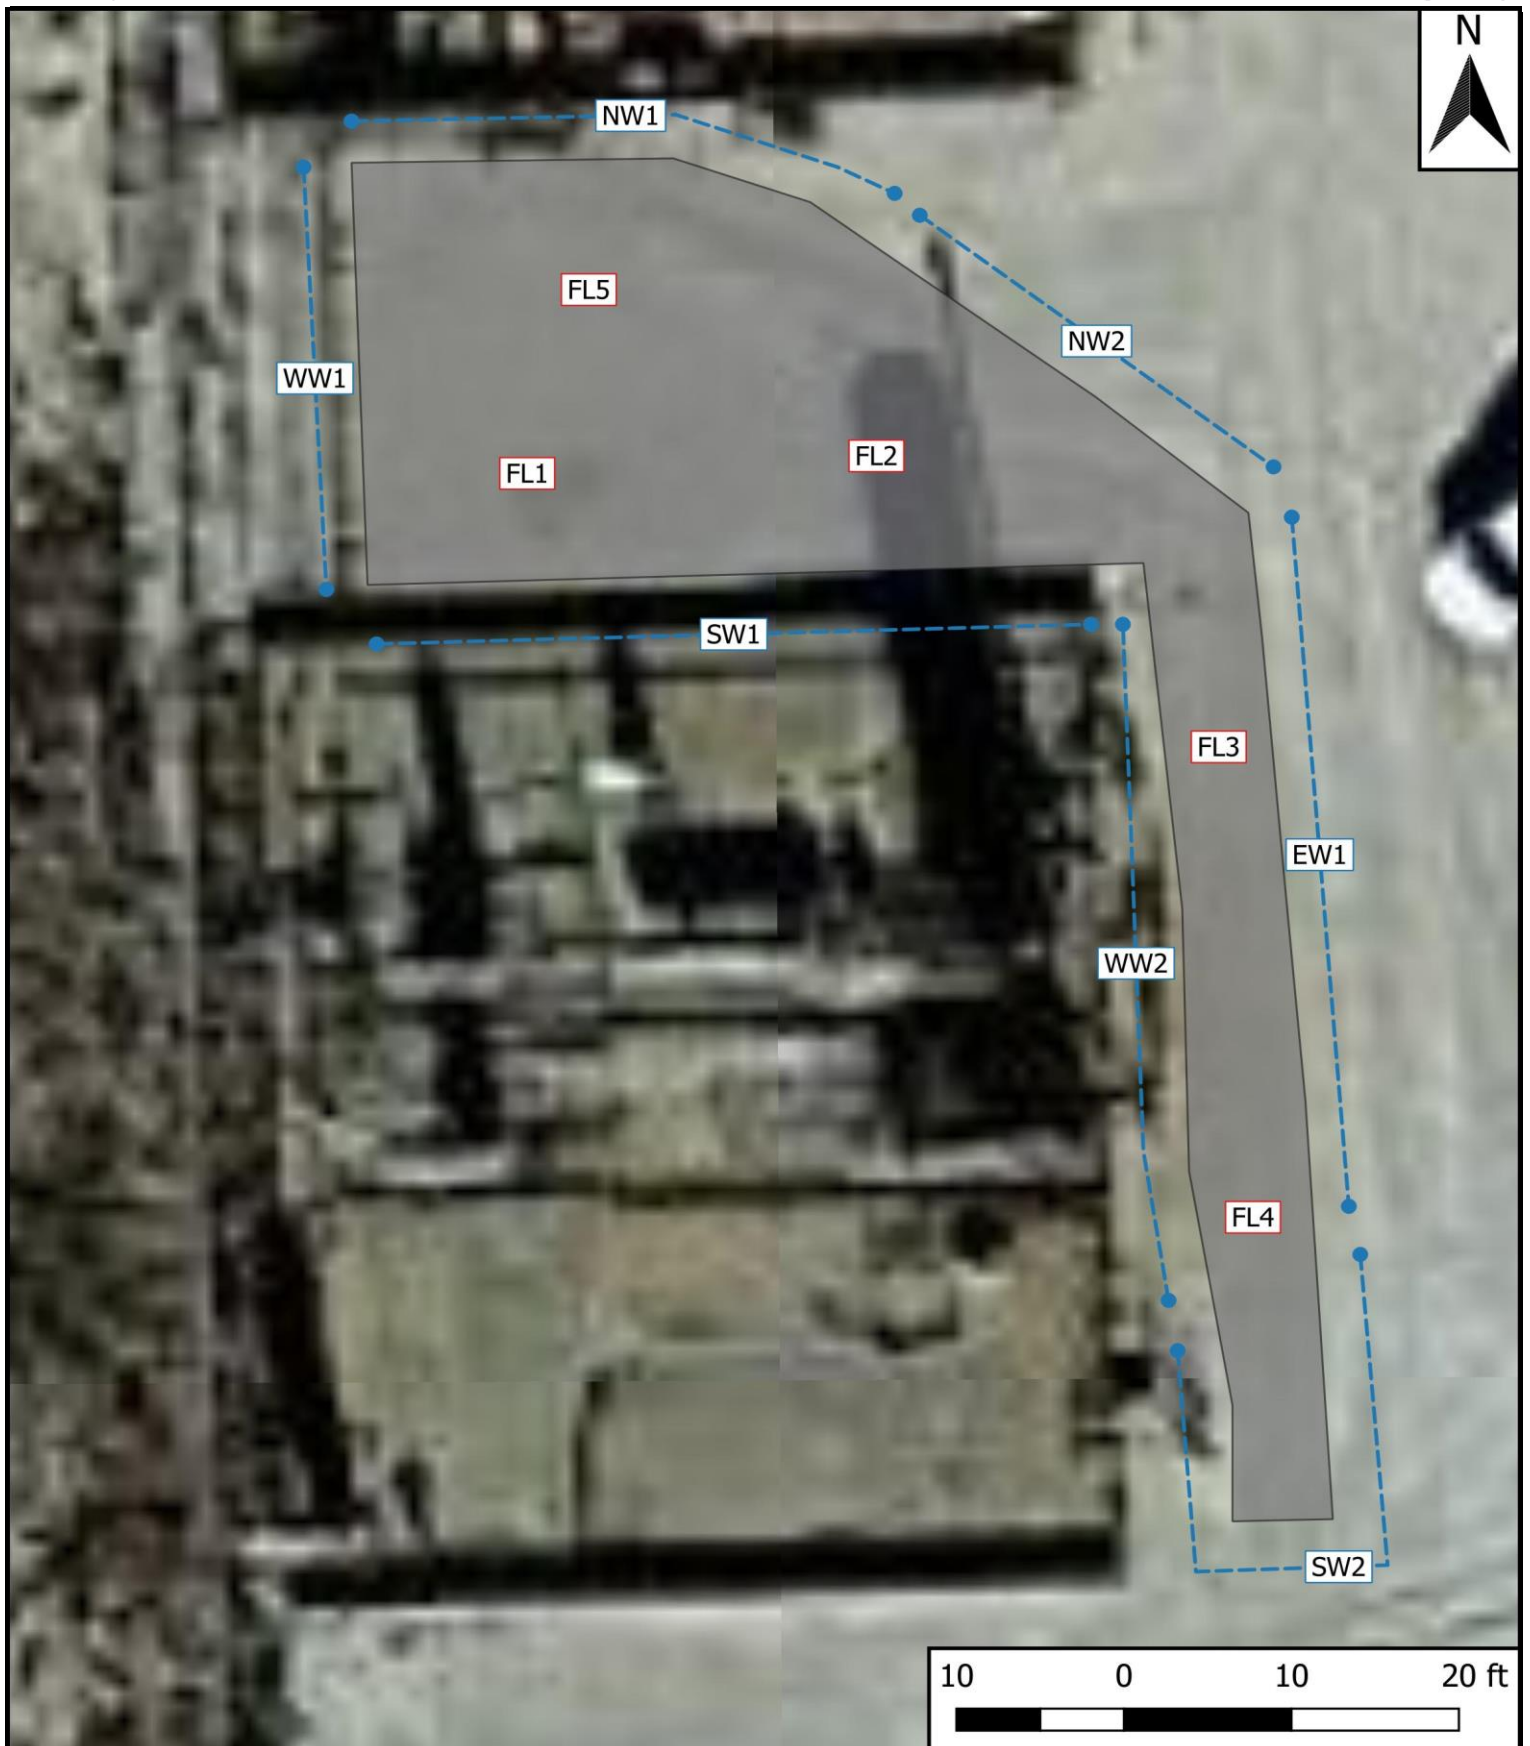
## **Figures 3A and 3B Sample Location Maps**

- Floor Sample
- Wall Sample
- Excavated Area

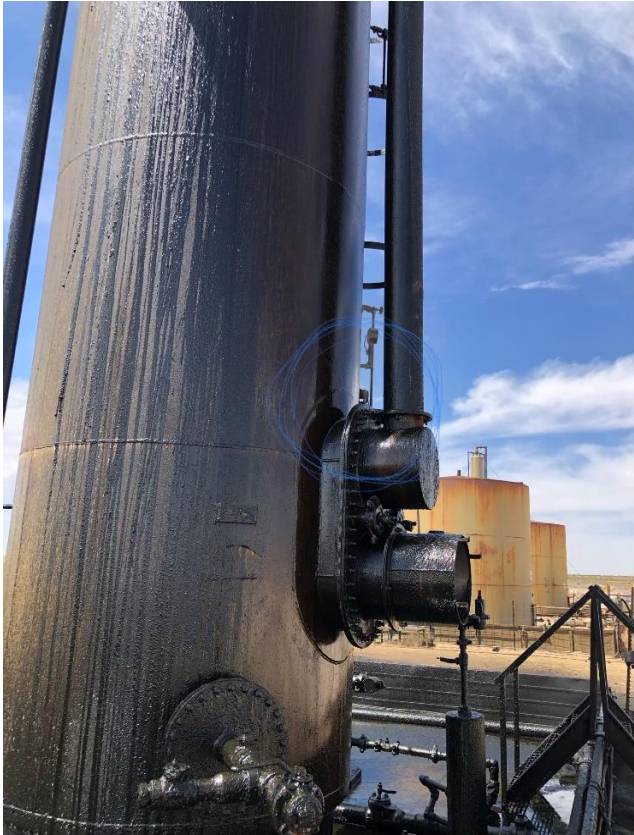
<b>Photo Number:</b> 2

<b>Photo Direction:</b> North	
<b>Photo Description:</b>  View of release area.
