May 22, 2023

Vertex Project #: 22E-02545

Spill Summary Report: Wiser State #002 Flowline
Section 09, Township 21 South, Range 26 East
API: 30-015-26461
County: Eddy

2023 Spill Assessment and Closure
May 2023

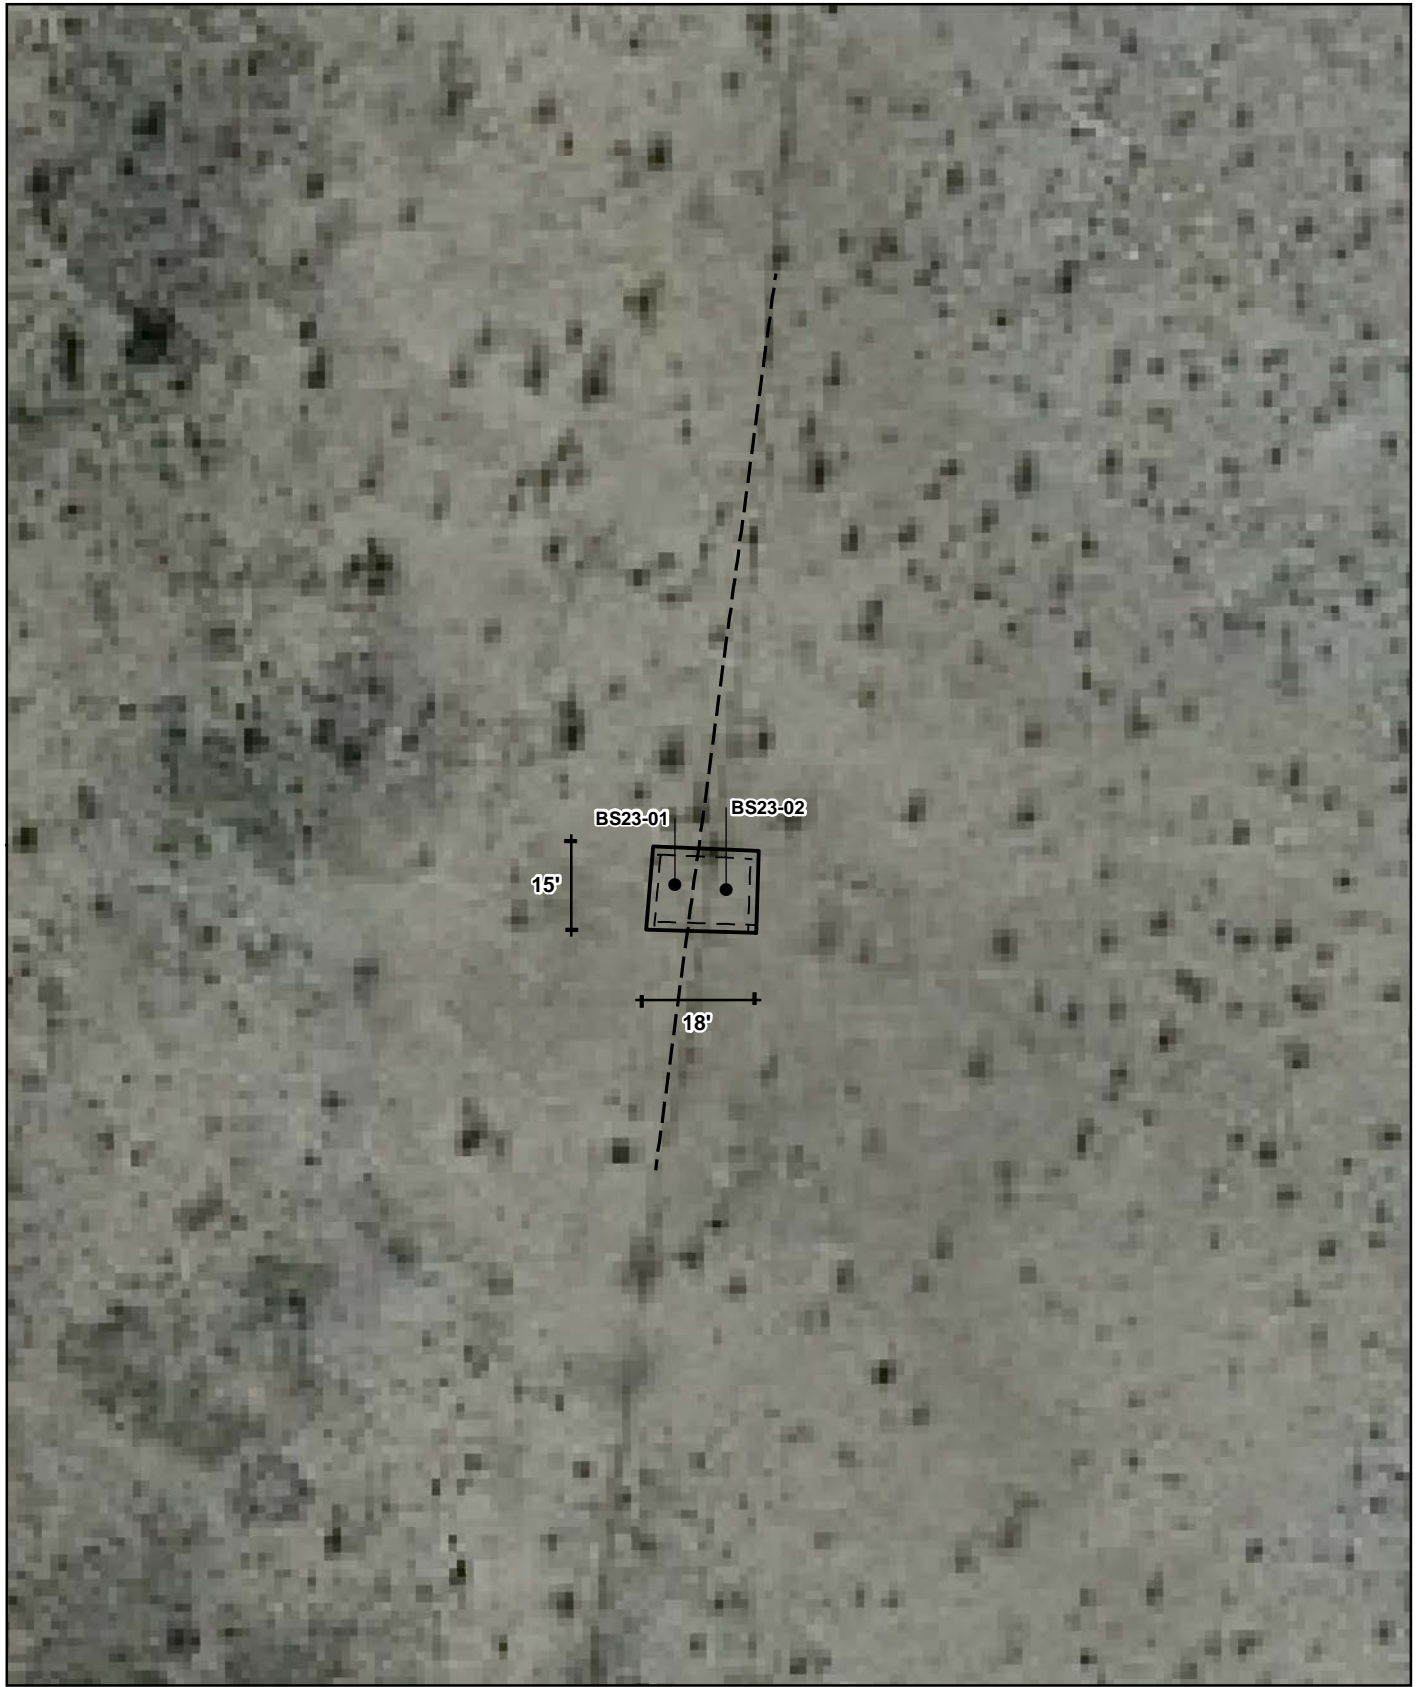
ATTACHMENT 1

The site is located approximately 0.72 miles east of the McNew Subdivision of Carlsbad, New Mexico. The legal location for the site is Section 09, Township 21 South and Range 26 East in Eddy County, New Mexico. The release area is located on State property. An aerial photograph and site schematic are presented on Figure 1, Attachment 1.

● Base Sample - - - Flowline (Aboveground)

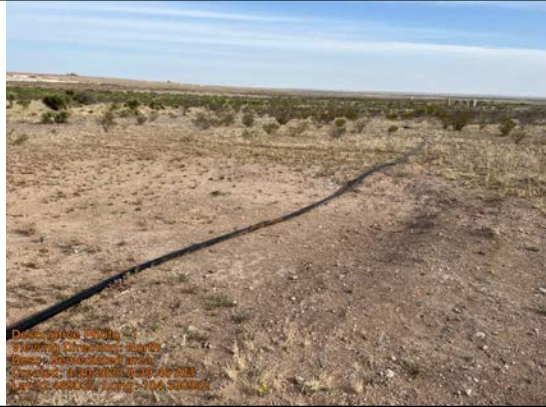
Viewing Direction: North

Remediated area

The area was fully remediated and backfilled with local soils. Confirmatory samples were analyzed by the laboratory and found to be below allowable concentrations as per the New Mexico Administrative Code (NMAC) Closure Criteria for Soils Impacted by a Release locations “under 50 feet to groundwater”. Based on these findings, Tascosa Energy Partners, LLC requests that no further action is needed.

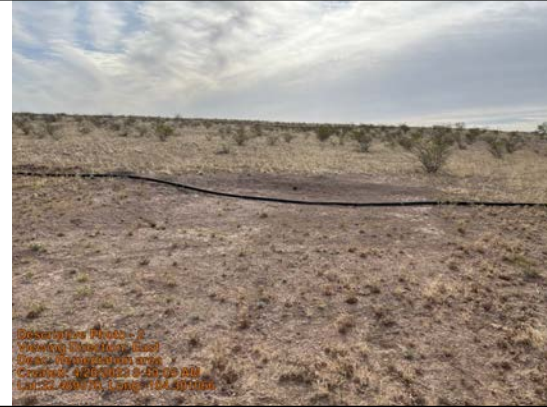
Viewing Direction: East

Remediation area

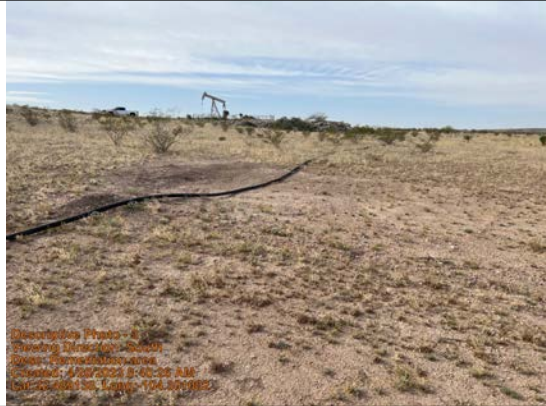
Viewing Direction: South

Remediation area

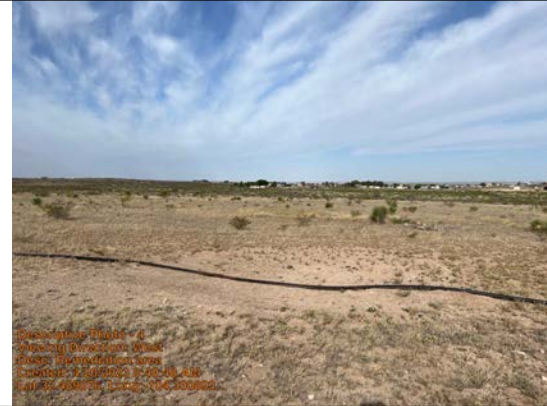
Viewing Direction: West

Remediation area
