nJMW1317737425 – Dozier Federal Com 1 (06.16.2013)

Release Notification and Corrective Action

Subject: **Soil Assessment and Remediation Work Plan**
Cimarex Energy
Dozier Fed Com No. 1
30-015-10804 2RP-1689

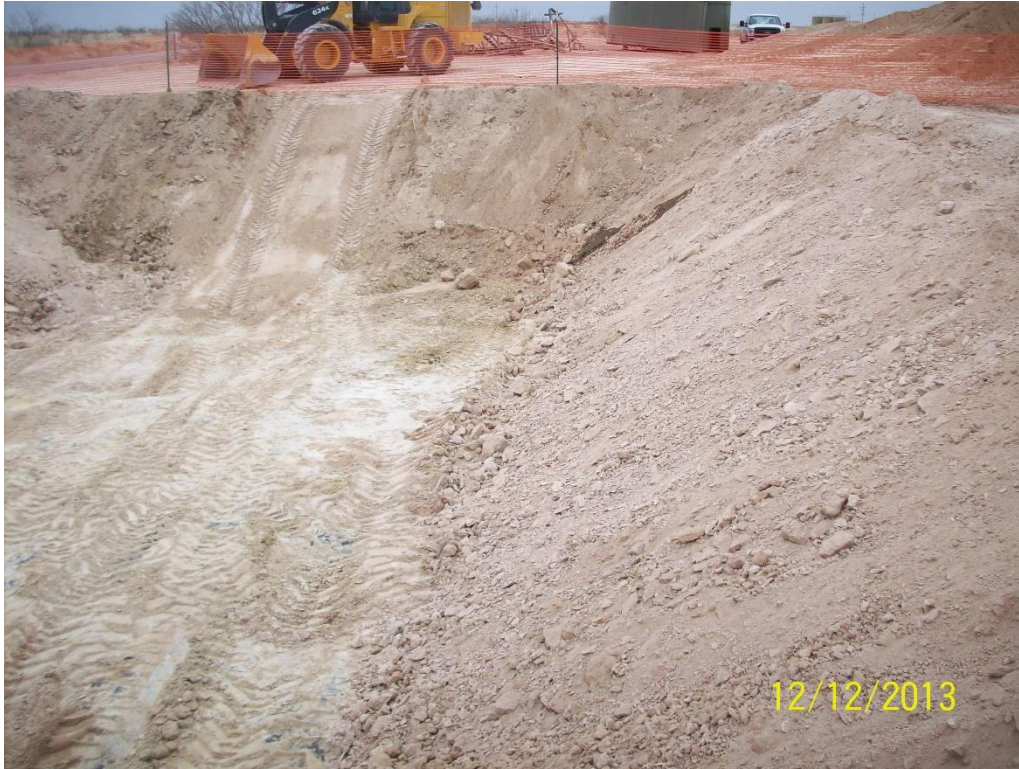
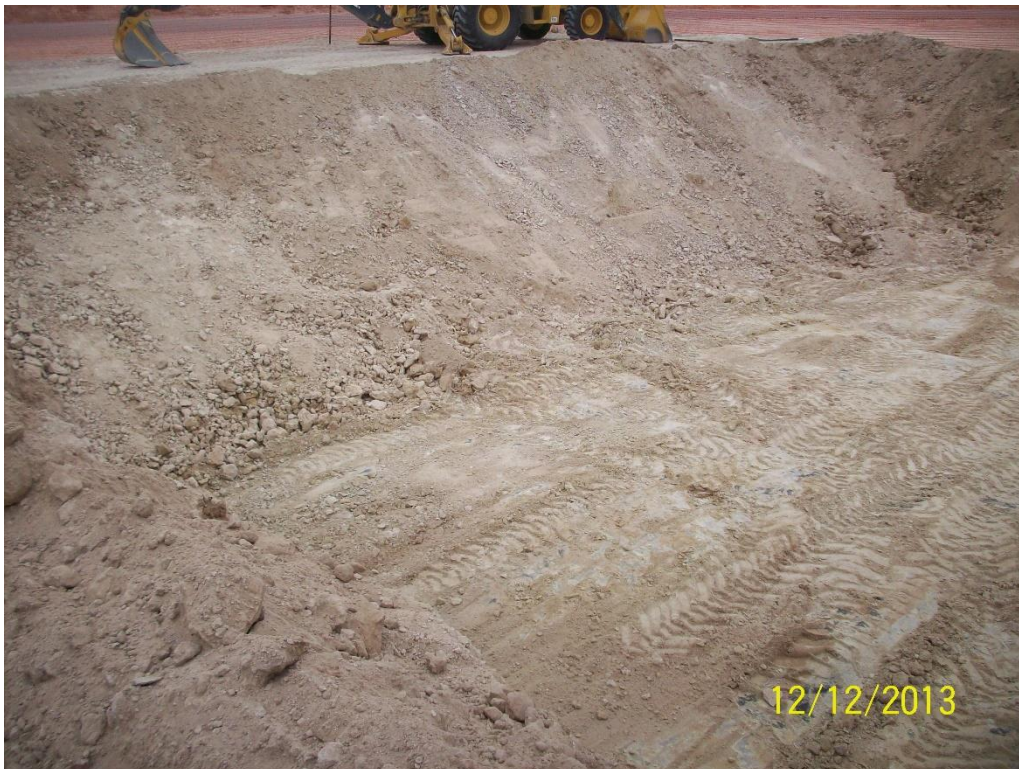
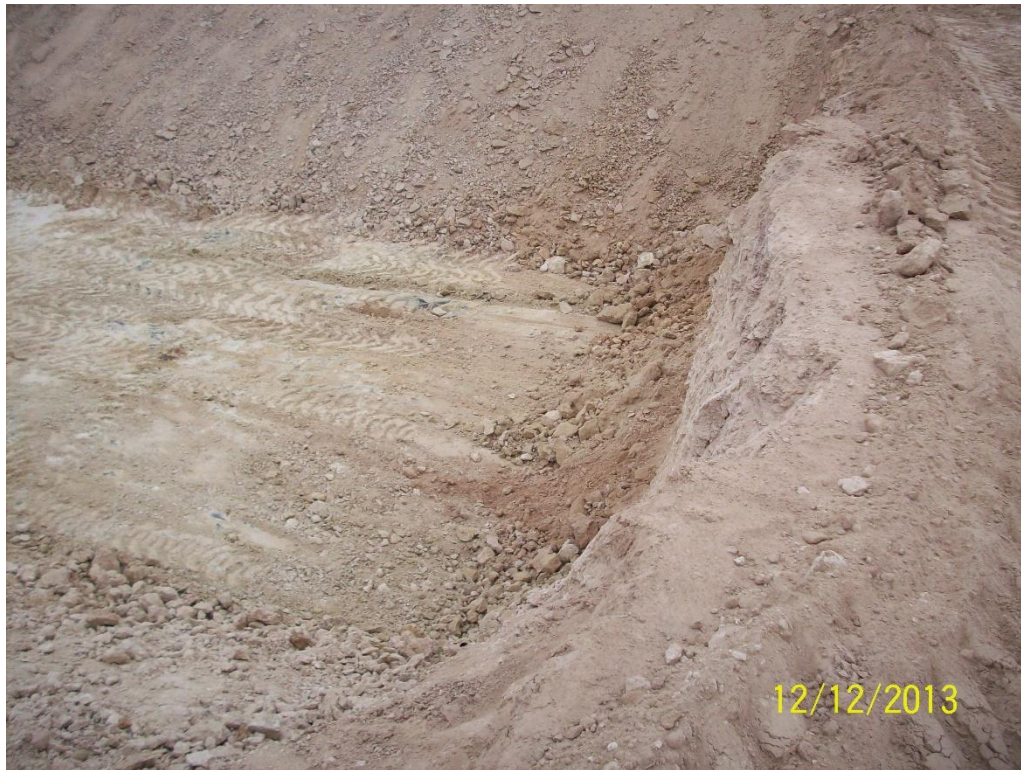
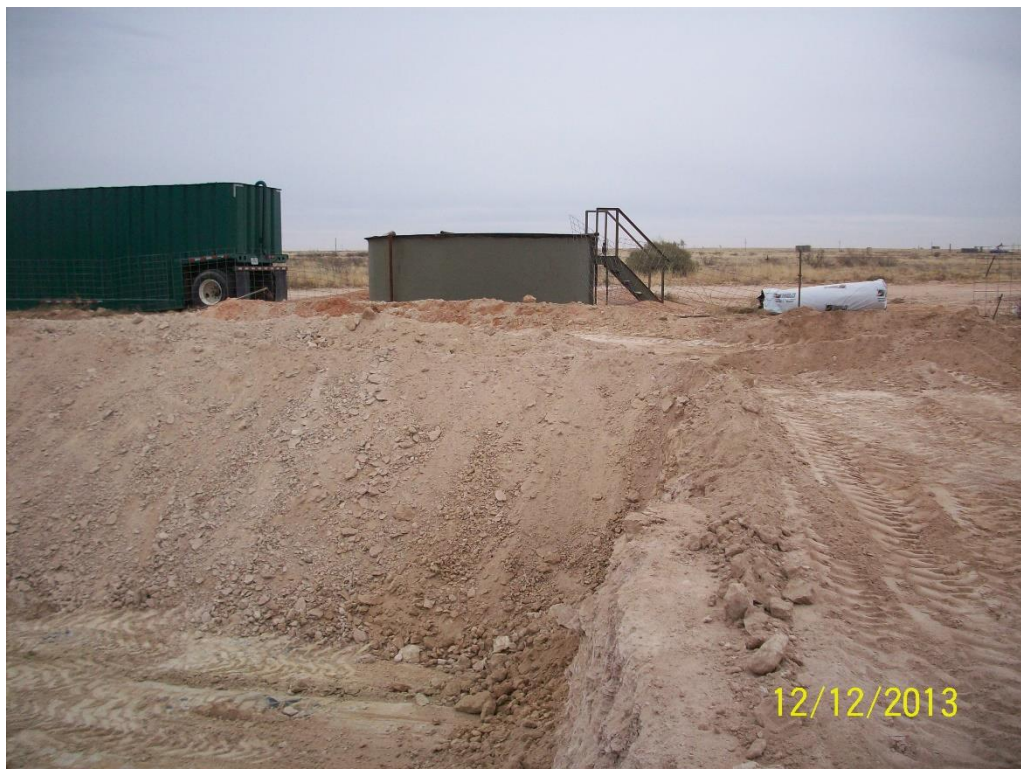
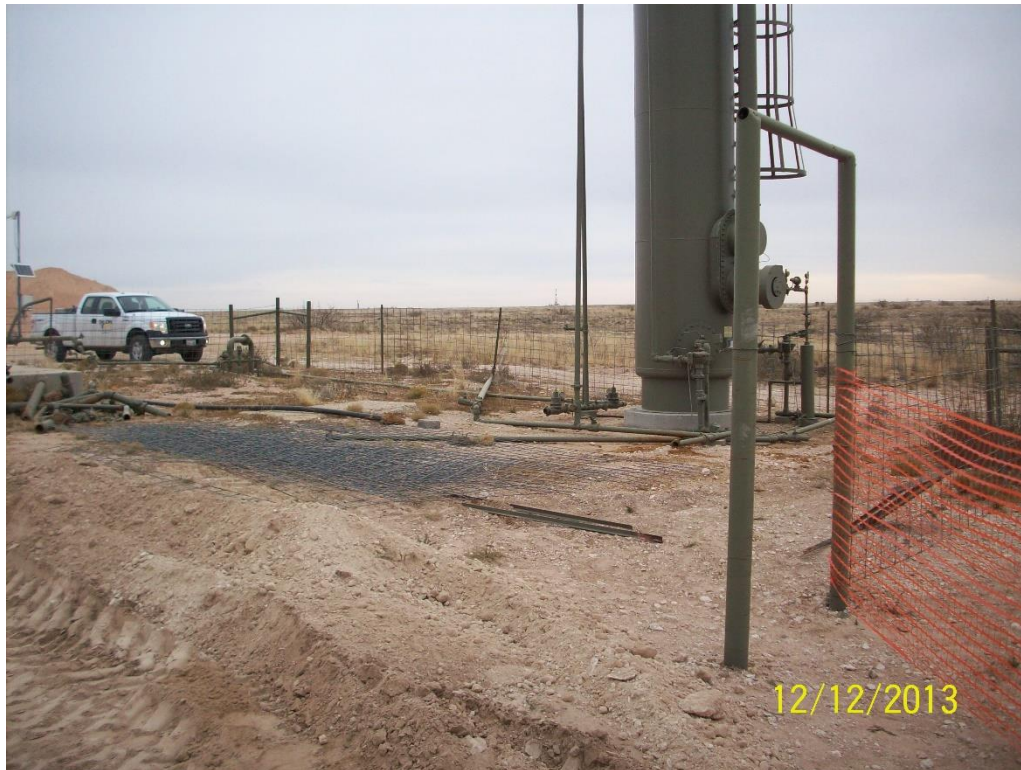
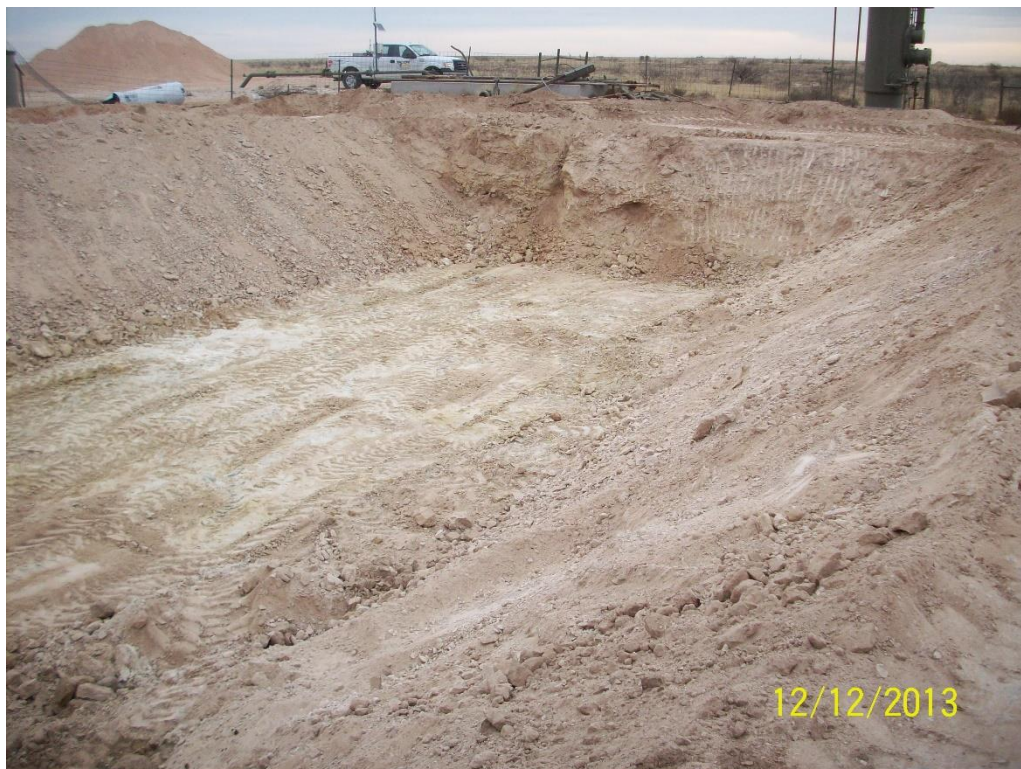
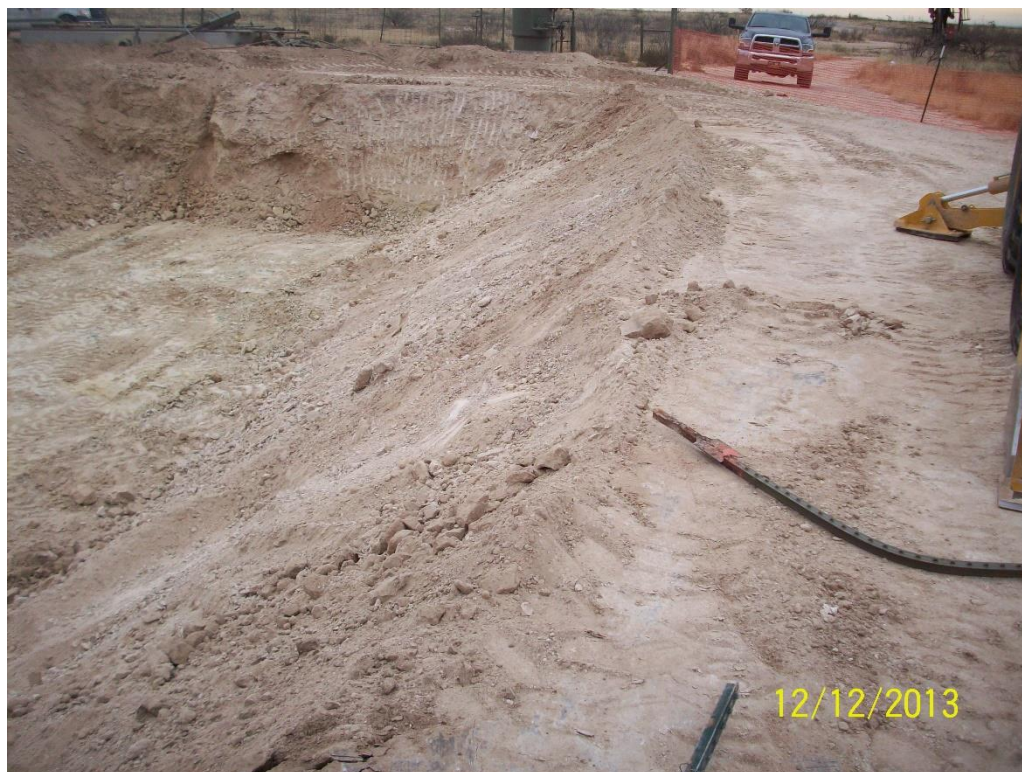
The tanks were removed and the battery has been excavated to the depth of 10', which is under the Recommended Remedial Action Levels (RRALs). We are asking for approval to backfill.
