Release Notification

Re: Second Quarter 2023 – Solar SVE System Update

Bell Federal GC B#1
San Juan County, New Mexico
Hilcorp Energy Company
NMOCD Incident Number: NCS1729355513

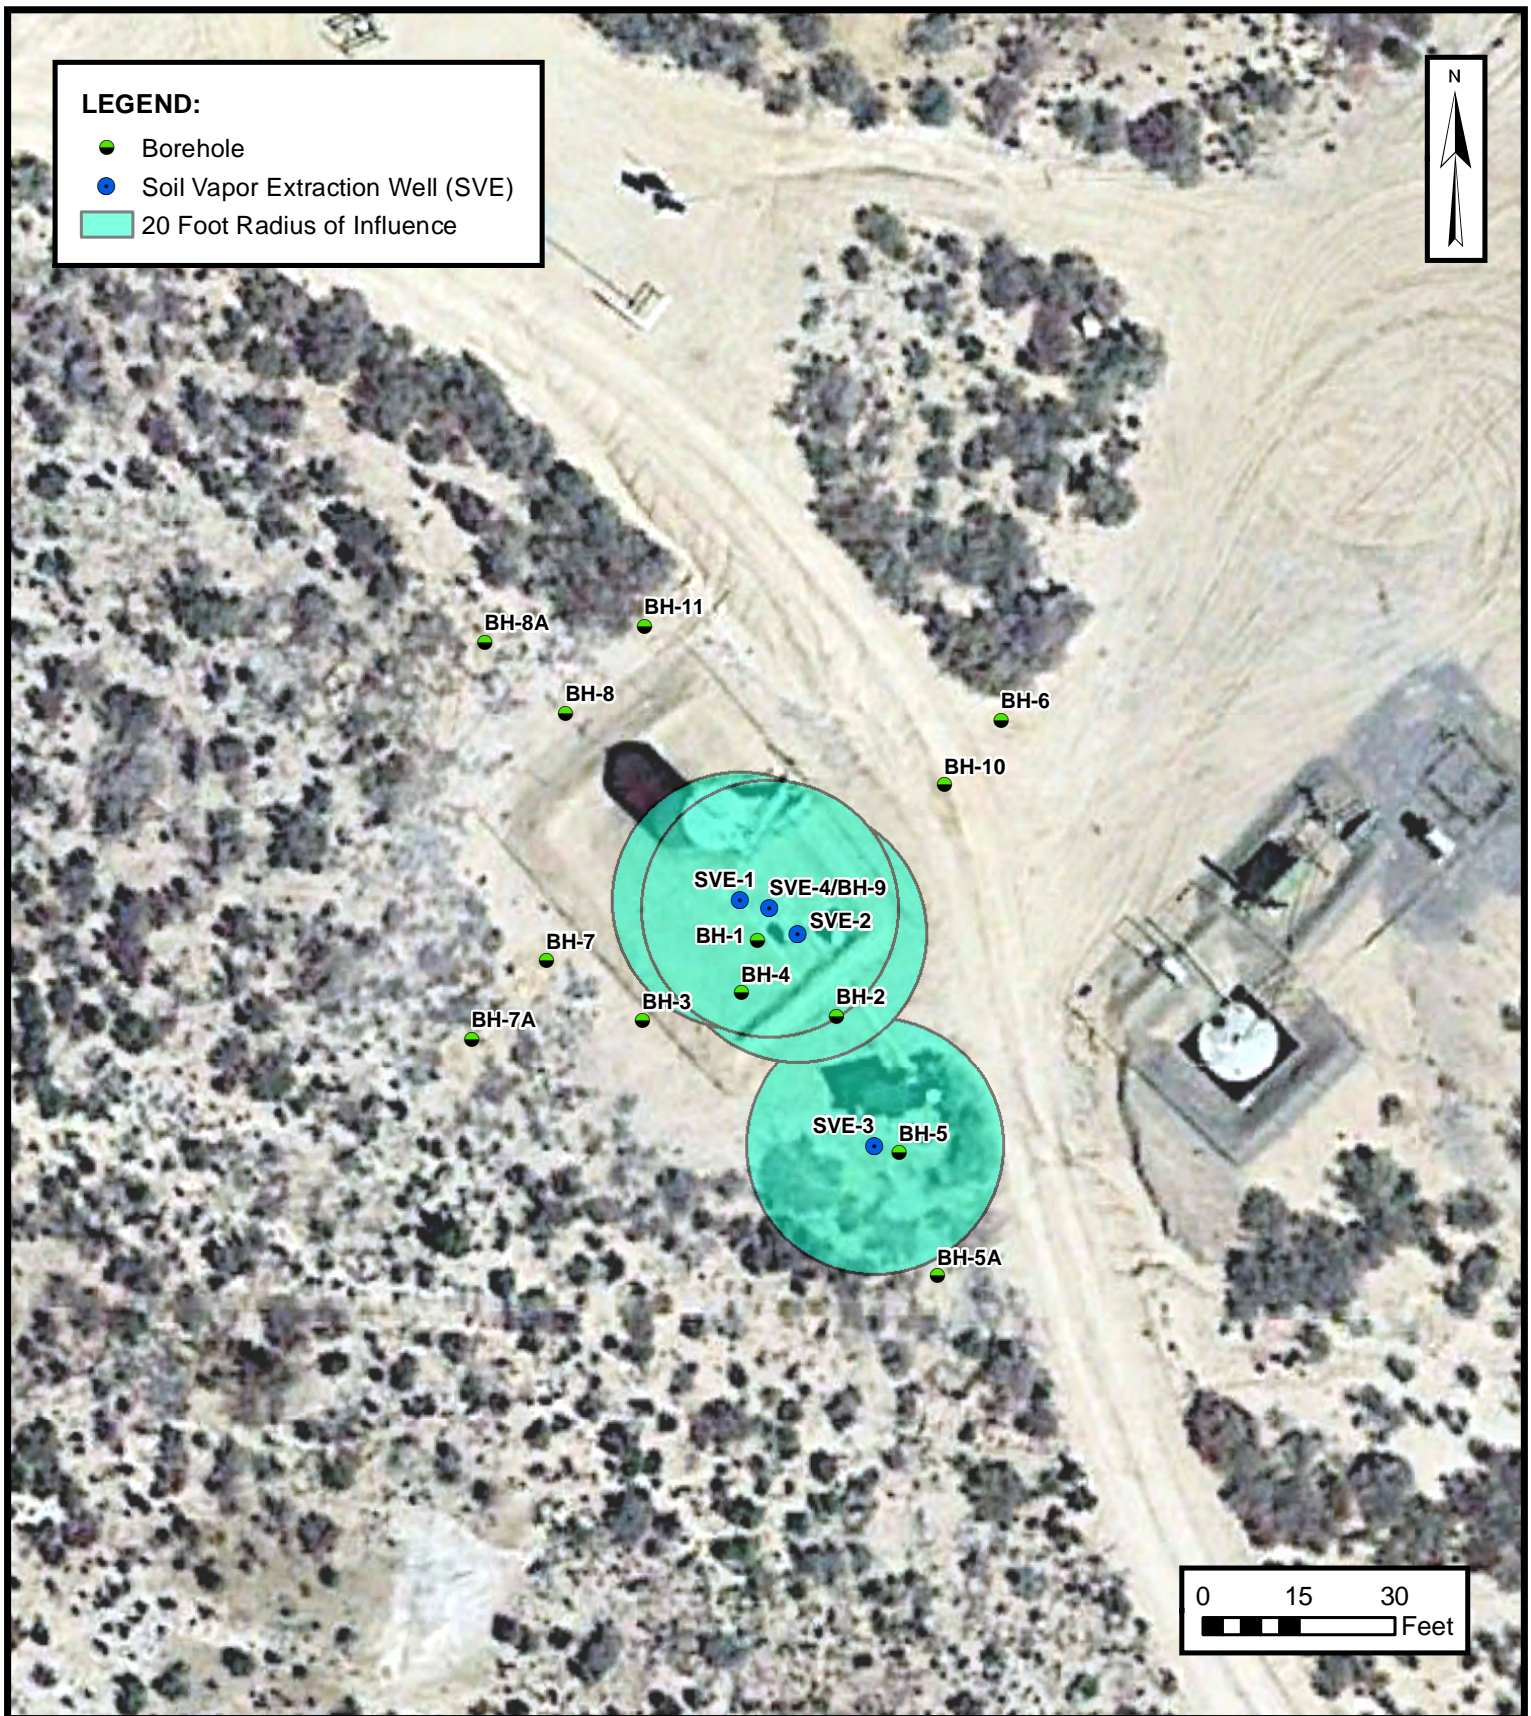
FIGURE
2

Currently, a solar SVE system is operating at the Site, which consists of a 1/3-horsepower blower capable of producing 22 cubic feet per minute (cfm) flow at a vacuum of 29 inches of water column (IWC); three solar panels, with a total of 915 watts of maximum power output; and charged by four 12-volt deep cycle batteries that subsequently power the SVE blower. The system operation is controlled by a timer adjusted throughout the year based on available nominal daylight hours (generally nine hours per day during the winter and 14 hours per day during the summer). Four SVE wells (SVE01 through SVE04) are currently present at the Site as depicted on Figure 2.

SVE SYSTEM CONFIGURATION

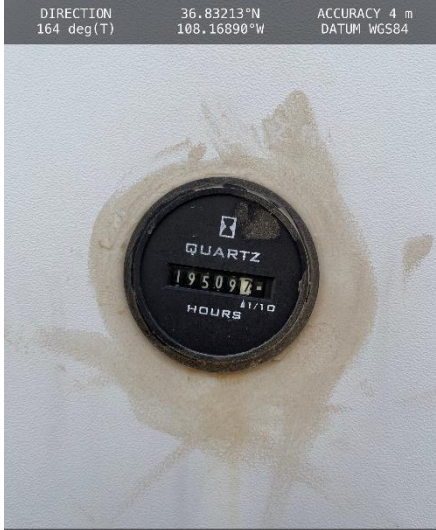
Photograph 1 Runtime meter taken on March 9, 2023 at 1:57 PM Hours = 19,509.7

Weather Service (NWS) for the Site location. Between these dates, the actual runtime for the system was 1,424.8 hours, equating to a second quarter 2023 runtime efficiency of 107.4 percent (%). For solar SVE systems, runtime efficiency can be greater than 100% when the solar panels charge the system's batteries during daylight hours and continue to run the SVE blower for a longer duration of time than the nominal daylight hours available at the Site due to excess energy stored in the batteries. Table 1 presents the SVE system runtime compared to nominal available daylight hours per month. Appendix B presents photographs of the runtime meter for calculating the second quarter runtime efficiency.
