Re: Second Quarter 2023 – SVE System Update

OH Randel #5
San Juan County, New Mexico
Hilcorp Energy Company
NMOCD Incident Number: NVF1602039091
Ensolum Project No. 07A1988025

Hilcorp Energy Company
Second Quarter 2023 – SVE System Update
OH Randel #5

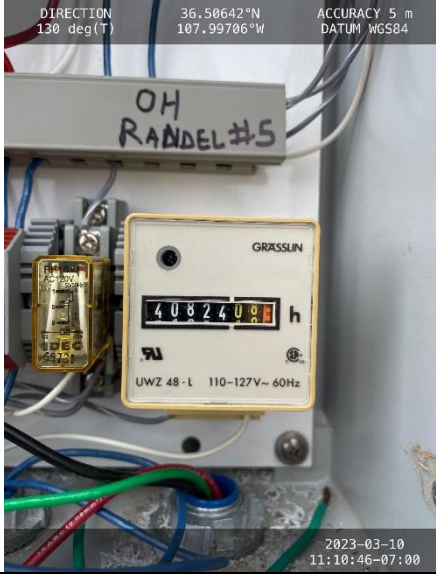
<p>Photograph 1</p> <p>Runtime meter taken on March 10, 2023 from SVE Skid 1 (original SVE system) at 11:10 AM Hours = 40,824.08</p>

During the second quarter of 2023, Ensolum and Hilcorp personnel performed bi-weekly operation and maintenance (O&M) visits to verify the system was operating as designed and to perform any required maintenance. Field notes taken during O&M visits are presented in Appendix A. During the second quarter of 2023, all SVE wells, except SVE-6 and SVE-11, were operated in order to induce flow in areas with remaining soil impacts. SVE wells SVE-6 and SVE-11 are screened at depths shallower than the remaining soil impacts at the Site and have been turned off in order for the SVE system to induce a higher flow and vacuum on the remaining open wells. Between March 10 and June 23, 2023, SVE Skid 1 operated for 2,241 hours with a runtime efficiency of 89 percent (%) and Skid 2 operated for 1,833 hours with a runtime efficiency of 73%. Table 1 presents the SVE system operational hours and percent runtime. Appendix B presents photographs of the runtime meter for calculating the second quarter runtime efficiency.

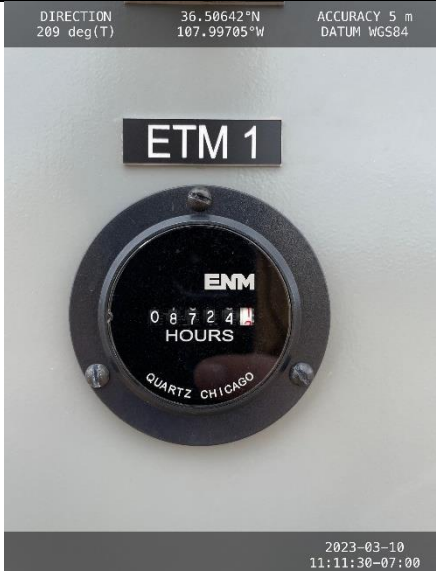
<p>Photograph 2</p> <p>Runtime meter taken on March 10, 2023 from SVE Skid 2 (new SVE system) at 11:11 AM Hours = 8,724.1</p>

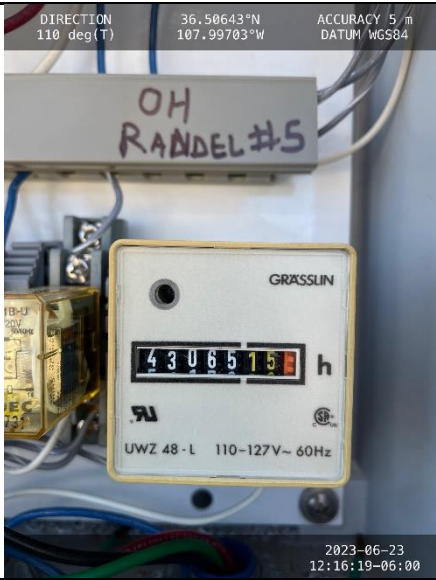
<p>Photograph 3</p> <p>Runtime meter taken on June 23, 2023 from SVE Skid 1 (original SVE system) at 12:16 PM Hours = 43,065.15</p>
