Re: Third Quarter 2023 – SVE System Update

Lambe 2C
San Juan County, New Mexico
Hilcorp Energy Company
NMOCD Incident Number: NVF1836050592

Ensolum, LLC (Ensolum), on behalf of Hilcorp Energy Company (Hilcorp), presents this *Third Quarter 2023 – SVE System Update* report summarizing the soil vapor extraction (SVE) system performance at the Lambe 2C natural gas production well (Site), located in Unit H, Section 20, Township 31 North, and Range 10 West in San Juan County (Figure 1). Specifically, this report summarizes Site activities performed in July, August, and September of 2023 to the New Mexico Oil Conservation Division (NMOCD).

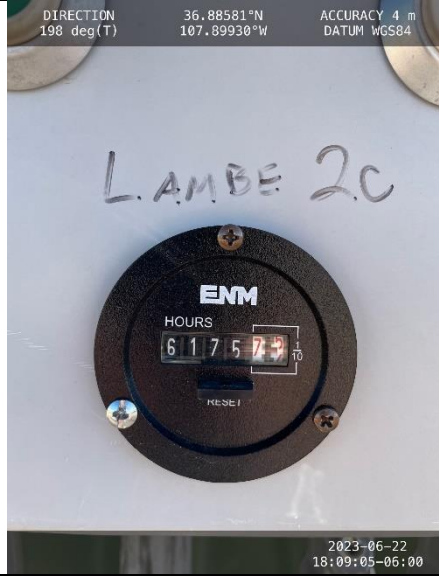
Photograph 1 Runtime meter taken on June 22, 2023 at 6:09 PM Hours = 6,175.76

presents photographs of the runtime meter for calculating the third quarter runtime efficiency. Table 1 presents the SVE system operational hours and calculated percent runtime.

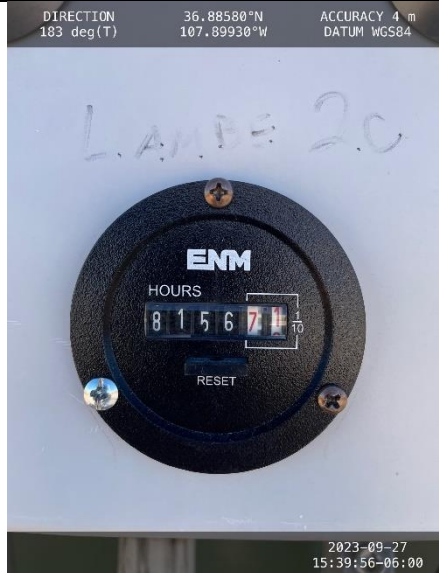
Photograph 2 Runtime meter taken on September 27, 2023 at 3:39 PM Hours = 8,156.71
