### Report Type: Closure Report 2RP-1825 / 2RP-4224 (NAB1714639317)

Site:	Coyote Compressor Station					
Company:	Targa Resources					
Section, Township and Range	Unit C	Sec. 09	T 25S	R 27E		
Lease Number:						
County:	Eddy County					
GPS:	32.1502			-104.198000		
Surface Owner:	State					
Mineral Owner:						
Directions:	From intersection Black River Village Rd and Road Runner Rd, travel south on Road Runner Rd for 6.55 Miles. Turn right (Northwest) onto lease road, follow for 0.74 miles. Turn left (Southwest) onto lease road and follow for 0.89 miles. Location is on the right (north of the road).

**RE: Closure Report  
Targa Resources  
Coyote Compressor Station  
Eddy County, New Mexico  
2RP-1825 & 2RP-4224  
#NAB1714639317**

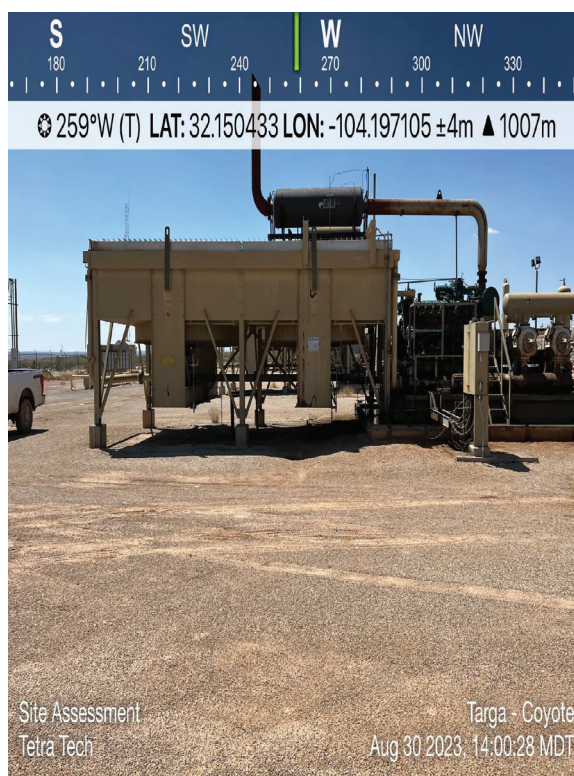
View of Area of Source and L1 – View West

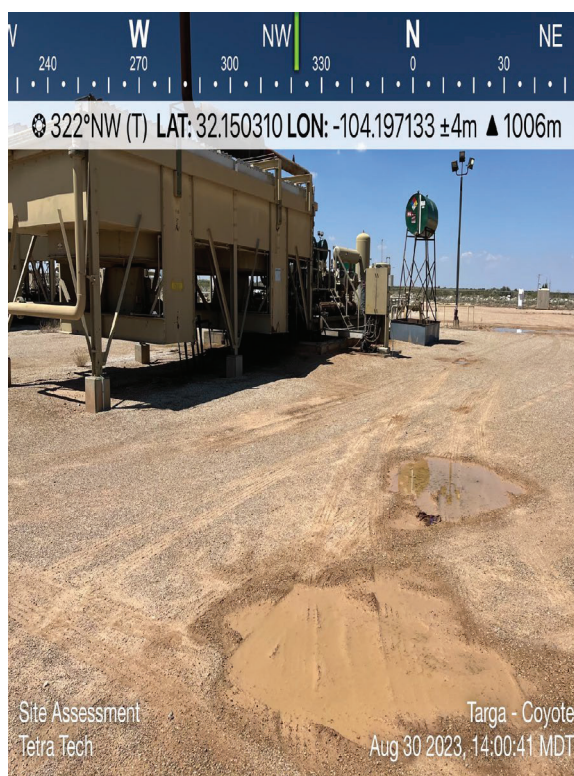
View of Area of Source and L1 – View Northwest
