Remediation Plan

Closure

Re: Closure Request

Cooksey 36 PA ST Com #1H Tracking #: NAPP2305359369

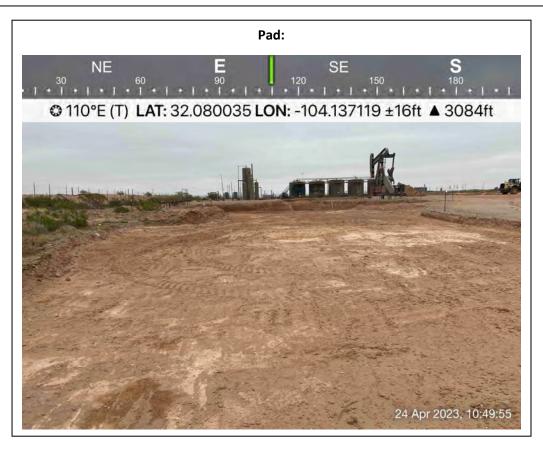
Excavation
