## Closure Report

Government D #006  
Eddy County, New Mexico  
API ID # 30-015-25315  
**Incident #** NMCS0318225470

Matador Resources  
5347 N. 26<sup>th</sup> Street 2<sup>nd</sup> Floor.  
Artesia, NM 88210

Talon/LPE  
408 W. Texas Avenue  
Artesia, New Mexico 88210

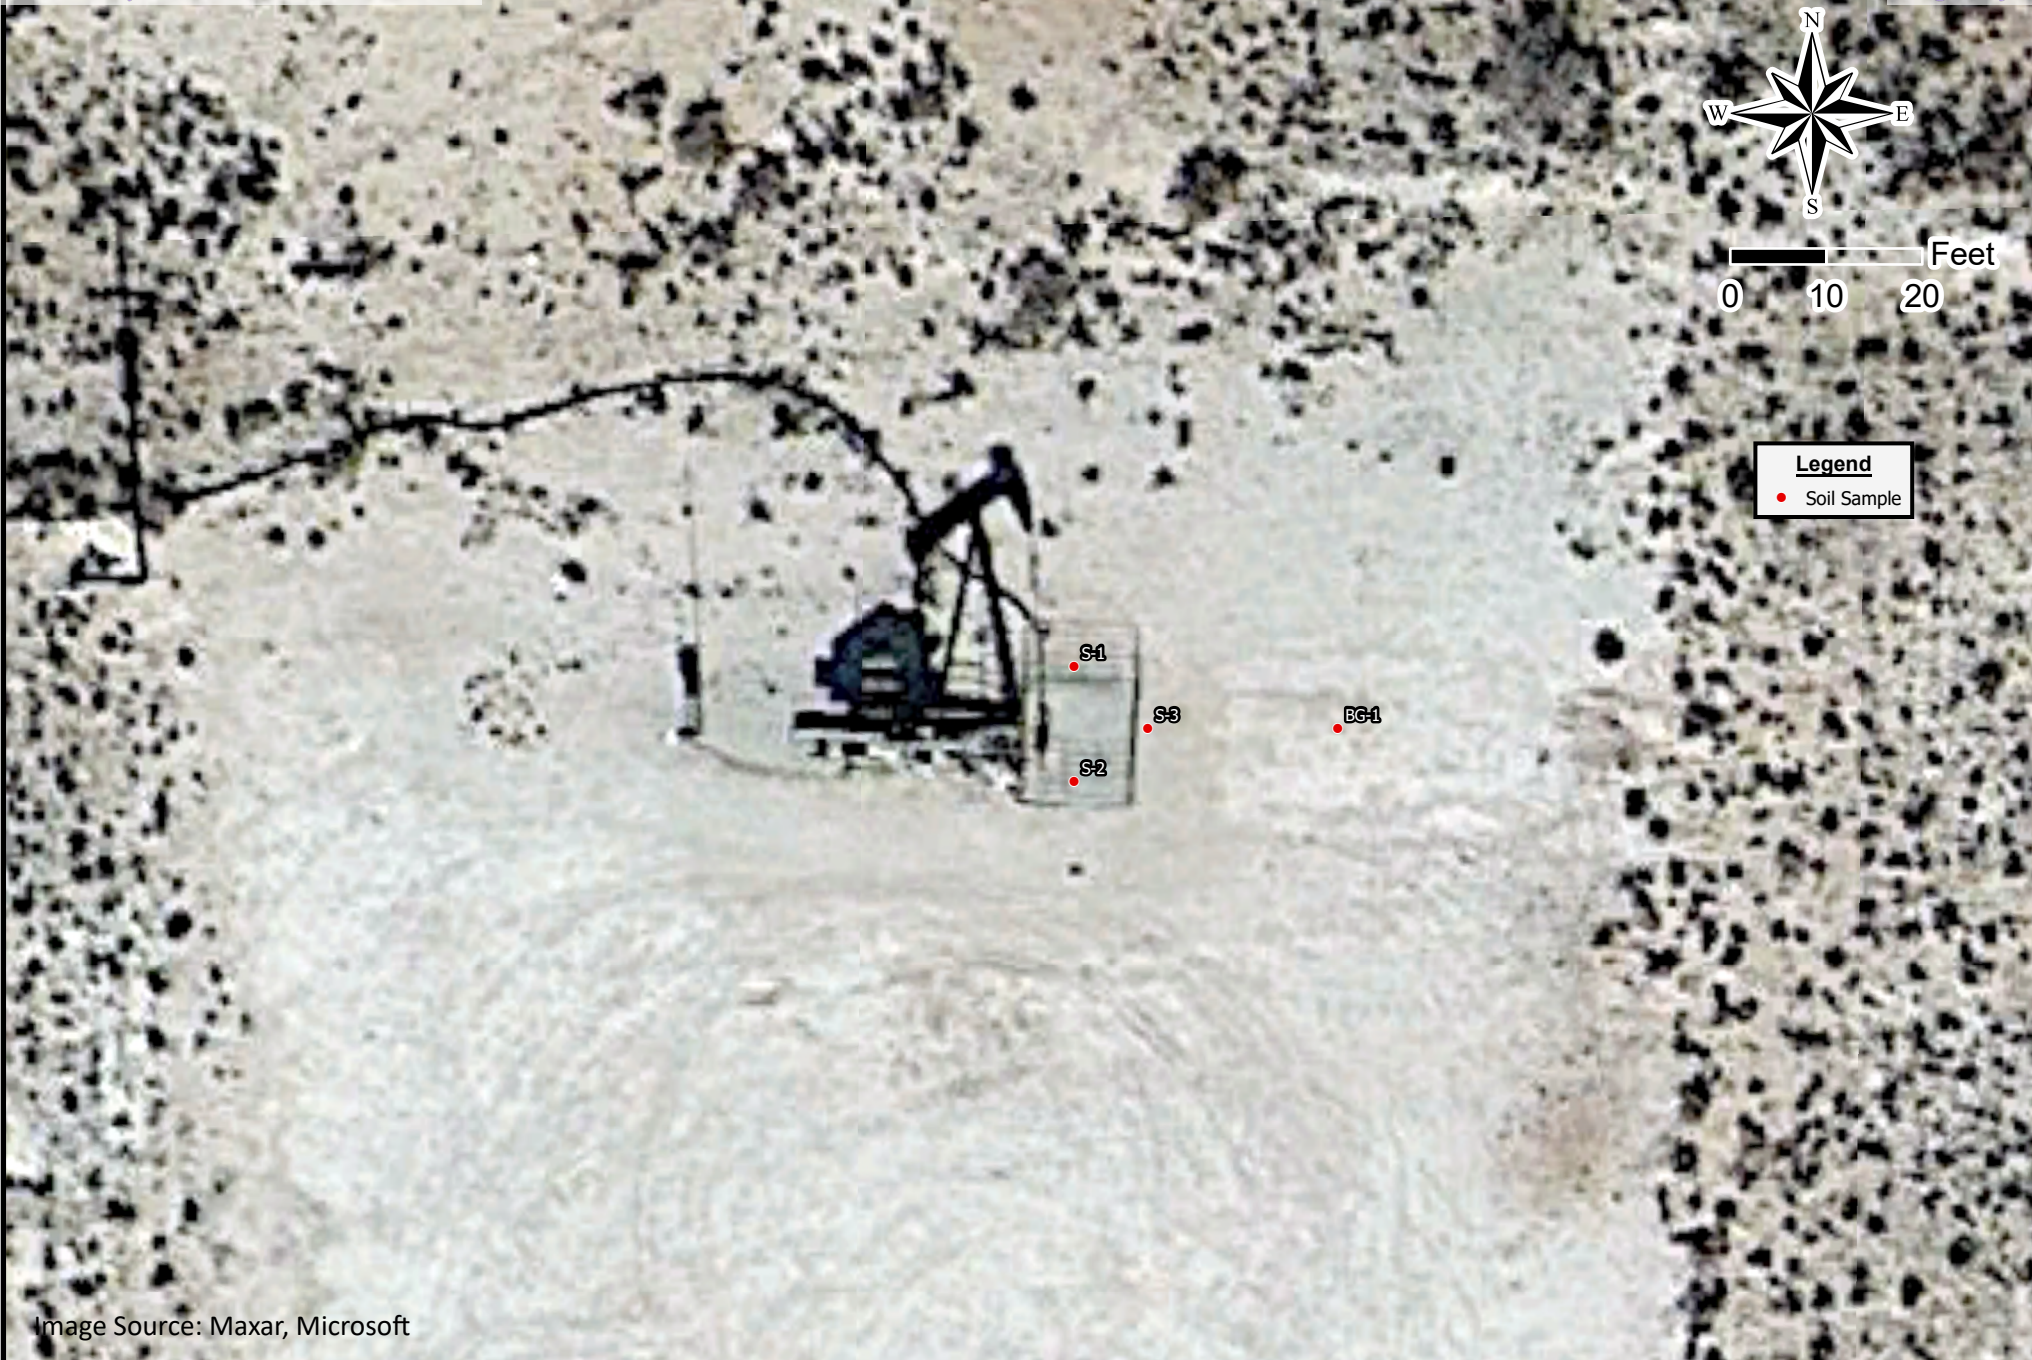
Matador Resources Company  
Government D #006  
Eddy County, NM  
Figure 1 - Site Assessment Map

On June 28th, 2023, Talon personnel mobilized to the site to conduct an initial site assessment of the site east of the wellhead. The impacted area was photographed, sampled utilizing a hand auger, and mapped. All soil samples were properly packaged, preserved, and transported to Cardinal laboratories with the chain of custody for analysis of Total Chlorides (Method SM4500Cl-B), TPH (EPA Method 8015M), and volatile organics (BTEX, EPA Method 8021B). Sample locations are shown on the attached Figure 1 ([Appendix I](#)) and the results of our sampling event are presented on the following data table.

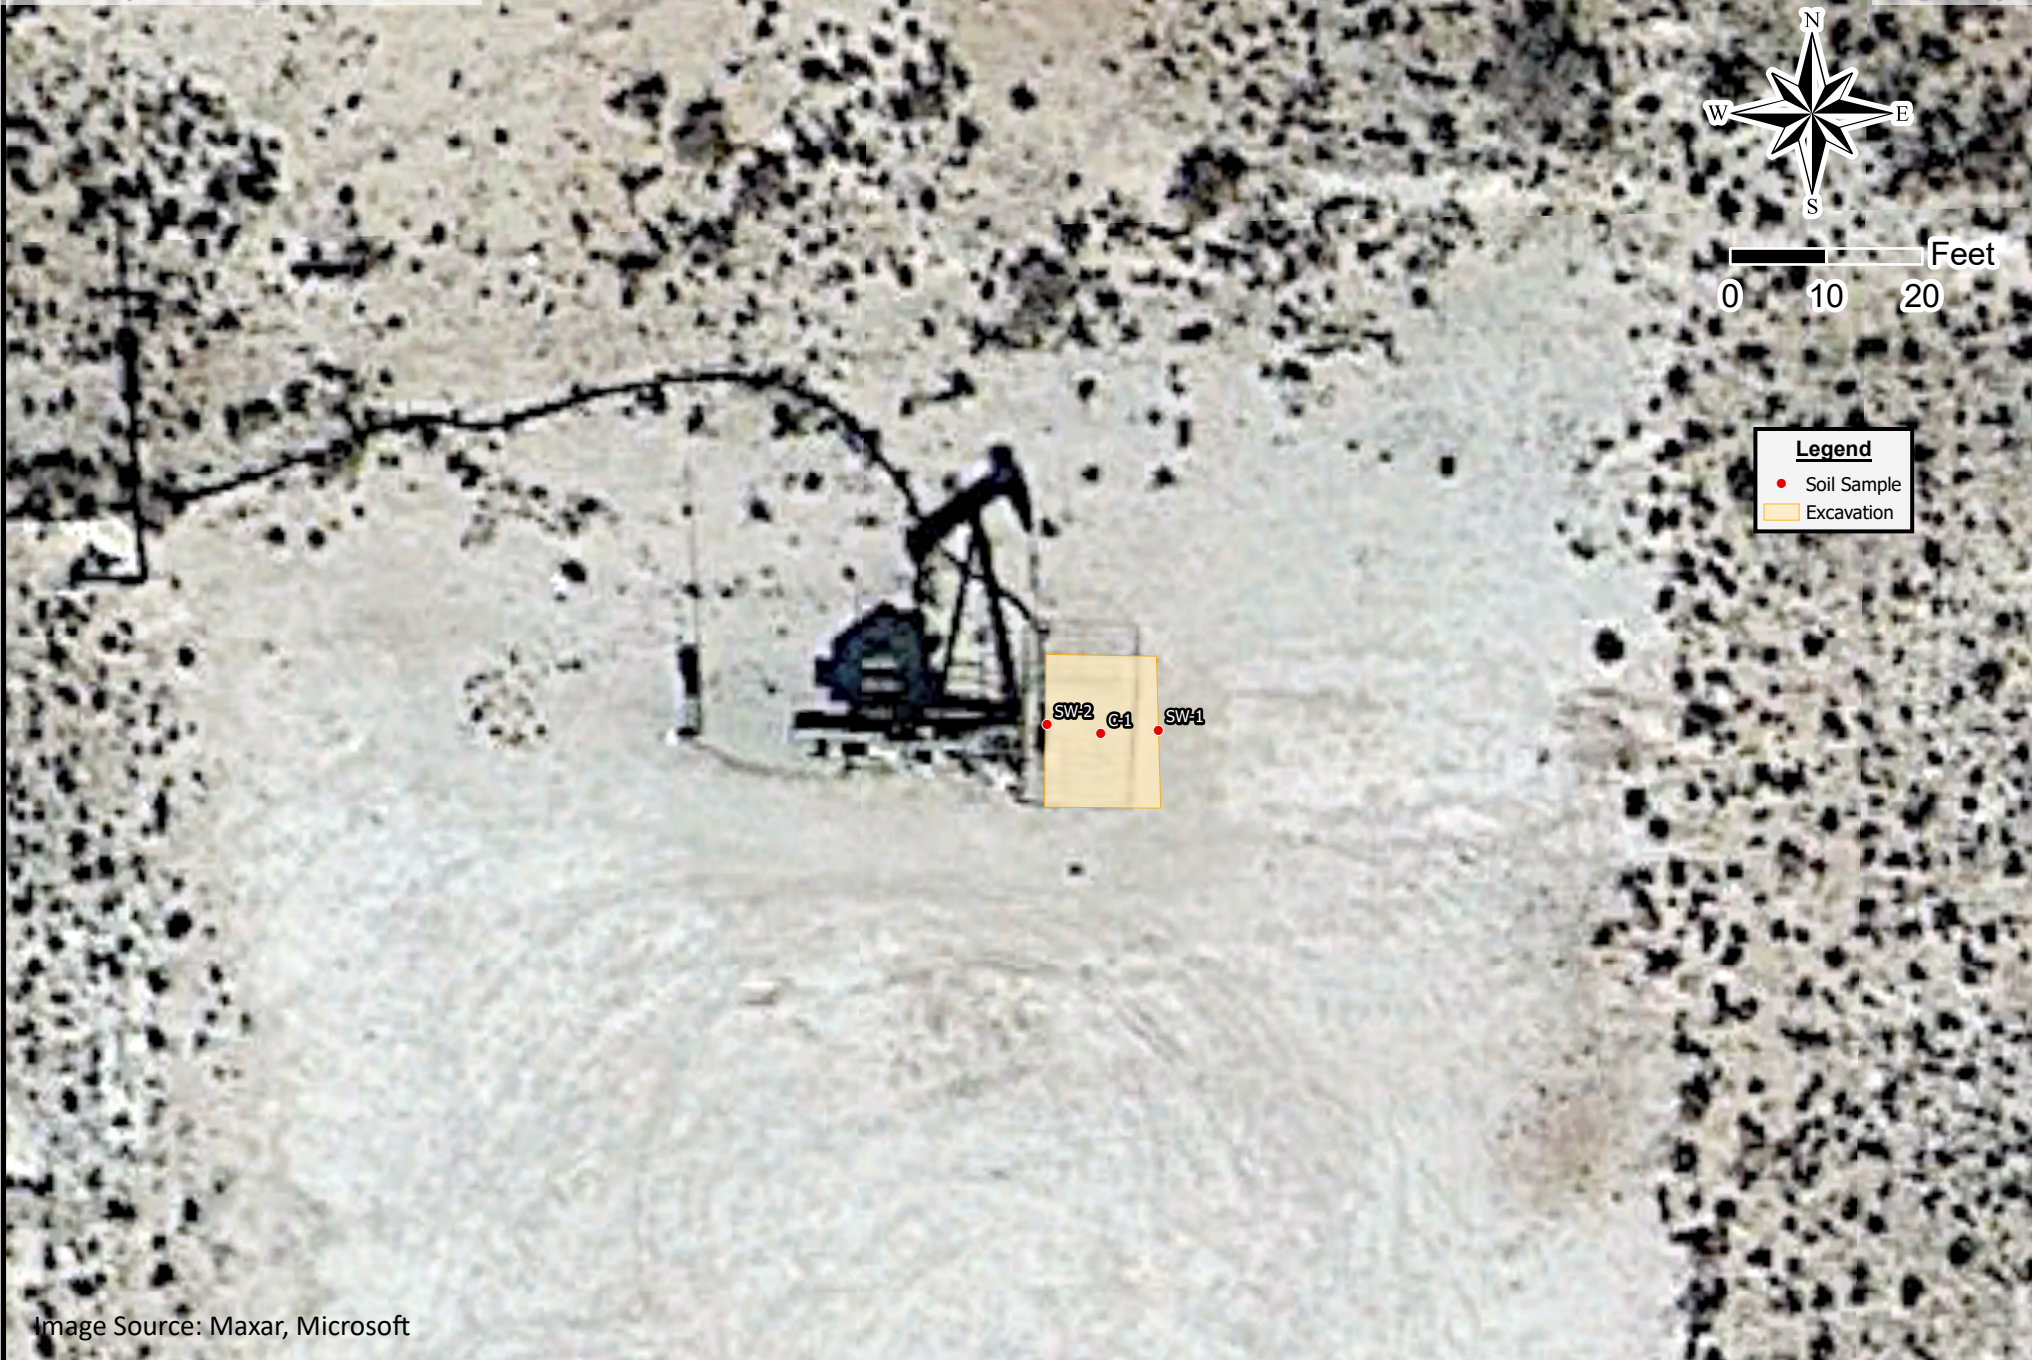
Figure 5 - Excavation Map

The soil sample results from the laboratory analytical are summarized in the data table below. Sample locations are illustrated on Figure 5 in [Appendix I](#) and complete laboratory analytical reports are presented in [Appendix V](#).

On September 1, 2023, Talon personnel returned to location to remove impacted soils located around suspected historical release area in pasture. A Hydrovac was used to excavate 3.5 feet bgs. of contaminated soils and confirmation samples were collected. The samples were transported with the chain of custody to Envirotech Laboratories, for analysis of Total Chlorides (EPA 300), Total Petroleum Hydrocarbons (TPH, EPA Method 8015D) and Volatile Organics (BTEX, EPA Method 8021B).

- The impacted areas on location were excavated to depth of 3.5 feet bgs. Talon personnel utilized a PID and field titrated soil samples for total chlorides to guide the vertical and horizontal extents of the excavation process.
- Pursuant to NMOCD guidance, confirmation soil samples were collected at 200 square foot intervals and analyzed for TPH, BTEX and Total Chlorides to insure all areas had reached NMOCD closure criteria.
- The excavated areas were backfilled with new like material (caliche), machine compacted, and contoured to match the surrounding location.
- Copies of the Final C-141s are presented in [Appendix III](#).
- Photographic documentation is provided in [Appendix IV](#).

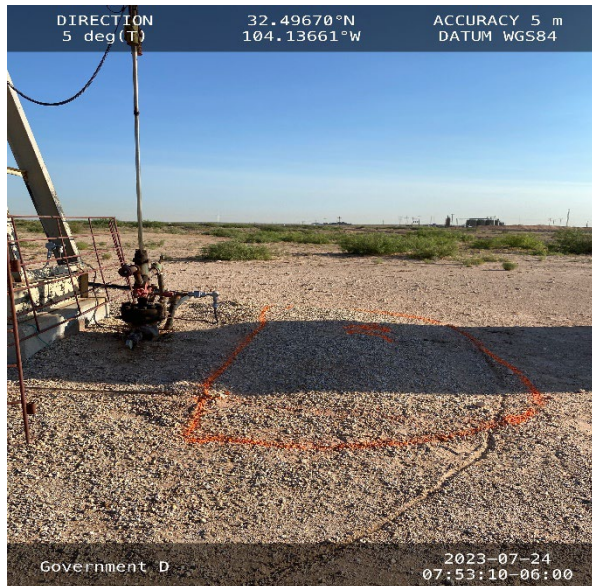
**Photograph No.1 Description:**

Outlined Excavation

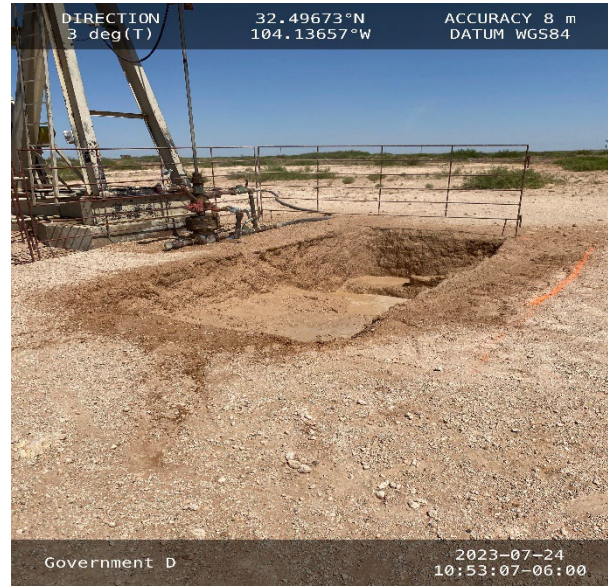
**Photograph No.2 Description:**

Excavation

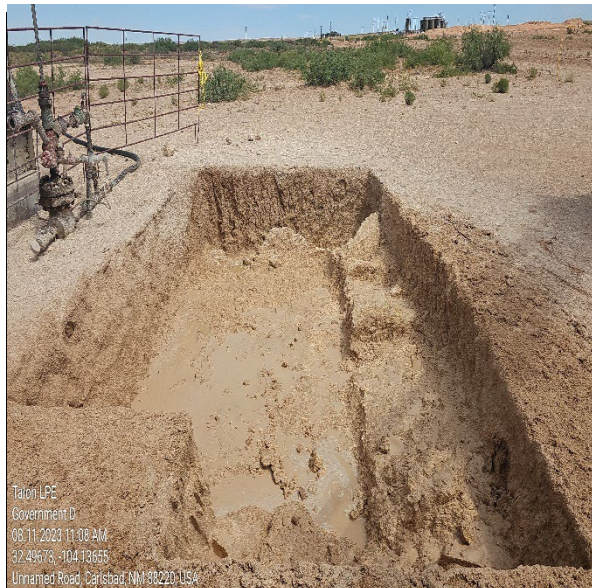
**Photograph No.3 Description:**

Finished Hydrovac
