October 24, 2023

**Re: Closure Report
ConocoPhillips (Heritage COG Operating, LLC)
Graham Cracker 16 State #002H Tinhorn Release
Unit Letters N and O, Section 9, Township 26 South, Range 28 East
Eddy County, New Mexico
Incident ID# nAB1806438251**

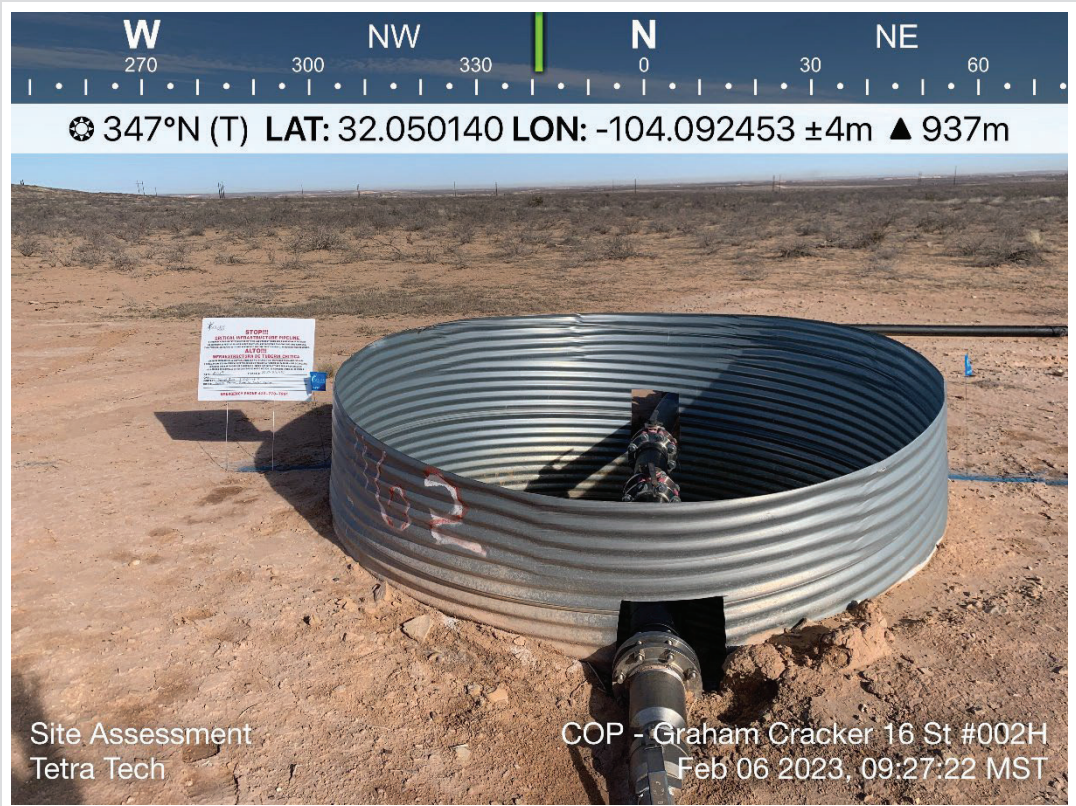
TETRA TECH, INC. PROJECT NO. 212C-MD-02989	DESCRIPTION	View north/northwest of tin horn northeast of lease pad.	1
	SITE NAME	Graham Cracker 16 St #002H	2/6/2023

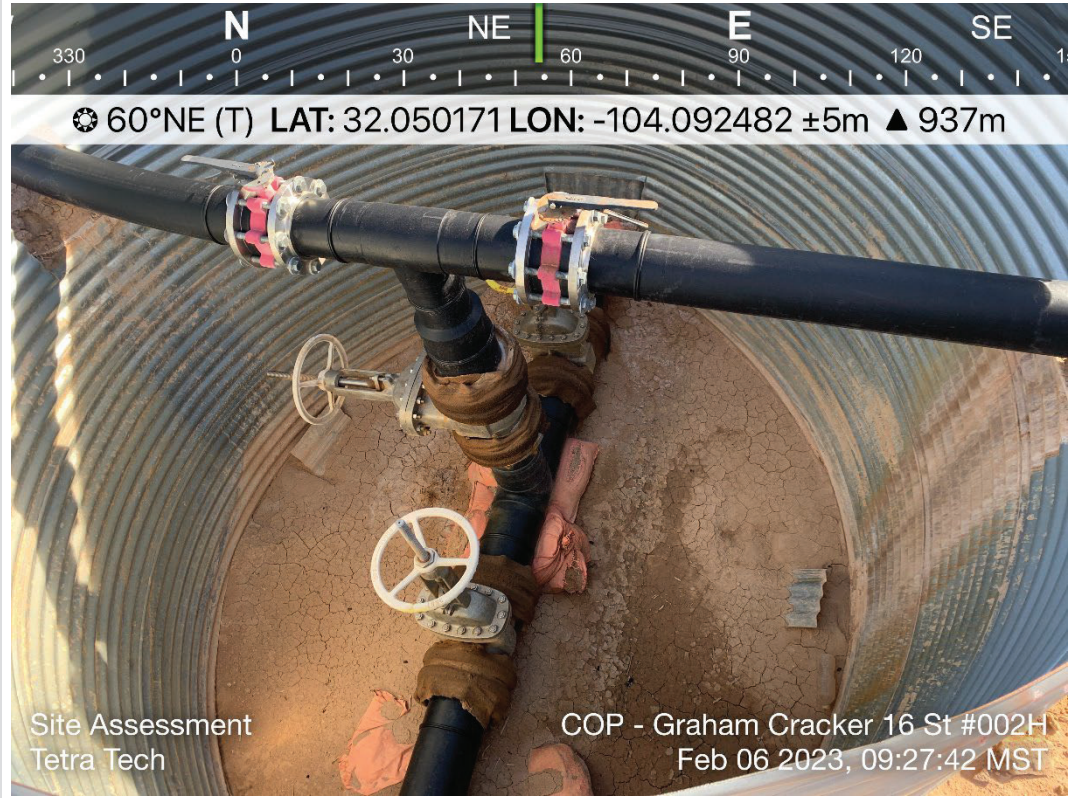
TETRA TECH, INC. PROJECT NO. 212C-MD-02989	DESCRIPTION	View inside of tin horn northeast of lease pad.	2
	SITE NAME	Graham Cracker 16 St #002H	2/6/2023

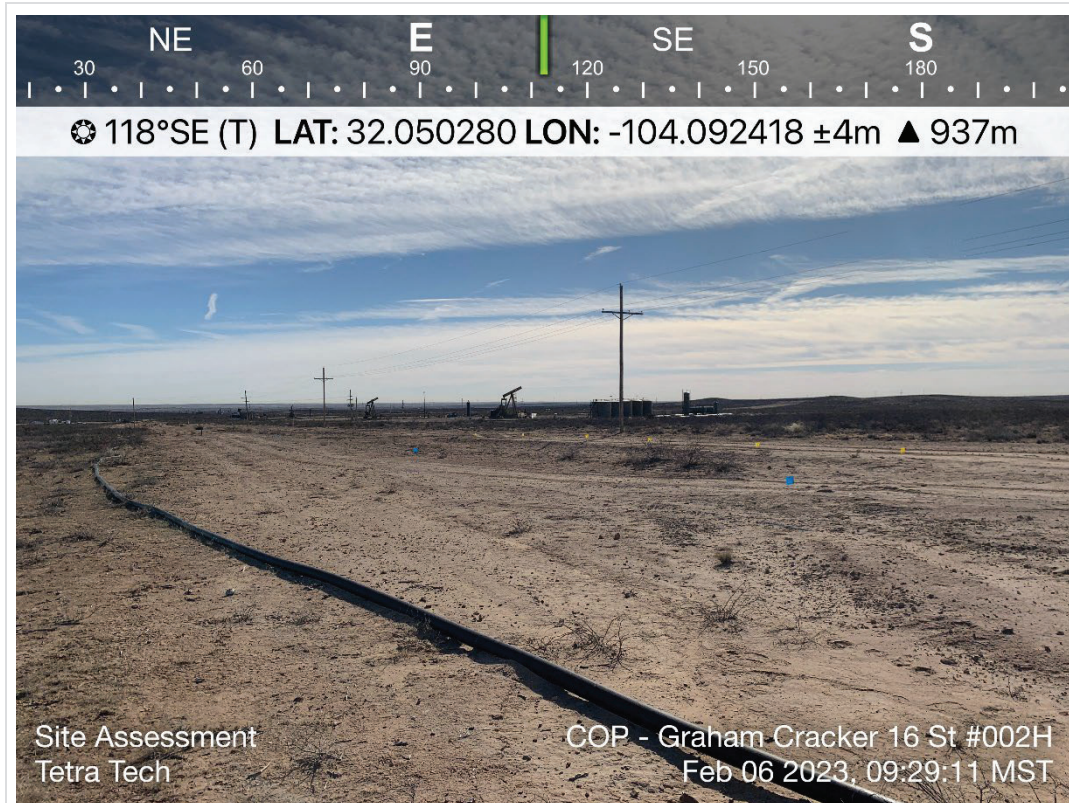
TETRA TECH, INC. PROJECT NO. 212C-MD-02989	DESCRIPTION	View east/southeast of surface polylines and overhead power lines.	4
	SITE NAME	Graham Cracker 16 St #002H	2/6/2023

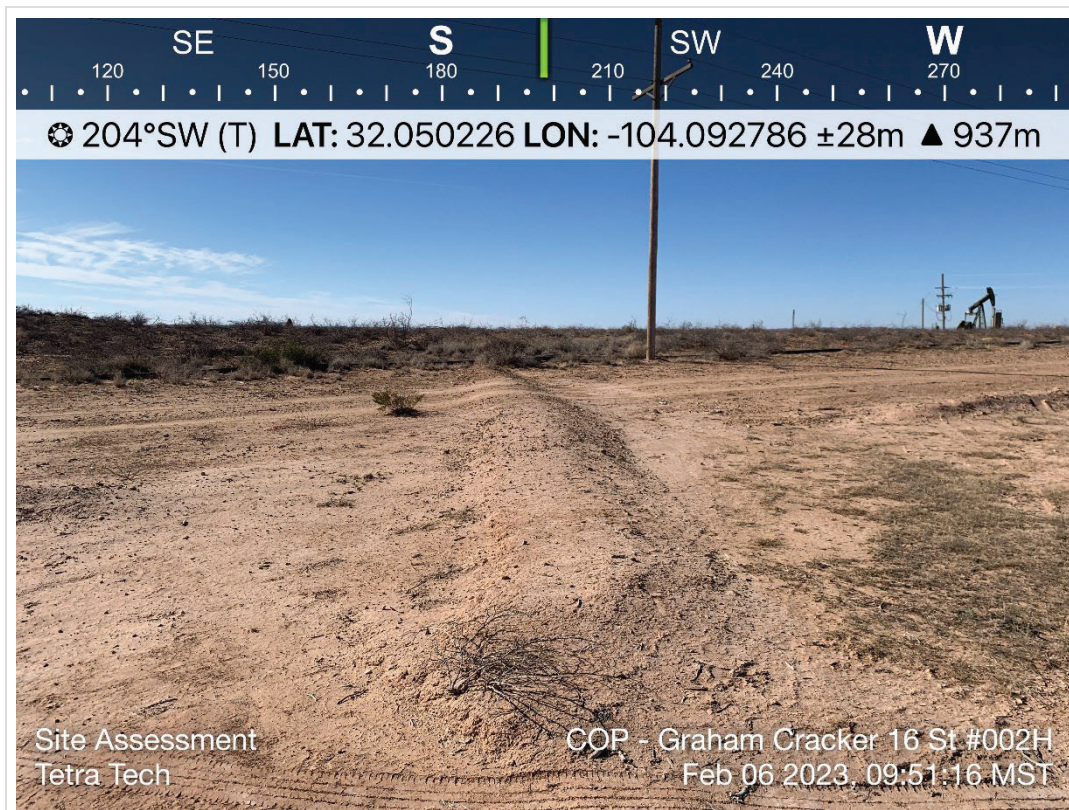
TETRA TECH, INC. PROJECT NO. 212C-MD-02989	DESCRIPTION	View south/southwest of subsurface pipelines and overhead power lines.	5
	SITE NAME	Graham Cracker 16 St #002H	2/6/2023

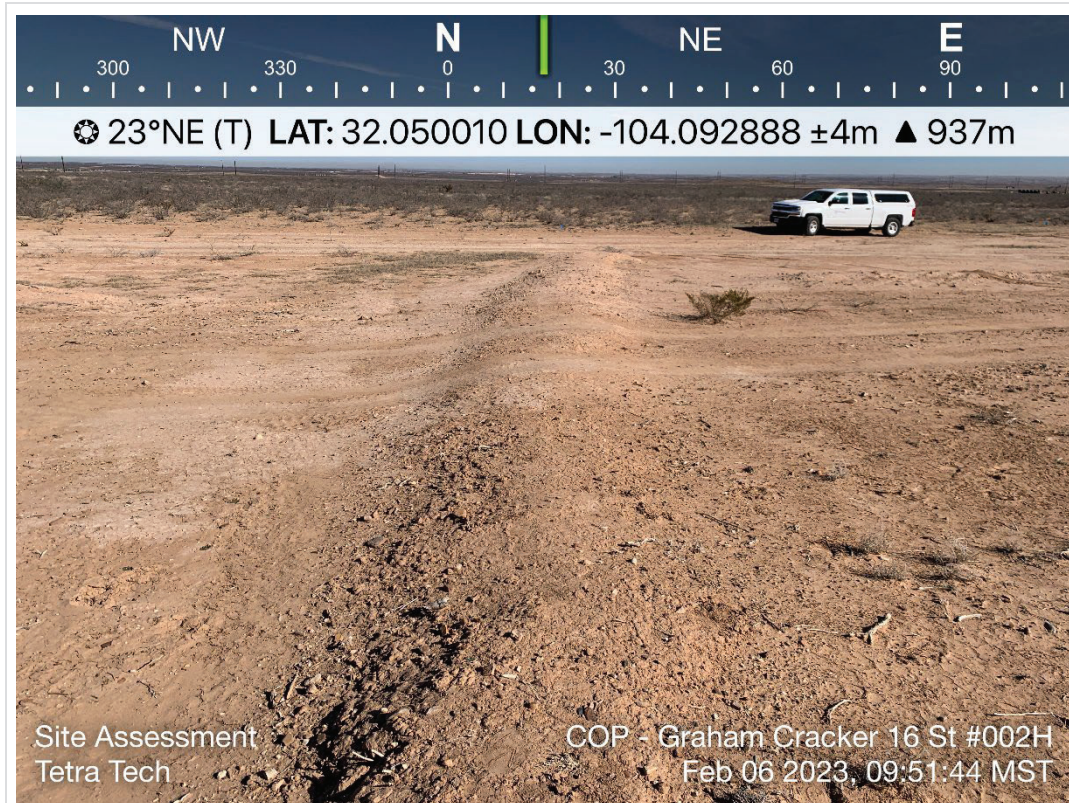
TETRA TECH, INC. PROJECT NO. 212C-MD-02989	DESCRIPTION	View north-northeast of subsurface pipeline.	6
	SITE NAME	Graham Cracker 16 St #002H	2/6/2023

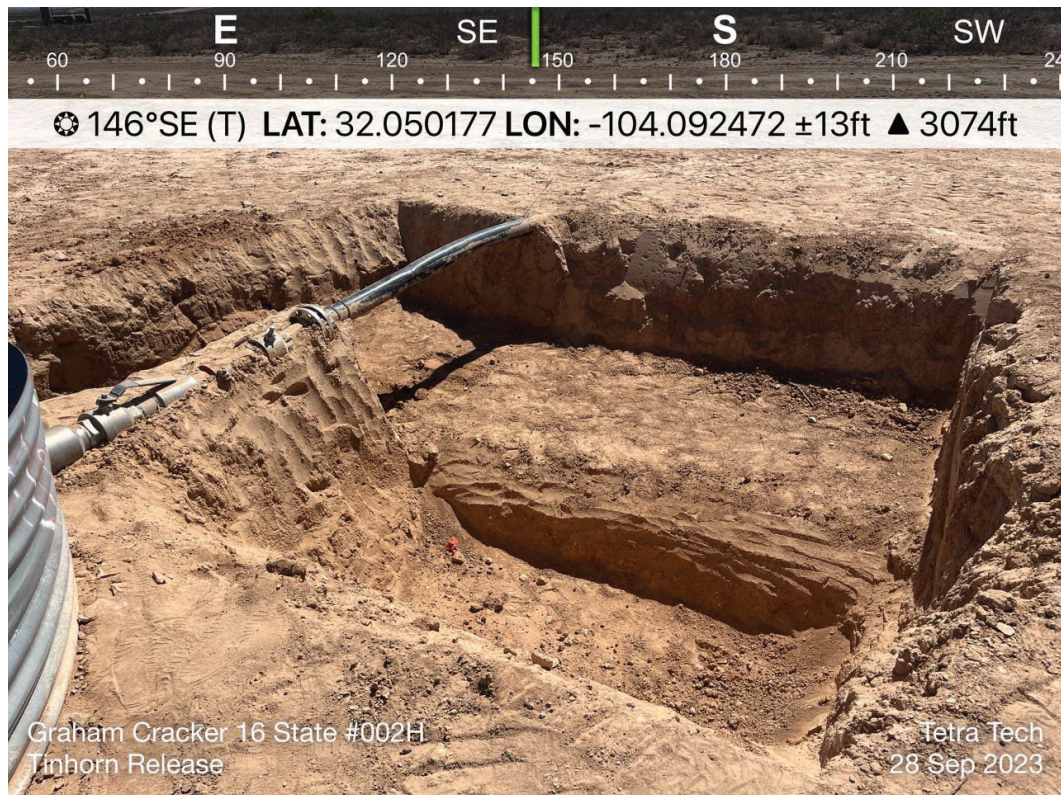
TETRA TECH, INC. PROJECT NO. 212C-MD-02989	DESCRIPTION	View southeast of open excavation. Surface poly flowline.	8
	SITE NAME	Graham Cracker 16 St #002H	9/28/2023

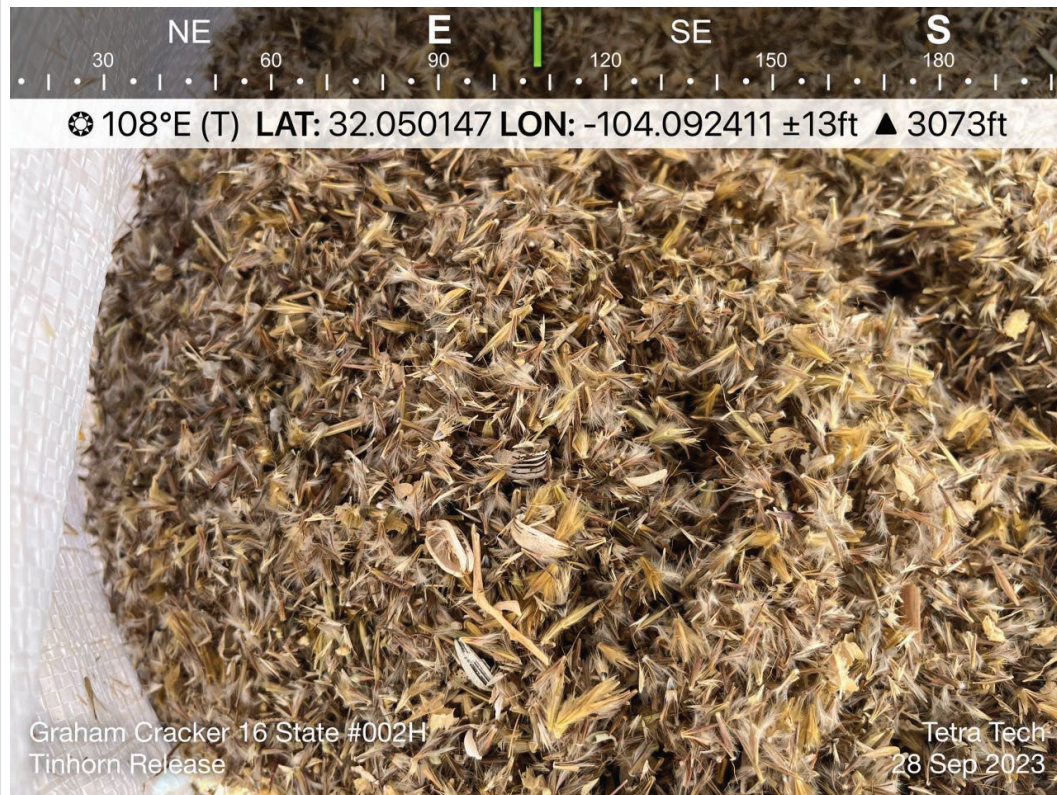
TETRA TECH, INC. PROJECT NO. 212C-MD-02989	DESCRIPTION	NM SLO Loam (L) seed mix.	10
	SITE NAME	Graham Cracker 16 St #002H	9/28/2023

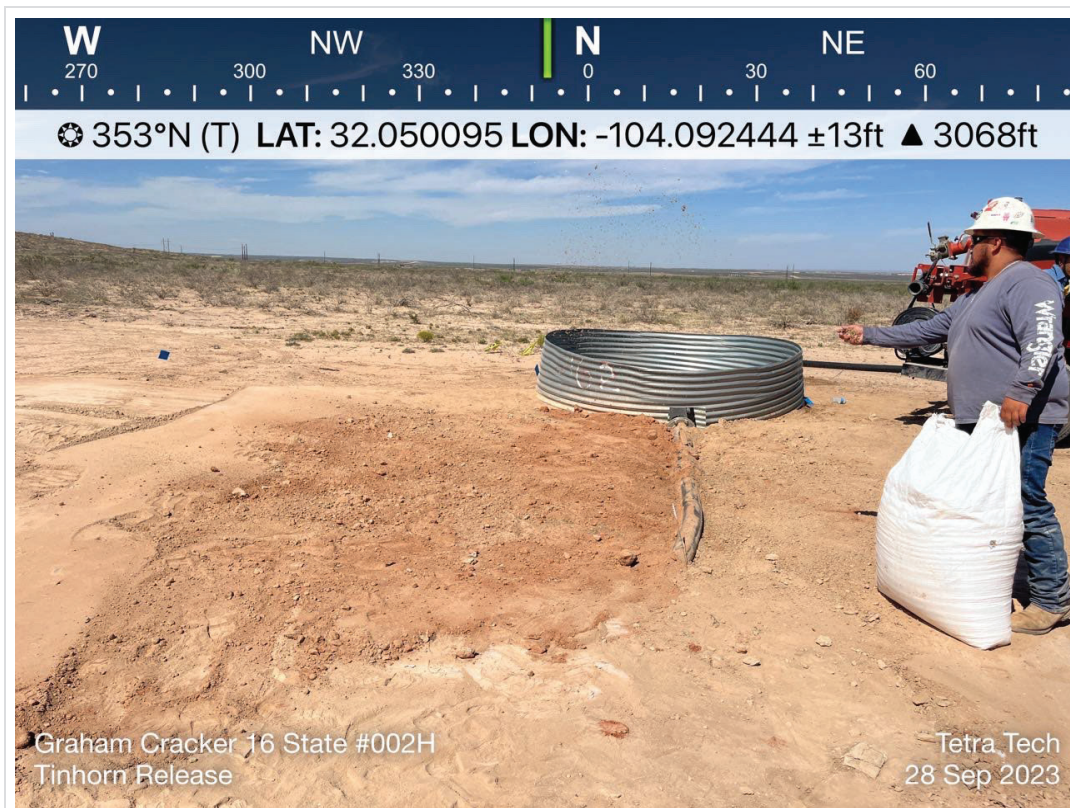
TETRA TECH, INC. PROJECT NO. 212C-MD-02989	DESCRIPTION	View north of reclamation activities.	11
	SITE NAME	Graham Cracker 16 St #002H	9/28/2023

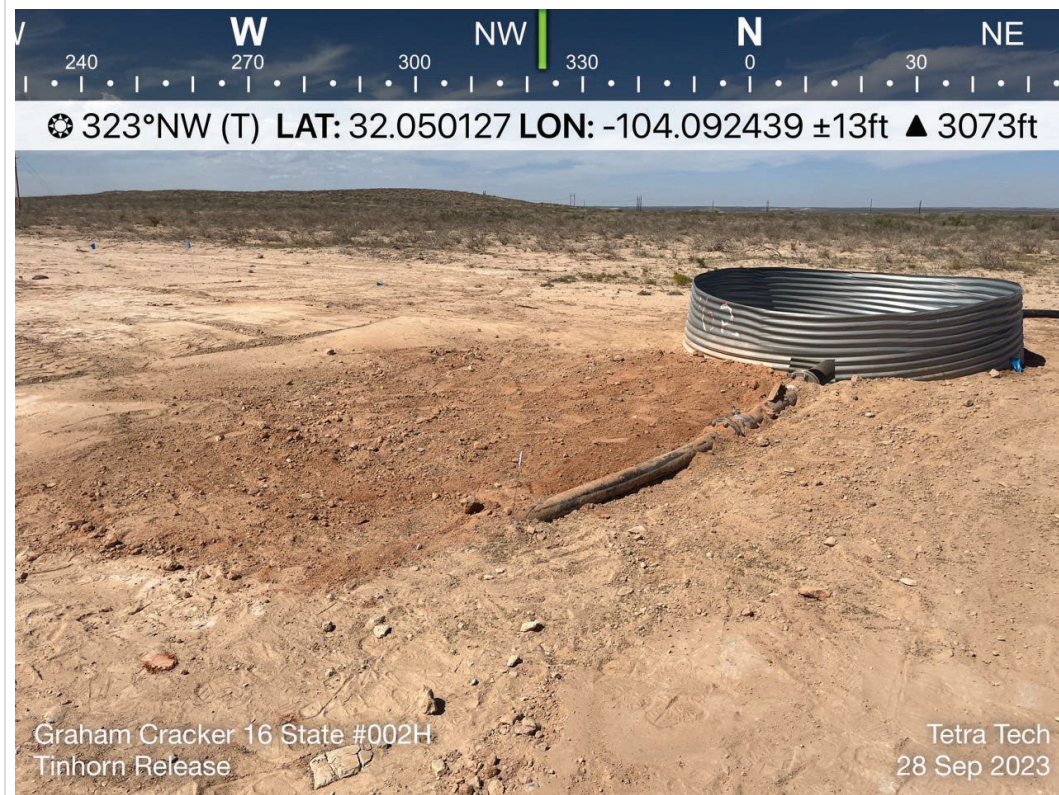
TETRA TECH, INC. PROJECT NO. 212C-MD-02989	DESCRIPTION	View northwest of backfilled and seeded area.	12
	SITE NAME	Graham Cracker 16 St #002H	9/28/2023
