**Re: Closure Request
Rojo 10-13 34-37 Tank Battery
Incident Number nAPP2129826922
Lea County, New Mexico**

Ensolum, LLC (Ensolum), on behalf of BTA Oil Producers, LLC (BTA), has prepared this *Closure Request* to document assessment and soil sampling activities performed at the Rojo 10-13 34-37 Tank Battery (Site). The purpose of the Site assessment and soil sampling activities was to assess for the presence or absence of impacts to soil following a release of produced water within a lined containment at the Site. Based on field observations, field screening activities, and soil sample laboratory analytical results, BTA is submitting this *Closure Request*, describing Site assessment and delineation activities that have occurred and requesting no further action and closure for Incident Number nAPP2129826922.

BTA Oil Producers, LLC
Closure Request
Rojo 10-13 34-37 Tank Battery

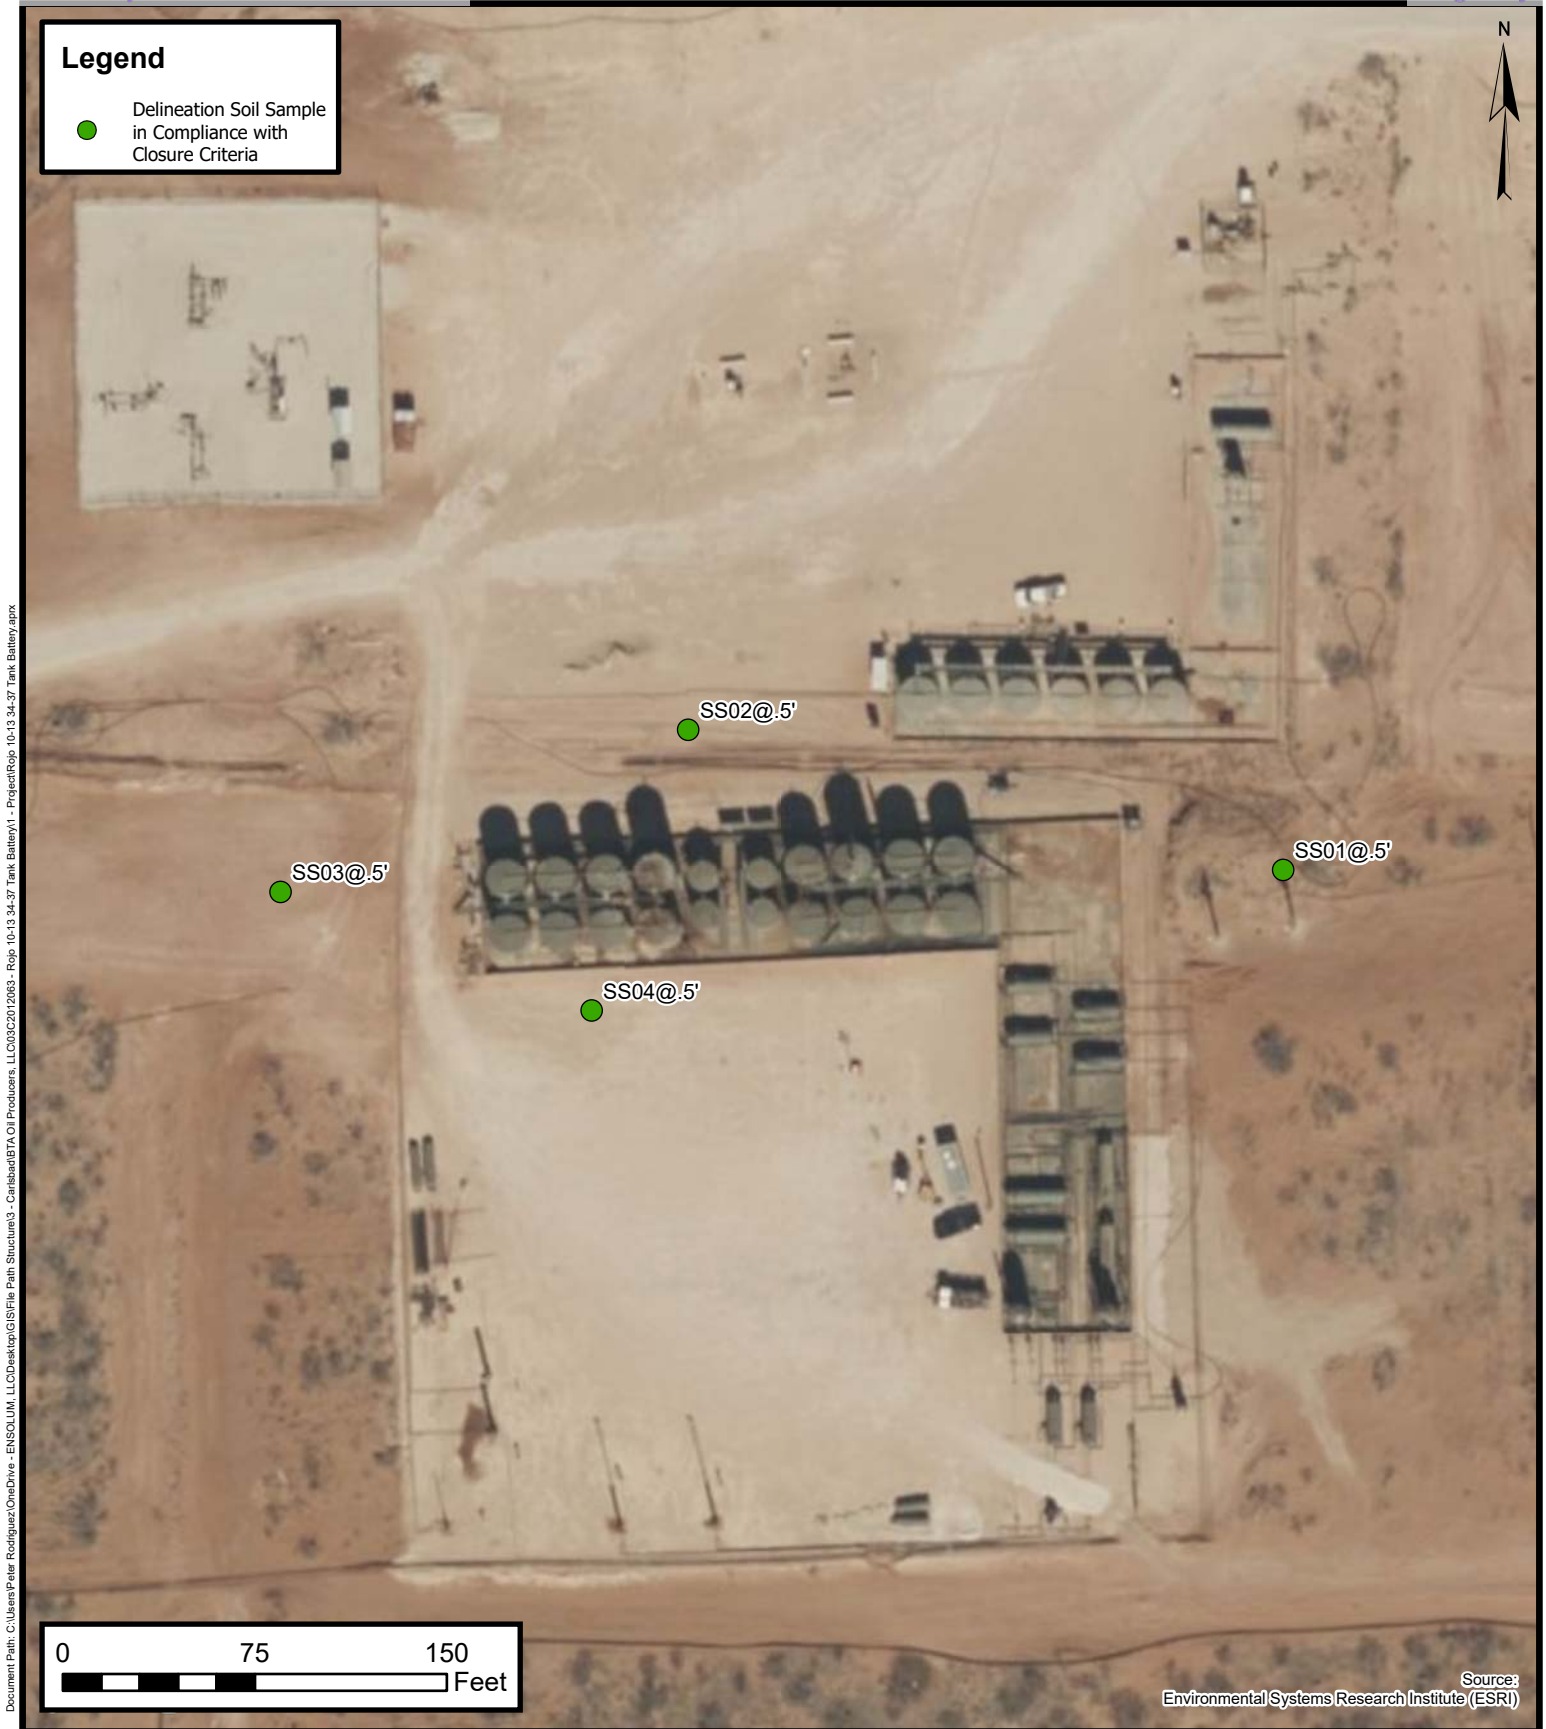
FIGURE
2

Four discrete delineation soil samples, SS01 through SS04, were collected at a depth of 0.5 feet bgs to confirm the lateral release extent did not extend outside or breach the containment. Delineation soil samples were field screened for volatile organic compounds (VOCs) utilizing a calibrated photoionization detector (PID) and chloride using Hach® chloride QuanTab® test strips. The delineation soil sample locations are depicted on Figure 2. Photographic documentation was conducted at the Site. A photographic log is included in Appendix B.

Delineation Soil Sample Locations

Laboratory analytical results for delineation soil samples SS01 through SS04 indicated all COC concentrations were compliant with the most stringent Table I Closure Criteria and successfully defined the lateral extent of the release. Laboratory analytical results are summarized in Table 1 and the complete laboratory analytical reports are included as Appendix C.

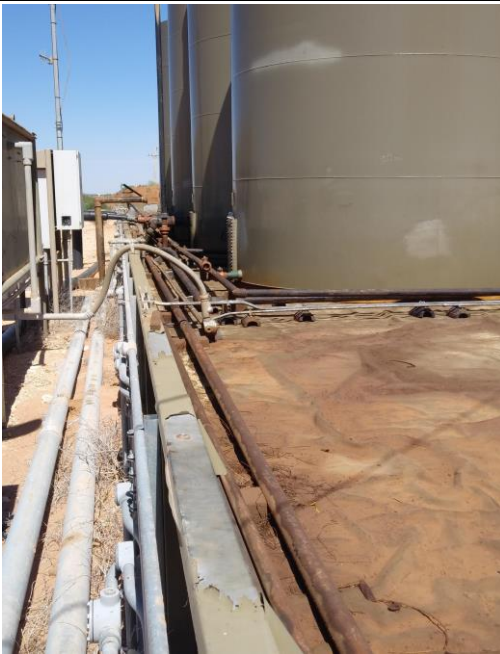
Photograph: 1 Date: 6/19/2023
Description: View of the lined containment deemed to be in good condition, facing east.

A 48-hour advance notice of the liner inspection was provided via email on June 14, 2023, to the NMOCD. A liner integrity inspection was conducted by Ensolum personnel on June 19, 2023. Upon inspection, no rips, tears, holes, or damage was observed. The liner was determined to be sufficient, and all released fluids have been removed.

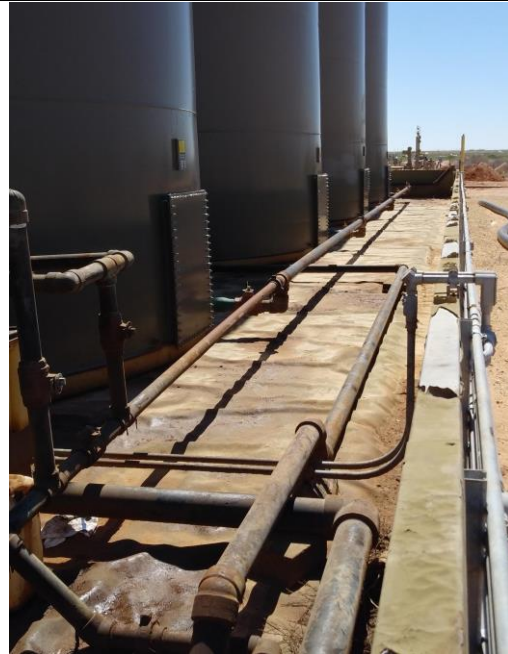
Photograph: 2 Date: 6/19/2023
Description: View of the lined containment deemed to be in good condition, facing west.

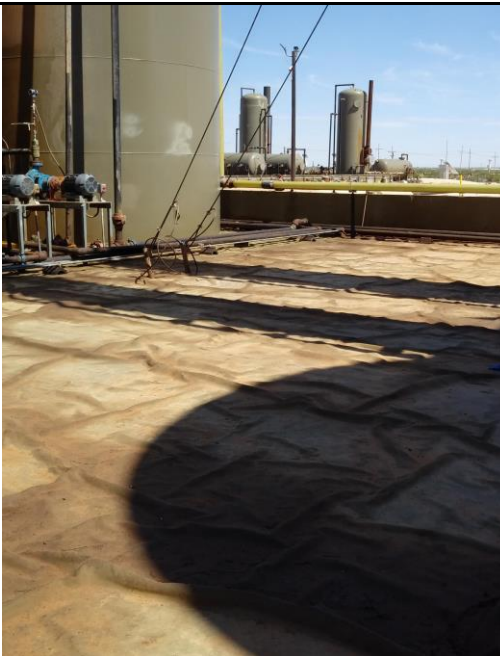
Photograph: 3 Date: 6/19/2023
Description: View of the lined containment deemed to be in good condition, facing south.

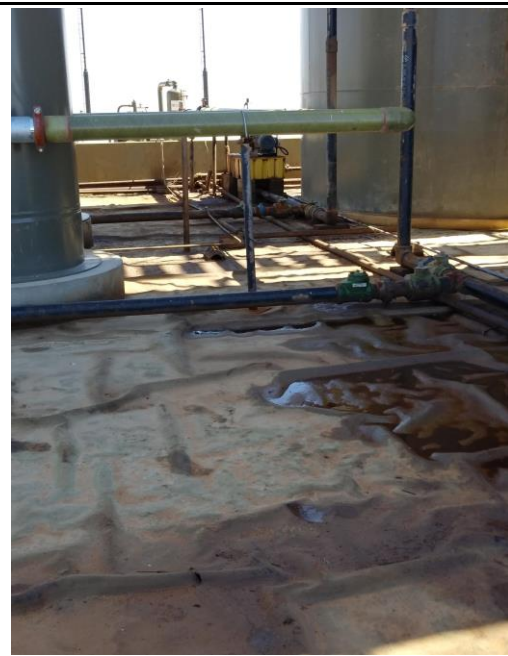
Photograph: 4 Date: 6/19/2023
Description: View of the lined containment deemed to be in good condition, facing north.
