A-2-3-5 EXT 2 LINE

Revised Remediation Summary & Closure Report

NMOCD Incident No. nAPP2312333253
UL "G", Sec. 20, T17S, R35E
32.82257, -103.47281
Lea County, New Mexico

November 1, 2023

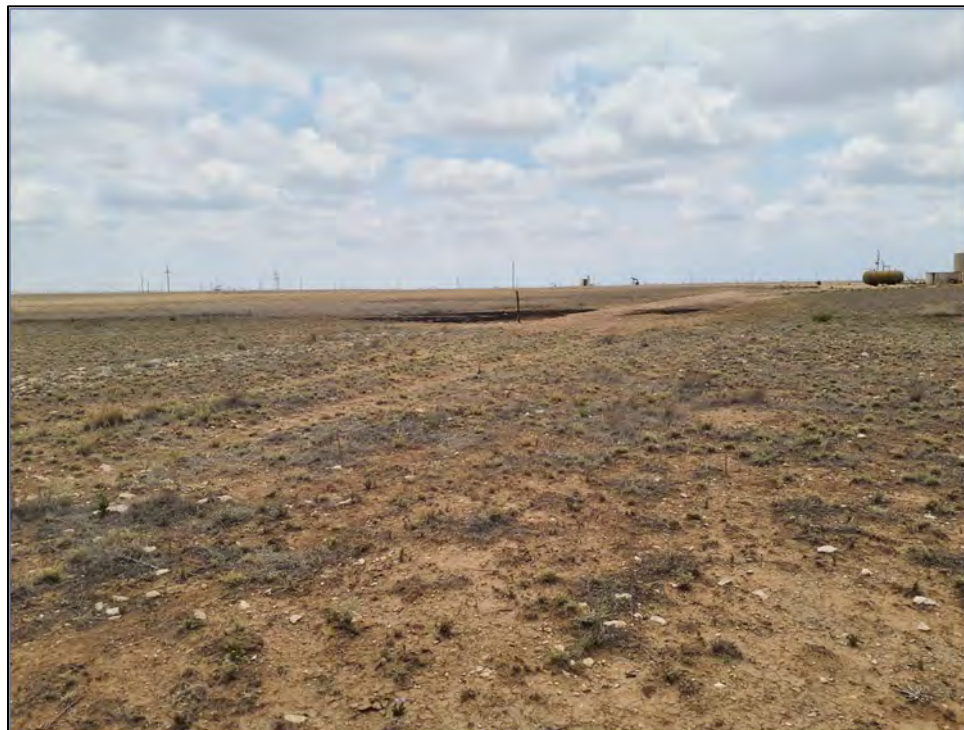
Figure -3 Overview of survey area from north edge, facing south (Frame -0255)

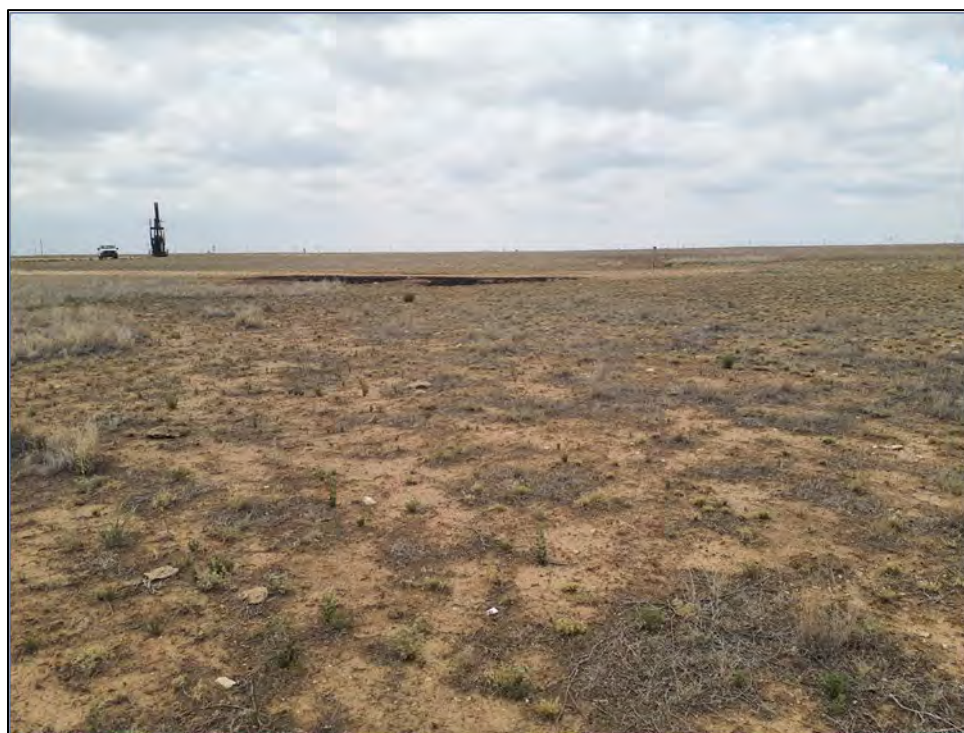
Figure 4. Overview of survey area from east edge, facing west (Frame -9557).

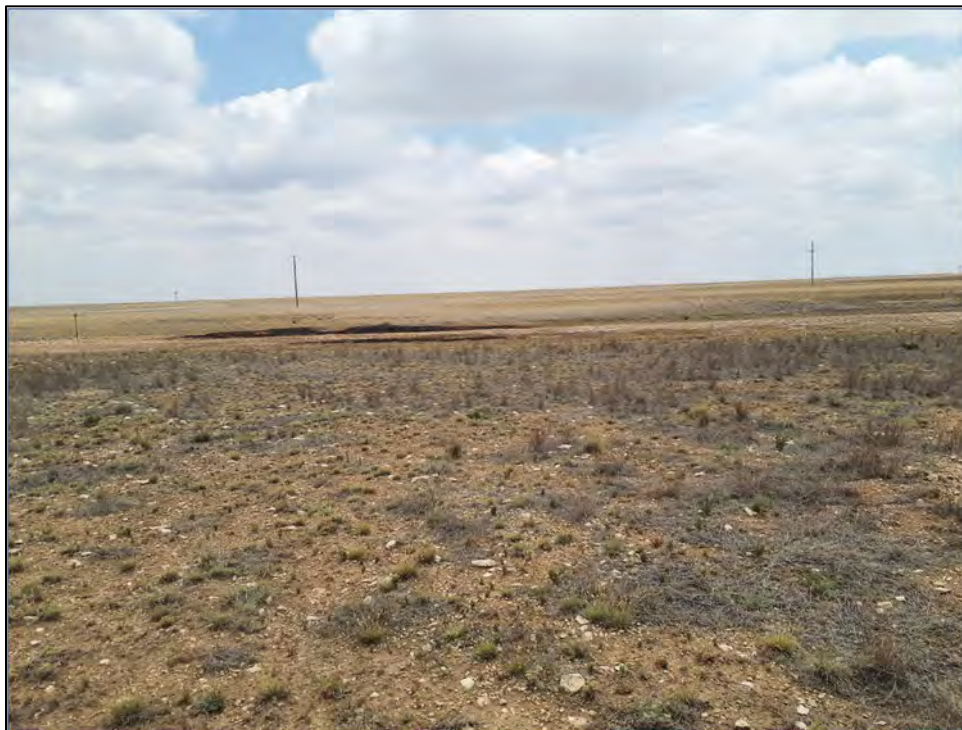
Figure -5. Overview of survey area from west edge, facing east (Frame -9555).

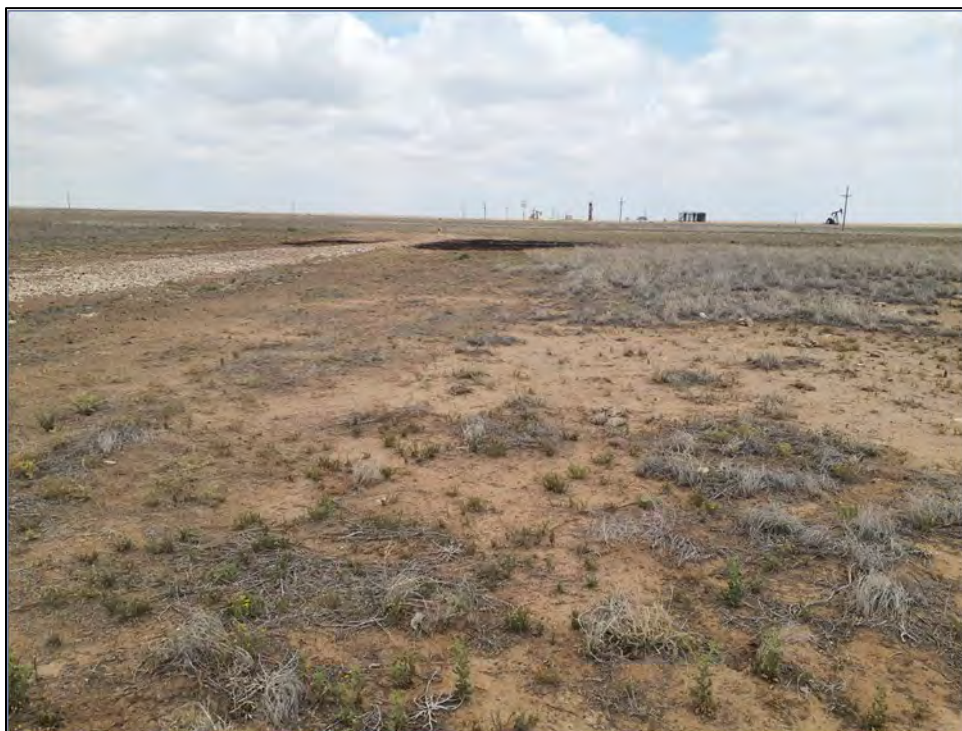
Figure -6. Overview from south edge of survey area, facing north (Frame -5292).

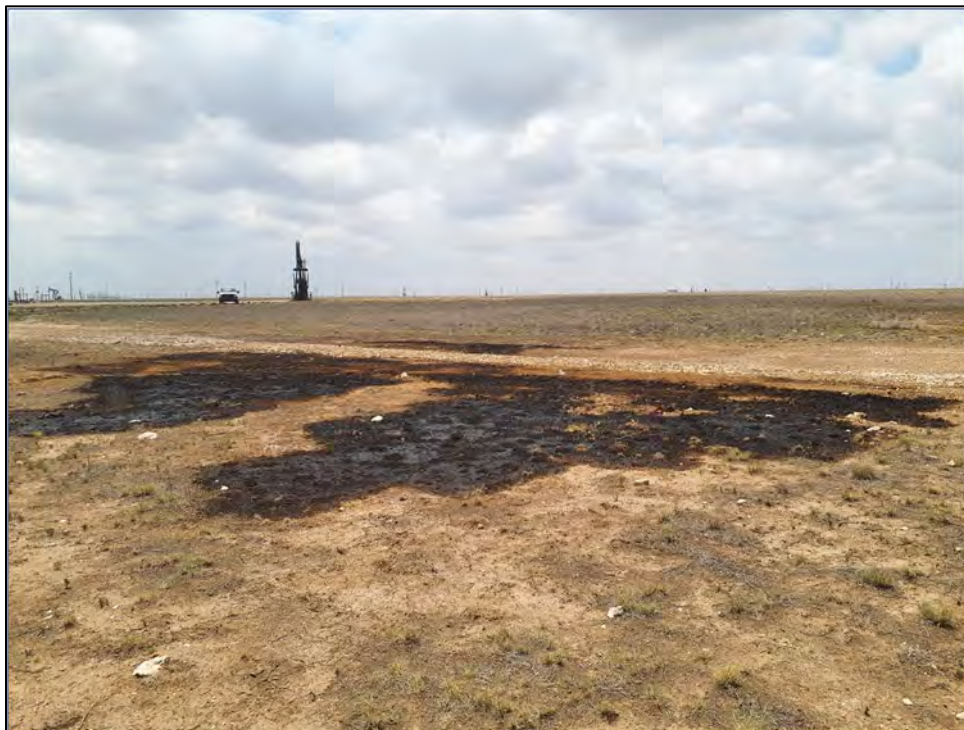
Figure 7. Detail of spill, facing west (Frame -2908).

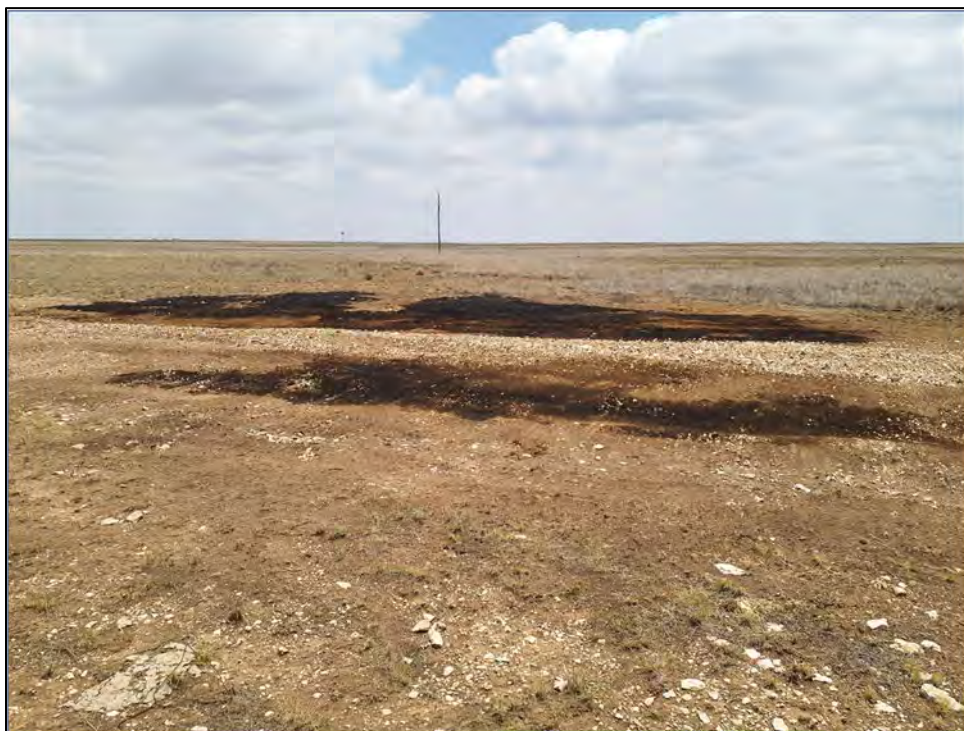
Figure 8. Detail of spill, facing east (Frame -1734).
