CARMONA RESOURCES

Closure Report
Cascade 29 Federal Com 75H Drill Cuttings
Incident ID: nAPP2320576371
Lea County, New Mexico
Unit B Sec 5 T26S R33E
32.079316°, -103.591916°

Re: Closure Report
Cascade 29 Federal Com 75H Drill Cuttings
Incident ID: nAPP2320576371
Cimarex Energy Co. of Colorado
Site Location: Unit B, S5, T26S, R33E
(Lat 32.079316°, Long -103.591916°)
Lea County, New Mexico

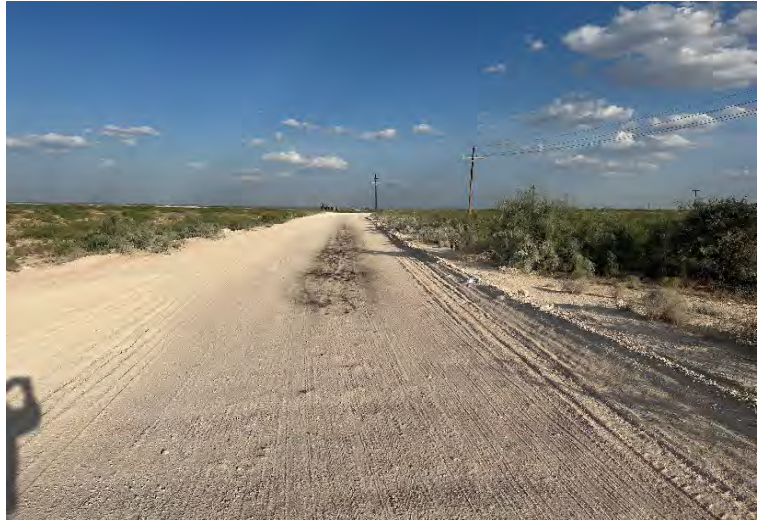
Description:
View of the initial release.

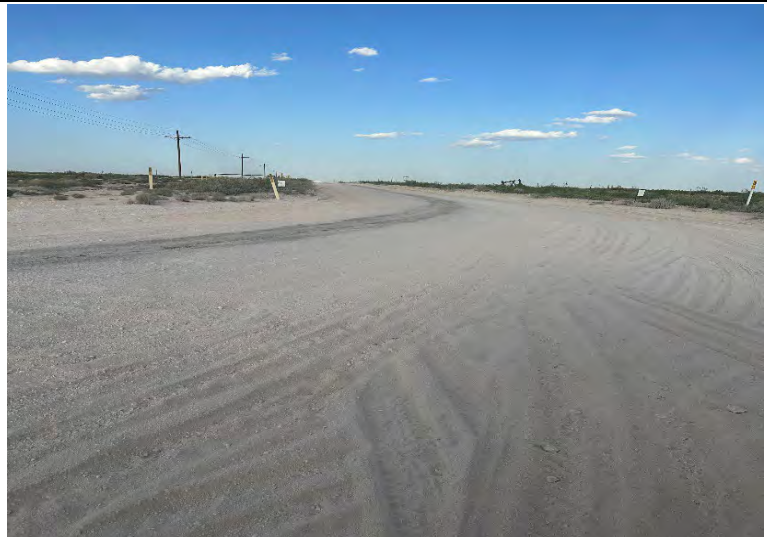
Photograph No. 2

Description:
View of the initial release.

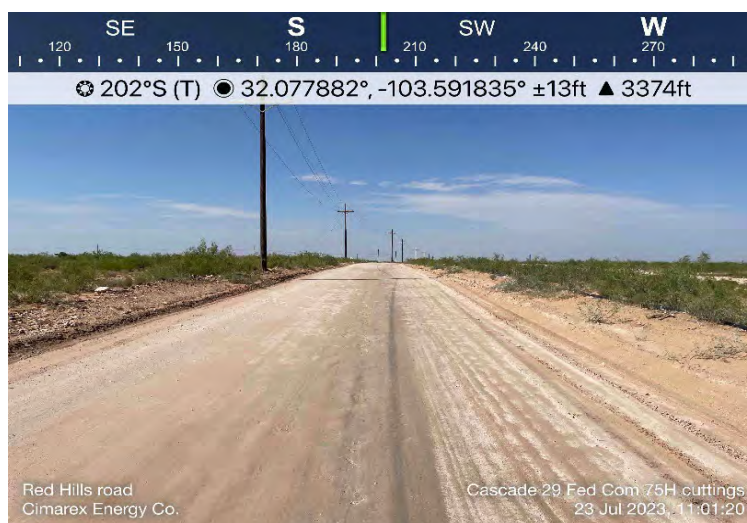
View South, lease road during surface scrape.

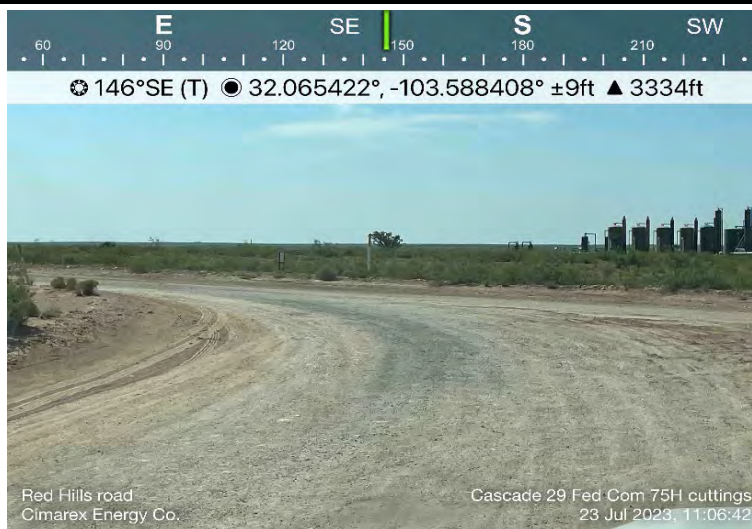
Photograph No. 5

View Southeast, lease road during surface scrape.

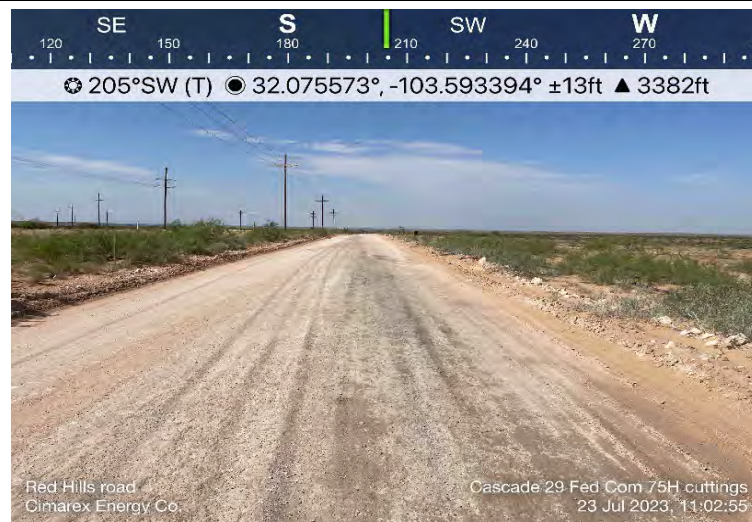
Photograph No. 6

View South, lease road during surface scrape.

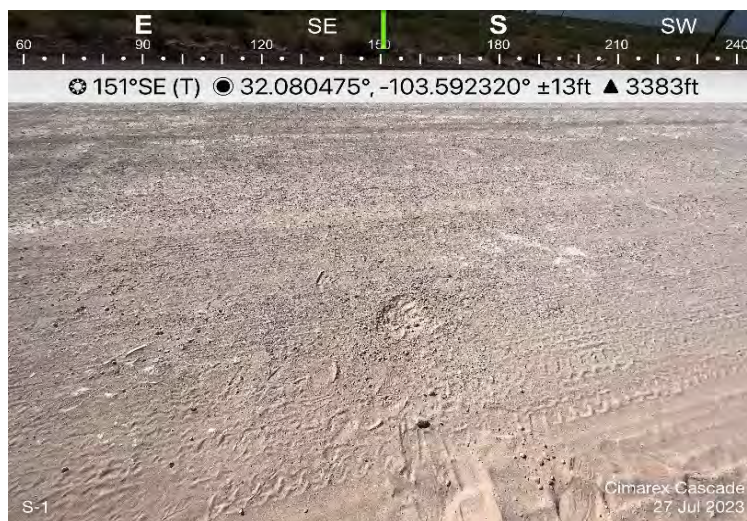
View Southeast, lease road during sampling event.

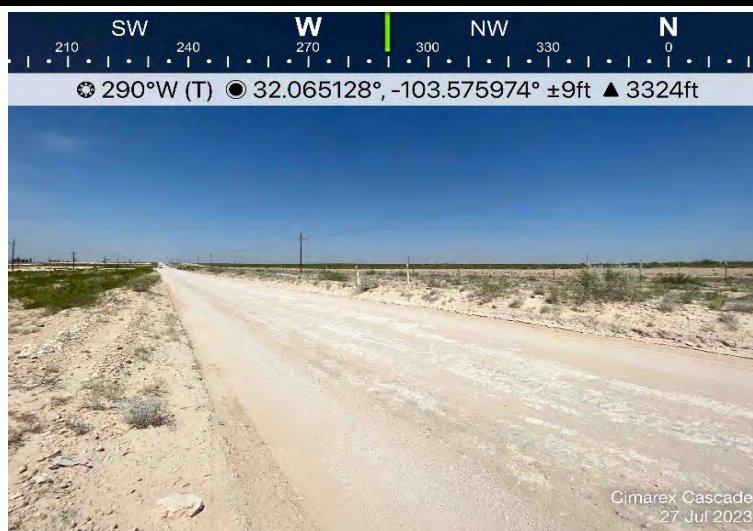
**Photograph No. 8****Facility:** Cascade 29 Federal Com 75H**County:** Lea County, New Mexico**Description:**

View West, lease road during sampling event.

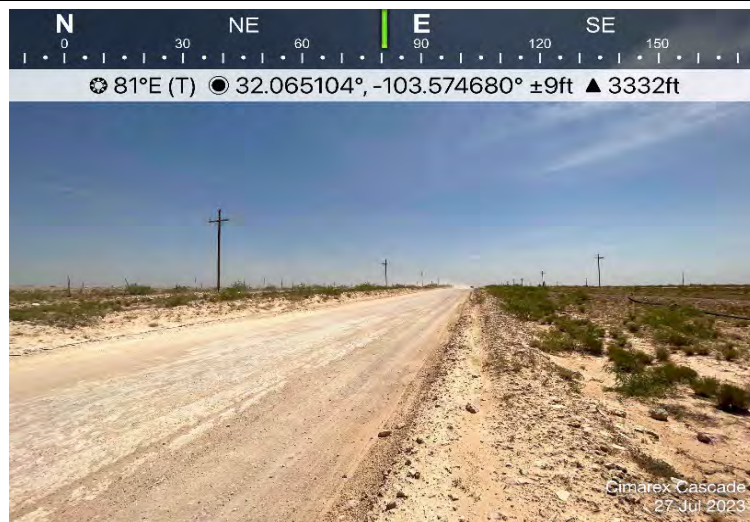
**Photograph No. 9****Facility:** Cascade 29 Federal Com 75H**County:** Lea County, New Mexico**Description:**

View East, lease road during sampling event.

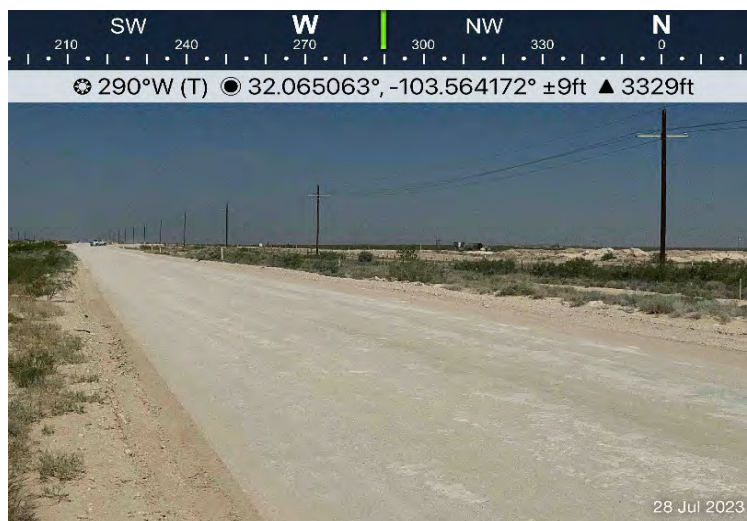
View West, lease road during sampling event.

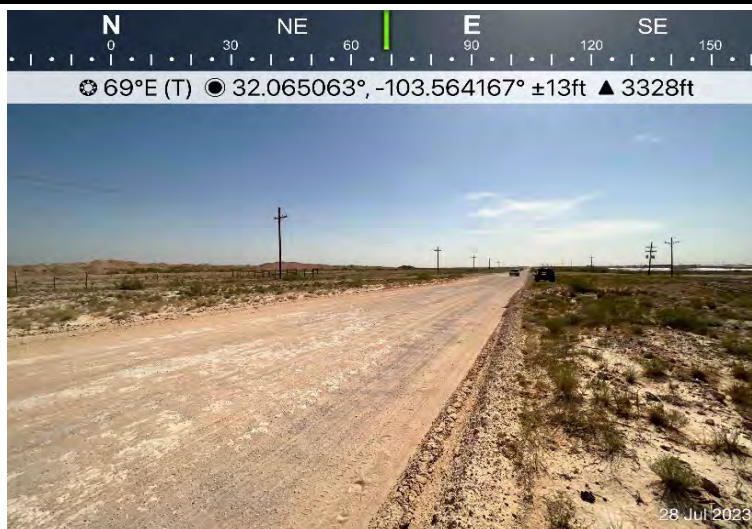
Photograph No. 11

View East, lease road during sampling event.

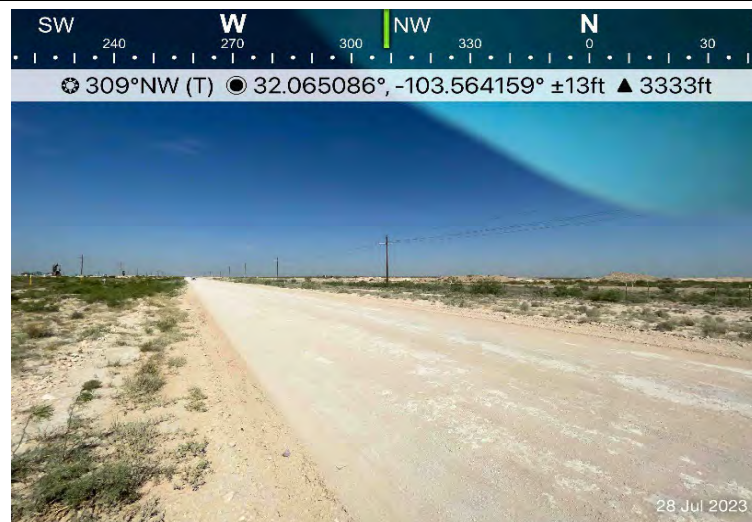
Photograph No. 12

View Northwest, lease road during sampling event.
