SITE CHARACTERIZATION AND REMEDIATION PLAN

**SCOUT EH FEDERAL #6
UNIT G, SECTION 34, TOWNSHIP 18S, RANGE 35E
EDDY COUNTY, NEW MEXICO
32.706401, -104.470685
RANGER REFERENCE NO. 5375**

**SITE CHARACTERIZATION AND REMEDIATION WORK PLAN
SCOUT EH FEDERAL #6
UNIT G, SECTION 34, TOWNSHIP 18S, RANGE 35E
EDDY COUNTY, NEW MEXICO
32.706401, -104.470685
RANGER REFERENCE NO. 5375**

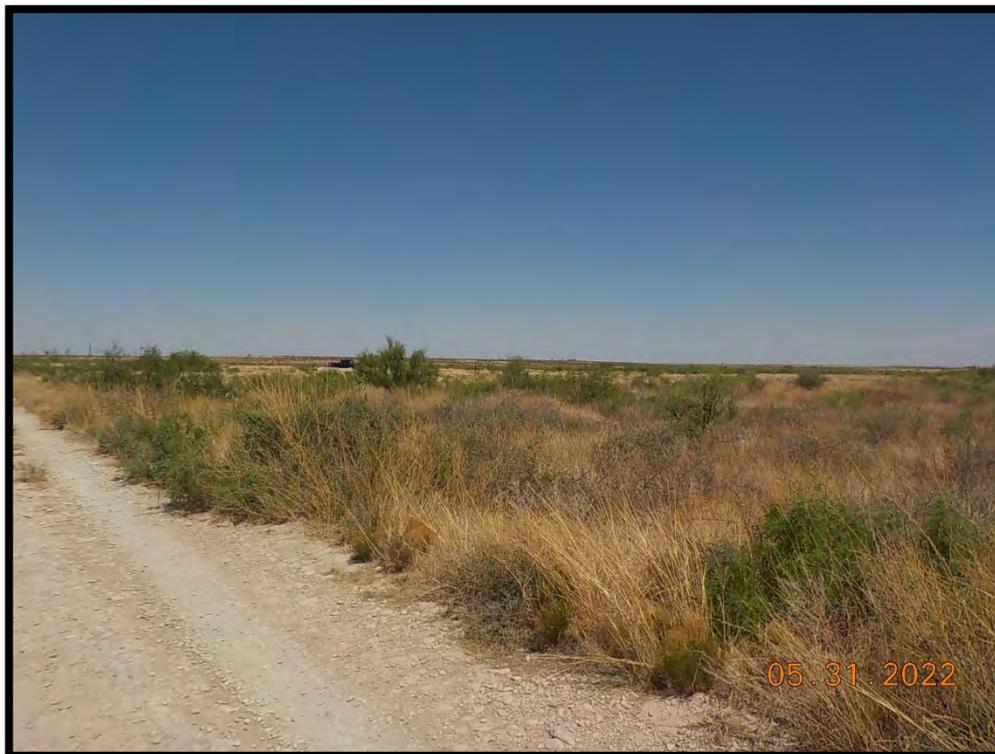
PHOTOGRAPH NO. 4 – A view of the mapped and observed area located to the west of the site during the May 31, 2022, inspection. The view is towards the east-southeast.

(Approximate GPS: 32.706278, -104.472653)

The mapped riverine feature on the National Wetland Inventory Map Viewer was found to be located at a higher topographic location than the approximate midpoint of the dense vegetation area. During the inspection of the area, no defined bed, banks, or indication of water flow were observed. Ranger personnel collected GPS plot points of the lowest topographic area within the dense vegetation area which confirmed that this area was further west of the mapped riverine feature and in the approximate midpoint of the denser vegetative cover area.

The area of the mapped riverine feature was noted to have denser vegetative cover than the surrounding areas; however, the vegetation type is similar to that of the surrounding areas. The observed predominant vegetation was comprised of mixed grasses (switchgrass, *Panicum Virgatum* and blue gramma, *Bouteloua gracilis*), Honey Mesquite (*Propis glandulosa*), Broom Snakeweed (*Guitierrezia sarothrea*), and Catclaw Acacia (*Senegalia greggii*). The observed vegetation is not classified as hydrophytic vegetation indicative of a wetland feature.

Based on the documented location of probable waterflow, observed vegetation types, and lack of defined bed or banks, it does not appear that a wetland feature exists near the Site, and the riverine feature is located to the west of where it is mapped. Based on the observed conditions, the area does not appear to warrant the utilization of more stringent Table 1 Criteria as required by NMAC 19.15.29.12(C).

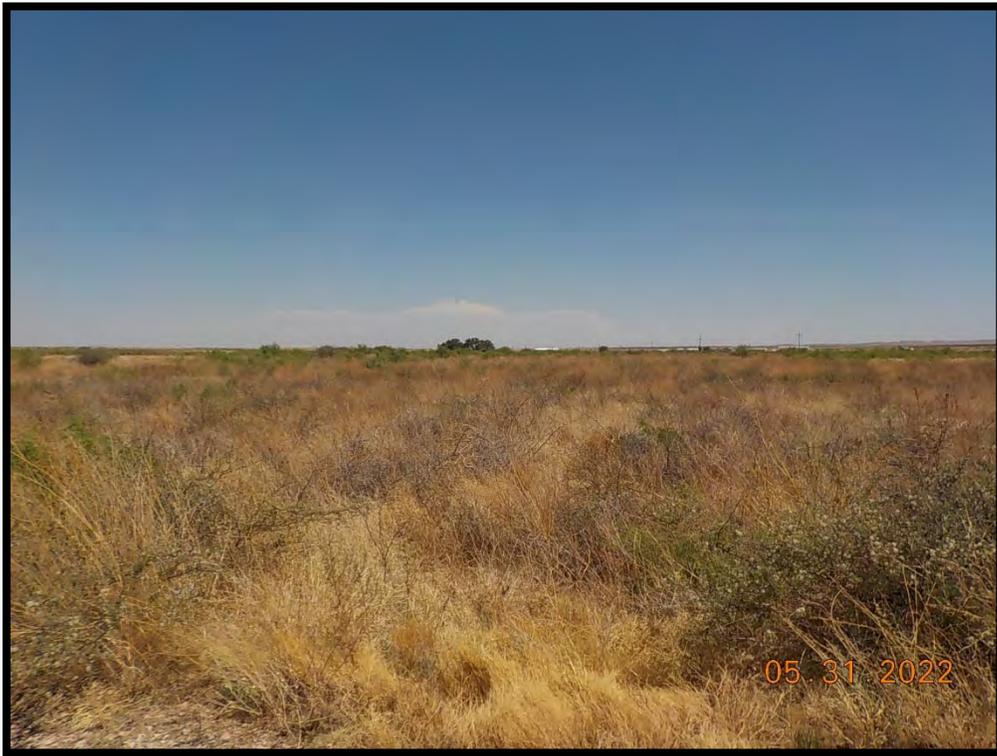
PHOTOGRAPH NO. 5 – An additional view of the mapped and observed area located to the west of the site during the May 31, 2022, inspection. The view is towards the southeast.
(Approximate GPS: 32.706440, -104.472056)

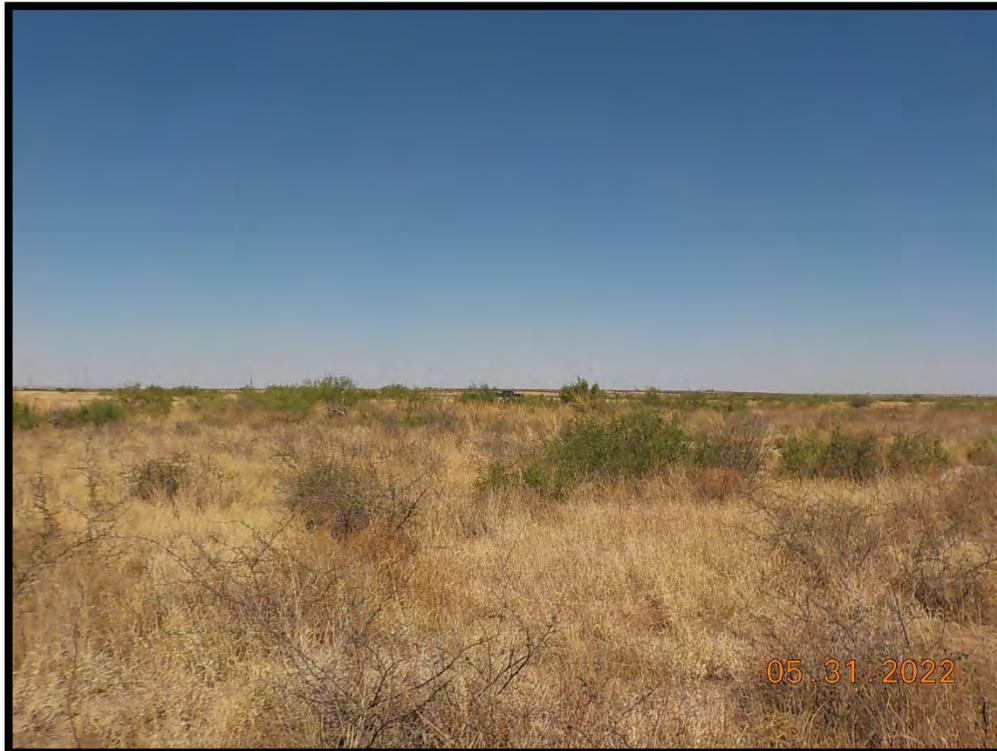
PHOTOGRAPH NO. 6 – An additional view of the mapped and observed area located to the west of the site during the May 31, 2022, inspection. The view is towards the east towards the Site. A vehicle parked at the Site can be seen in the photograph.
(Approximate GPS: 32.705808, -104.472047)

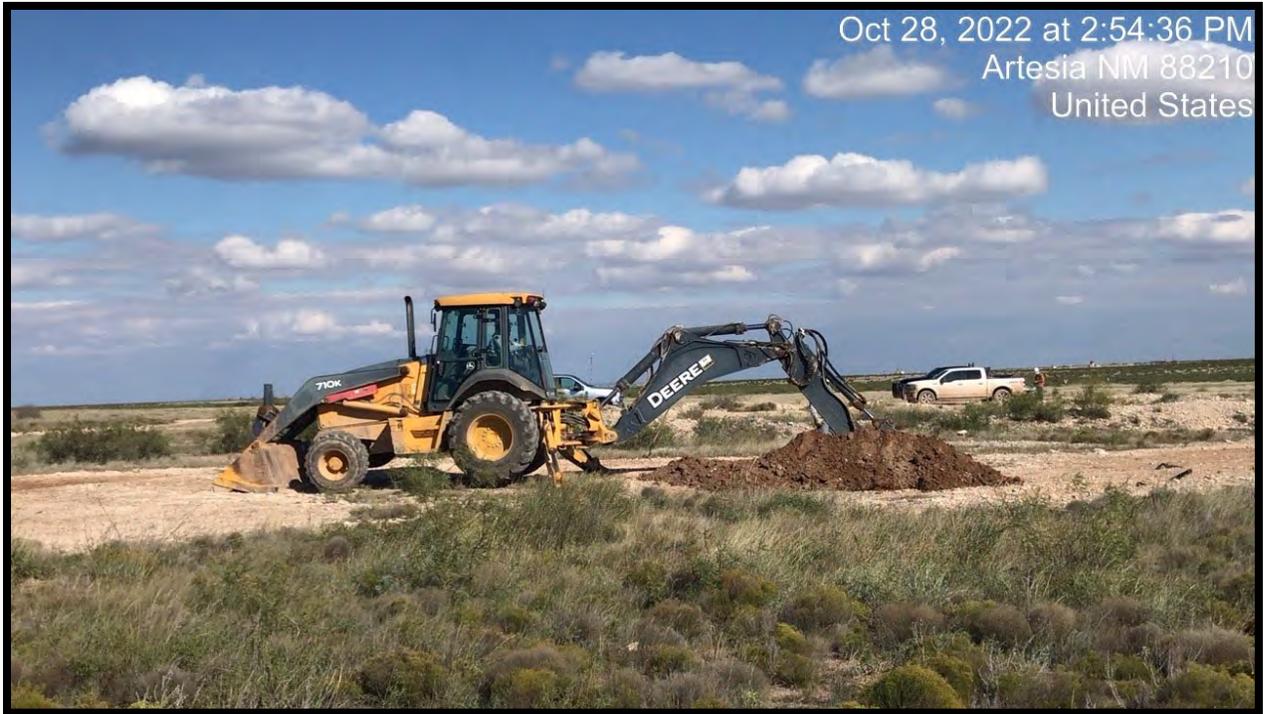
PHOTOGRAPH NO. 7 – A typical view of the October 28, 2022 vertical delineation test excavation activities.

The test excavations were completed to a depth of approximately 17'-20' bgs (the limit of the on-site backhoe). Ranger field screened the soils from each one-foot interval utilizing an OVM and field chloride titration kit. All field chloride results were found to exceed 600 mg/Kg chloride. No elevated OVM readings were obtained at the TH-1 location; however, OVM readings ranging from 11 to 940 parts per million vapor (ppm_v) were detected in the samples collected below 9' bgs in test excavation TH-2. Soil samples were subsequently collected from TH-1 at depths of 19' and 20' bgs to document the constituent of concern (COC) concentrations at the terminal depth of this test excavation. Soil samples were collected from test excavation TH-2 at depths of 12' (depth of the highest field chloride result) and 17' bgs (depth of the highest OVM reading).

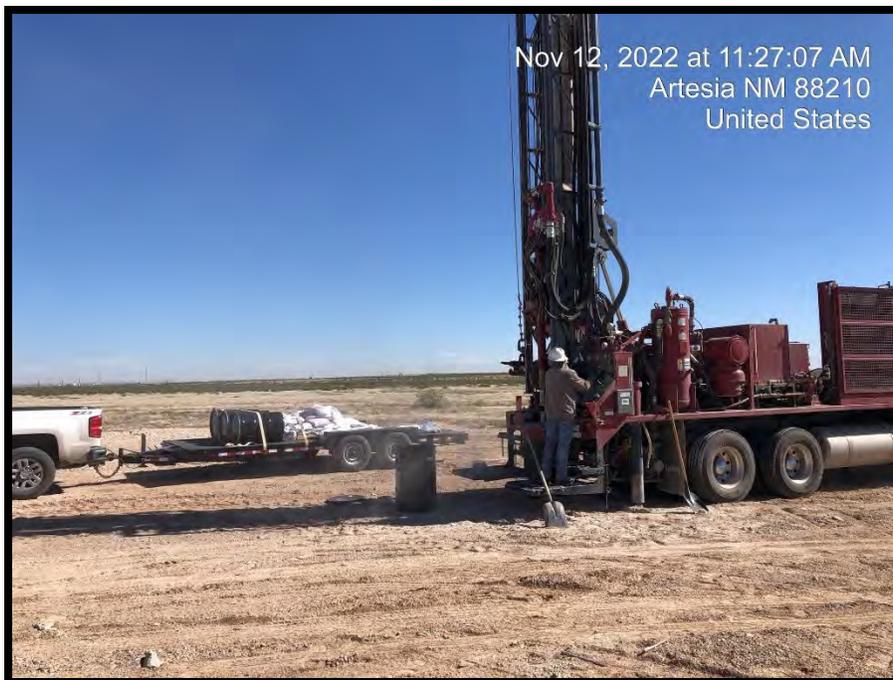
PHOTOGRAPH NO. 8 – A typical view of the November 12, 2022 vertical delineation soil boring installation activities.

During the installation of the three soil borings, no saturated soils were encountered, and the borings were all found to be dry. As such, the soil borings were properly plugged and abandoned by the on-site driller.

The November 12, 2022 soil analytical data documented that soil borings B-1 and B-3 had elevated chloride concentrations remaining at their terminal depths of 70' and 60' (1,900 mg/Kg and 1,300 mg/Kg, respectively). Soil boring B-2 was found to contain 450 mg/Kg chloride at its terminal depth of 25'. There were no BTEX or TPH exceedances of the proposed site closure criteria documented in the soil borings.

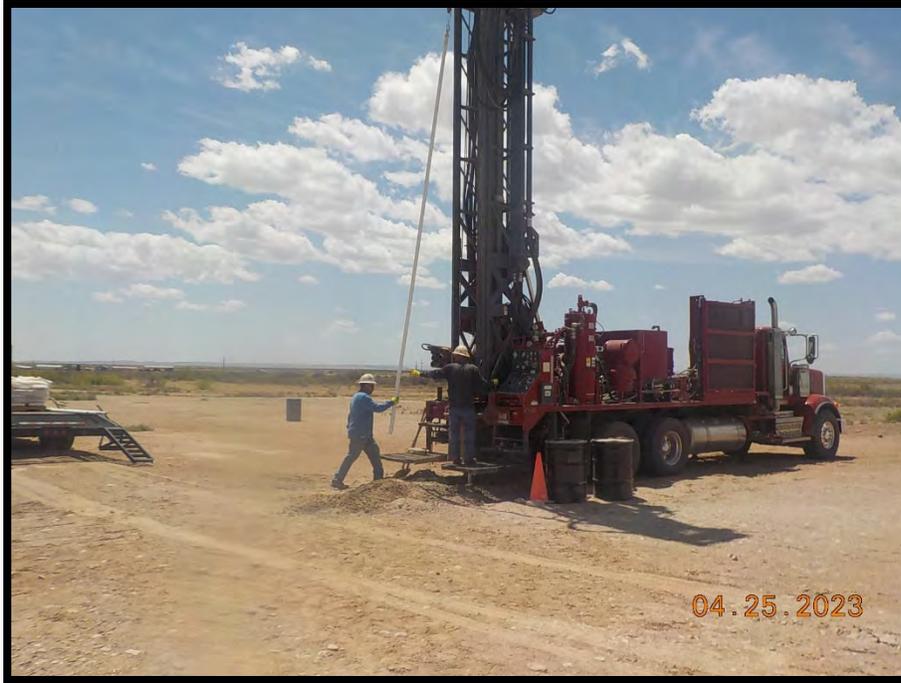
PHOTOGRAPH NO. 9 – A typical view of the April 25, 2023 vertical delineation soil boring and temporary monitor well installation activities.

During the installation of the soil borings, no obvious saturated soils were encountered. However, as discussed in Section 2.1, above, these two soil borings were then advanced to a terminal depth of 105' bgs and converted to temporary monitor wells to collect additional site-specific depth-to-groundwater information due to the questionable results obtained by the initial depth-to-groundwater soil boring SB-1. As discussed in Section 2.1, upon gauging the wells on April 28, 2023, temporary monitor well B-1.A was found to be dry. Temporary monitor well B-3.A was found to contain groundwater at a depth of 73.18' bgs. The results of the depth-to-groundwater investigative activities conducted at the subject site suggest that a discontinuous, perched water-bearing zone appears to be present at the site at an approximate depth of 73 to 85 feet bgs which overlies the deeper area water table.

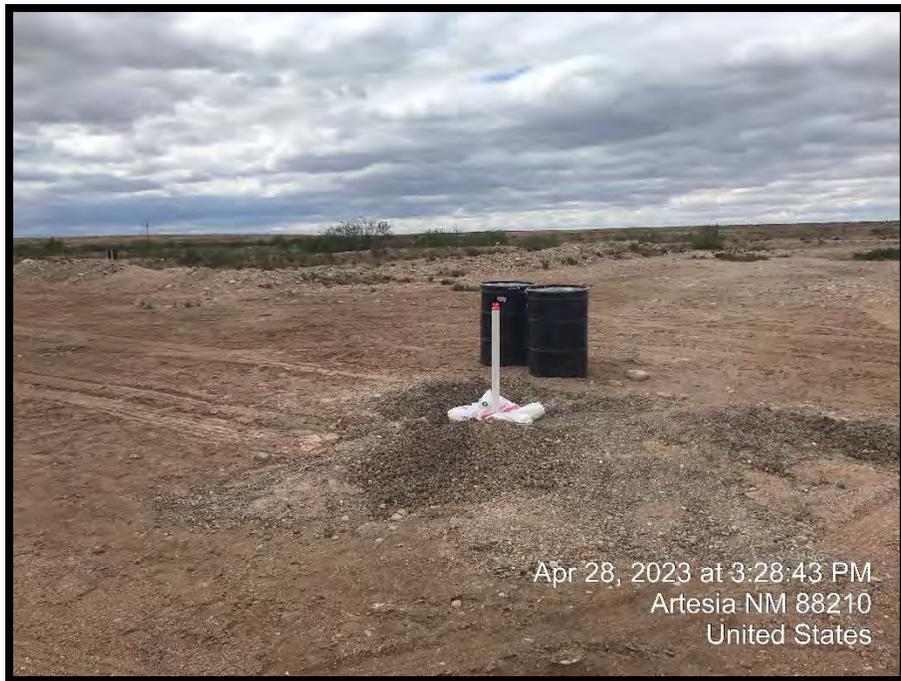
PHOTOGRAPH NO. 10 – A typical view of the April 2023 temporary monitor wells at the time of gauging on April 28, 2023.

Upon gauging the wells on April 28, 2023, temporary monitor well B-1.A was found to be dry. Temporary monitor well B-3.A was found to contain groundwater at a depth of 73.18' bgs, and similar to temporary monitor well SB-1, the encountered groundwater was detected just above a clayey silt unit present at a depth of 75' bgs, and an underlying clay unit present at a depth of 85' bgs. Upon completion of the depth-to-groundwater investigation activities, the temporary monitor wells were properly plugged and abandoned.
