June 5th, 2023

Re: Site Assessment, Remediation, and Closure Report
Snapping 2 St. #004H
API No. 30-015-39071
GPS: Latitude 32.0657806 Longitude -103.7426834
UL -- P, Sec. 02, T26S, R31E
Eddy County, NM
NMOCD Ref. No. NAB1915041303

**SITE PHOTOGRAPHS
DEVON ENERGY
SNAPPING 2 STATE 4H**

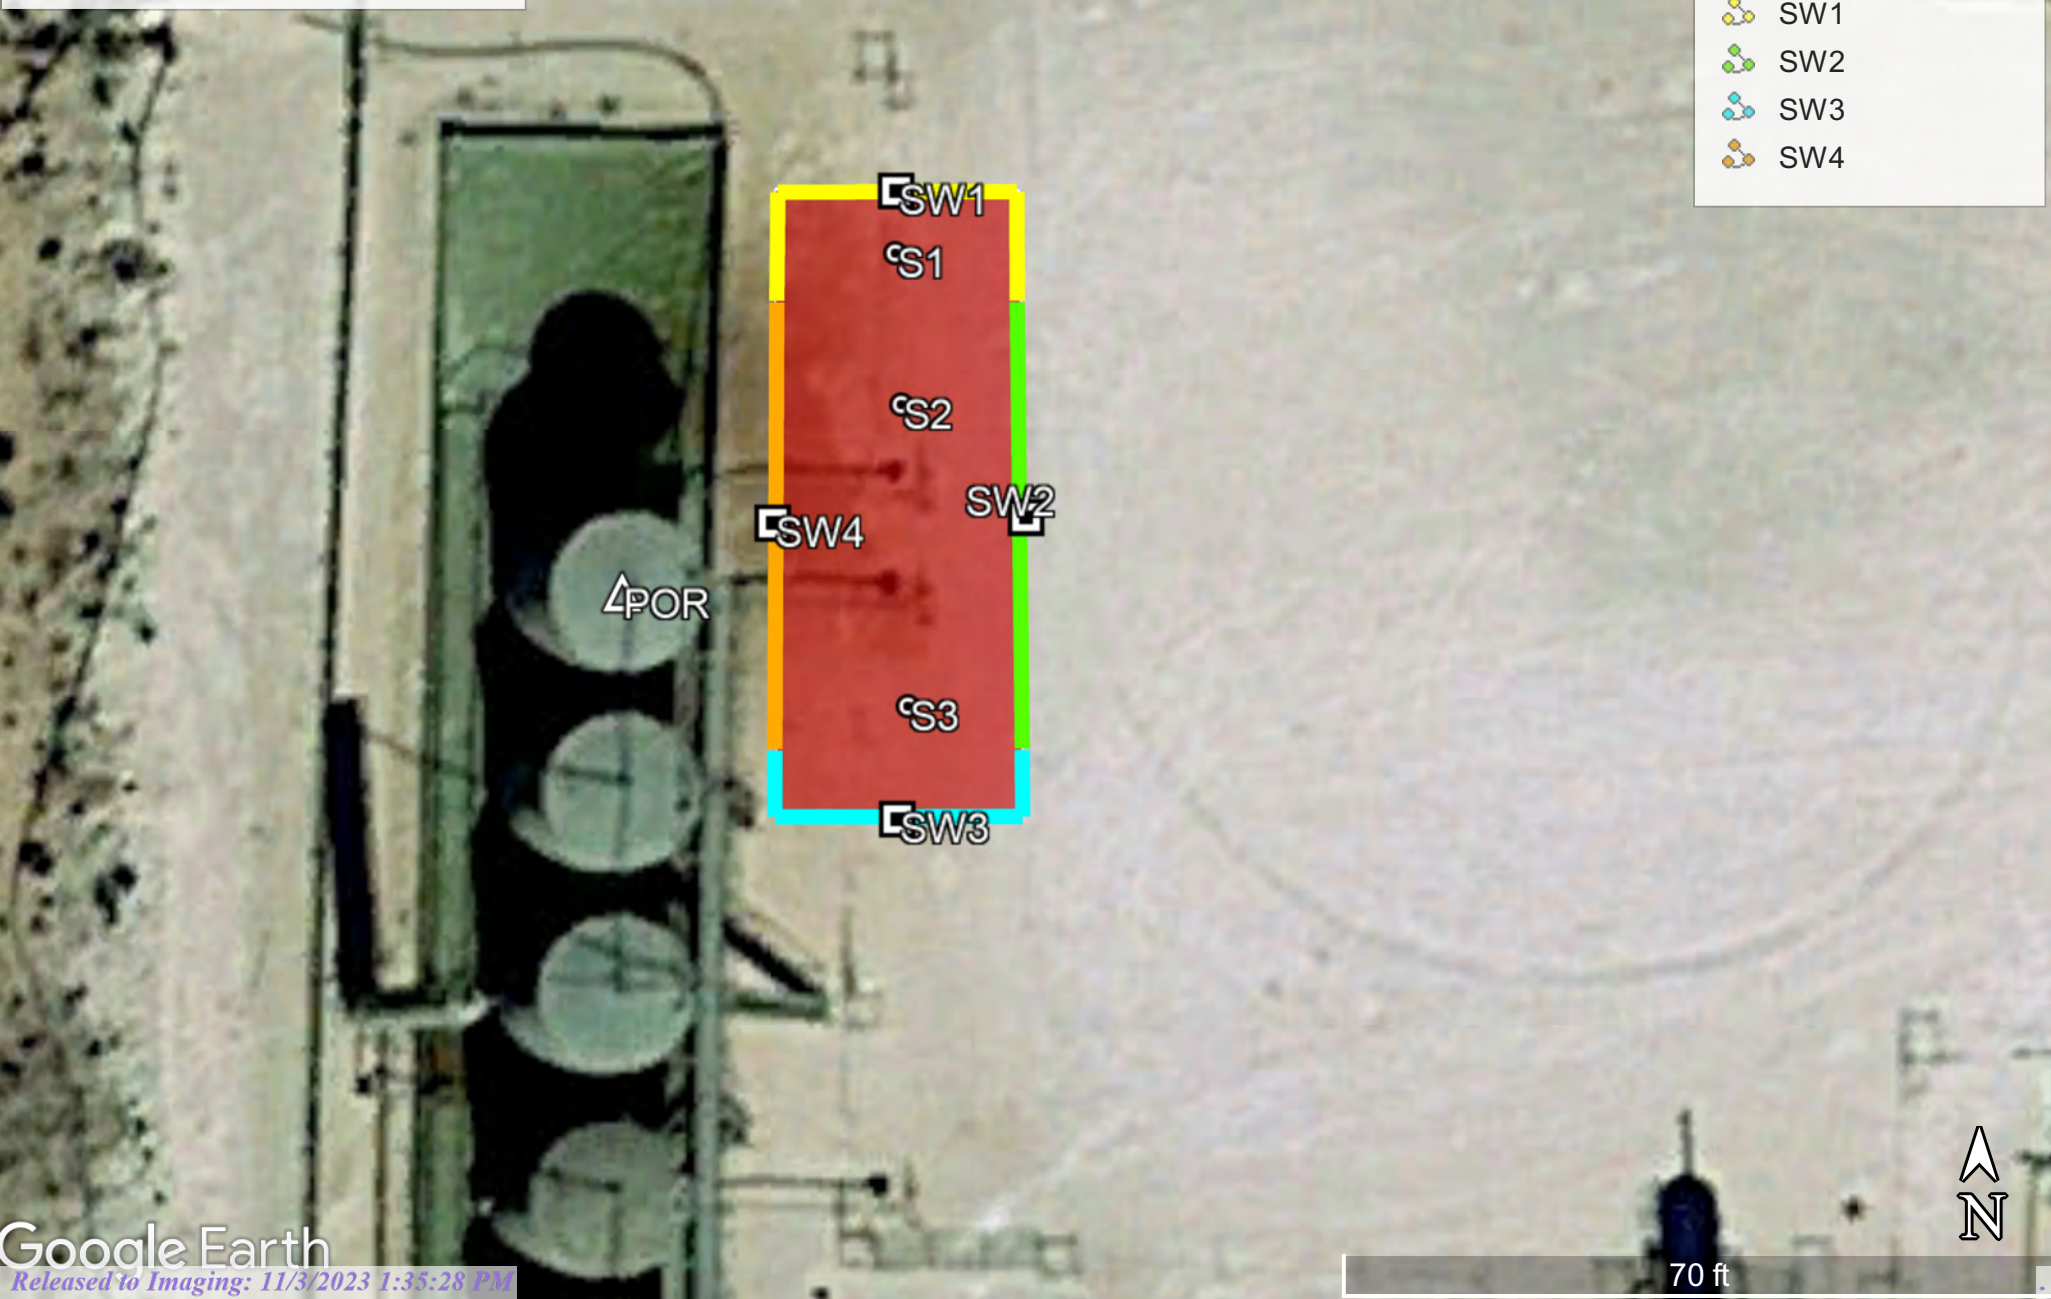
4-Site Map

On May 19th, 2023, Pima Environmental mobilized personnel to assess the impacted area. Pima sampled the area surrounding the point of release. Pima collected a total of thirteen soil samples for laboratory analysis. Three bottom samples (S1-S3) were collected at depths of 1, 3, and 5 feet to determine vertical delineation. Additionally, side wall samples (SW1-SW4) were collected at a depth of 6 inches to determine horizontal delineation. An initial site map can be found in Figure 4.

- Bottom Sample
- Point of Release
- Release Area
- Side Wall Sample
- SW1
- SW2
- SW3
- SW4

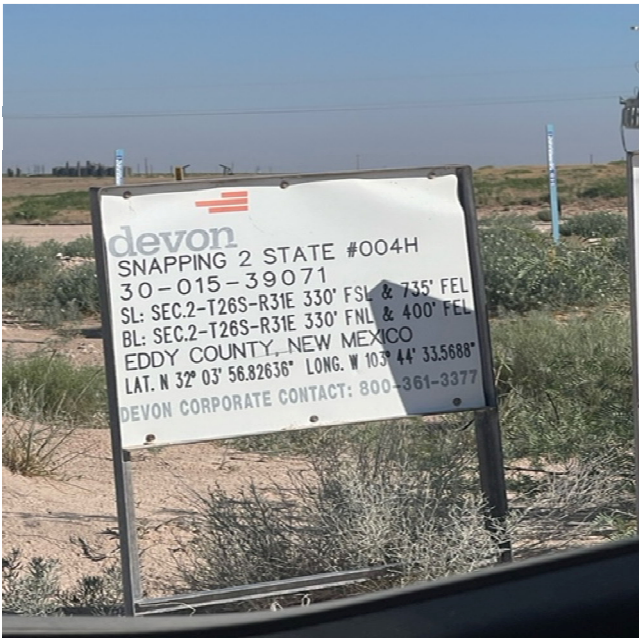
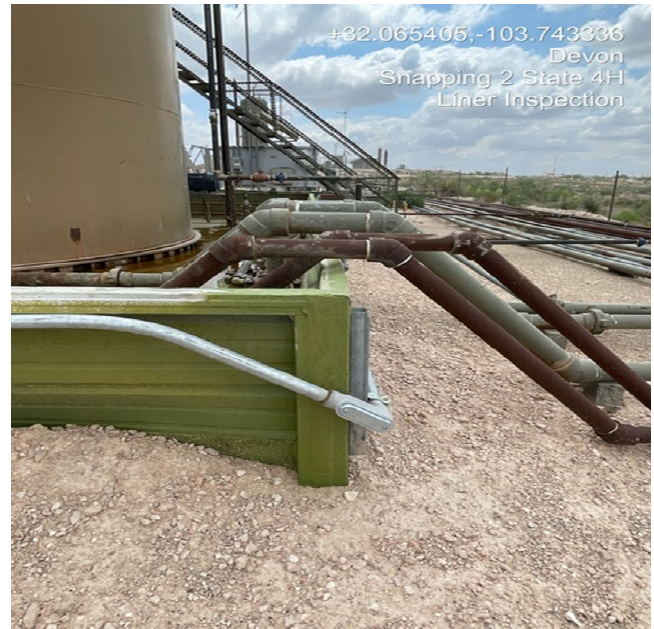
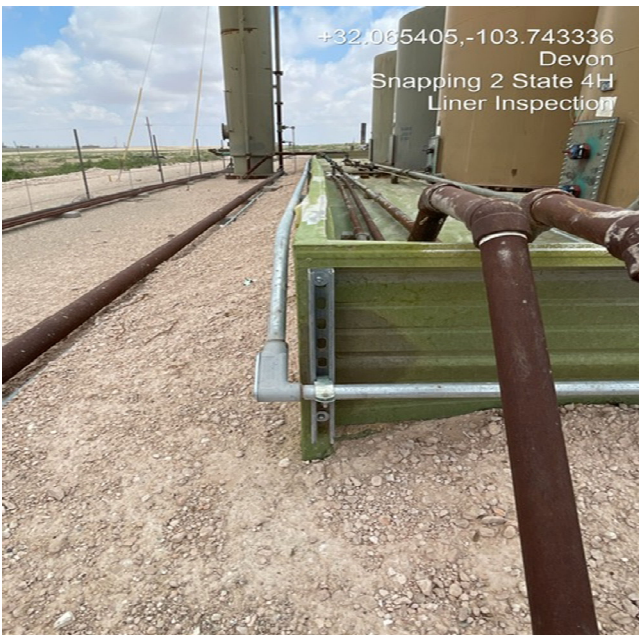
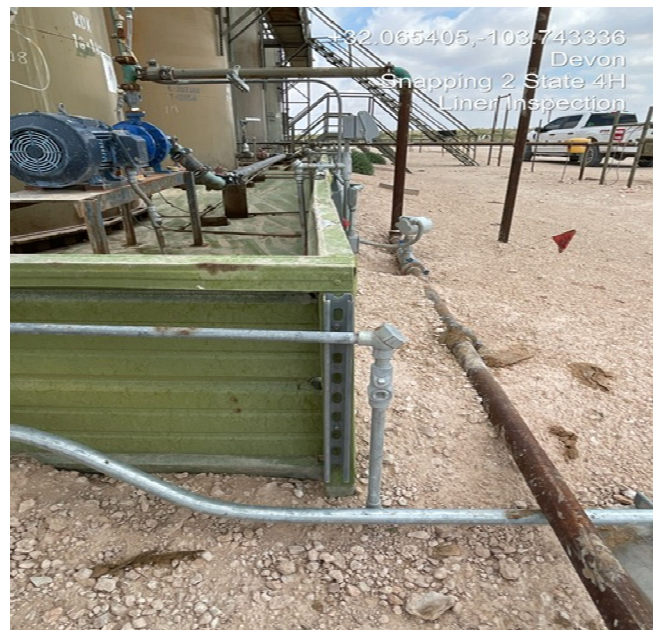
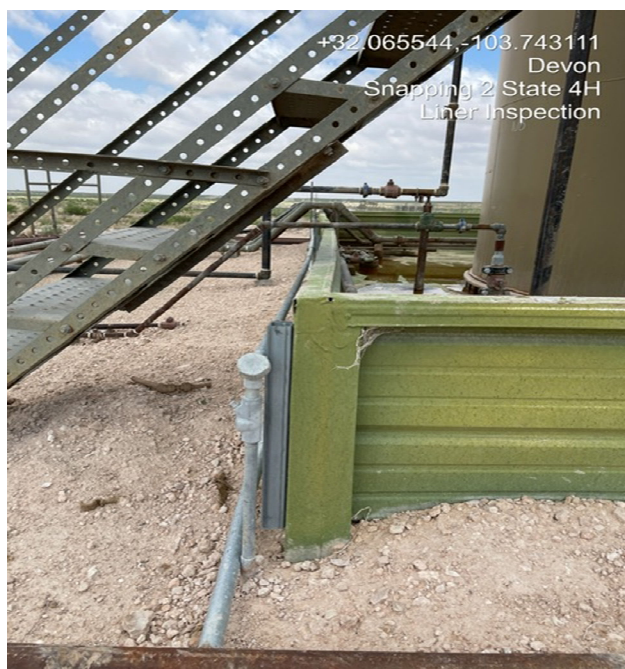
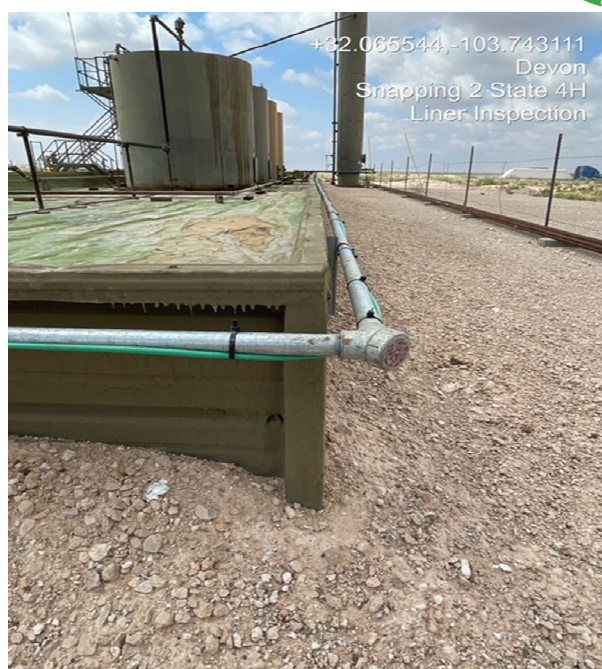
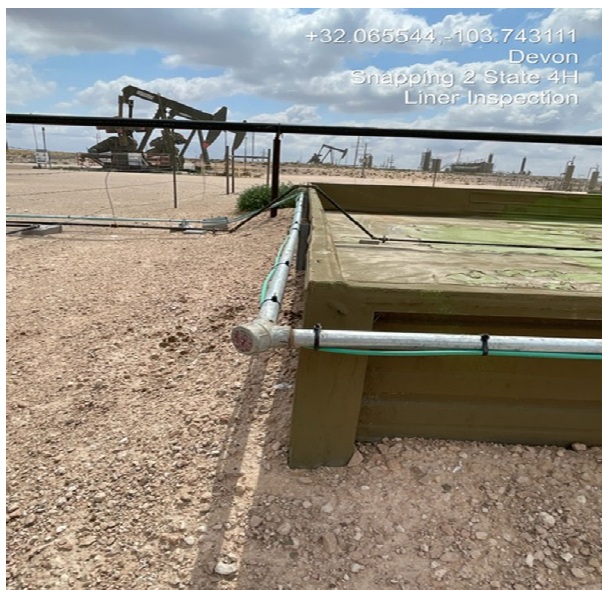
On June 4th, 2023, after sending the 48-hour Notification (Appendix C) via email, Pima Environmental conducted a liner inspection at the Snapping. We concluded that this liner and containment maintained its integrity and was able to retain the fluids. The Liner Inspection form and photographic documentation can be found in Appendix D.

Visualization	Yes	No	Comments
Is there a tear in the liner?		X	
Are there holes in the liner?		X	
Is the liner retaining any fluids?		X	
Does the liner have integrity to contain a leak?	X

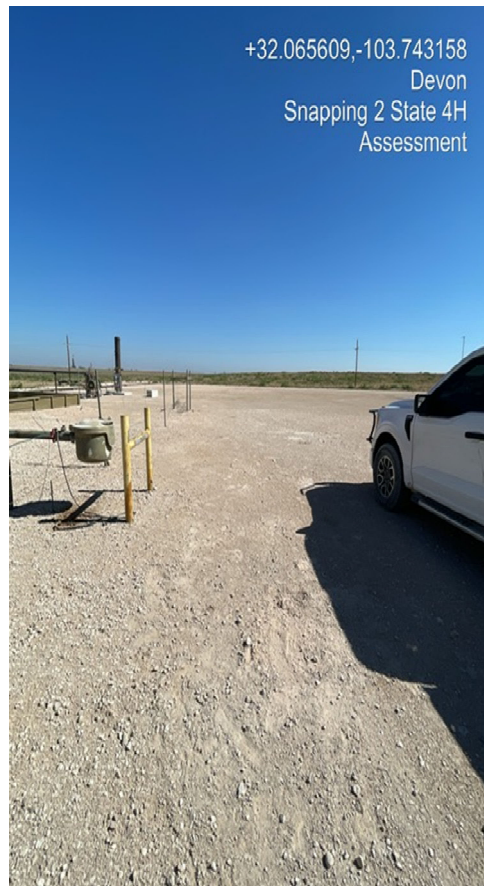
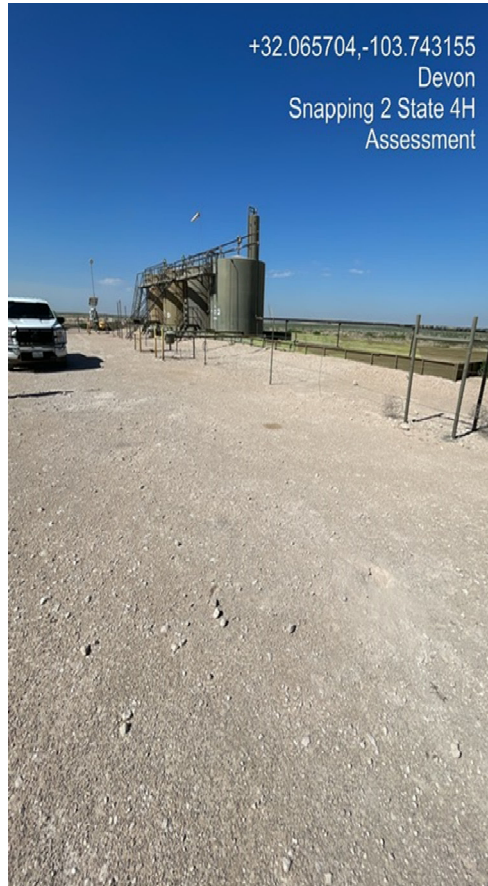
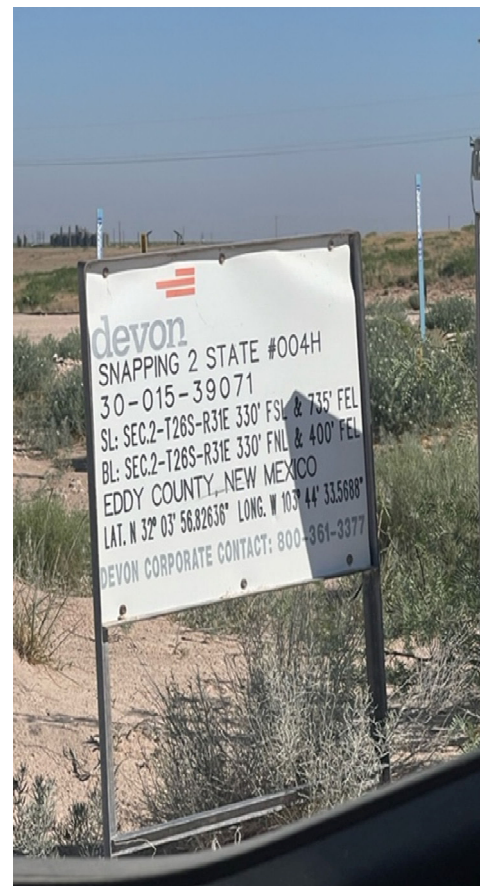
Assessment

Based on the sample results, the bottoms and sidewalls are below NMOCD Closure Criteria 19.15.29 NMAC. See Appendix D for Photographic Documentation.
