Incident ID	NAPP2310456005
District RP	
Facility ID	
Application ID

May 23, 2023

Re: Site Assessment, Remediation, and Closure Report
Derringer Federal SWD #1
API No. 30-015-30828
GPS: Latitude 32.568079 Longitude -104.115857
UL - N, 18, T20S, R29E
Eddy County, NM
NMOCD Ref. No. NAPP2310456005

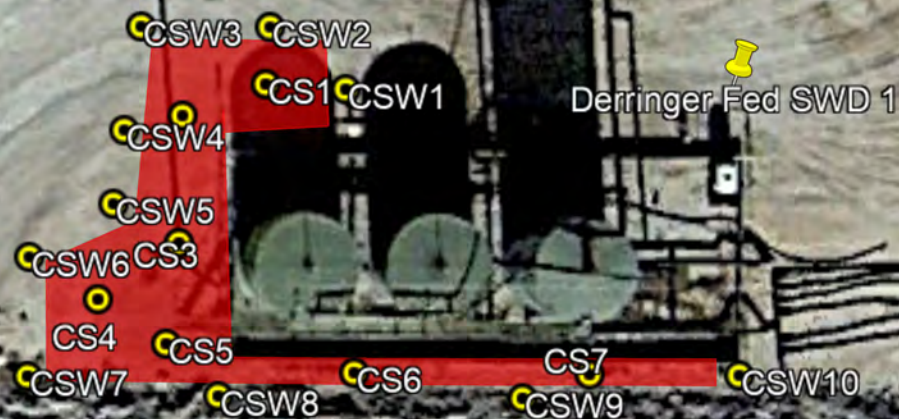
Confirmation Samples

On April 23, 2023, after sending a 48-hour notification (Appendix C), Pima returned to the site to collect confirmation samples of the excavation. The results of this sampling event can be found in the following table. A Confirmation Sample Map can be found in Figure 5.

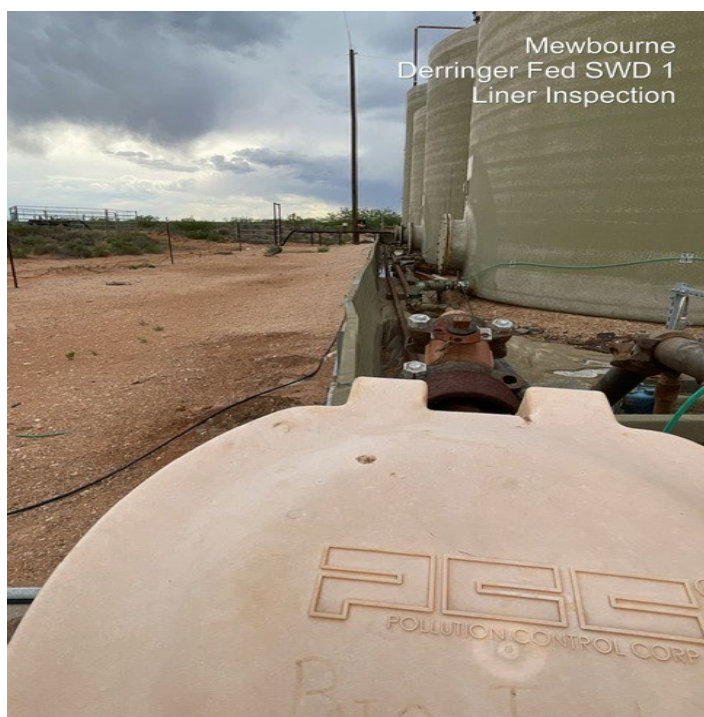
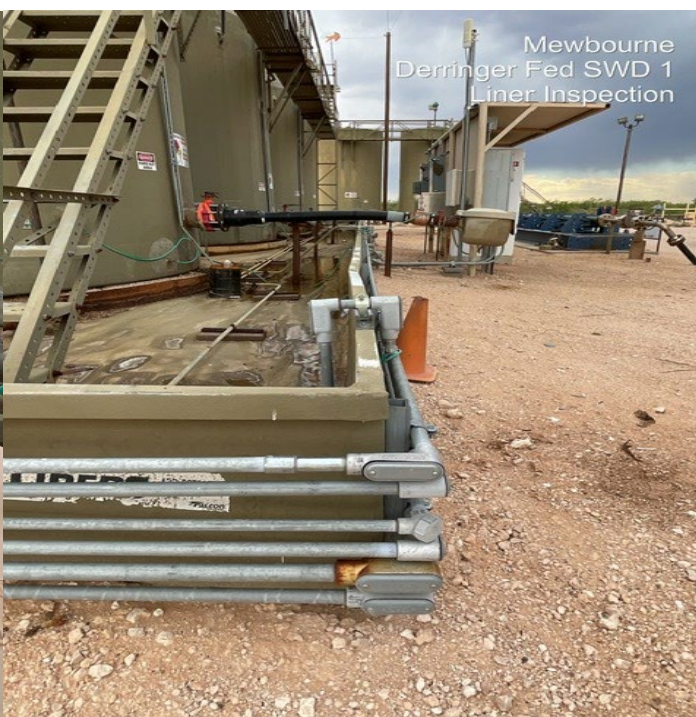
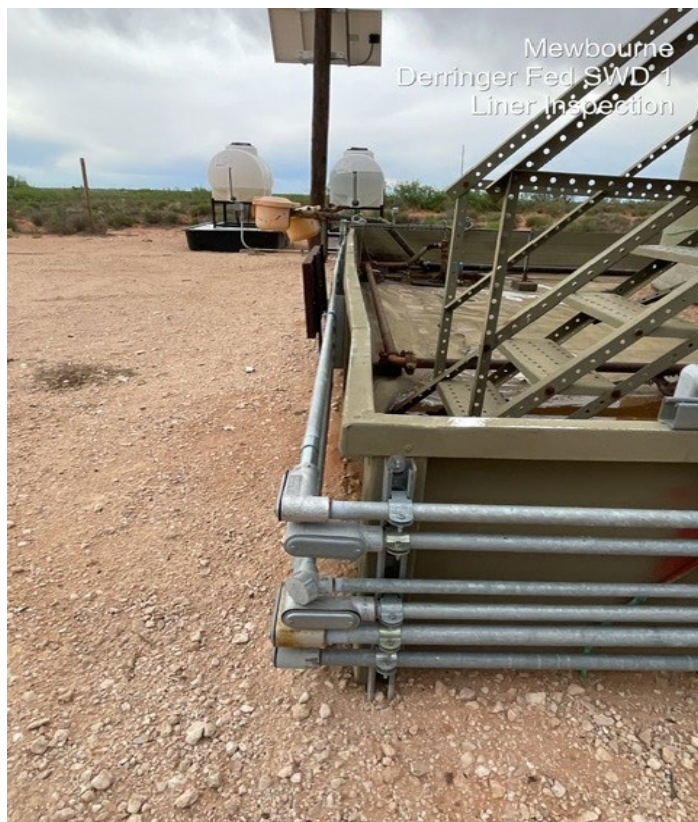
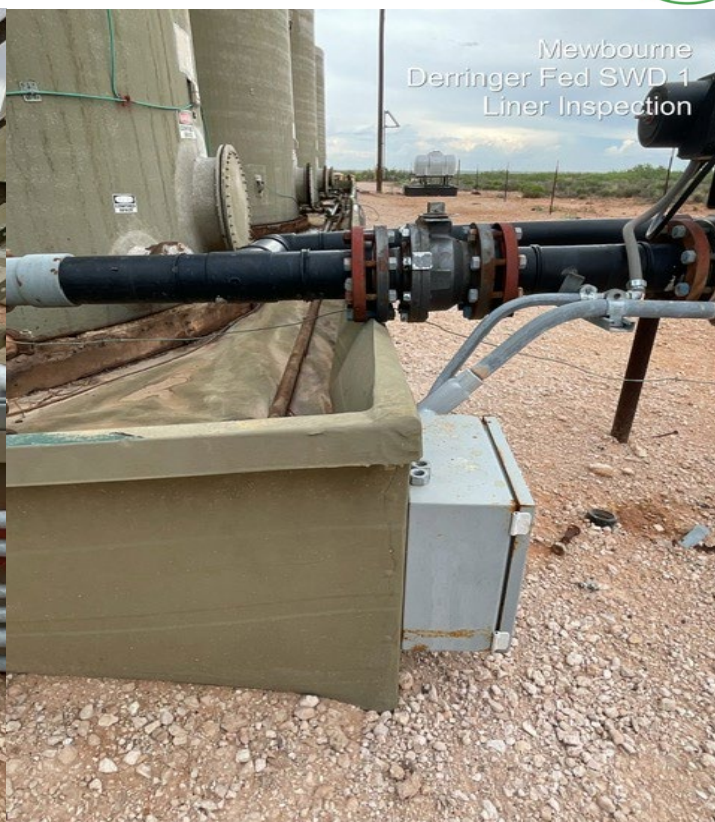
On April 30, 2023, after sending the 48-hour Notification (Appendix C) via email, Pima Environmental conducted a liner inspection at this location. We concluded that this liner and containment maintained its integrity and was able to retain the fluids. The Liner Inspection Form and photographic documentation can be found in Appendix D.
