**Re: REVISED Closure Report
ConocoPhillips
(Heritage COG Operating LLC)
West Brushy 8 Federal SWD #001 Release
Unit Letter A, Section 08, Township 26 South, Range 29 East
Eddy County, New Mexico
Incident ID# nAB1702748717
2RP-4094**

REVISED Closure Report
October 30, 2023

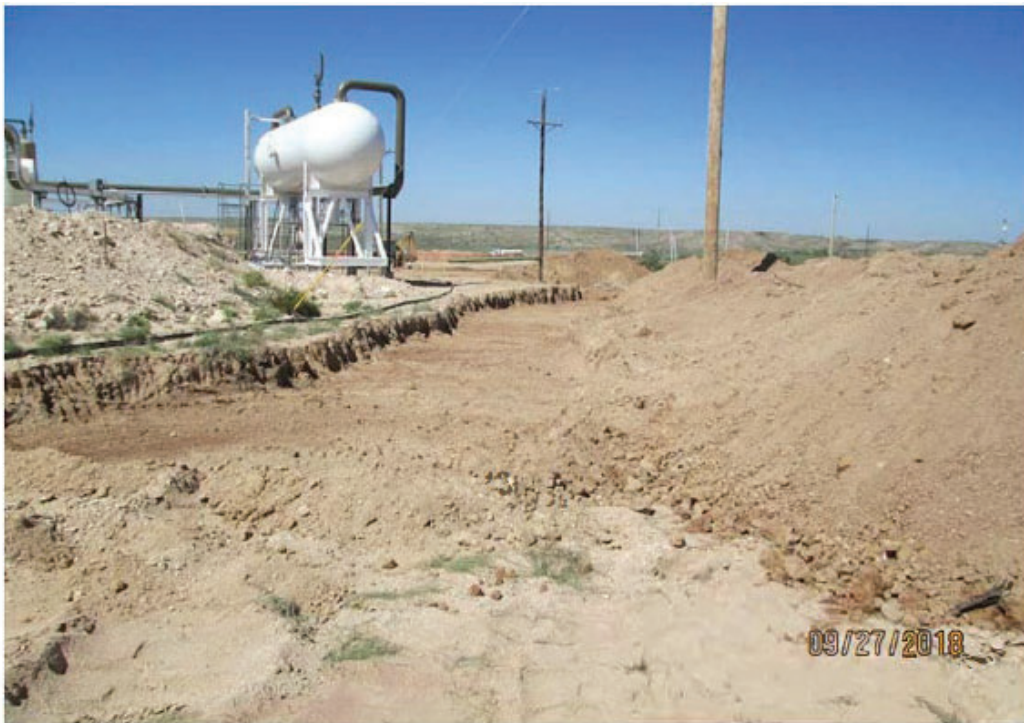
TETRA TECH, INC. PROJECT NO. 212C-MD-02997	DESCRIPTION	View north of open excavation in vicinity of SP3 to approximately 2-3 ft bgs. Power poles and high-pressure tank to rear.	1
	SITE NAME	West Brushy 8 SWD #001 Release	9/27/2018

- Photographic documentation of remedial activities from the Closure Report was geolocated to identify areas associated with Incident ID nAB1702748717, and these photographs confirm that the area was excavated to the proposed depths of 2-3 feet bgs.

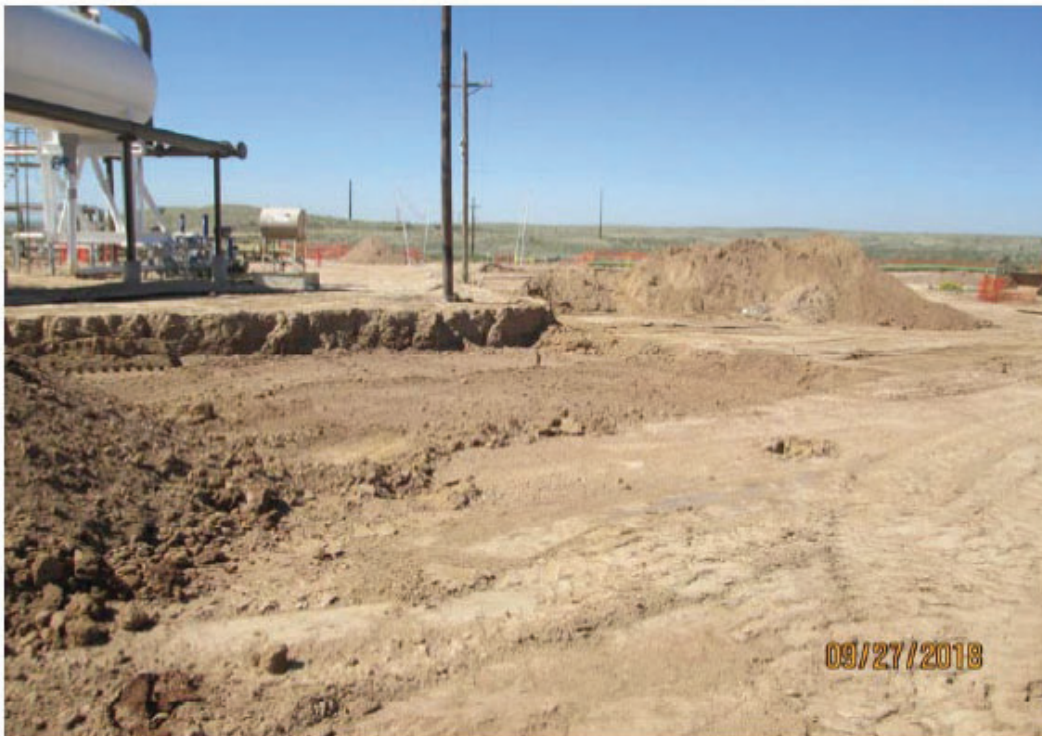
TETRA TECH, INC. PROJECT NO. 212C-MD-02997	DESCRIPTION	View north of open excavation in vicinity of SP2 to approximately 3 ft bgs. Power poles and high-pressure tank in view.	2
	SITE NAME	West Brushy 8 SWD #001 Release	9/27/2018

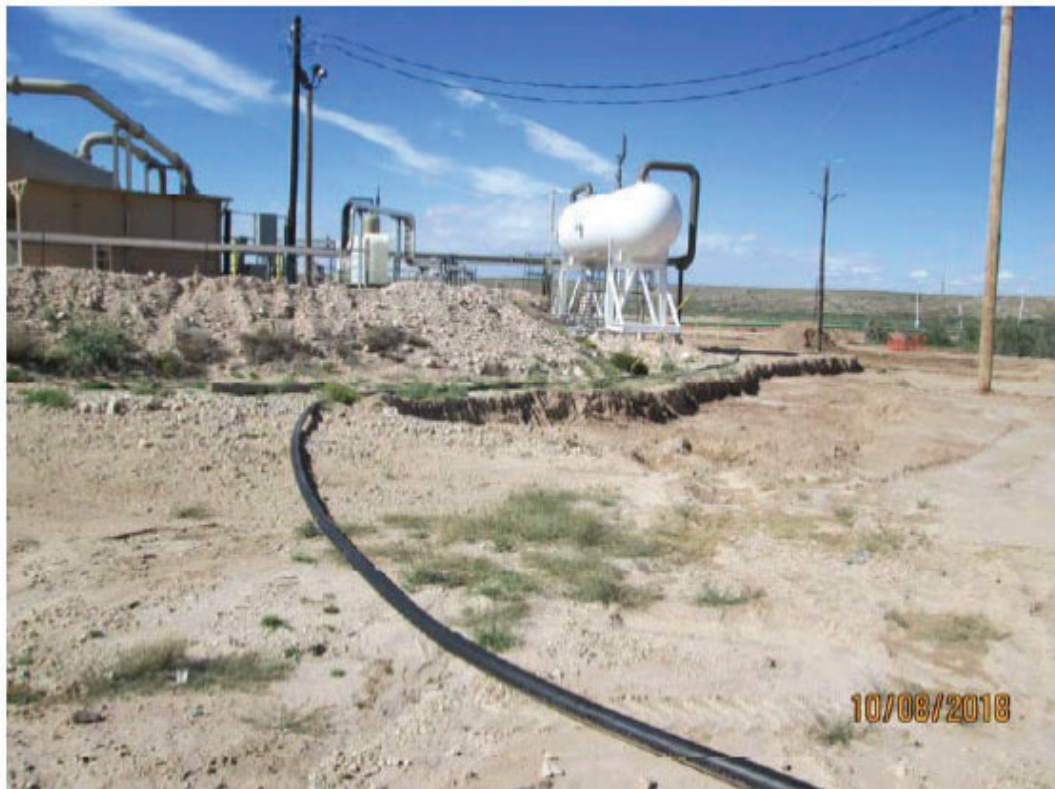
TETRA TECH, INC. PROJECT NO. 212C-MD-02997	DESCRIPTION	View north of open excavation in vicinity of SP3 to approximately 2 ft bgs. Power poles and high-pressure tank in view.	3
	SITE NAME	West Brushy 8 SWD #001 Release	10/08/2018

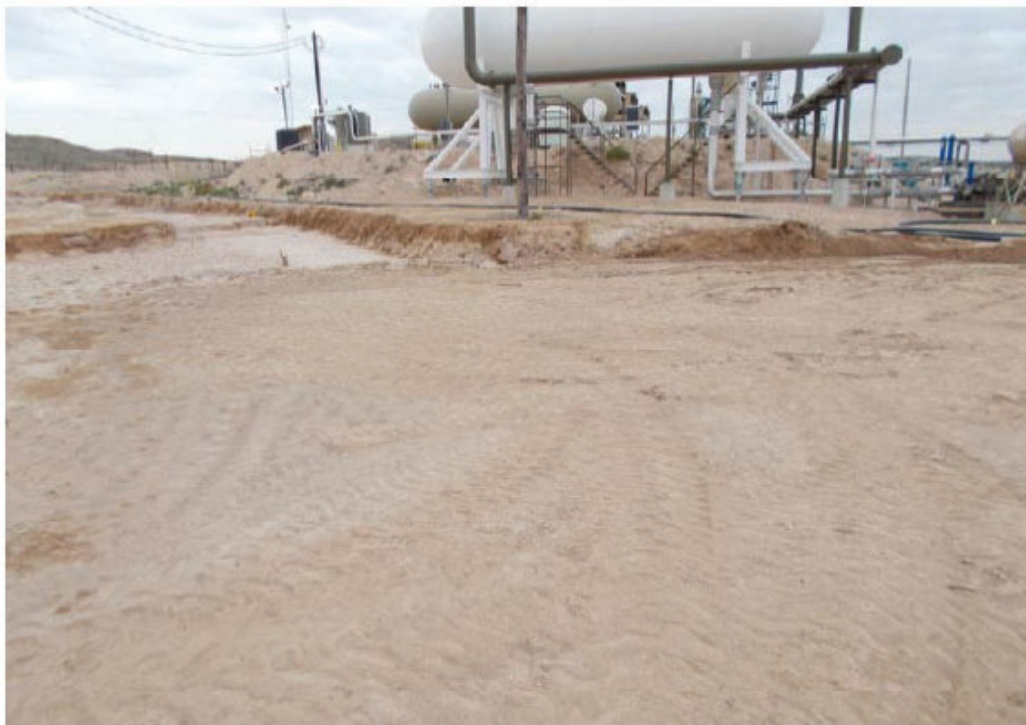
TETRA TECH, INC. PROJECT NO. 212C-MD-02997	DESCRIPTION	View west of open excavation in vicinity of SP1 to approximately 3 ft bgs. High-pressure tank in view.	4
	SITE NAME	West Brushy 8 SWD #001 Release	10/08/2018

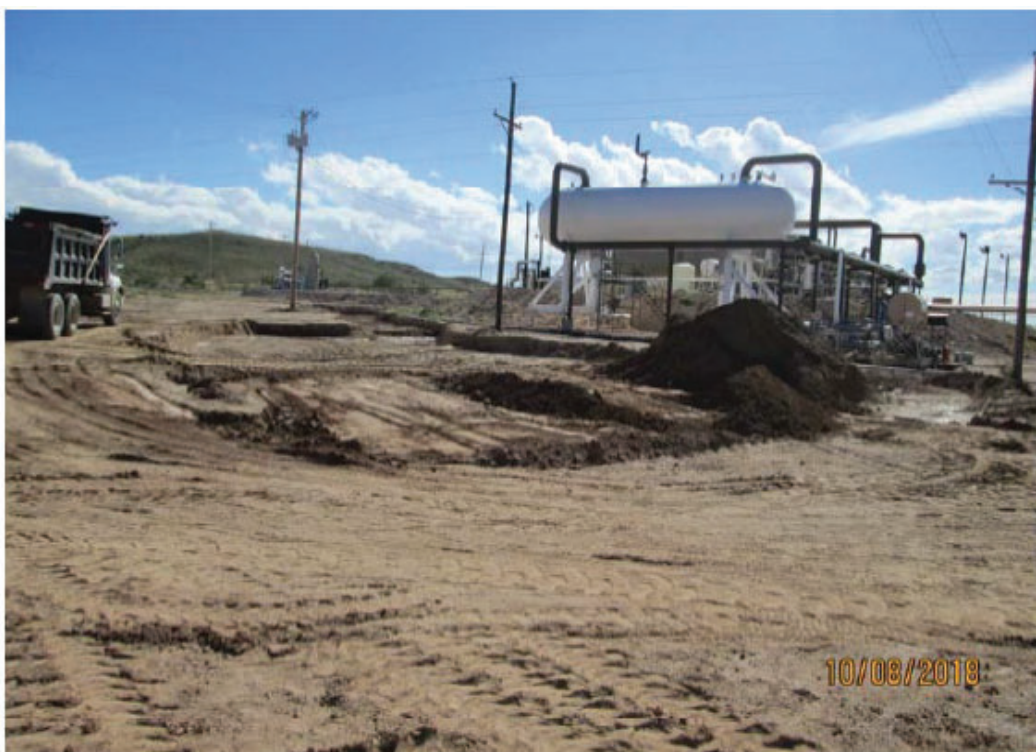
TETRA TECH, INC. PROJECT NO. 212C-MD-02997	DESCRIPTION	View southwest of open excavation in area of SP1 to approximately 3 ft bgs. Power poles and high-pressure tank in view.	5
	SITE NAME	West Brushy 8 SWD #001 Release	10/08/2018

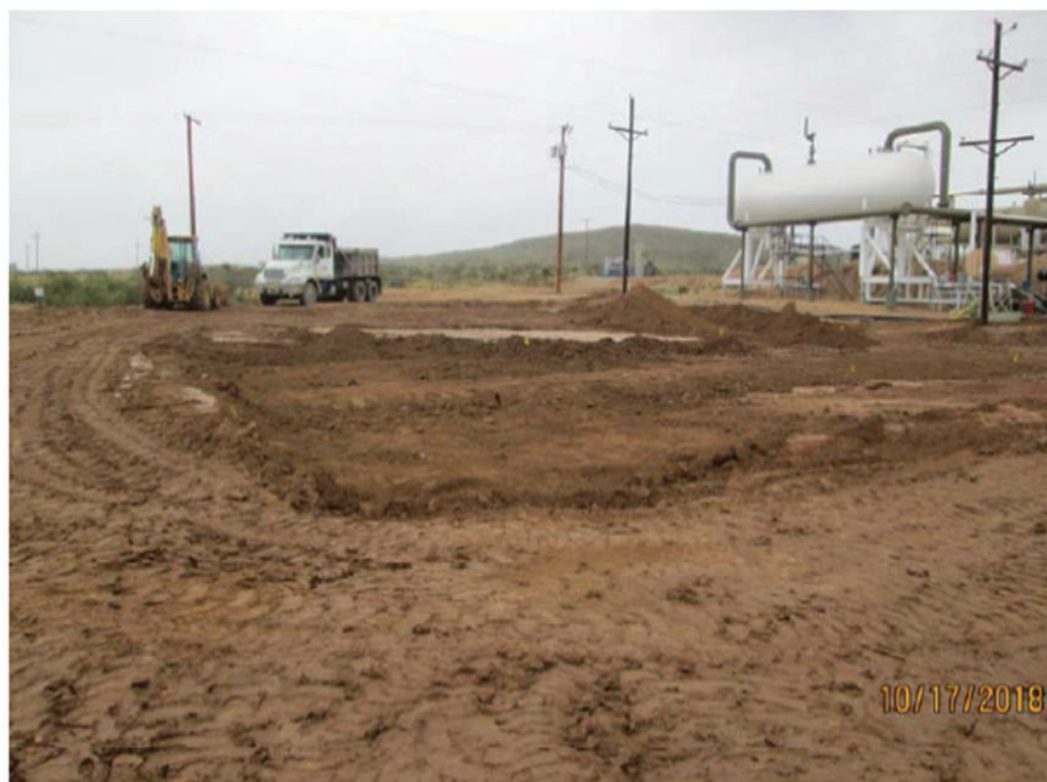
TETRA TECH, INC. PROJECT NO. 212C-MD-02997	DESCRIPTION	View south of backfilling operations. Power poles and high-pressure tank to west.	6
	SITE NAME	West Brushy 8 SWD #001 Release	10/17/2018

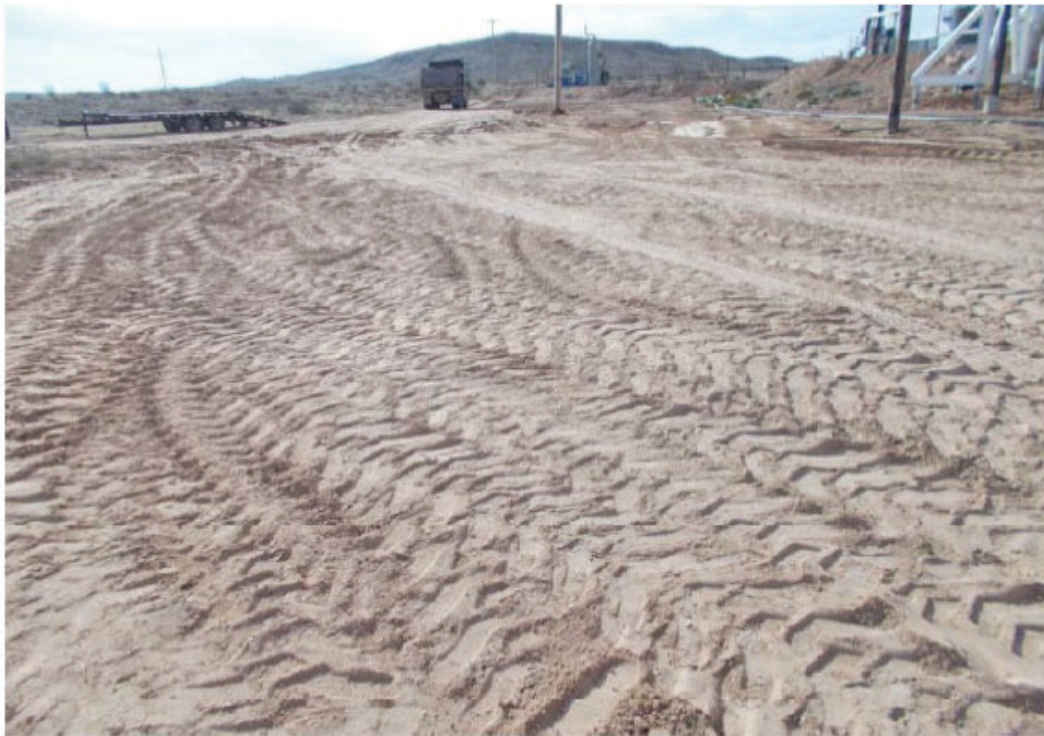
TETRA TECH, INC. PROJECT NO. 212C-MD-02997	DESCRIPTION	View west of backfilled area south of facility infrastructure.	7
	SITE NAME	West Brushy 8 SWD #001 Release	10/17/2018

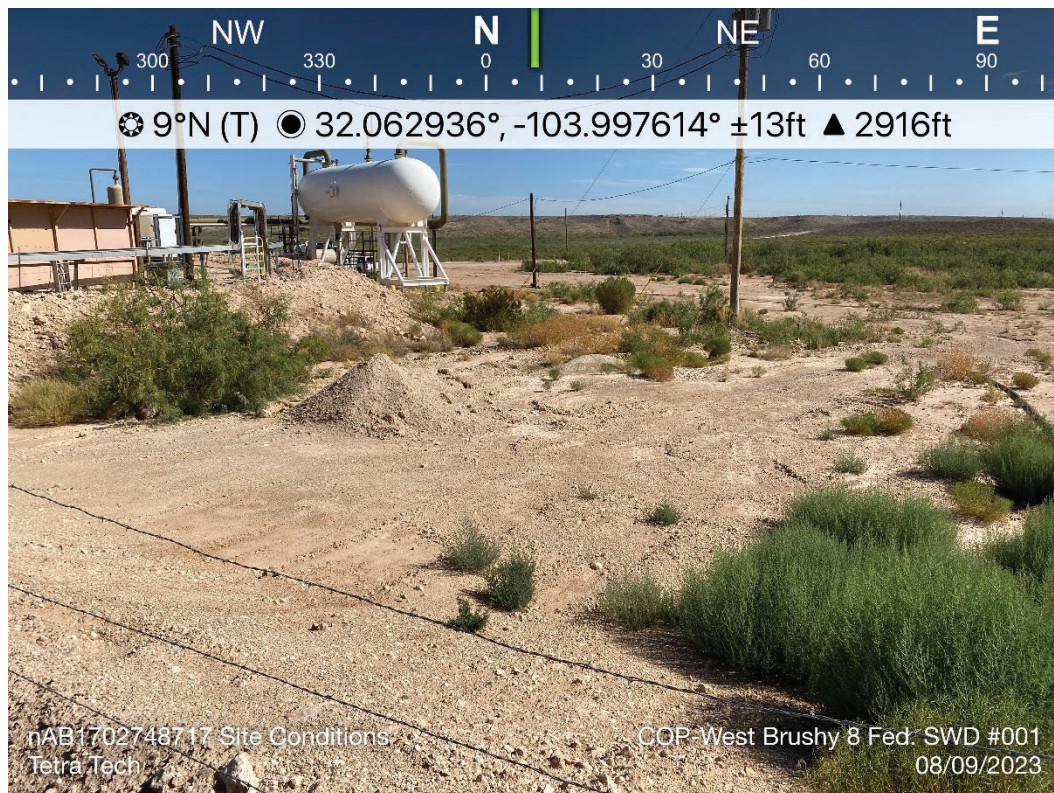
TETRA TECH, INC. PROJECT NO. 212C-MD-02997	DESCRIPTION	View north of 2023 site conditions. Equipment yard fencing visible in foreground.	8
	SITE NAME	West Brushy 8 SWD #001 Release	8/9/2023

- No visible evidence (staining, odor, etc.) was observed in the former release area during the 2023 site visit evaluations.
- Vegetative growth was present in portions of the remediated area, which is currently being used for active production activities.

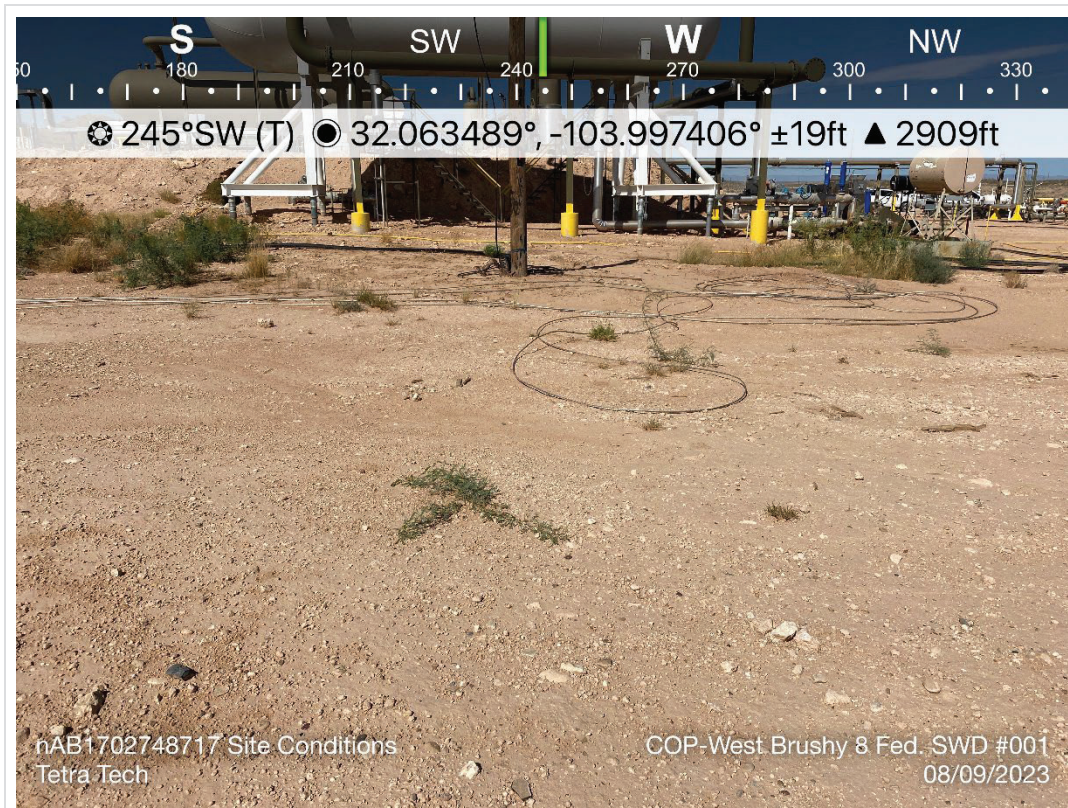
TETRA TECH, INC. PROJECT NO. 212C-MD-02997	DESCRIPTION	View west-southwest of 2023 site conditions.	9
	SITE NAME	West Brushy 8 SWD #001 Release	8/9/2023

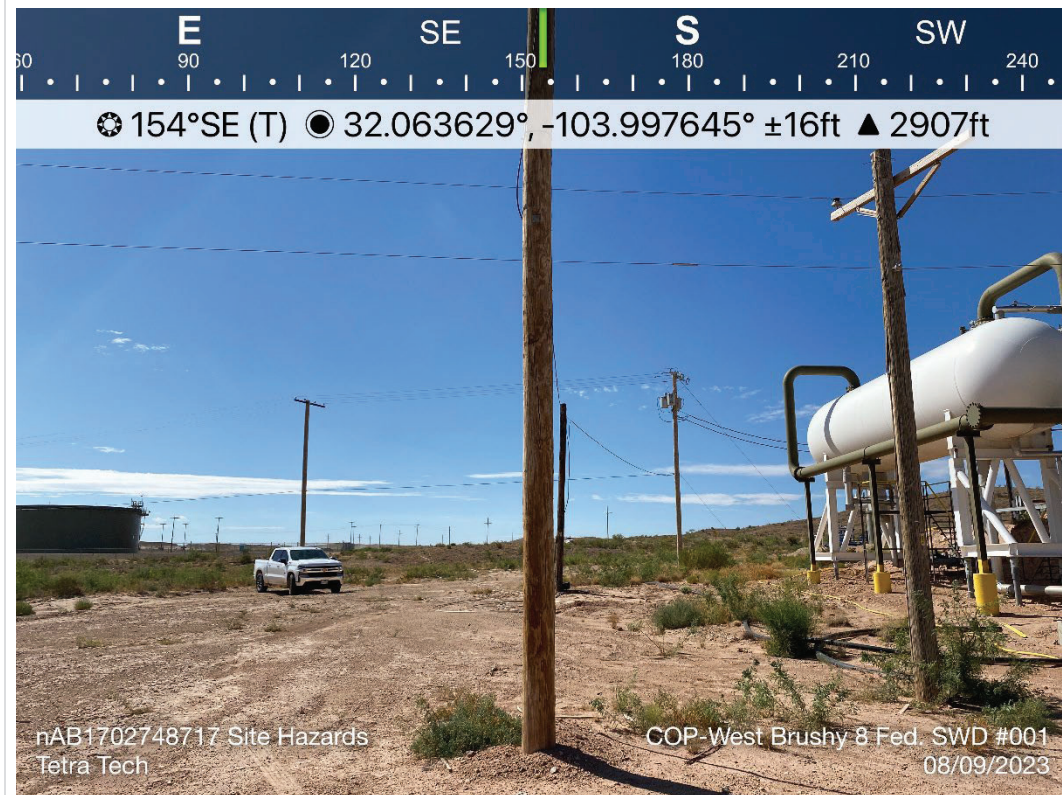
TETRA TECH, INC. PROJECT NO. 212C-MD-02997	DESCRIPTION	View south-southeast of 2023 site conditions.	10
	SITE NAME	West Brushy 8 SWD #001 Release	8/9/2023
